Legacy Roads and Trails Monitoring Project

Road Decommissioning in the Bull Run River Watershed

Mt. Hood National Forest

December 2, 2011

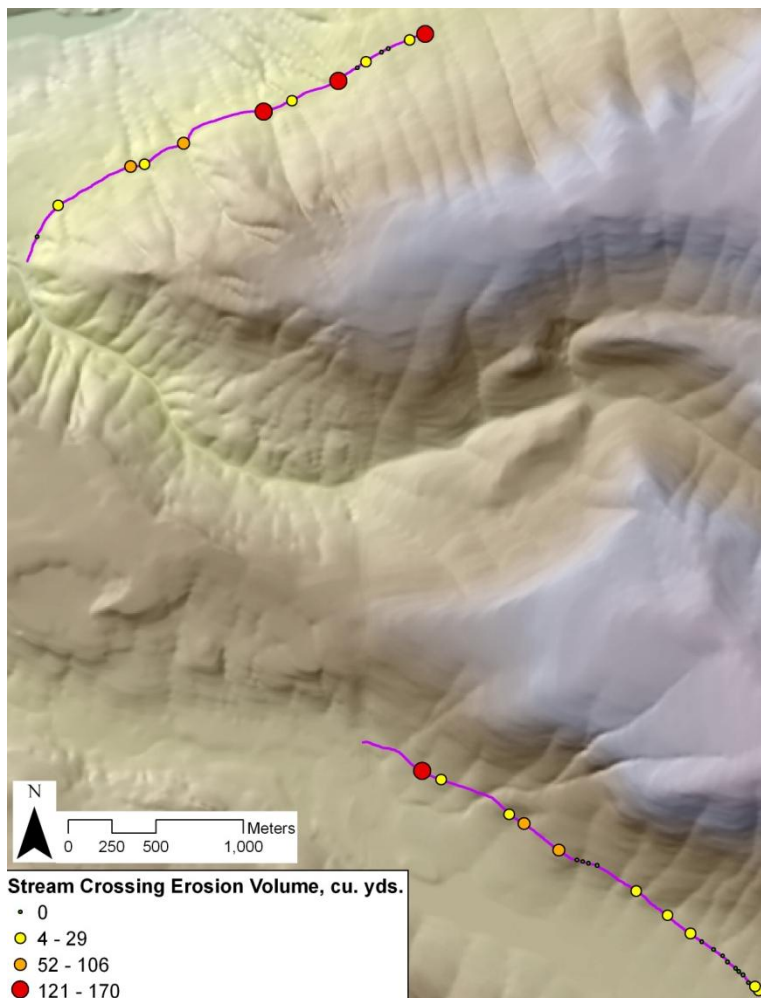
At 21 of 36 (58%) observed post-treatment stream crossings, high flows due to the storm-event resulted in the crossings becoming scoured and eroding large amounts of sediment from the channel bottoms (Figures 8-10). This sometimes led to failures along the side slopes, which were undercut. Further side slope failures can be expected due to this undercutting. A tape was used to estimate the volume of sediment eroded from the stream crossings to the nearest cubic yard. 956 yd³ of sediment was eroded from the channel bottoms, and 122 yd³ was eroded from the side slopes in this manner, for a total of 1,078 yd³ and an average of 30 yd³ per crossing (Table 7). This is consistent with Cook and Dresser (2010), who found an average of 28 yd³ of erosion in similar environments. This volume is 8% of the fill volume that could be expected to eventually fail, had the crossings remained intact and untreated (13,010 yd³, above). The mass of the eroded sediment was about 1,300 tonnes (calculated using a bulk density of the fill of 1.6 tonnes/m³; Madej, 2001).

Figure 8. Locations and quantities of stream crossing channel erosion along both decommissioned roads.

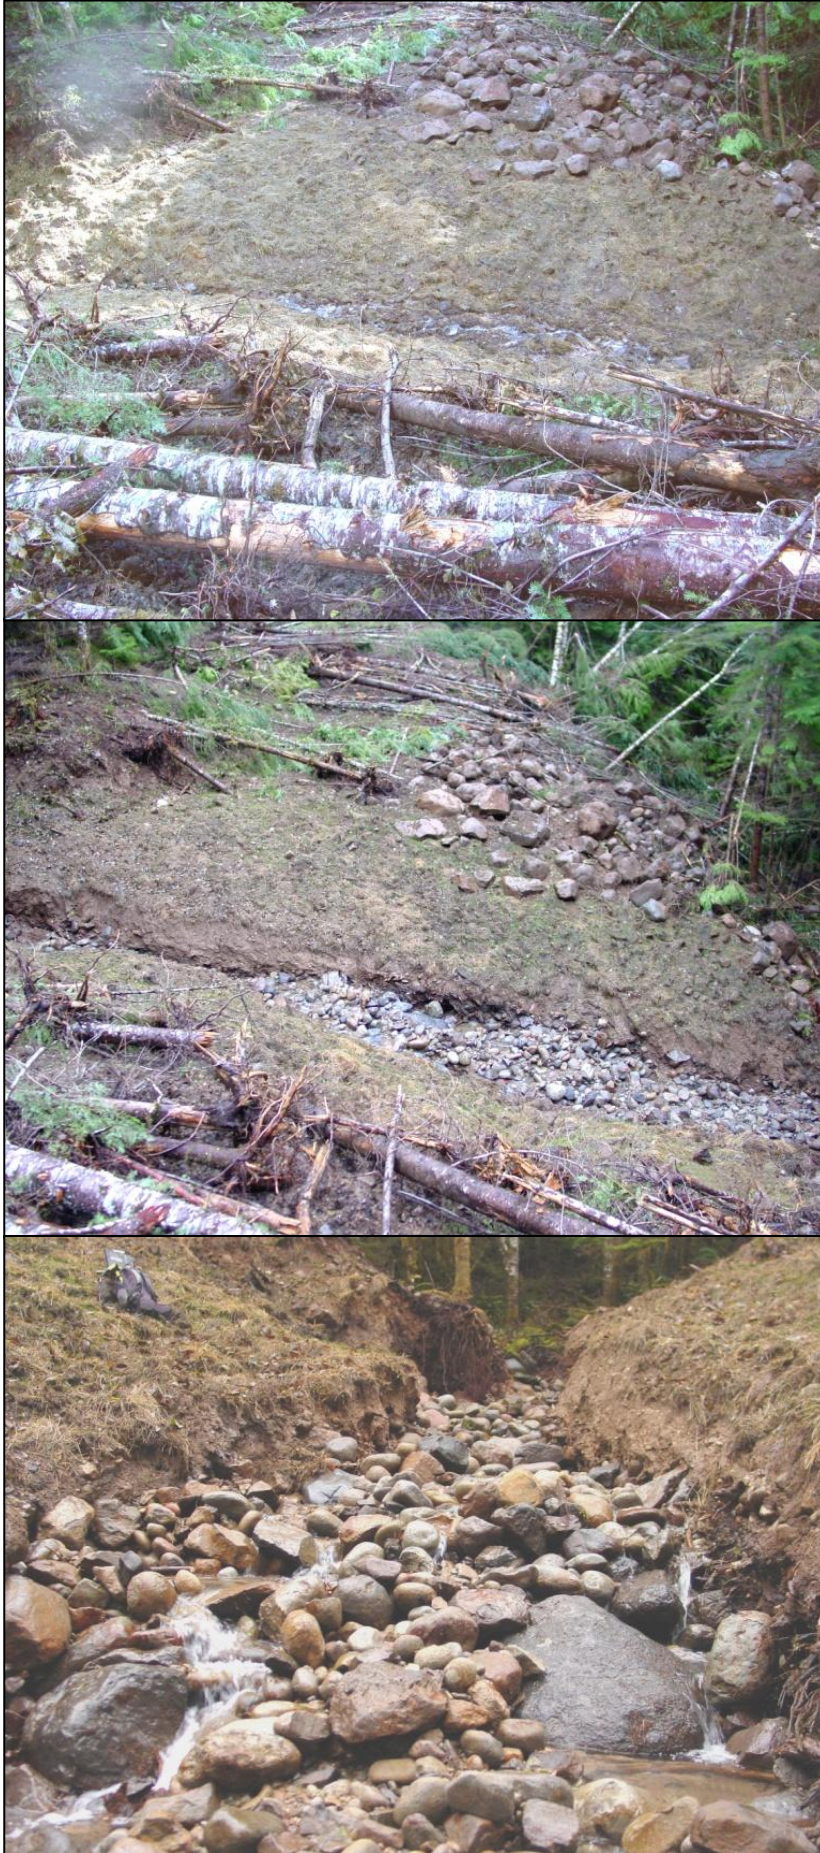
Figure 9. Excavated stream crossing on NFSR 1210428. Condition before the storm (top), with some scour already present; view from same location after the storm (middle); and view in the channel after the storm (bottom). 178 yd³ of sediment was eroded from this crossing during the storm. This crossing was located on an unstable stream channel that runs through an historic landslide (T. Parker, personal communication, 2011)

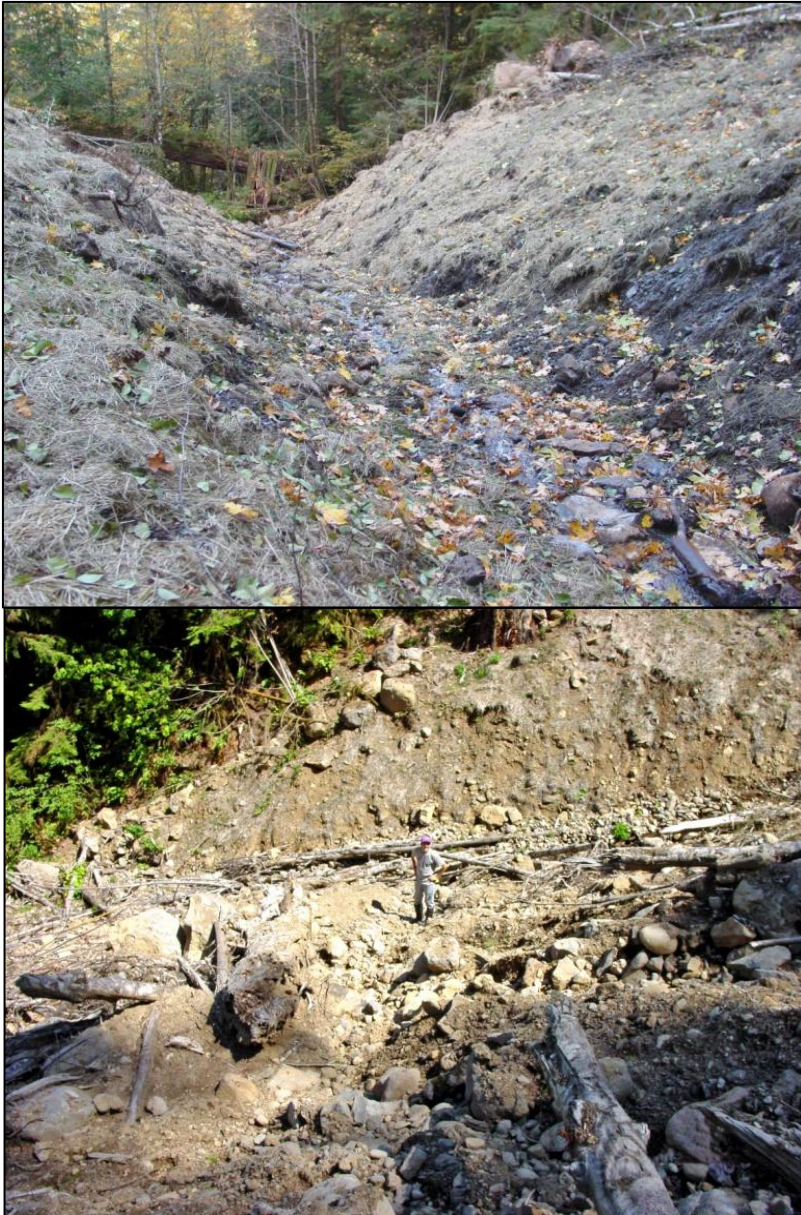
Figure 10. Excavated stream crossing on NFSR 1211000. Condition before storm (top) and after storm (bottom). 121 yd³ of sediment was eroded from this crossing by the storm.

During the field survey, it was visually observed that failures of this nature most commonly occurred at crossings with channel bottoms that were too narrow relative to the stream width and had a longitudinal slope that was shallower than the natural channel. Erosion depth was typically limited to the level of the buried natural soil surface and crossing sediment sizes became coarser after the storm, as finer sediments were washed away. Project design criteria generally called for crossing channel widths to be 1.1 bank full stream widths, for side slopes to not exceed 50% slope, and for longitudinal crossing slopes to match the natural contours of the uphill stream. These criteria were not met in some places, which may have led to increased crossing erosion. For example, ten crossings had at least one side slope in excess of 50% slope. This suggests that had design criteria been met during the implementation phase, many of these problems may not have occurred.

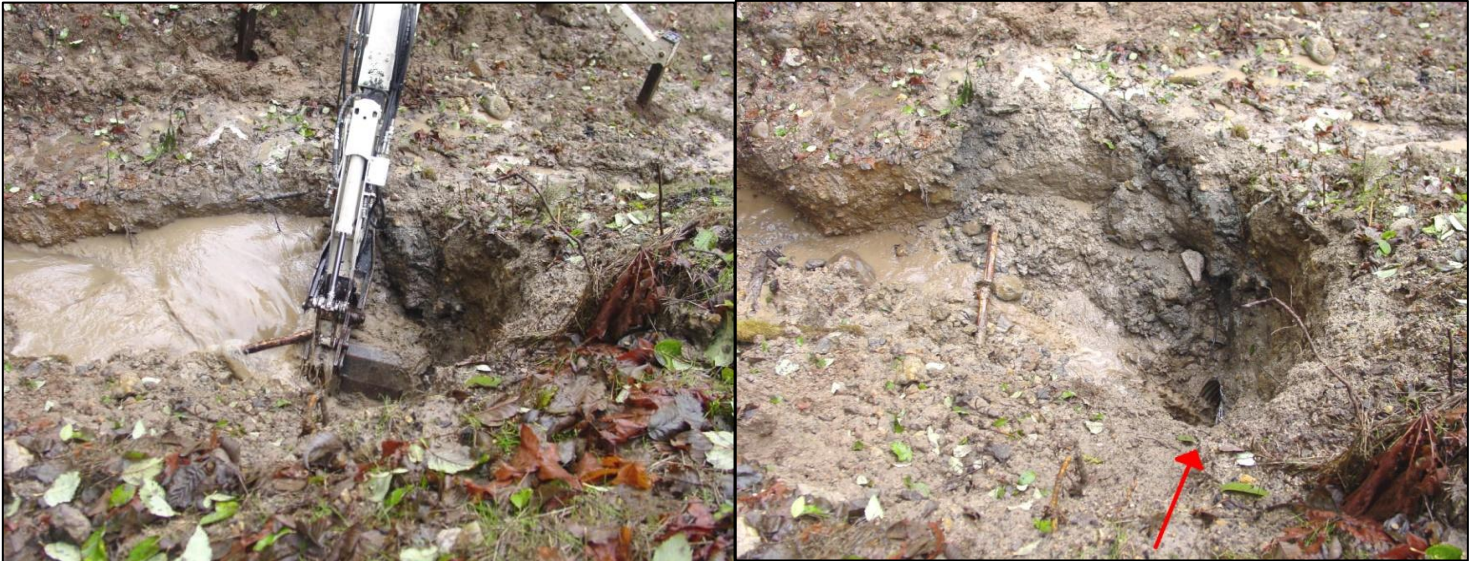
At one stream crossing, a previously unnoticed buried pipe was located after the treatment was complete. The pipe opening became scoured out and was routing water through it, allowing for possible further fill failure. A spider-type excavator was brought in to pinch the uphill end of the culvert closed and re-bury the opening, so that it would no longer be able to divert water from the intended excavated channel bottom (Figure 12). This reduced or eliminated the risk of further failure due to the culvert. Additionally, the crossing was slightly re-shaped to reduce the risk of side slope failure. This illustrates the importance and difficulty of finding and removing old and potentially buried culverts.

Figure 11. Excavated crossing on NFSR 1211000 that had a second buried pipe. The spider excavator dug down to the pipe opening (top), and exposed the inlet (bottom, with arrow) before it was pinched closed and re-buried.

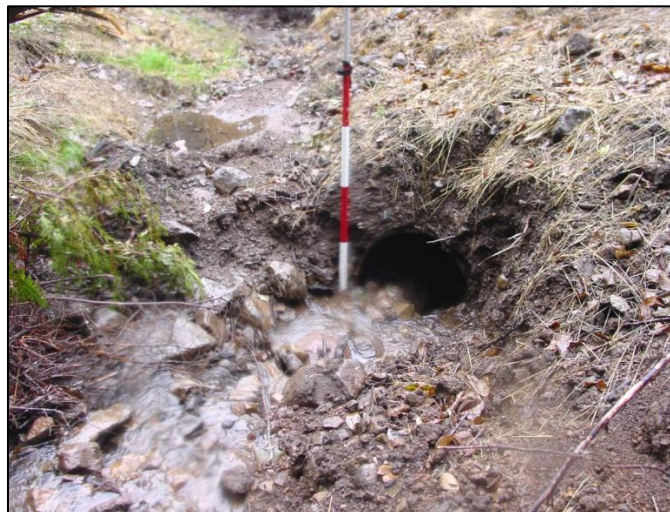
At another stream crossing on NFSR 1210428, a buried pipe was scoured out and was flowing water at the time of the post-storm event survey (Figure 12). There were no plans to treat this pipe as above (this crossing is about 1 km from the start of the road, as opposed to 300 m for the above crossing).

Figure 12. Second pipe that was left in after the crossing excavation and was flowing water at the time of the survey.

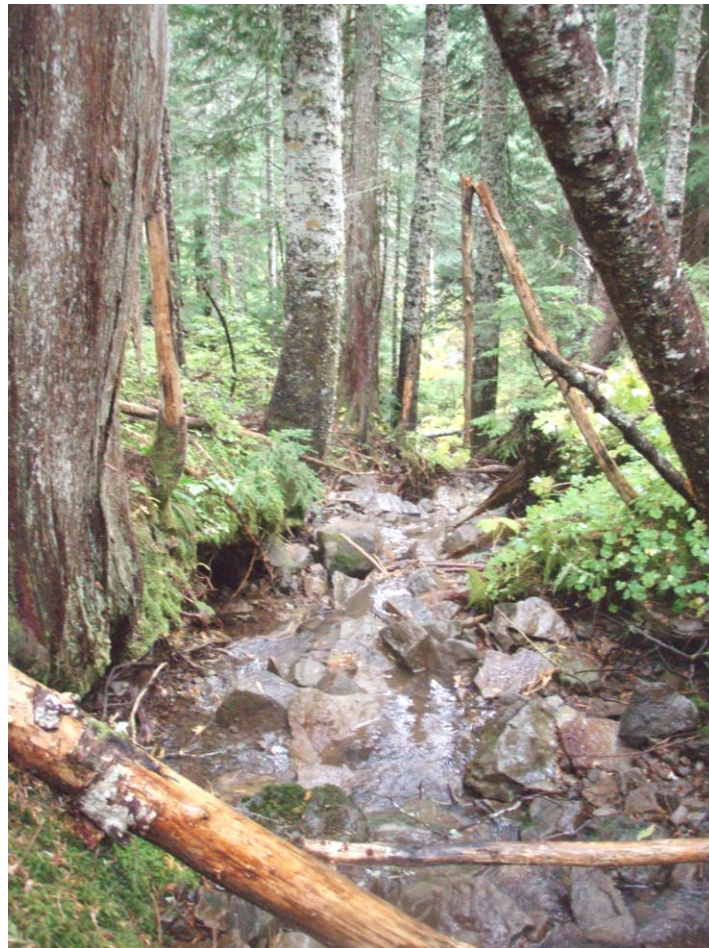
Control roads had an average SBI of 2.3 (Figure 14), and none of the 29 observed crossings had diversion potential. There was 4430 yd³ of fill at risk. One crossing on road 1200-222 was observed to have plugged and overtopped before the storm-event (Figure 13). This crossing had an SBI of 3. There were no changes to the stream crossings due to the storm event.

Figure 13. Stream diversion of the Little Sandy River on the 1200-222 control road. This was present during the pre-storm survey.

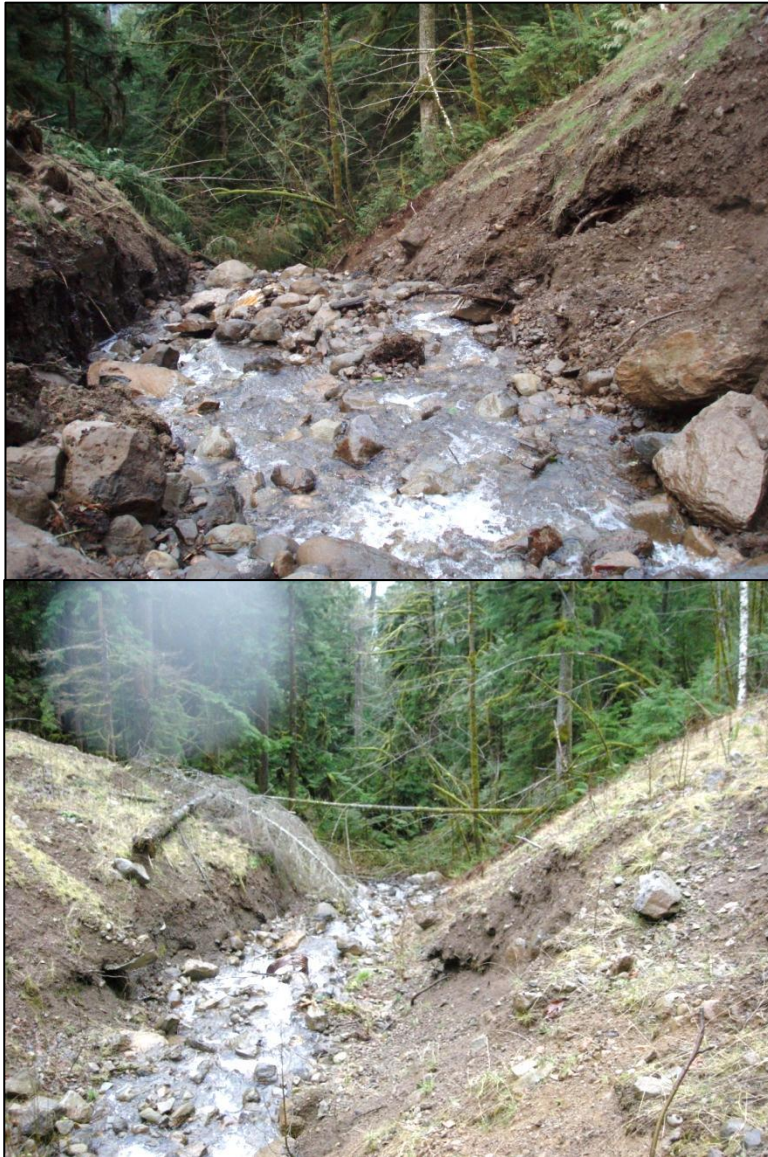
After another 25 year recurrence interval stream flow event in 2011 and 2012, further field reconnaissance was conducted by forest personnel. Though the side slopes of the stream crossings were still eroding to a stable angle, there was limited additional erosion observed overall (Figure 15). Stream crossing erosion may represent a one-time impact in this case, as the channels adjust to a stable slope and width.

Figure 15. Stream crossing in road 1211 in 2008 after the initial 25 year recurrence interval storm (top) and in 2012 after the more recent 25 year recurrence interval storms (bottom). There may be some side slope erosion, but no new major erosion was observed.

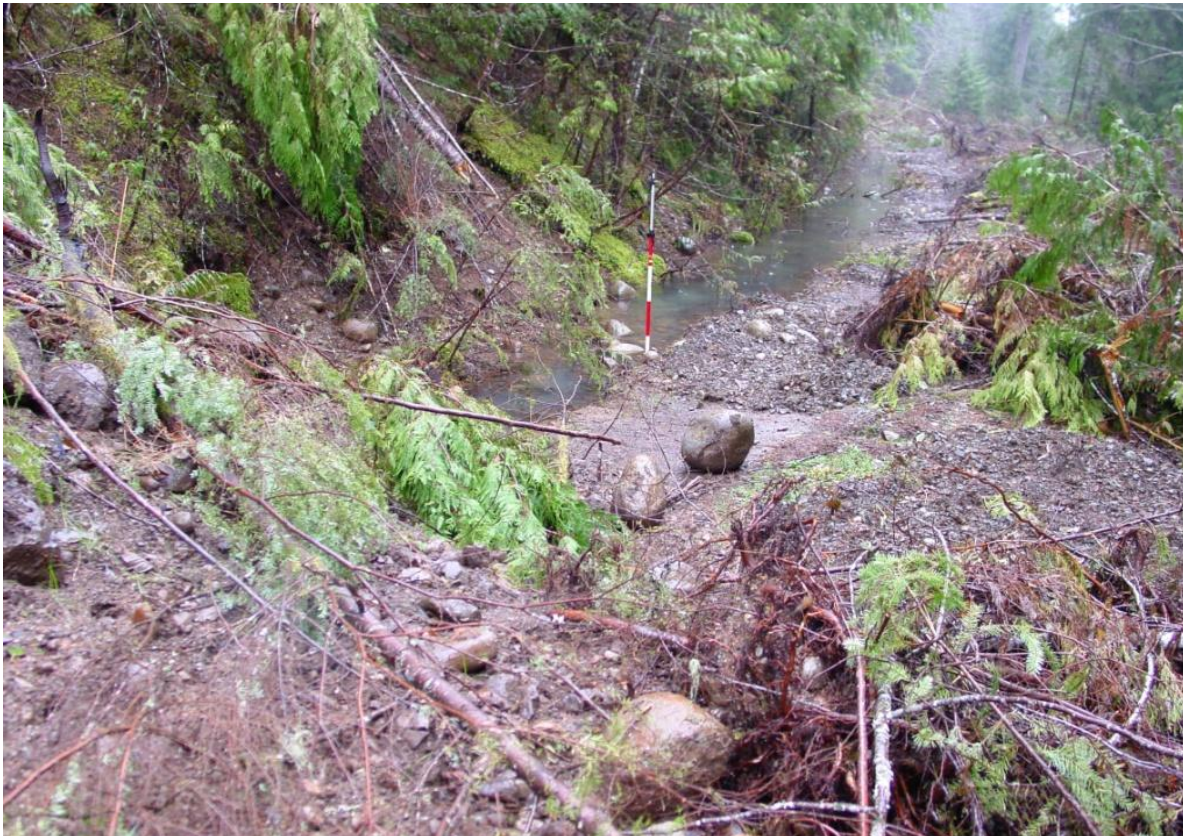
Figure 16. Pool behind a fill pile from a stream excavation on NFSR 1210428 that was placed on the uphill side of the crossing, preventing the water running down the ditch from draining.

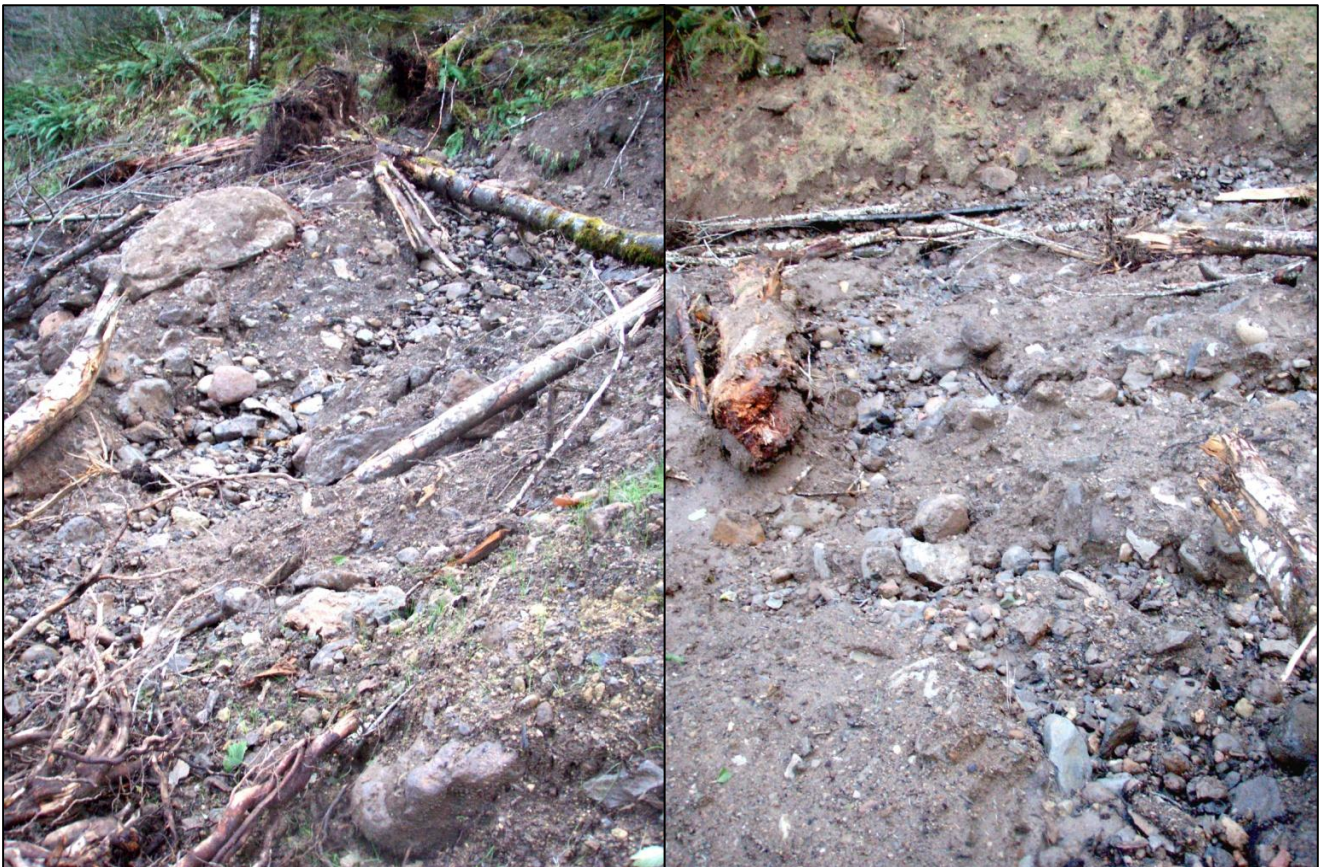
The post-storm monitoring revealed problems that were the result of poorly placed stream crossing excavation debris and fill, which became saturated in some places where it was placed on the uphill side of the crossing (6 of 36 crossing sites), which caused water to pool behind the fill pile and saturate (Figure 16). In one location, the fill pile was placed over top of a natural spring, which resulted in the fill becoming saturated and failing as small gullies and landslides into the crossing (Figure 17).

Figure 17. Spring that emits from a fill pile on NFSR 1211000. Upper part of pile (left), and channel from pile into the stream crossing (right).
