Power Fire GRAIP Watershed Roads Assessment

Bear River, Panther Creek, and
Upper North Fork Mokelumne River Watersheds
Eldorado National Forest, California

April, 2016

U.S. Forest Service

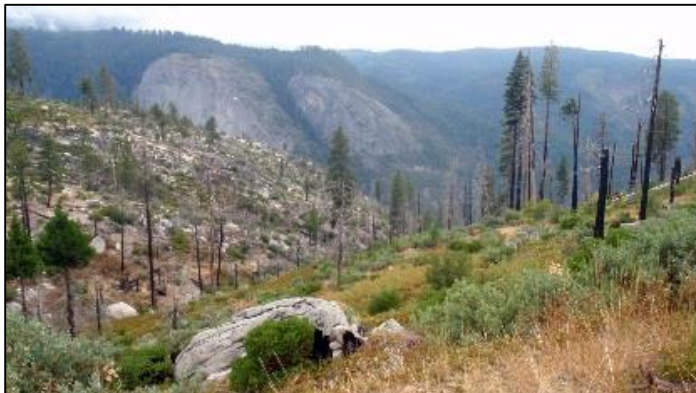
Figure 3. High severity burn area along road 8N16D in the Power Fire showing removal of forest cover in foreground, and intact forest in non-burned area in the North Fork Mokelumne River canyon in the background.

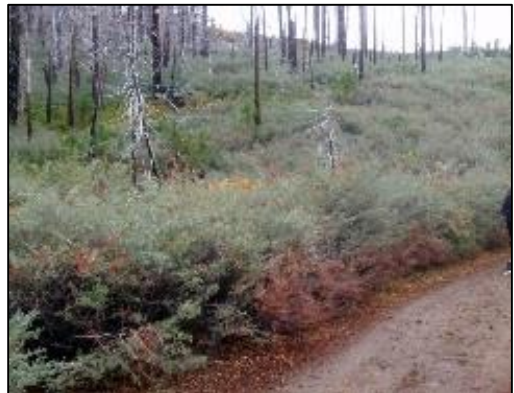
Figure 4. High severity burn area in the Power Fire showing dense shrub regrowth 10 years post-fire in 2014 on road 8N06.

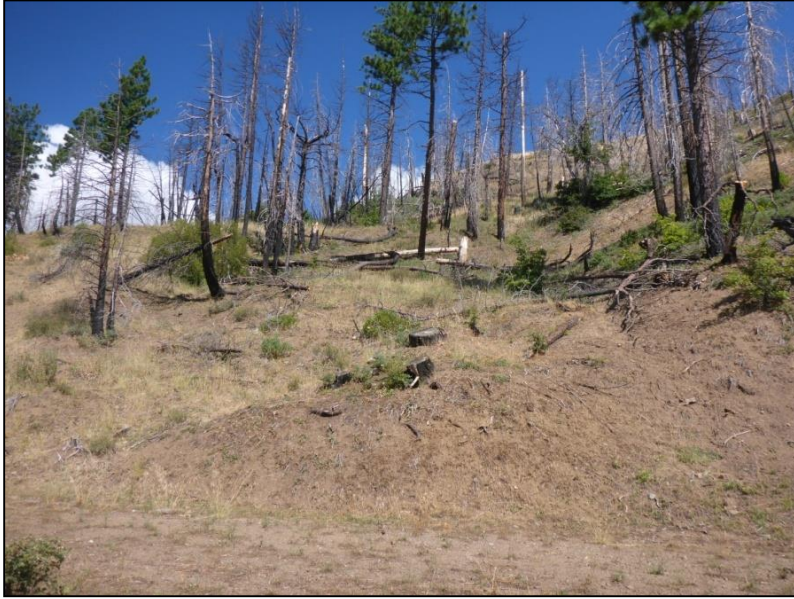
Figure 21. Cutslope failure type landslide.

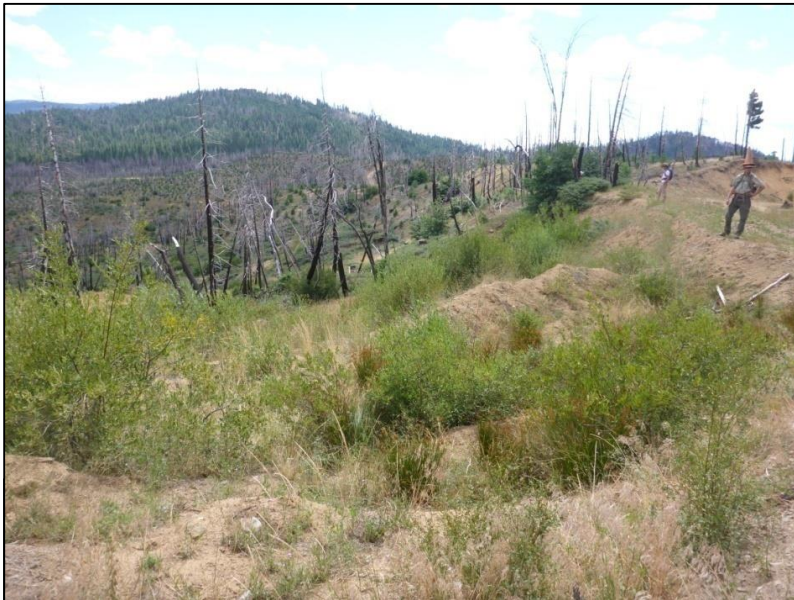
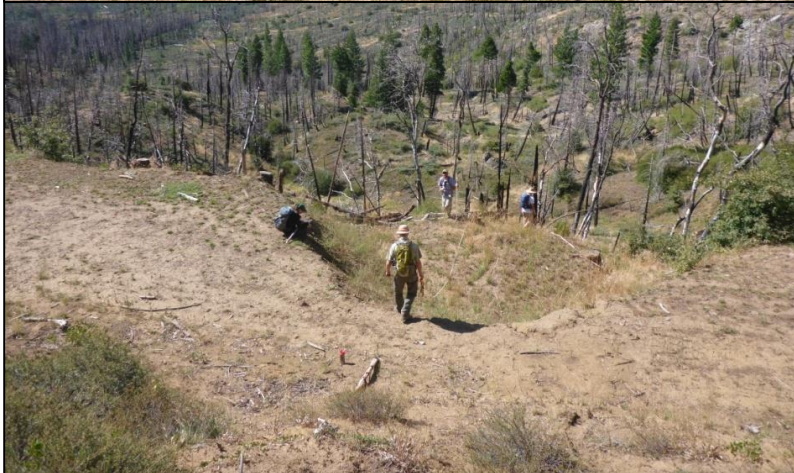
Figure 22. Fillslope failure type landslides.

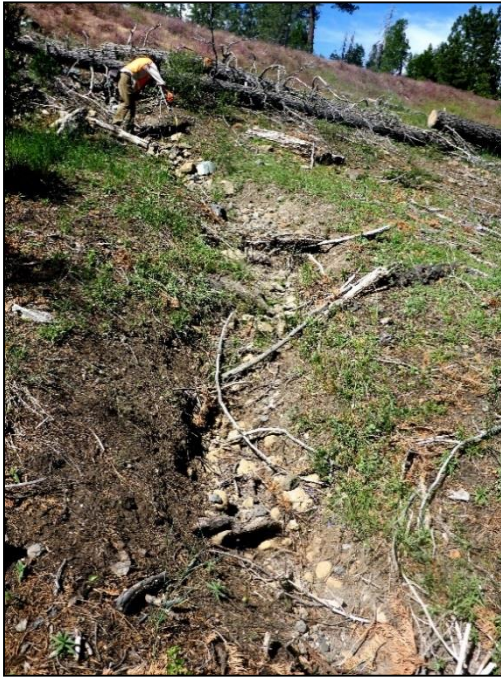
Figure 29. Gully below the outlet of a ditch relief culvert.

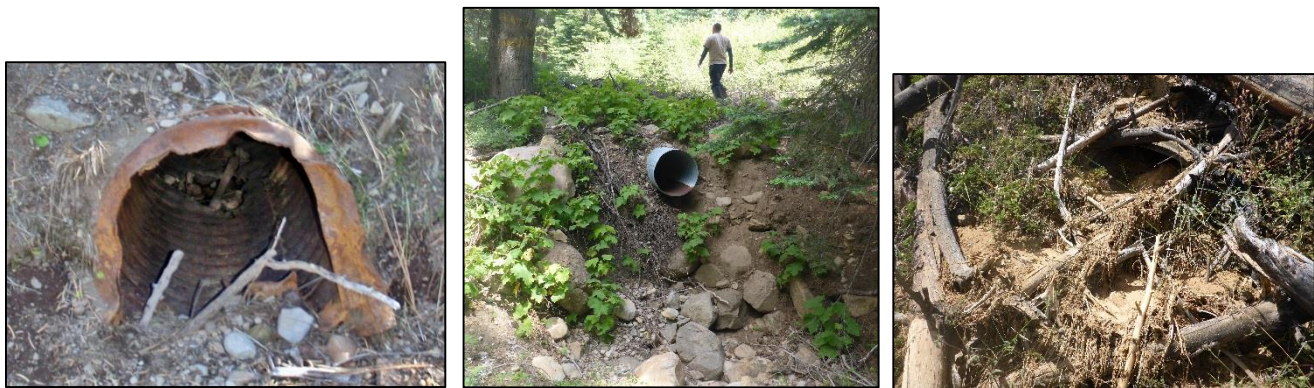
Figure 40. Problems with ditch relief culverts. The left culvert is rusted through. The middle culvert is set high in the fill. The right culvert has an occluded inlet.
