#### **RED APPLE FIRE**

**Red Apple Fire Burned Area Report**

**Emergency Assessment of Post-Fire Debris Flow Hazards**

Wildfire-Associated Landslide Emergency Response Team Report

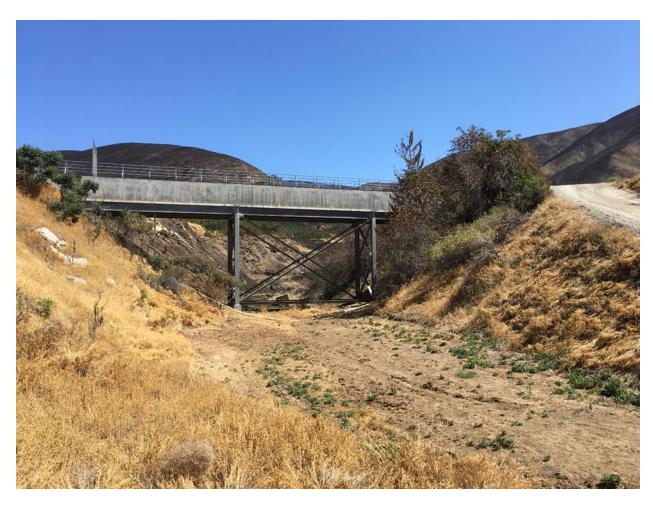
The unnamed drainage above Red Apple and Kenoyer Roads (Location 4 on Plate 1; Fig. 1) had 773 acres burned with moderate and high soil burn severity. The drainage is steep and is modeled with a High hazard (see section *U.S. Geological Survey post-fire debris flow hazard assessment* below) of debris flows. The irrigation canal is elevated where it crosses the drainage in a flume but could be impacted if enough debris were to pass through the drainage and undermine the canal. See Table 4 for additional data on soil burn severity for the basin.

Only one of the basins has a combined High debris flow hazard: the unnamed drainage on the west side of the fire above Red Apple and Kenoyer Roads above Location 4 (Plate 1). The irrigation canal at this location is elevated across this drainage but the footings and support structure of the canal likely weren't designed to take the impact of a debris flow, should one occur. If a debris flow occurs, this area of the canal could be vurnerable and undermined. There are other small drainages along the west side of the fire that are shown as having a Moderate debris flow hazard but have a higher probability of debris flow generation than other drainages in the burn area. These can be viewed on the USGS website by toggling on the *Basin Probability* data layer. We've noted these drainages as Locations 5 to 10 on Plate 1 for additional review of infrastrure and potential armoring in preparation for potential debris flows.

**Figure 1.** Photo taken where irrigation canal crosses unnamed drainage in a flume with high combined hazard for debris flows. This location is above the intersection of Kenoyer and Red Apple Roads (Location 4 on Plate 1).

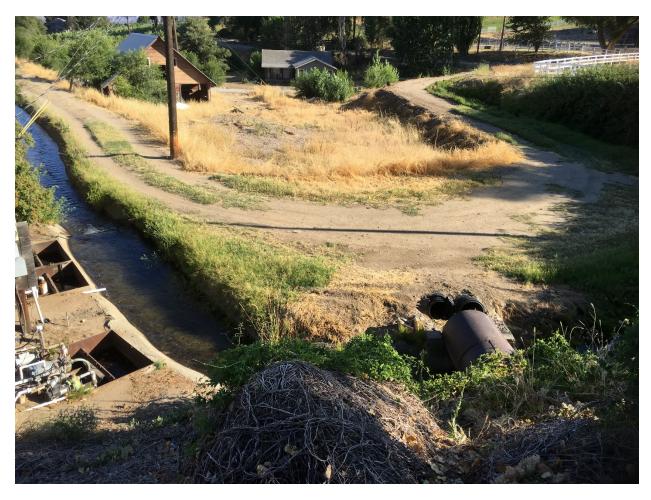
This drainage has a Moderate combined debris flow hazard rating for the modeled storm. Based on evidence of past debris flows and the Moderate debris flow hazard, nearby residents should be alerted to the hazard, and stormwater conveyance should be evaluated in case there are vulnerabilities to the irrigation canal (Location 20 on Plate 1; Fig. 2).

**Figure 2.** Photo taken downstream of Burch Hollow Lane, near 3510 Burchvale Rd (Location 20 on Plate 1). Depending on the amount of sediment that travels through the larger metal culvert, the smaller corrugated culverts could be clogged resulting in sediment in the canal.

Irrigation district managers should closely inspect storm water conveyance above the irrigation canal along the west and southern perimeter where drainages cross the canal. These crossings could be vulnerable to additional sedimentation, and if the irrigation water is running, additional damage to the system could occur. We made an attempt to highlight locations where issues might occur but not all areas were visited during this reconnaissance survey. These locations are described in Appendix B and marked on Plate 1.
