# COLUMBIA RIVER GORGE NATIONAL SCENIC AREA

## *Burned Area Emergency Response Summary – Eagle Creek Fire*

**October 10, 2017**

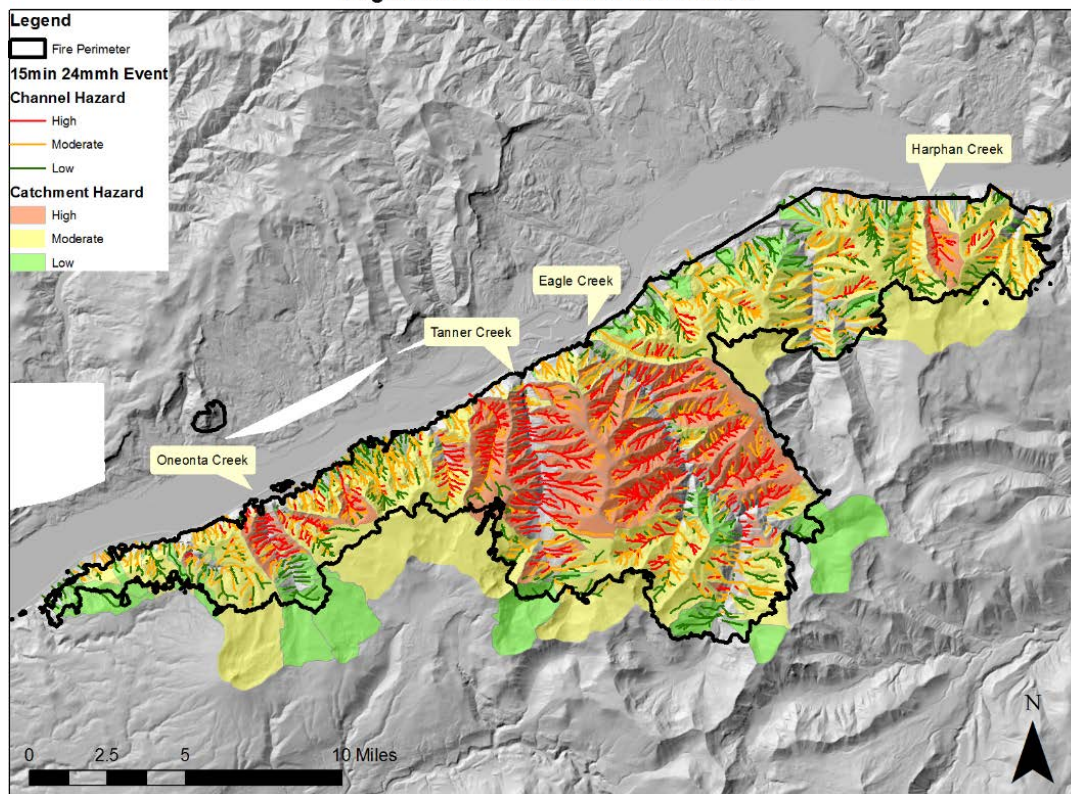
Eagle Creek Fire Debris Flow Hazard

Fire increases the potential for debris flows. The U.S. Geological Survey (USGS) used the SBS map in their modeling to predict risk of debris flow. They found that 31% of the drainages are at high risk of debris flow, 42% are at moderate risk, and 27% are at low risk. The highest risk for debris flow was found in Eagle,

Tanner, Moffett, McCord, Horsetail and Oneonta drainages. While ground observations and model results indicate an increase in debris flow initiation in the headwaters, it is unlikely that they will run out to the I-84 corridor. However, there is a chance that debris will collect and create debris dams and subsequently dislodge during storms when stream discharge is at a maximum. These debris dam outburst floods could pose serious risk to anyone downstream during high flow events

since they carry logs, rocks, and a deluge of mud and water and could affect I-84, Highway 30 and/or the railroad.

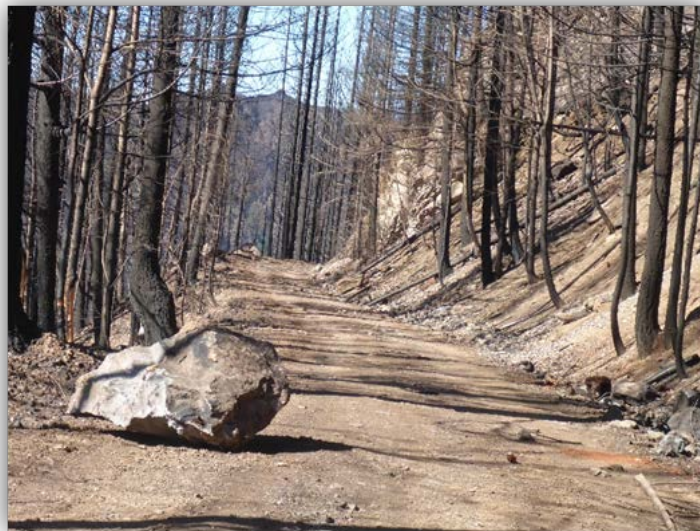
Rockfall also poses a serious threat to people recreating on trails, at viewing locations, and along the Historic Columbia River Highway 30. Rock slides have already deposited piles of gravel to boulder-sized rock fragments onto the Historic Highway and onto trails. We anticipate this will be exacerbated through treefall, and will continue to occur until ground cover grows back. Recently a fire-killed tree toppled on Shellrock Mountain and slid approximately 1,500 feet down to I-84, where it penetrated a retaining wall, slid across the eastbound lanes, and displaced the barriers in the median.

A large rock found on Forest Road 777 illustrates rockfall hazards in the wake of Eagle Creek Fire.

Options for reducing post-fire peak stream flows, soil erosion, and debris flow potential are limited due to the nature of the burn and slope characteristics. As a result, treatment recommendations focus on mitigation measures to minimize loss of life and damage to VARs. These mitigations include closures, warning signs, and public safety approaches such as installation of an early warning system to notify areas when damaging storms may be approaching.

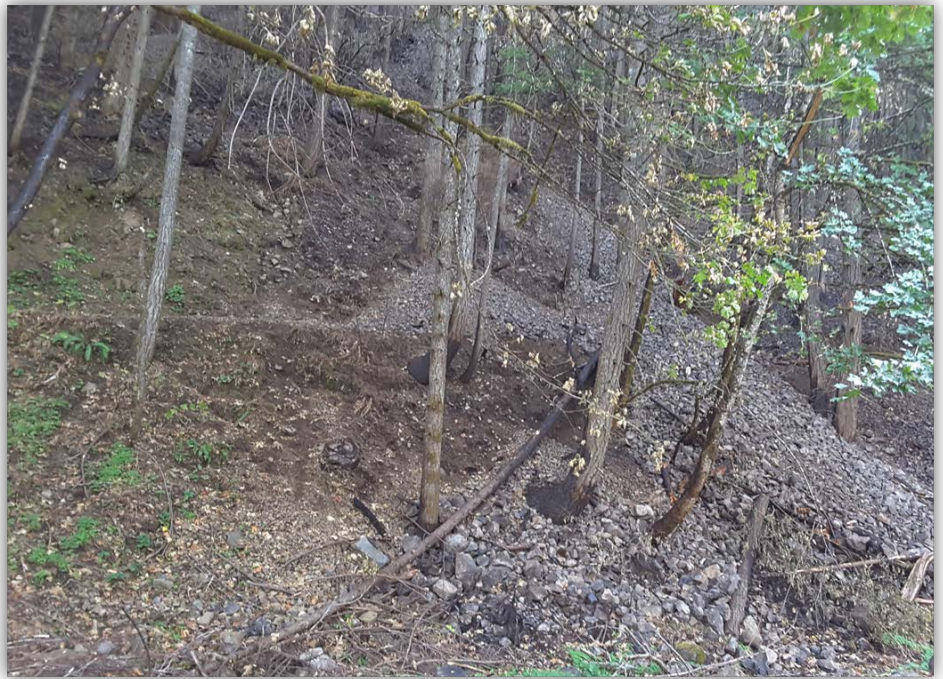
On Gorge slopes where moss and vegetation burned, scree (small rocks) and talus (larger rocks) can collapse onto trails and roads, creating hazards and blocking routes.
