LEAD-BASED PAINT INSPECTION REPORT

Sun Chief Mill Site
Southeast Corner of Arizona 77 and US 70
Globe, Arizona

CSC Project # 5002357

Inspection Date: January 26, 2009

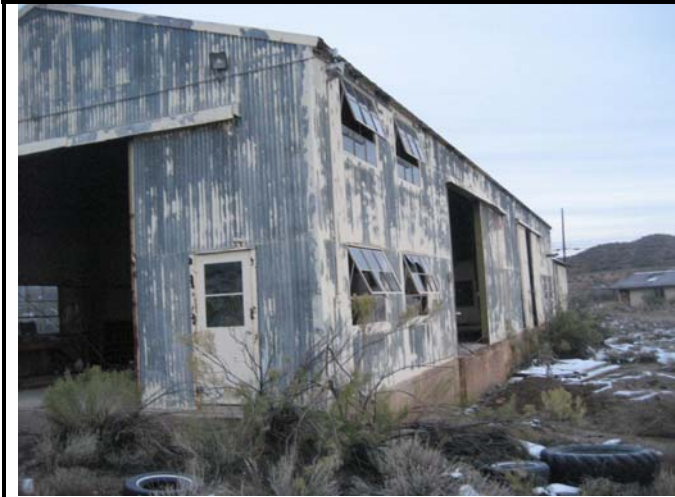
Photo 1: Warehouse overview

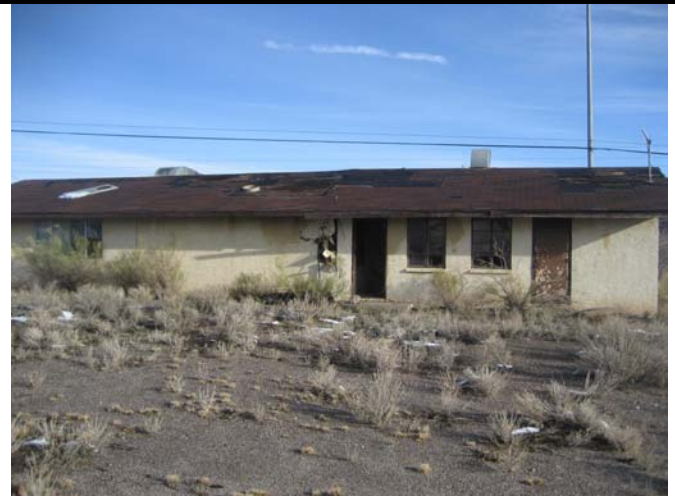
Photo 2: Office overview

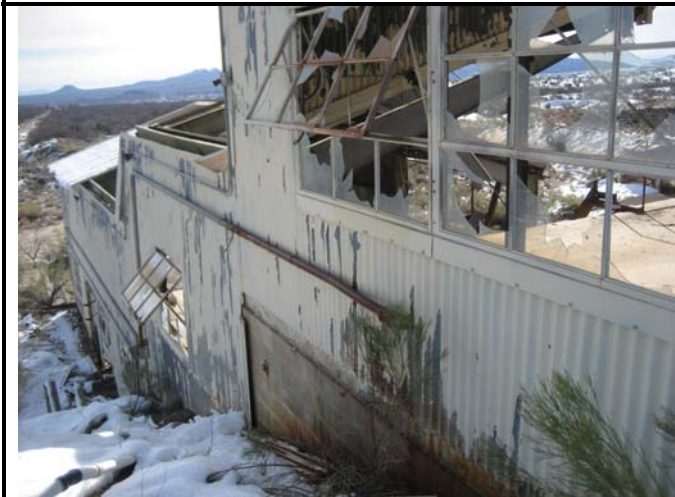
Photo 3: Mill overview

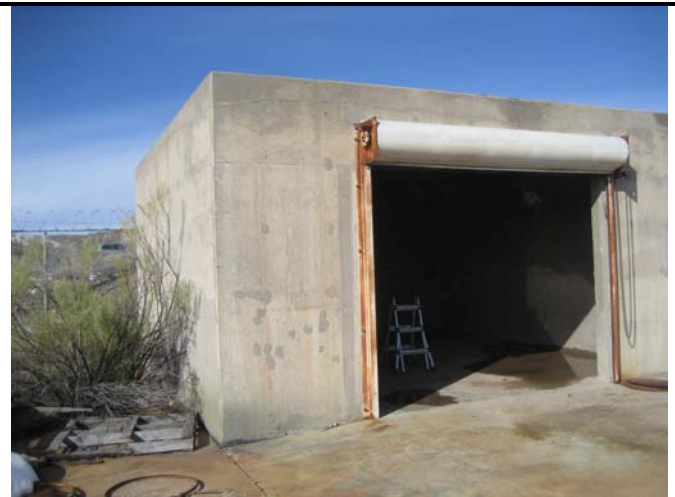
Photo 4: Bunker overview

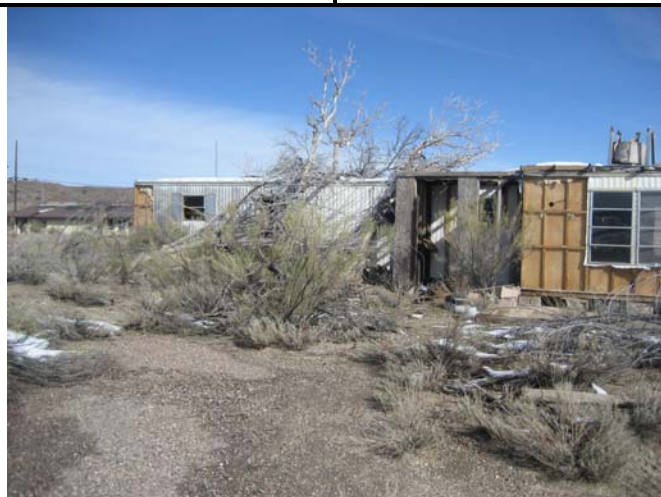
Photo 5: Trailer overview
