EVALUATION OF MIKE HORSE DAM

January 2005

Stephen Romero, P.E.
Regional Geotechnical and Dams Safety Engineer
U.S. Forest Service

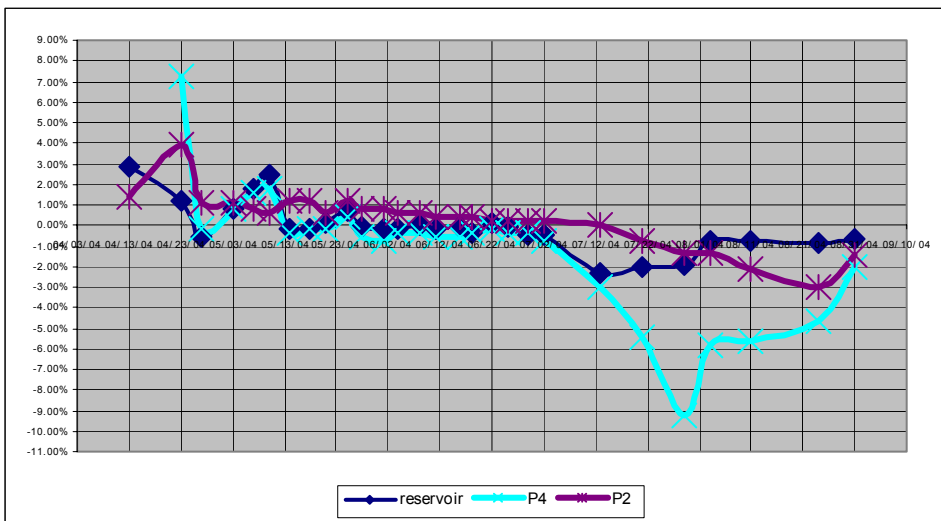
Figure 8: The response of P4 to reservoir changes suggest a hydraulic connection to the reservoir through east abutment.

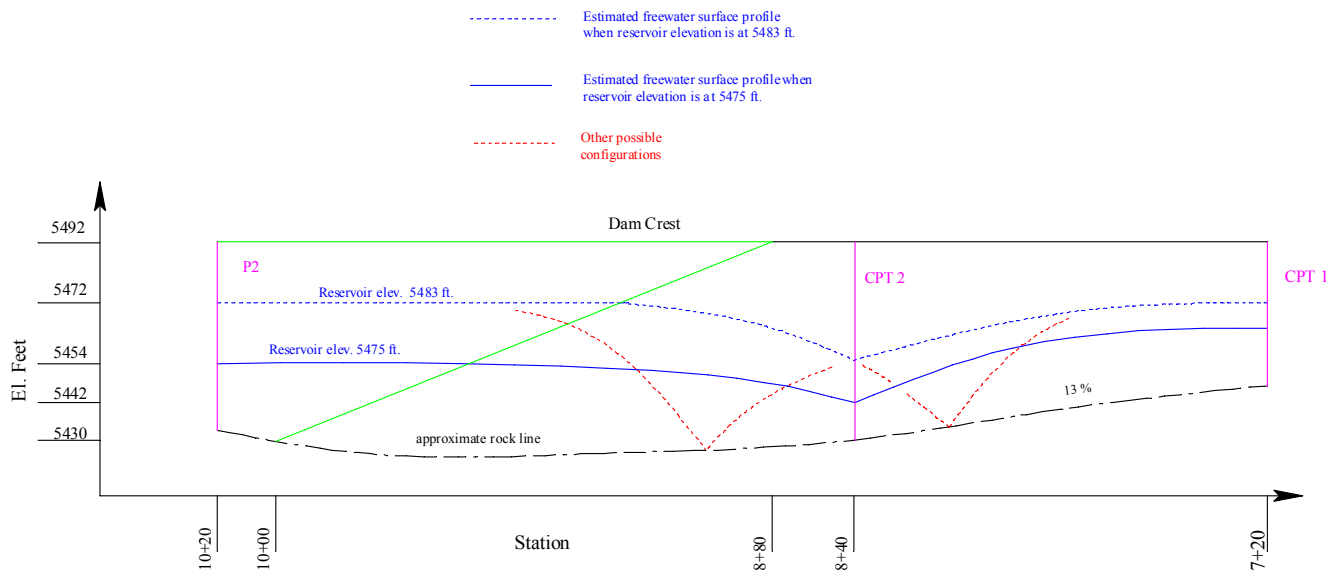
The net result can be approximated as a linear depression in the groundwater surface extending roughly from CPT 2 to the dam toe. The depression geometry suggest a localized zone is impacting the seepage regimen within the dam. If the depression is linear it is unlikely the piezometers or CPT's intercepted the vertex of the depression. Alternative configurations are displayed in Figure 9. Figure 10 displays the relative positions of the free water surface at CPT 1 (derived from two points) and CPT 2 (derived from 3 points) on the day of testing. Figure 11 displays a trimetric interpretation of the data. The accuracy of the free water surface can be improved with more testing.

Figure 9: Depiction of groundwater profile derived from piezometer and pore pressure measurements obtained from pressure transducer on cone penetrometer. Section taken through dam crest. Profile adjusted to reflect differences in permeability between reconstructed section and original embankment.

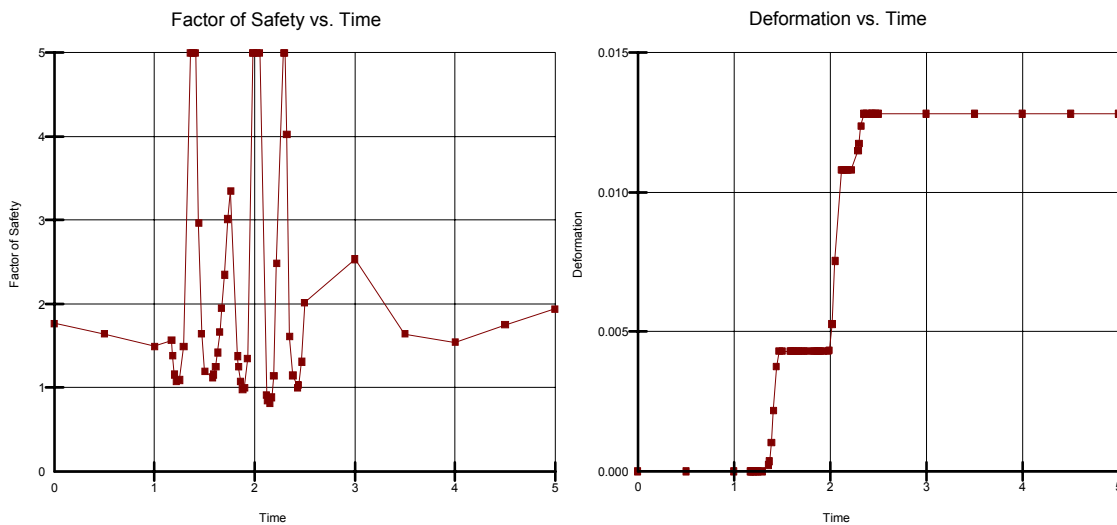
The factor of safety against a circular arc and irregular circular-wedge slope failure on the downstream dam face temporarily drops below 1 for both the 500 year and 2500 year events. Total deformation is less than .015 feet during the 500 year event and .1 feet for the 2500 year event indicating the dam should not fail catastrophically during the earthquake. Refer to Figures 20, 21, and 22.

Figure 20: Factor of Safety and Deformation versus time – 500 year event. Time is in seconds and displacement in feet.

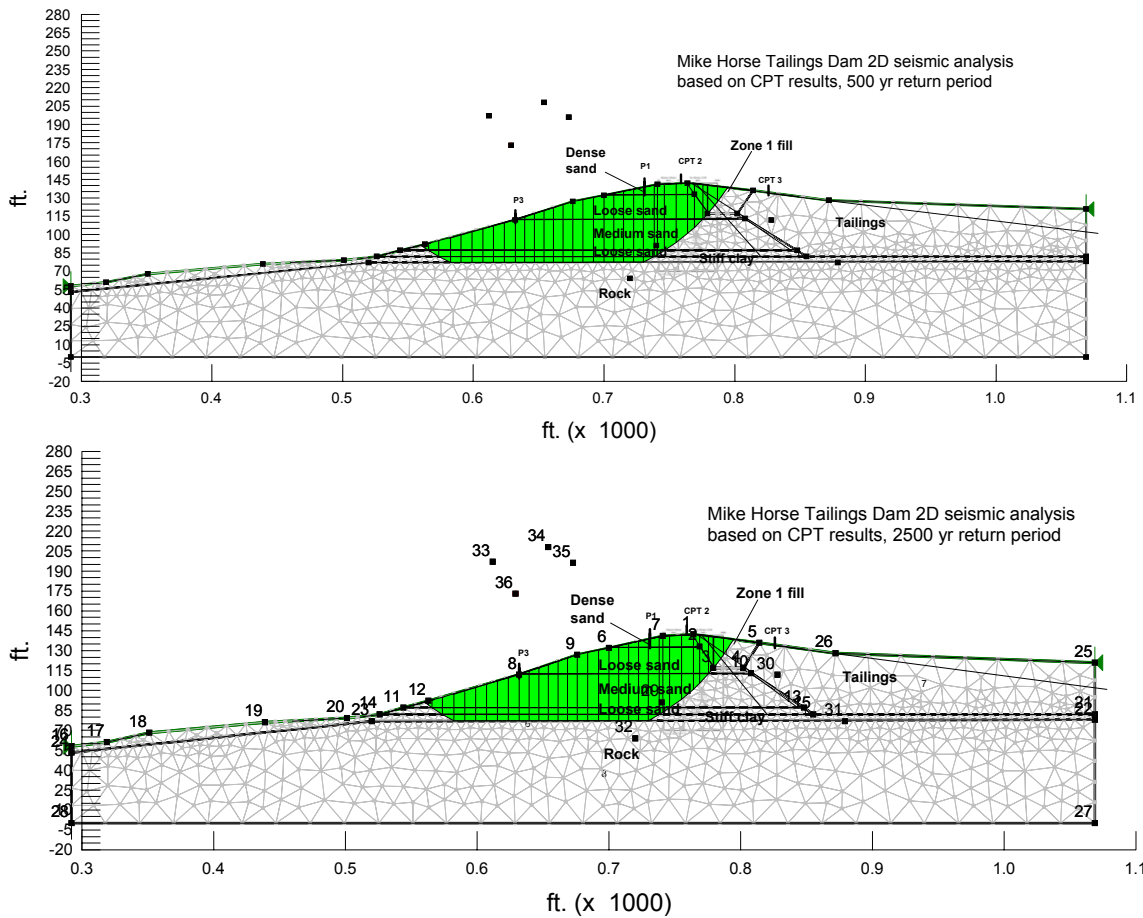
Figure 22: Critical sections for the 500 year and 2500 year events
