7700—Transportation Systems
2500—Watershed and Air Management
September 1998
9877 1806—SDTDC

Response of Road- Stream Crossings to Large Flood Events in Washington, Oregon, and Northern California

September 1998

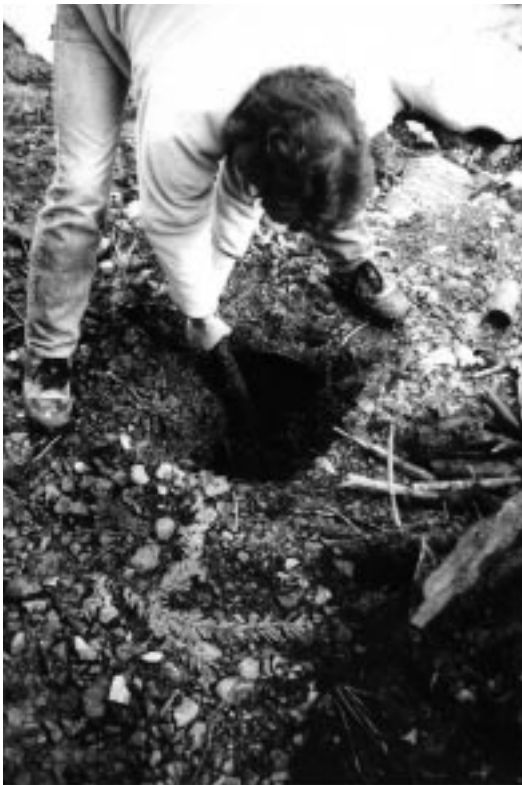
R9800126

Figure 2—Woody-debris plugging often results in burial of the inlet, suggesting sediment plugging as the cause. However, upon excavation several pieces of wood were discovered here, lodged across the inlet, indicating that woody debris initiated the plug.

Woody-debris failures usually resulted from multiple pieces of wood lodging across the inlet of the culvert, trapping sediment upstream and plugging the inlet. Small pieces of wood appeared to be just as likely to initiate plugging as were large pieces (Flanagan, in preparation). Of the measured woody debris initiating culvert plugging, 23 percent ($n = 13$) were shorter than the diameter of the culvert they plugged. Failure from exceeding hydraulic capacity was infrequent (9 percent of the failures).

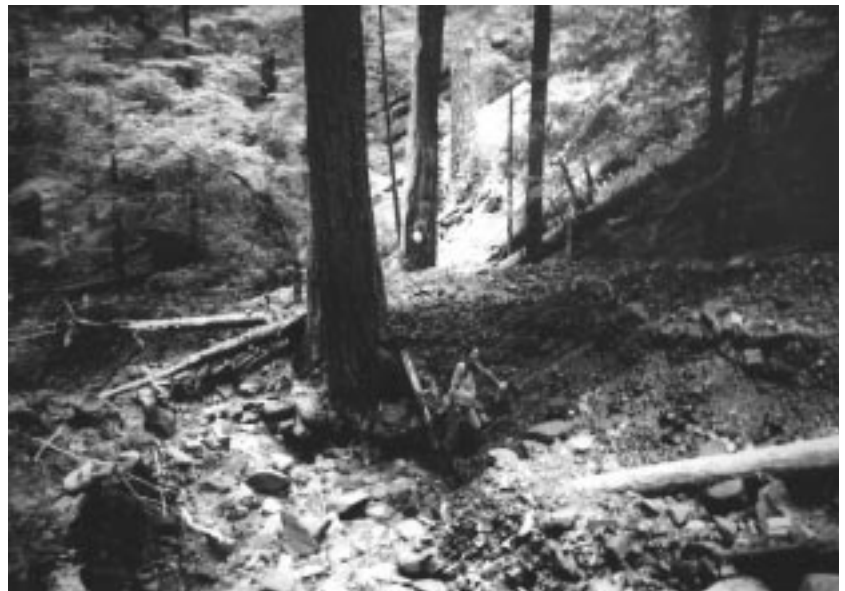
R9800127

Figure 3—Debris flows were relatively easy to identify. Evidence consisted of either evacuated channels upstream of the crossing or, as in this photo, large, poorly stratified deposits where the flow was impounded against the road fill.

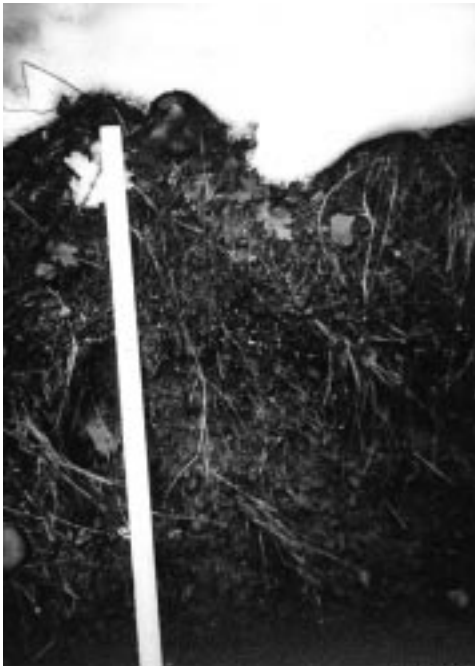
R9800128

Figure 4—Hydraulic exceedence was often difficult to determine. At this site, evidence consisted of a debris line near the center of the photo and removal of litter in the bottom half of the photo. Snow cover during flooding and surveys resulted in different evidence than would have occurred without snow cover. Evidence was rapidly obscured by litter-fall, new growth, and additional rainfall.

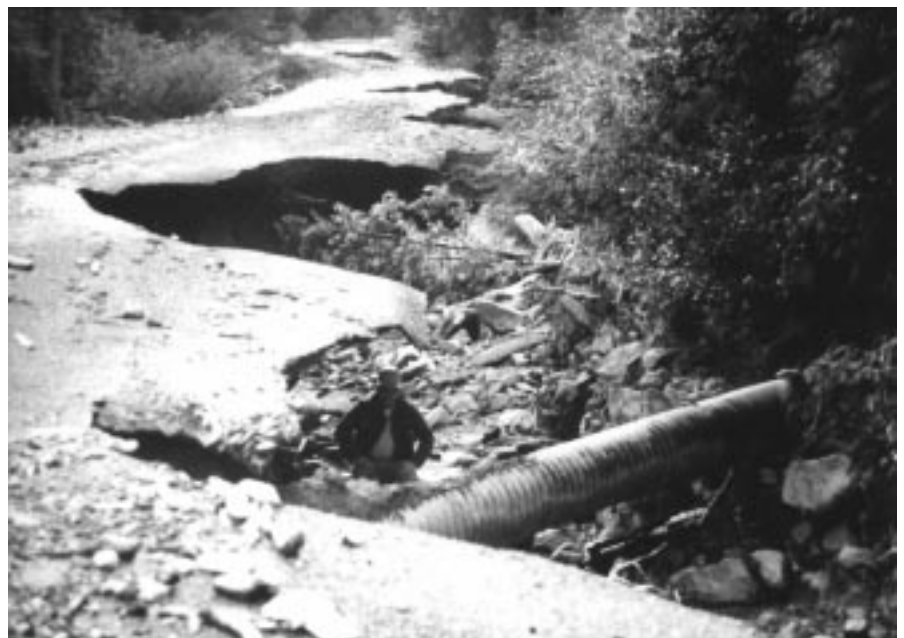
R9800129

Figure 5—Consequences of failure are usually simpler to characterize than mechanism of failure. Here, diversion of stream flow out of the natural channel and onto the road surface and ditch produced erosional consequences much greater than if the flows had flowed over the road surface and re-entered the natural channel near the culvert outlet. [Photo courtesy of R. Ettner, Siskiyou National Forest.]

- **Avoid stream diversion. Diversion of streams at overtopped crossings and plugged cross-drains is a major source of preventable effects.** Diversion can be prevented by locating and designing crossings to ensure that streamflow that overtops a crossing fill cannot leave its channel. For existing roads, diversion-prevention dips or other structures can be inexpensively constructed to “storm-proof” crossings that have diversion potential (Furniss et al. 1997).

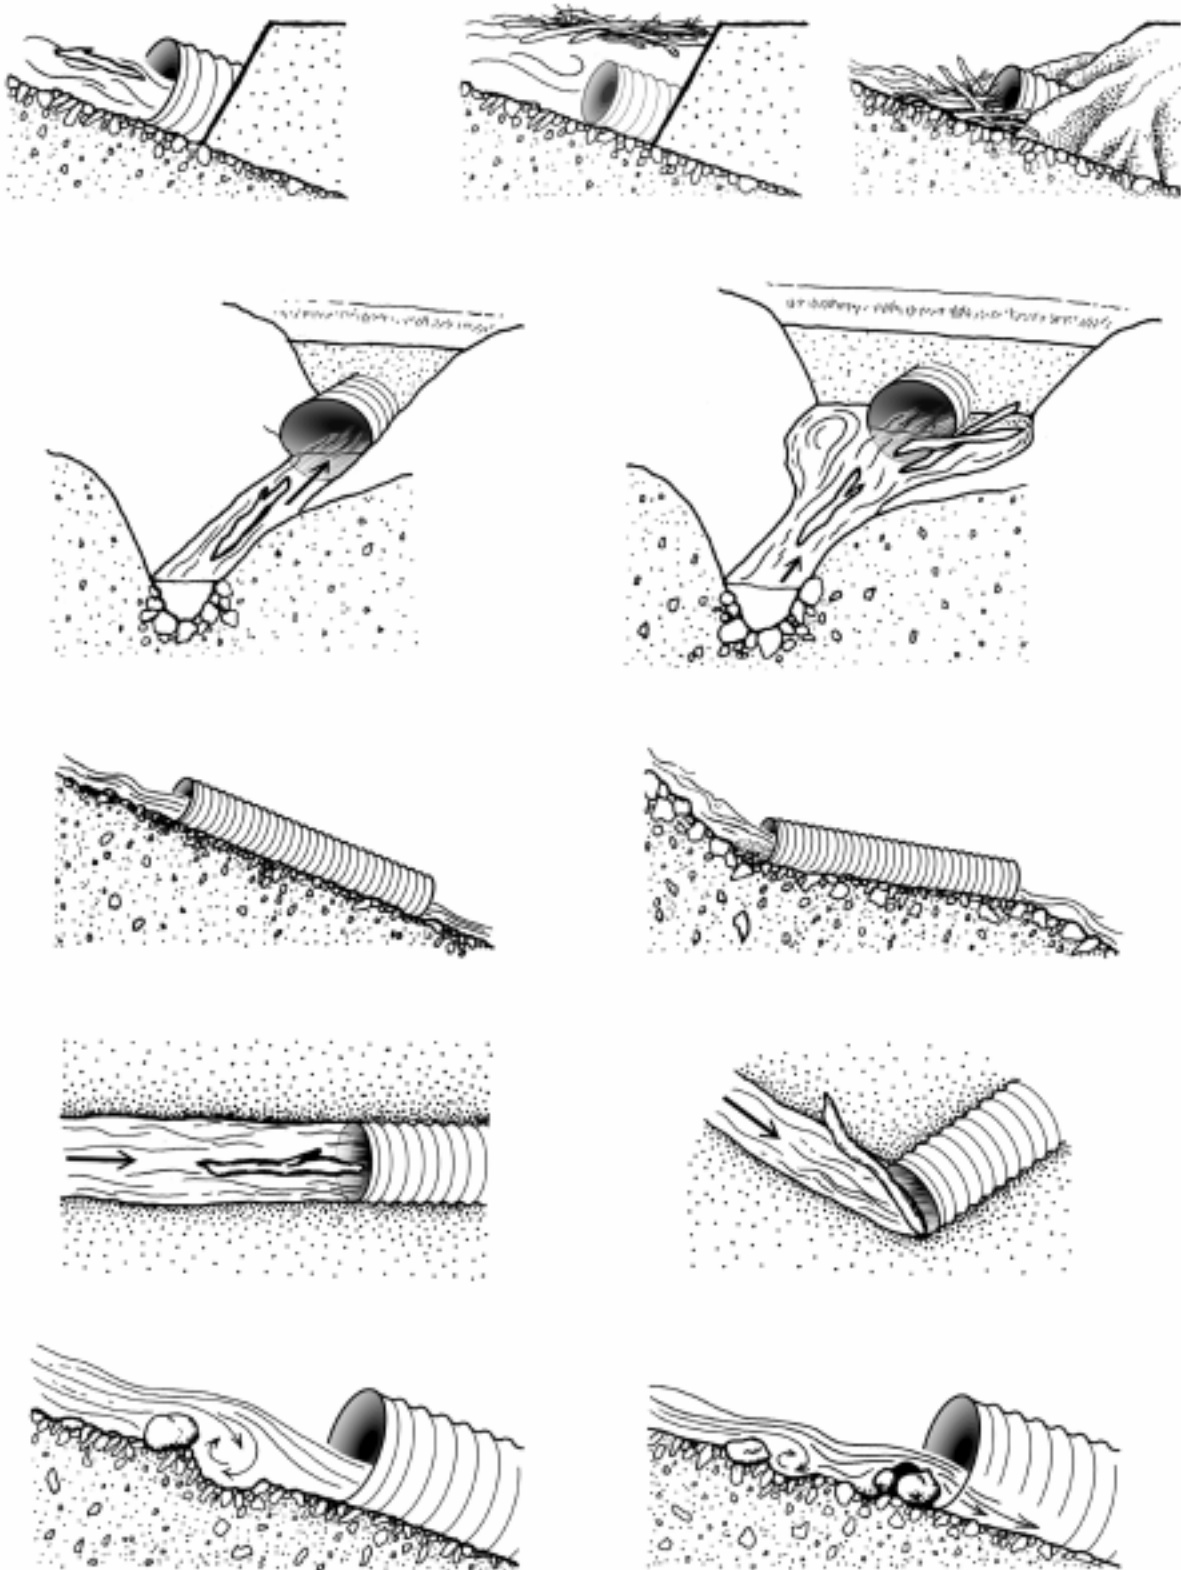
R9800164

Accumulation of headwater (water level above the top of the culvert) at culvert inlets will increase plugging hazard by retarding the passage of floating debris and by decreasing streamflow velocity and the capacity for sediment transport. Ponding at the inlet basin led to the accumulation or "rafting" of woody debris. When the inlet was re-exposed, it was instantly faced with an interlocking raft of wood exceeding the capacity of the inlet, therefore resulting in plugging (Figure 11a).

The behavior of sediment and debris at culvert inlets was crucial to stream-crossing performance. Crossings that presented the least change to channel cross-section, longitudinal profile, channel width, and alignment were most likely to pass sediment and debris (Figure 11b, c, d).

- Increases in channel width immediately upstream of the culvert inlet promoted accumulation of both woody debris and sediment at the inlet. In widened channels, woody debris can rotate and present larger effective widths to the culvert inlet, increasing the likelihood of lodgment, and resulting in reduction or plugging of the inlet. Narrow channels are more likely to present woody debris to the culvert inlet oriented with the flows and the culvert, and thus more effectively entrain and move sediment through the culvert. (Figure 11b). Wider channels also result in flows

Figure 11—Illustrations of increasing plugging hazard.

$HW/D = 0.5$ or 0.67 . We believe this criterion is prudent in any situations where woody debris and sediment must be passed (Figure 11a).

- **Culverts as wide, or nearly as wide, as the stream channel minimize the cross-sectional change in the channel and are least likely to plug.** For small streams, matching the culvert diameter to the channel width is a practical approach (Figure 11b). For larger streams, this approach may be cost-prohibitive and other inlet-configuration measures can be used to mitigate the narrowing of the channel cross-section caused by the culvert. Culverts should be set on the same or greater gradient as the natural stream channel to avoid accumulation of sediment at the inlet (Figure 11c).
