7700—Transportation Systems
2500—Watershed and Air Management
September 1998
9877 1805—SDTDC

Water/Road Interaction: Examples from Three Flood Assessment Sites in Western Oregon

Willamette National Forest

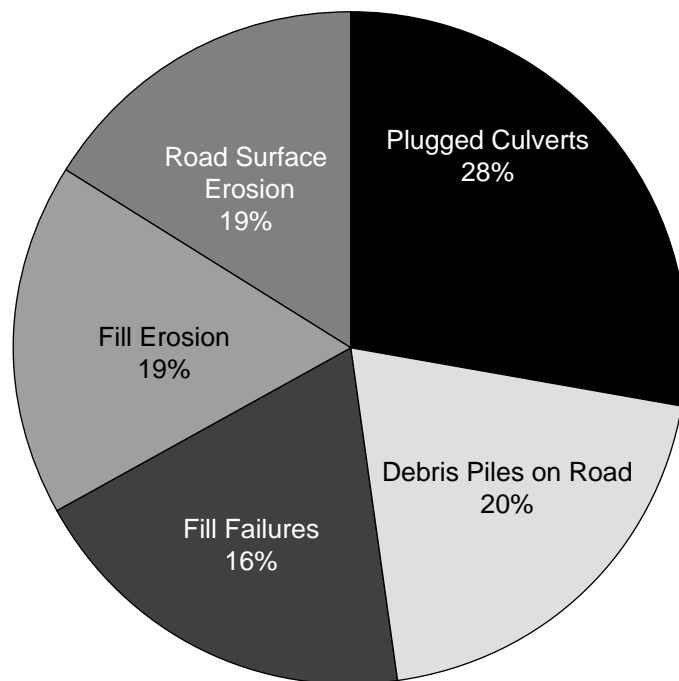
Figure 1—Road related storm damage by type (352 Sites on Detroit RD 1996).

Surveys of damage to roads and to local areas surrounding roads on the Detroit Ranger District showed that plugged culverts and road-surface and road-fill erosion accounted for most of the damage to roads and road-stream crossings (Figure 1).

Culvert plugging by stream bedload and woody debris was the most common type of failure overall (28 percent). Often a small branch caught in the culvert inlet and resulted in stream bedload accumulation and eventual burying of the inlet. Culverts that were 600 mm (24 inches) diameter or less accounted for 81 percent of the plugged culverts.

The cause of flood damage to roads from erosion of road surfaces and stream channels adjacent to roads, fill failures, and forest slides contributed about equally to road damage, each comprising 14 to 18 percent of the number of sites that were damaged. Cutslope failures contributed only 6 percent of sites that were damaged.

Damage to roads in the form of fill failures, fill erosion, road surface erosion and debris piles were all found at about the same frequency and contributed to 16 to 20 percent of the damage sites.

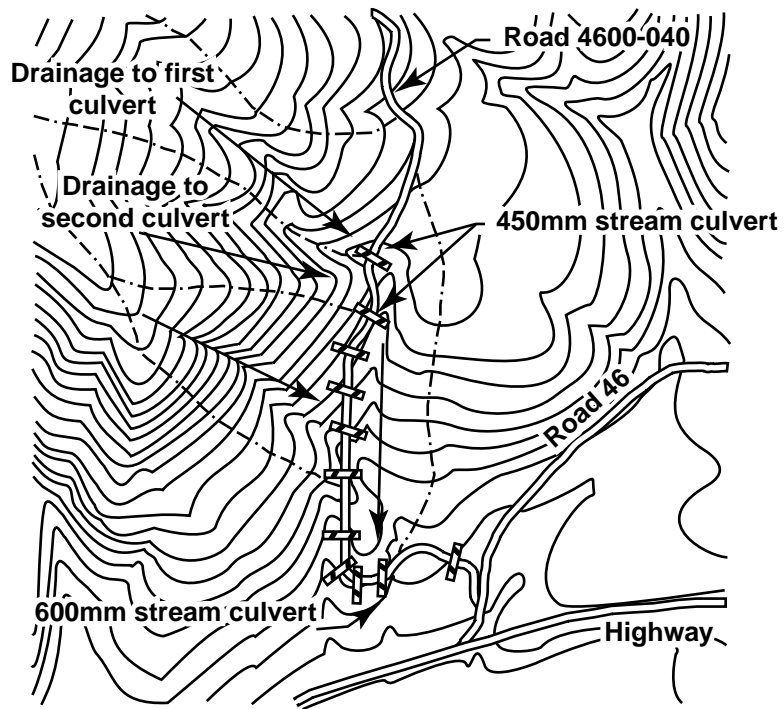
Figure 2—Breitenbush site map.

The damage on this site began where two adjacent small streams carrying high flows and sand- to cobble-sized bedload plugged road culverts (Figure 2). Both of these 1.0 to 1.5 m-wide stream channels crossed the road with 450-mm (18-inch) diameter corrugated metal pipes lying on a 5 percent

(stream) gradient. The upstream end of the culverts projected into widened inlet basins. Roadside ditches were open uphill and downhill to these inlet basins. Stream bedload accumulated at both of the culvert inlet basins, filling them until their inlets were buried. Storm flow was then diverted to the road ditch. The flow and stream sediment from the first culvert flowed down to the second culvert, where they combined and continued down the road ditch. The flow from the slope above the road and road surface drainage also accumulated in the ditch. The high volume and high-velocity flow—the road and ditch grade ranged from 8 to 11 percent—began eroding the road ditch to a depth limited only by bedrock lying from 0.5 to 3 meters below the originally constructed ditch bottom (Figure 3). At the entrances to ditch-relief culverts, either inlet basins were severely eroded or the entrances were plugged by sediment so that none of the culverts were transporting water across the road. The accumulated flow could not escape the ditch and continued down the road for 1.2 km (.75 mile).

Storm flow eventually eroded through softer road-fill material, forming a 1.3-m-deep gully. Debris was carried into a small, intermittent drainage where some of it was deposited. The remainder was carried further downhill into a larger stream drainage. This larger drainage crossed the road near the junction via the forest highway with a 900 mm (36 in.) culvert. The entrance basin to this crossing was filled by debris and the pipe entrance was buried. The stream flow overtopped the road and eroded through the

fill approximately one meter down to bedrock, carrying the material 100 meters to the forest highway below. Debris deposited on the highway and the flow spread over the road surface and was dispersed into the forest below.

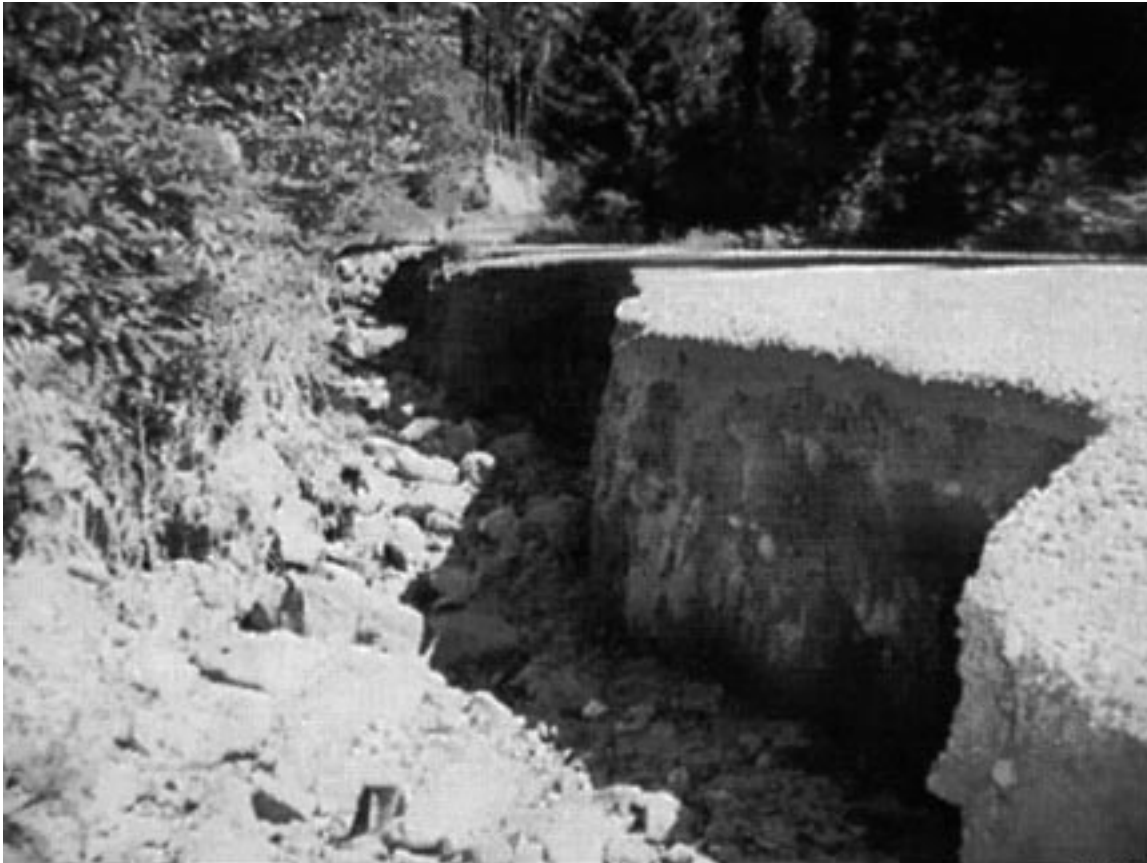
Figure 3—Severe gullying at Breitenbush flood-assessment site.

The dense, well-graded gravel road surface received little damage from surface runoff during the storm. Sediment and rock debris were scattered onto the road surface at some locations. A summary of drainage features and observations of what happened during and after storm events is shown in Table 2. Virtually all of the material that eroded and moved off site came from the unlined ditches and resulting gullying that occurred during the storm (Figure 3).

The soils at both Breitenbush and K Creek are easily eroded. Ditches would have benefited from either more frequent relief culverts or from erosion protection that could have been provided by grass or small riprap. Natural ditch vegetation was insufficient and natural armoring through erosion of fines, leaving coarse rock fragments for protection, did not occur at either site. The high-energy conditions and high-volume flow at the Breitenbush site produced very high erosional forces. It would be expensive and difficult to provide adequate protection for those conditions. At the K Creek site, the high-flow conditions were able to erode the unprotected ditch. In both cases, the road surfacing provided some protection from erosion and gully formation into the road. The key to preventing ditch erosion at these sites would appear to be in preventing plugging of stream culverts and diversion (see Table 5). Other important road-drainage features, such as closer spacing of cross drains could have reduced overall road damage since they would have provided additional places for diverted stream flow and drainage to escape. Ditch dams would have been helpful in getting ditch water into ditch relief culverts, especially at steeper grade sites.

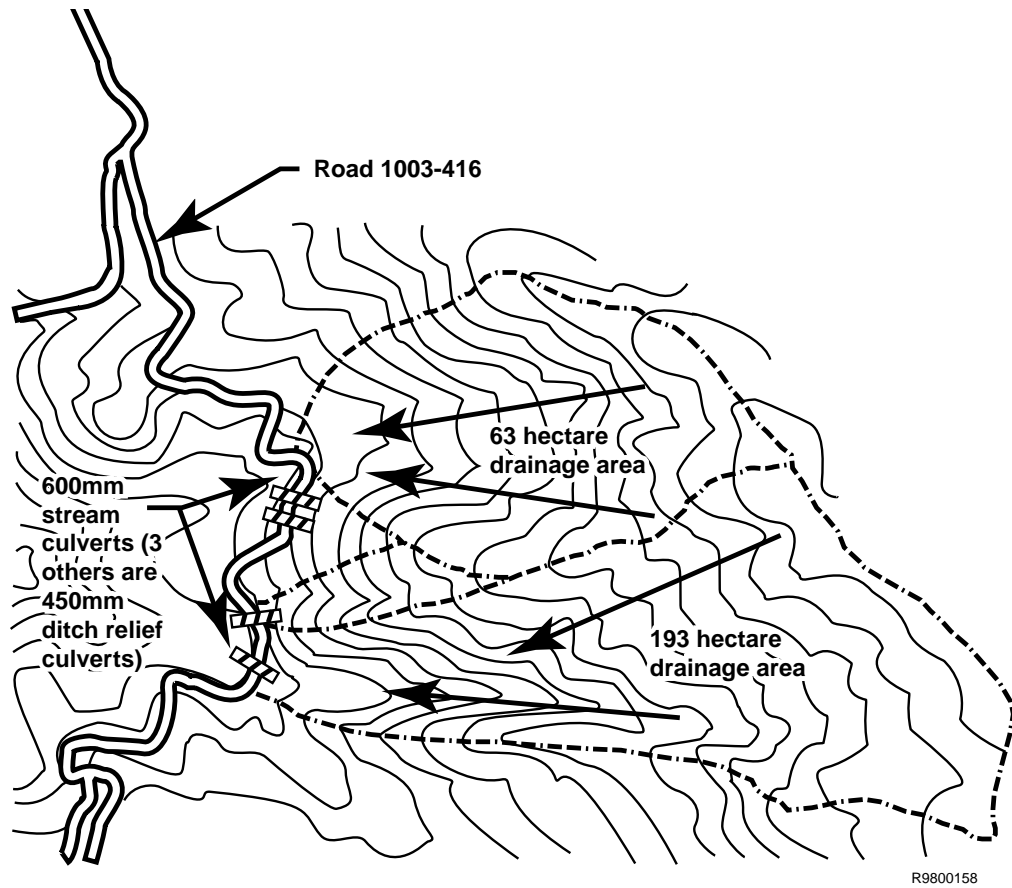
Figure 4—K-Creek site map.

Damage at this site began at the 2.7-km stream crossing, where debris filled a stream crossing culvert inlet basin, plugging the 600-mm (24-in.) corrugated metal pipe and diverting the stream into the road ditch (Figure 4). As the road ditch was eroded, debris was scattered on the road surface in numerous places. Ditch relief culverts were plugged by coarse-grained sediment. A portion of the water was deflected off the road by this debris while the remainder flowed down the road ditch and traveled on the surface causing additional damage. Eventually the stream eroded through the road template creating a gully up to 3 m (9.8 ft) deep by 3 m (9.8 ft) wide (Figure 5). This gully followed the

road until it eroded through the fill, diverting the stream and depositing sediment in a broad, shallow basin adjacent to the road. The forest vegetation served as a buffer strip to help capture sediment before it reached stream channels. The basin allowed water to pool and drop suspended sediment. Location of cross drains and stream crossing culverts are shown in Table 3.

Debris generated from the diverted stream 0.5 km away was deposited in the inlet basin for a 600-mm (24-in.) diameter culvert near the bottom of the site (at location 3.2 km), plugging the inlet. The stream flow pooled and overtopped the road, eroding the fill and exposing the culverts. A summary of drainage features and observations of what happened during and after storm events at this site is shown in Table 3.

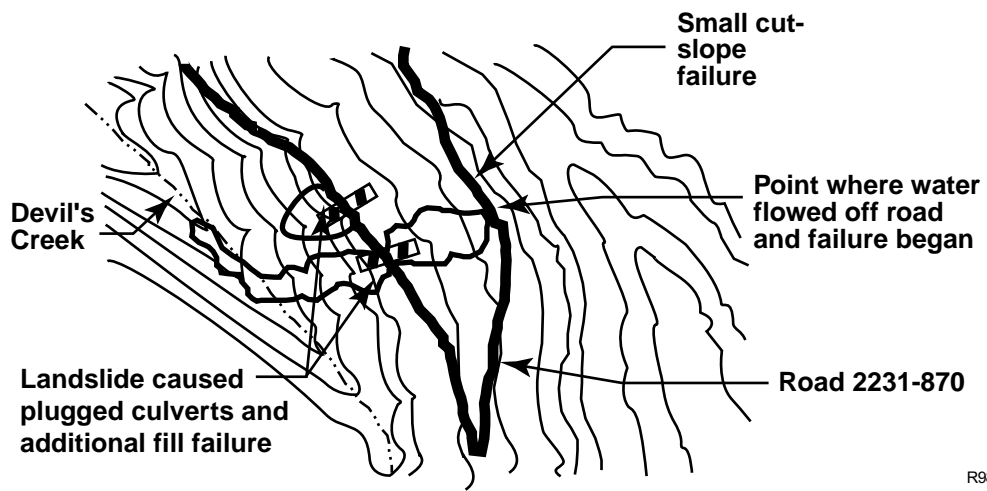
Figure 6—Devil's Creek site map.

This site involved the failure of a thin side cast road fill that scoured the soil off a drainage headwall on the hillside and deposited it on a lower segment of the road, within the lower segment of the drainage and within Devil's Creek (Figure 6). The failure was caused by water being diverted by a small cutslope slide (estimated volume was 5 cubic meters) that dammed a ditch, causing ditch water to run out onto the road surface, down wheel tracks and eventually over the fill slope edge of the road (Figure 7). The fill slope apparently failed as a result of saturation caused by rainfall combined with the overtopping ditch water eroding the toe of the fill. The failed fill slope became a fast-moving earth flow that

combined with wet 1- to 5-meter-thick surface soil in the drainage headwall, gathering volume as it moved and not stopping until it encountered the road below. The debris then filled the inlet basin of the road culvert, covered the road with about 800 cubic meters of debris, and sent the bulk of the debris into the drainage channel below the road and into Devils Creek. The channel debris swept up a forest slope, knocking down trees and burying the channel. The drainage eventually eroded through the channel debris to reconnect with Devil's Creek. It was estimated that, of the approximately 4200 cubic meters that were eroded and subsequently slid from the site, about 25 percent was stopped by the road, with the remaining volume ending up within the stream bed below. The road fill was partially eroded, damaging the outlet end of two 750-mm (30-inch) diameter stream culverts located at the site. Apparently, one of the culverts had been damaged in the past by a debris slide, left in place, and replaced with a new culvert of the same size.

Subsequent maintenance at the site removed debris from the road surface, but did not re-establish flow into the cross drain. Instead, water flowed into the road ditch and continued about 70 meters down to the next culvert. The sediment carried by the diverted drainage eventually plugged the next culvert, then diverted over the road surface, eroding approximately 3,000 cubic meters of road fill. The fill material was deposited in a flattened area below the road and within a forested buffer strip area below. Very little road fill reached Devil's Creek drainage below. The road culvert was severely damaged and the road subgrade was destroyed.

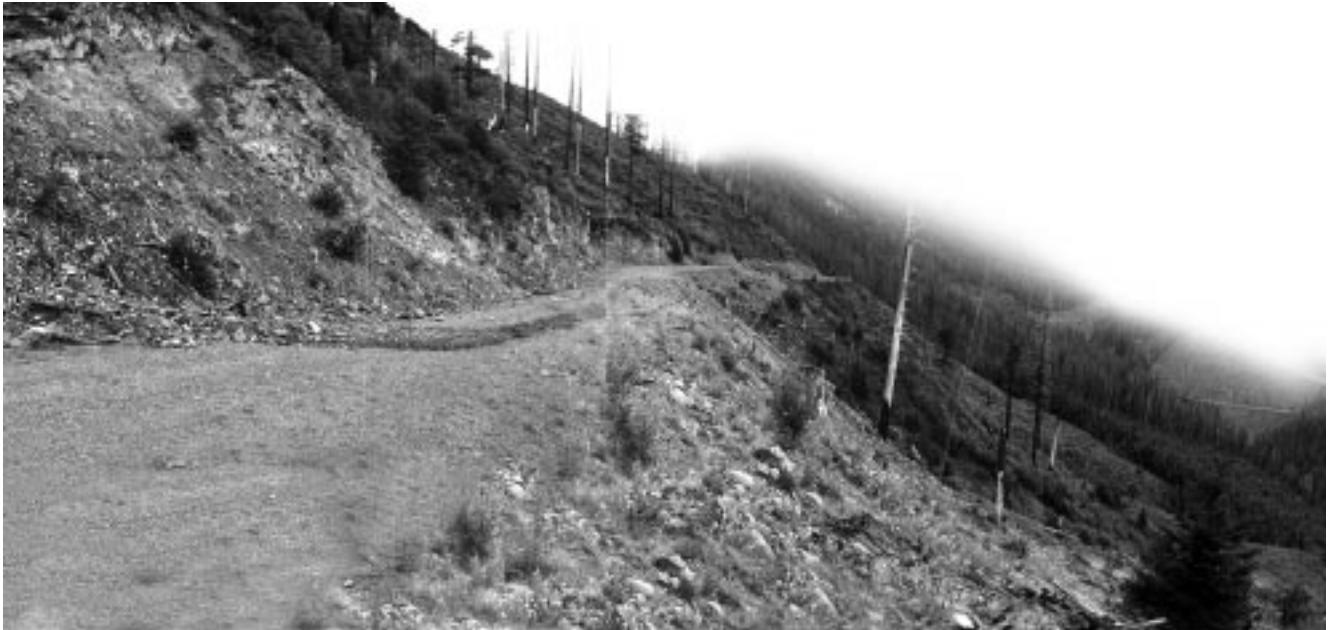
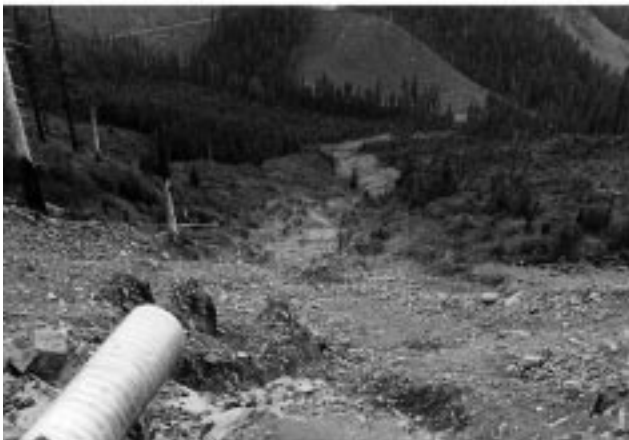
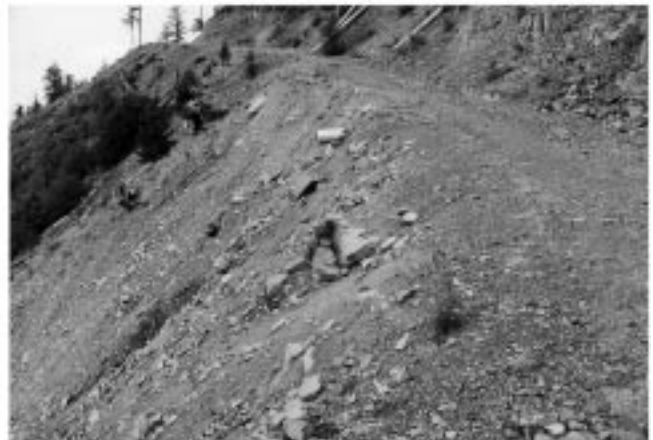
Figure 7—Initiation of debris slide at Devil's Creek flood-assessment site.

Damage to the Devil's Creek site resulted from a failed cut bank plugging a ditch. Wheel tracks carried the diverted water down the road until a surface depression was reached. The effect was to saturate a fill, which then initiated a slide at the toe of a slope. This small slide developed into a debris chute. The road is a full bench design that had a shallow layer of soil sidecast as waste during construction (a "sliver fill"). The sidecast soil lies on a thin mat of soil and organic matter (partially decomposed by now) such as stumps and brush. This created a zone of weakness that failed more readily than other soil in the area.

The topography and management regime below the road probably contributed to the failure. The area below the road was a 55 to 70 percent, ten-year-old, clear-cut unit. Typically, tree roots remaining in the soil in this type of area have significantly rotted, losing shear strength that helps hold soil on the slope. The

absence of large trees also meant there was little to stop a slide once it became mobile. The underlying bedrock mostly parallel to the slope, acted as a slip zone for the soil. This situation suggests that maintenance personnel should carefully monitor roads in similar areas with steep, wet, relatively shallow soils with thin fills. Unstable fills should be pulled back before they can fail. Also, during full bench construction, efforts to pull back fill spilled over the side may eliminate potential failures.

The \$5,000 to fix the upper road (clean ditch and ditch relief culvert) was small compared to the value of other resources that may could be damaged. In contrast to the other two sites, the role of the culvert/drainage design for this road was incidental to the initiation of the failure. The relatively small cut-slope failure that initiated this damage is an example of how seemingly isolated and innocuous events can trigger much more catastrophic results when "fail-safe" drainage designs are not used.
