Technology &  
Development  
Program

# Measuring Effects of Roads on Groundwater: Five Case Studies

**January 1999**

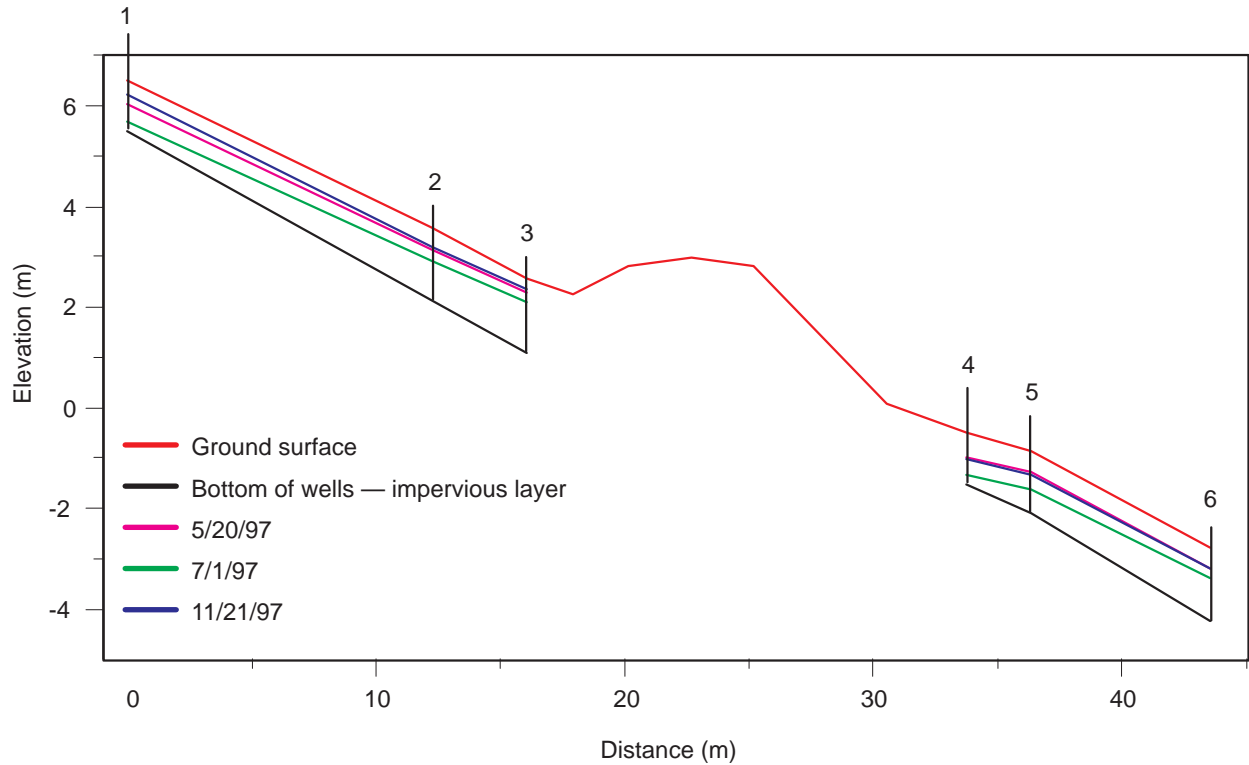
R9801978

Figure 1 displays the groundwater level data gathered by hand measurement for Greens Creek transect 1 and plotted on a cross section of the hillslope. Measured groundwater levels in all wells are consistently lower during the dry period (7/1/97) than during the wet periods (5/20/97 and 11/21/97). Also evident in figure 1 is that the water levels in wells 5 and 6 are at or near the levels shown in wells 1 and 2. During the dry period (7/1/97) the differences are much more

pronounced, with wells 1 and 4 having very low groundwater levels. The other wells have lower water levels, but still exhibit the general trend observed during the wet periods.

The groundwater levels at well 3 are high compared to well 1. Possible explanations for this include a damming effect from the road fill due to soil compaction causing reduced hydraulic conductivity and rerouting of groundwater from the road prism upslope of the site via the ditch. Underground geologic conditions may also be responsible. The level at well 4 is lower than wells 5 and 6, the wells lowest on the slope. These wells appear to have recovered to the levels in wells 1 and 2. One potential reason for the lowering of water in well 4 is rerouting of moisture due to surface concentration and flow caused by the compacted mineral soil of the traveled way. The ditch may be routing water in the form of surface flow away from the site that otherwise—if the road did not exist—would infiltrate the surface and

Figure 1—Greens Creek transect 1 cross section at given points in time.

contribute to groundwater levels. A second possibility is that despite the road's age and heavy use, the subgrade is porous and is intercepting the water and routing it away from well 4.

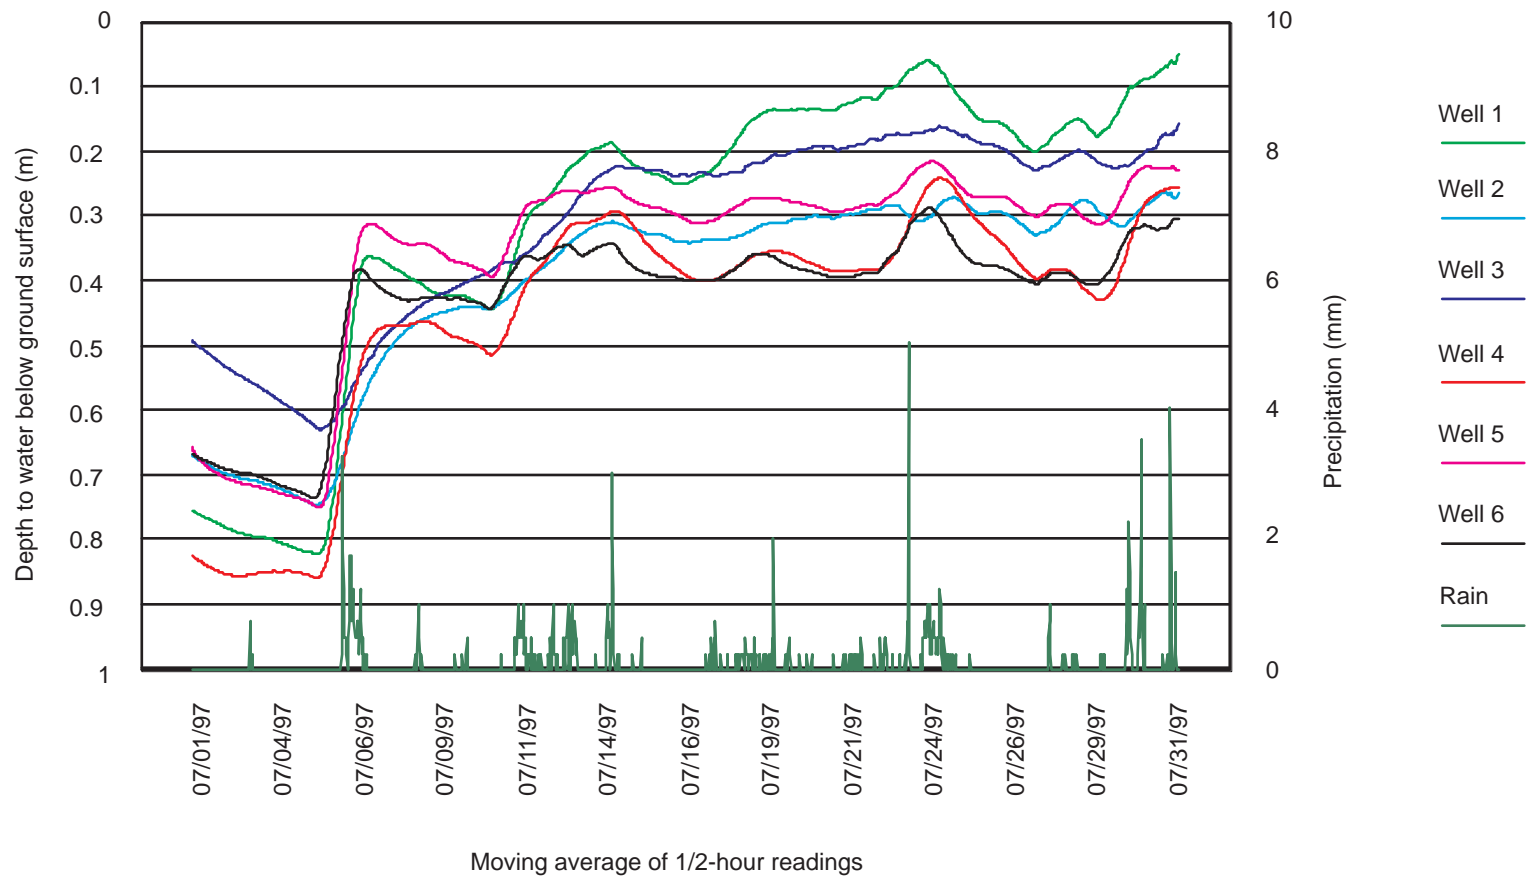
R9801979

Figure 2 displays a detailed and continuous "groundwater trace" at 30-minute intervals for each well.

Inspection of figure 2 reveals well 4 almost always displays greater distance from ground surface to water level (lower water level) as compared to wells 1 and 2 above the prism. However, care must be taken in directly interpreting results from the plot

in figure 2 due to possible differences in well depths. It may be useful to note the total depth of water measured in the wells from the bottom of the well which represents an impervious layer. This is shown in figure 1 as the distance from the bottom of the well to the groundwater surface. Examining all components of these plots together is the best method for interpreting effects of roads on groundwater hydrology. Results shown in figures 1 and 2 suggest several possible reasons for differences in groundwater levels in the wells above and below the road.

Figure 2—Continuous groundwater trace for Greens Creek transect 1.

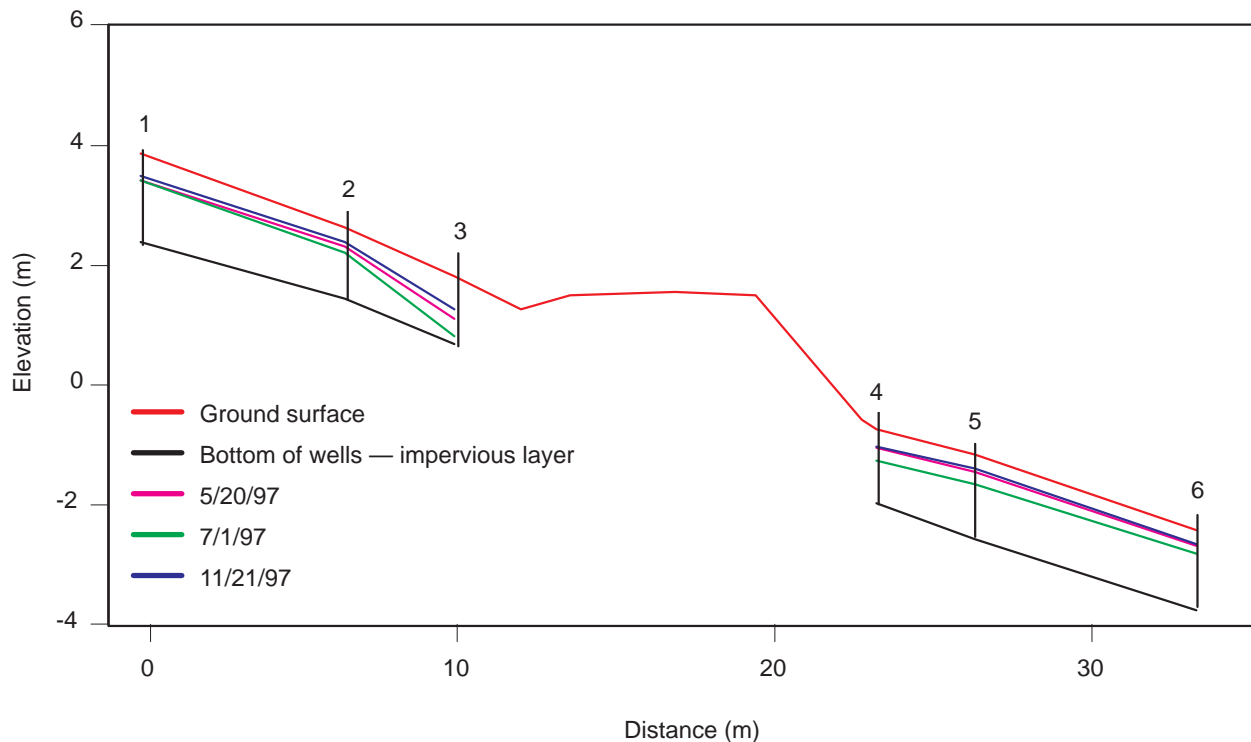
R9801980

Figure 3, Greens Creek transect 2 cross section, exhibits a large drawdown of groundwater for wet

and dry periods above the road at well 3 (figures 3 and 4). This is possibly caused by interception of groundwater flow by the ditch or by French drain behavior of the road fill at this site. Wells below the road show a rapid recovery of groundwater levels to those exhibited in wells 1 and 2 above the road. Water was observed flowing out of the toe of the fill on the downhill side of the road. This supports the possibility that the fill is acting as a conduit to drain groundwater near the ditch on the uphill side and discharge it downslope. This water could be recharging the groundwater table below the road.

Figure 3—Greens Creek transect 2 cross section at given points in time.

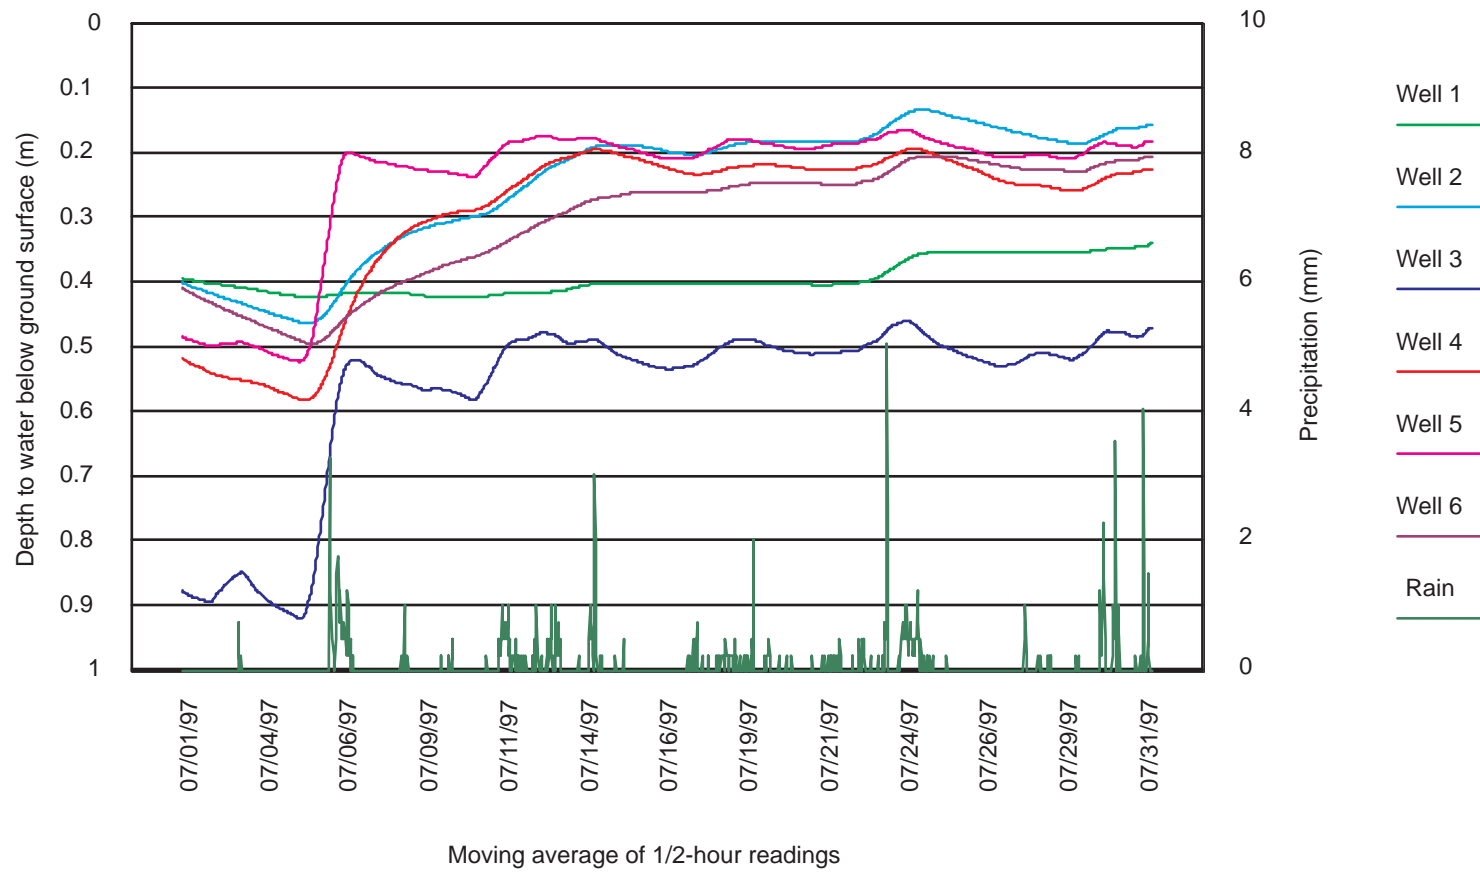
R9801981

Figure 4 also indicates that well 3 exhibits uniformly low groundwater levels. Well 3 appears flashier or more responsive to precipitation and dry periods than the other wells. Well 1 seems especially flat and unresponsive. It is possible the well tip was driven into impervious till, a pocket of fines, or a perched water table, all of which might buffer response to changing moisture conditions. Plots for the other wells also seem buffered to varying extents as compared to well 3.

Figure 4—Continuous groundwater trace for Greens Creek transect 2.

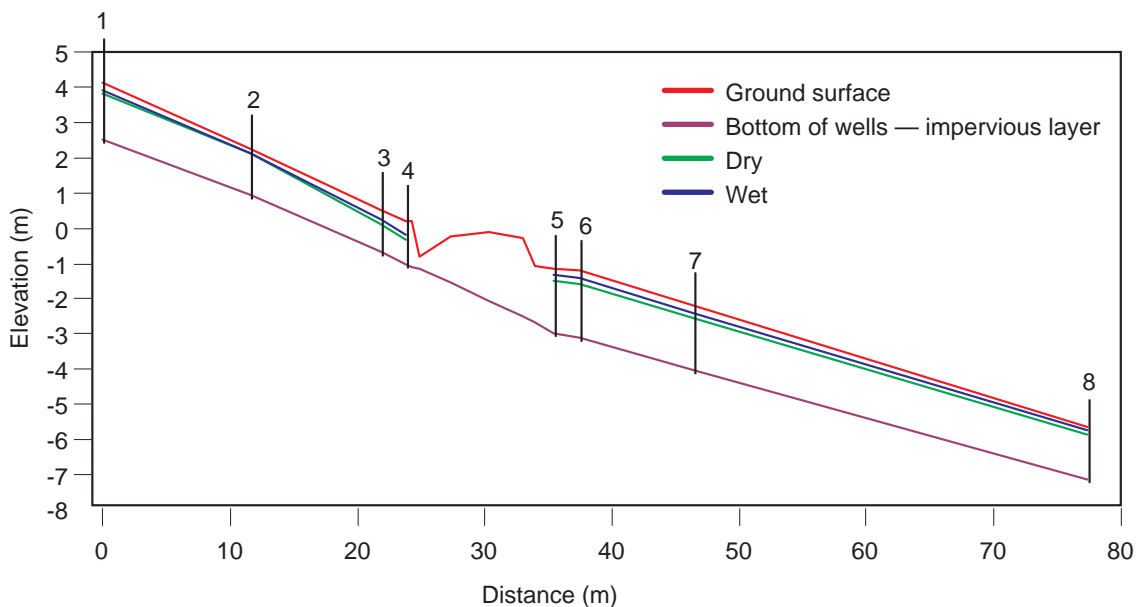
R9801982

The transect cross section shows a deep ditch cut into the muskeg subgrade (figure 5). The ditch is over a half meter deep with a back slope over a meter (table 1). Wells 3 and 4 show a drawdown, probably due to the deep ditch, with an apparent quick recovery downhill of the road as evidenced by water levels in wells 5 through 8. The ditch is below the water table, and it is likely interception is occurring along the backslope and ditch cut face. The quick recovery in well 5 suggests that the porous nature of the pitrun material used to construct the road is acting as a conduit for water in the ditch to recharge the groundwater table under and downhill of the road.

Figure 5—Wrangell Island transect cross section at given points in time.

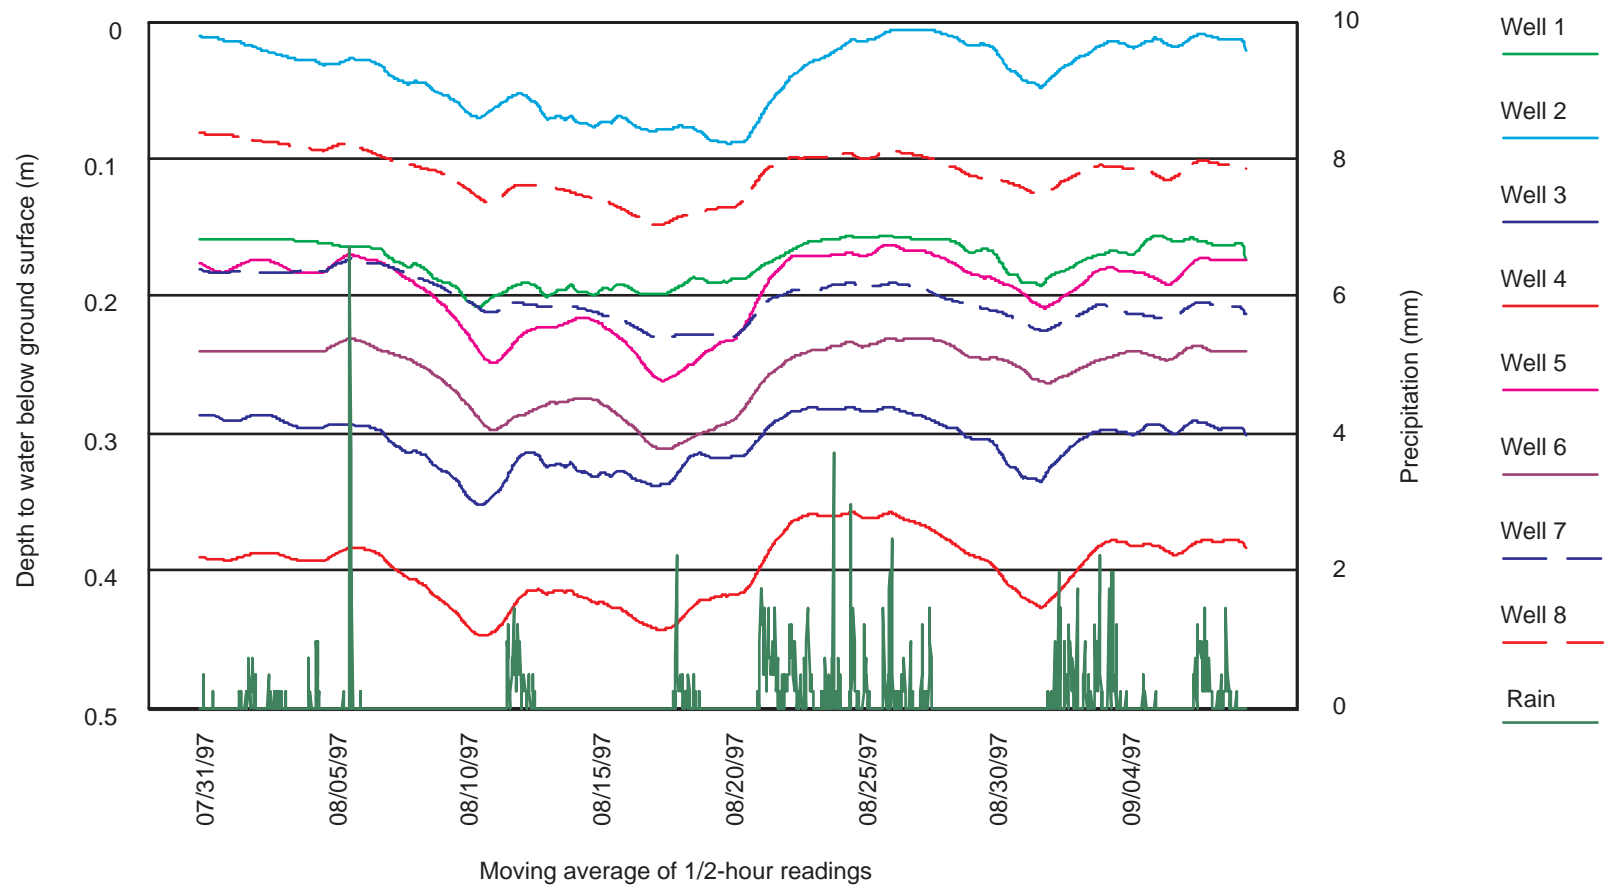
R9801983

groundwater trace (figure 6). The traces for wells 3 and 4 are consistently lower than the other wells substantiating the drawdown effect near the ditch. The fact that all wells react similarly to precipitation events suggests they are hydrologically connected or soil properties are homogeneous at this site. As was evident at the Greens Creek sites, effects of the road on groundwater appear to be localized to within a few meters of the road.

Figure 6—Continuous groundwater trace for Wrangell Island site.

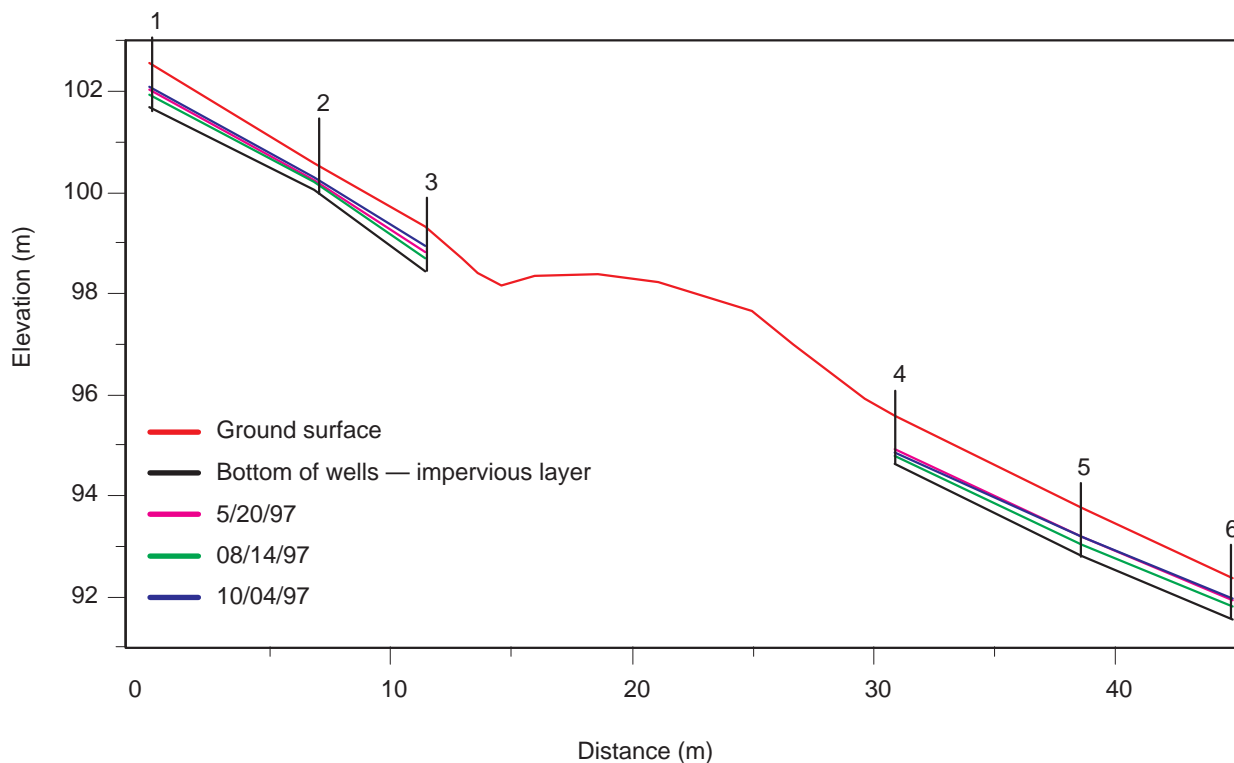
R9801984

The transect on the Margaret Lake road has similar depths of groundwater for wells 1 and 3 during both wet and dry periods (figure 7). The water levels in well 2 are close to the surface as a result of a shallow impervious layer. As was observed at the two transects at Greens Creek, well 4 just below the road shows a lower groundwater level relative to the surface than observed at any of the other wells. This suggests that the road is intercepting some groundwater flow. As at Greens Creek, water levels are recovering in wells 5 and 6 (figure 7).

The Margaret Lake road prism at this site has a shallow back slope and ditch; interception of groundwater by the ditch was not observed. However, during very wet conditions, a straight line down from well 3 to 4 on figure 7 intersects the ditch, indicating potential interception.

Figure 7—Margaret Lake road cross sections at given points in time.

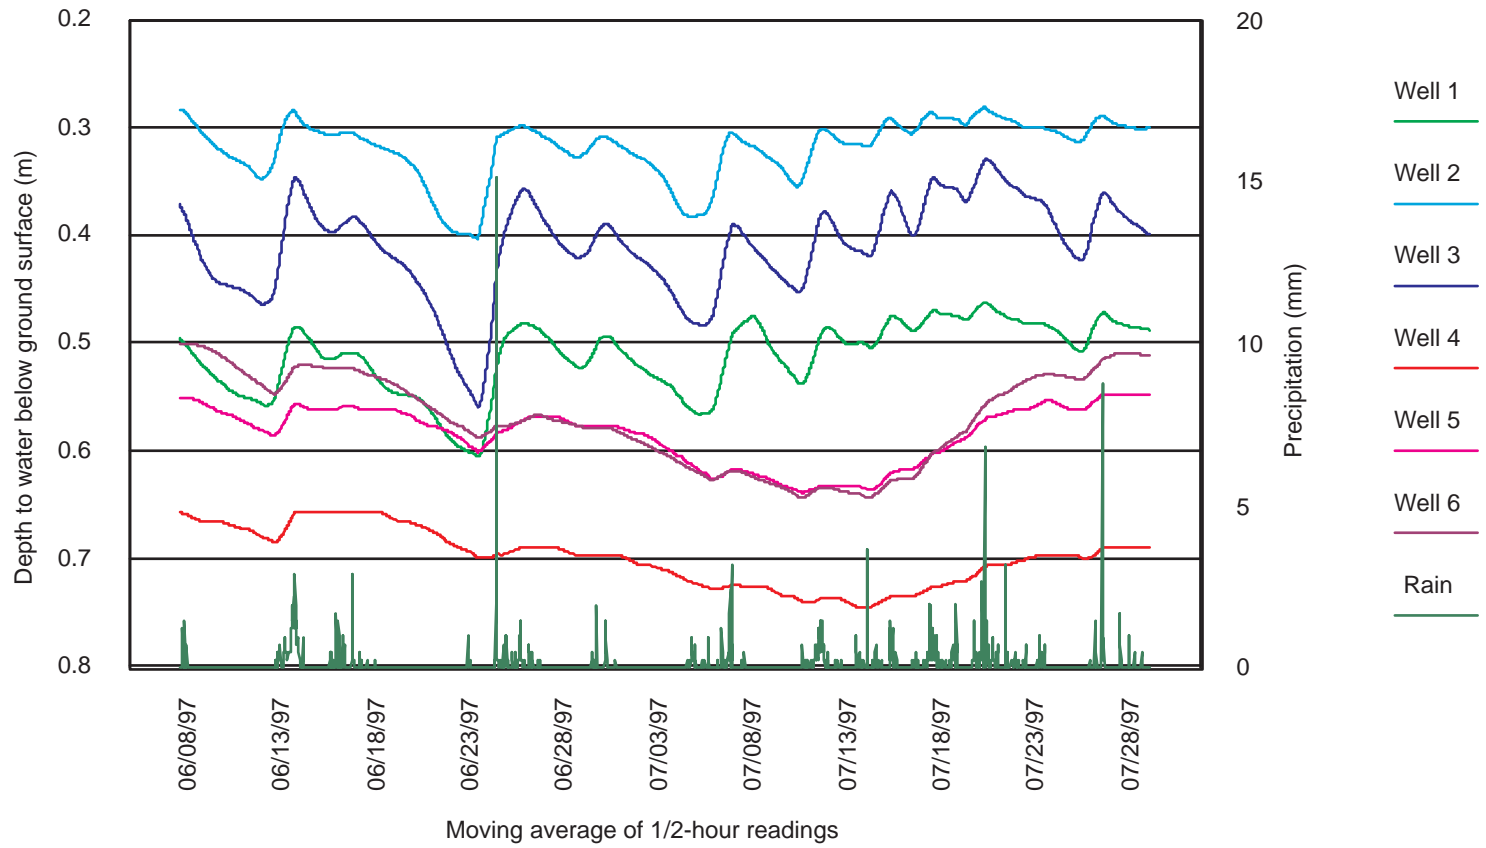
R9801985

road in this study. The age of the road and the high traffic use may cause a reduction in the porosity of the road prism. Figure 8 shows the groundwater trace recorded for the transect with the wells above the road reacting to precipitation and drying periods much more quickly and at greater magnitude than the wells below the road.

Figure 8—Continuous groundwater trace for Margaret Lake road.

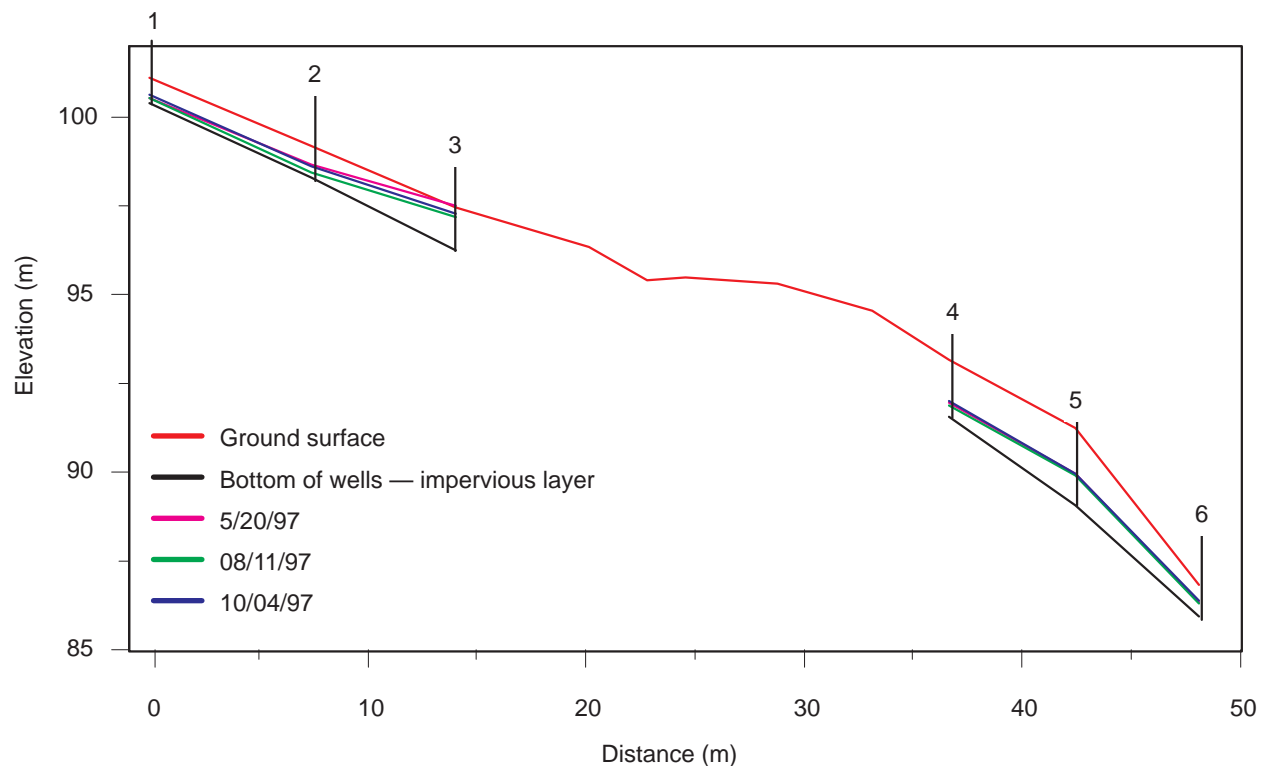
R9801986

This site had only hand measurement of groundwater levels; no electronic measurements were made (see figure 9).

This road was the least desirable site for a groundwater transect of any site in this study. The well transect was not installed perpendicular to the road due to the desire to install the wells in the fall line of the slope. This resulted in a skewed cross section plot depicting an elongated road cross section. Distances between the wells and the road are exaggerated. The road grade is a steep 14 percent, and excess material was sidecast during road construction 30 years earlier, extending the fill slope for several meters (table 1). This may be the cause of a bulge in the groundwater at well 5 (figure 9). The groundwater levels below the road show similar results found at the other sites. The water levels in well 3 are very elevated and near

the surface, which was also observed at transect 1 at Green Creek. This is probably a result of bedrock blocking water flow downslope near well 3 and causing a ponding effect.

Figure 9—Indian Point road cross sections at given points in time.
