# **Trabuco Ranger District Dam Removal and Aquatic Organism Passage Monitoring**

**Trabuco Ranger District  
Cleveland National Forest**

## **2017 Annual Report**

**November 17, 2017**

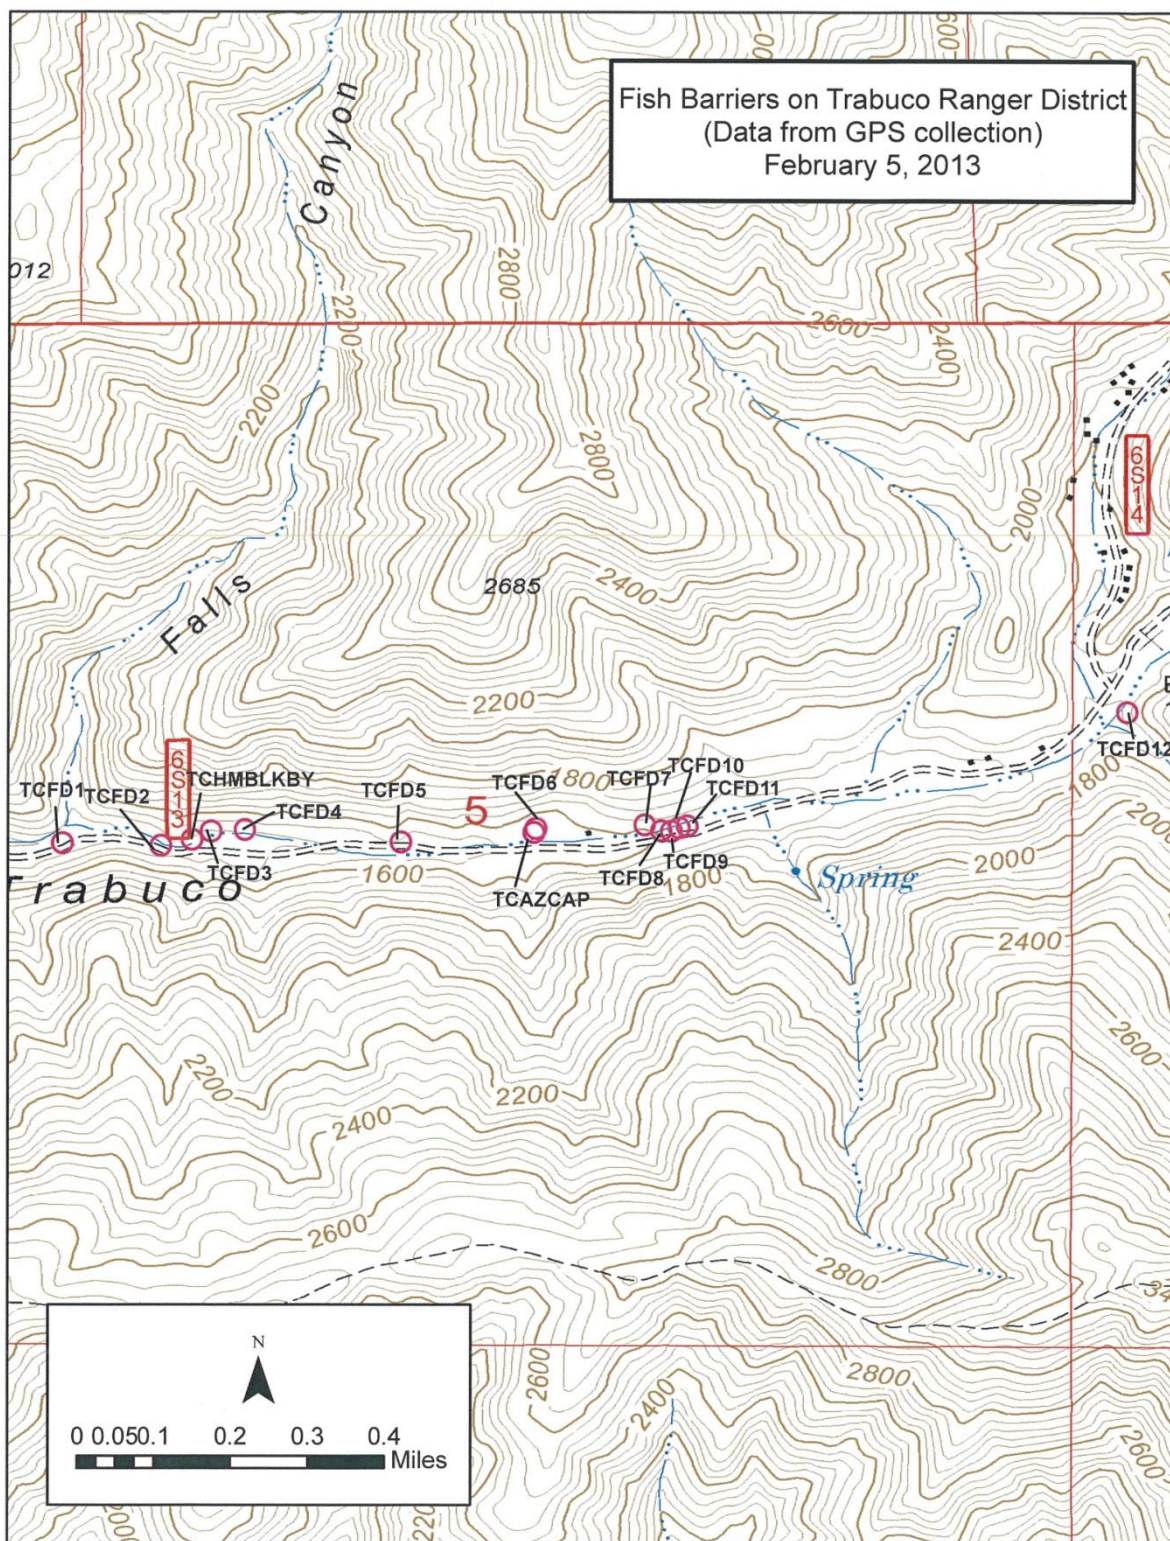
This reach obtained a Functional Rating of Functional- At Risk pre- implementation due to the system not being vertically stable as well as the stream not being in balance with the water and sediment supplied by the watershed. The vertical instability has been caused by scouring out of large plunge pools below the dams and sediment accumulation above the dams, resulting in large gradient changes in the channel.

This reach obtained a Functional Rating of Functional post-implementation for years one, two, and three. The removal of the dams has allowed for the system to become more vertically stable by allowing plunge pools to be filled with the material the dams were holding back creating a more natural gradient.

Dam removal and winter flows have allowed the channel to begin returning to a more natural bedload and sediment transport regime. The channel is moving towards a more natural gradient as sediment that was artificially stored behind the dams has been mobilized and redeposited in scoured out plunge pools that had formed below the dams. Since the rains of winter 2016-2017, the channel is now down to boulders and bedrock in the area where the dam previously stored sand and sediment.

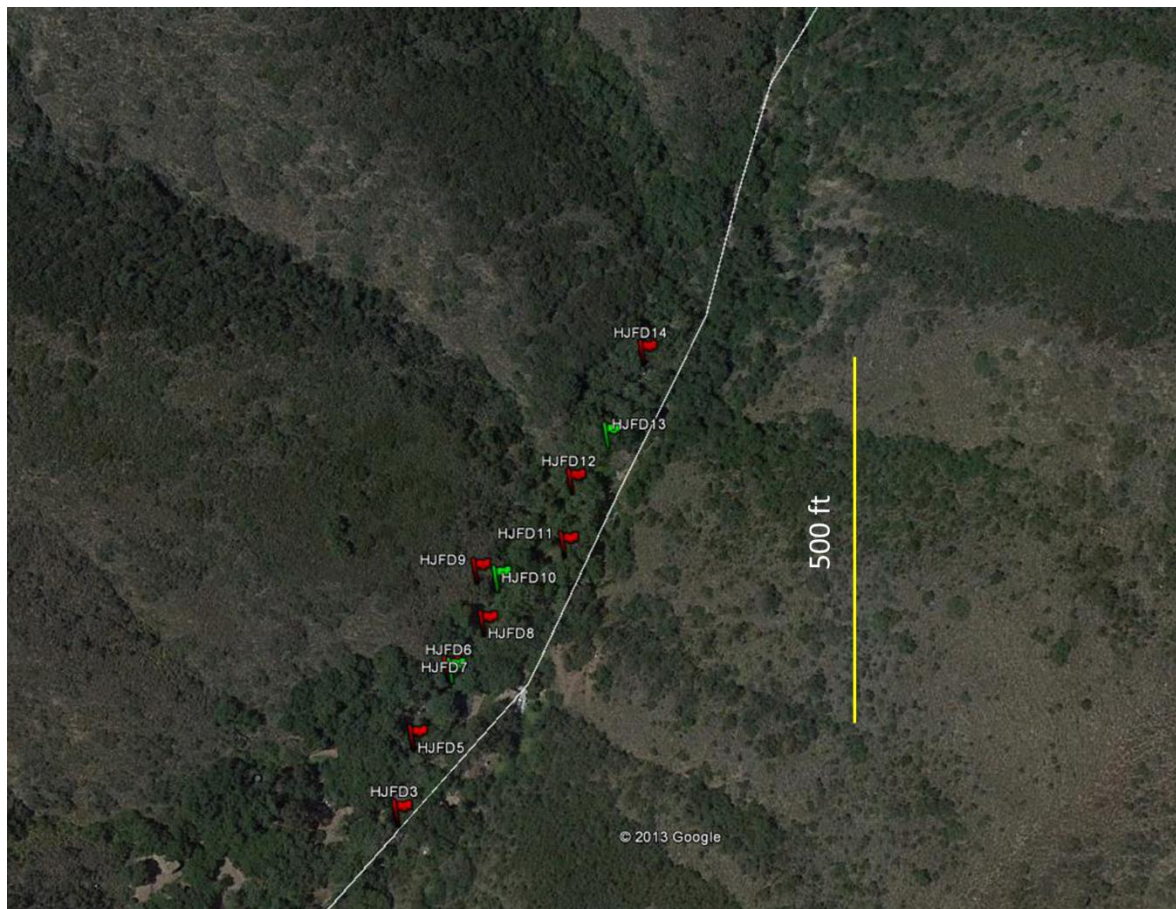
This reach obtained a Functional Rating of Functional- At Risk both pre- implementation and post implementation due to the presence of non-native plants preventing a diverse composition and age classes of riparian-wetland vegetation as well as the system not being vertically stable and the stream not being in balance with the water and sediment supplied by the watershed. Many of the characteristics that contribute to the Functional - At Risk rating are outside the scope of the project. Similar to Trabuco Creek, scouring occurred below the dams resulting in large plunge pools and sediment accumulation behind the dams resulting in large gradient changes in the channel. However, unlike Trabuco Canyon, to date the gradient has not been restored and sediment in the channel has not been mobilized to the point of filling in the plunge pools. The large variations in gradient still exist. There is no apparent trend in Holy Jim Creek at this point.

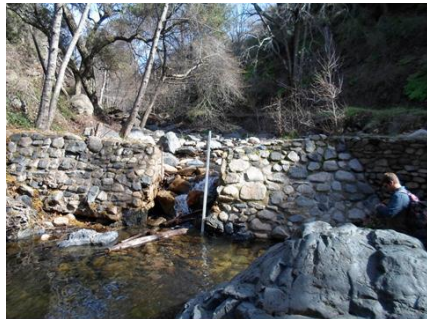
Site TCFD7 (UTM 11S 451247mE, 3726147mN)

Downstream of dam Feb 2013

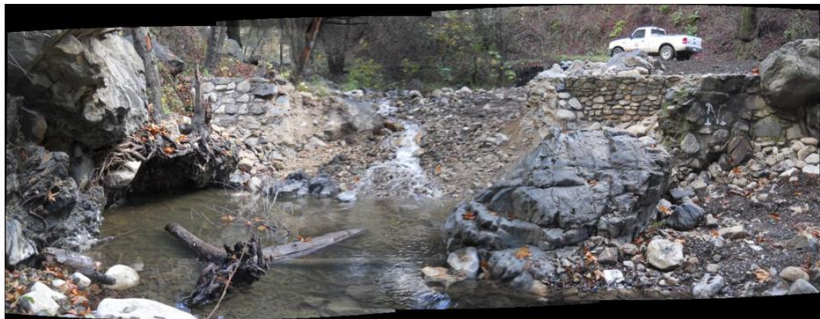
Downstream of dam after demo 19 Dec 2014

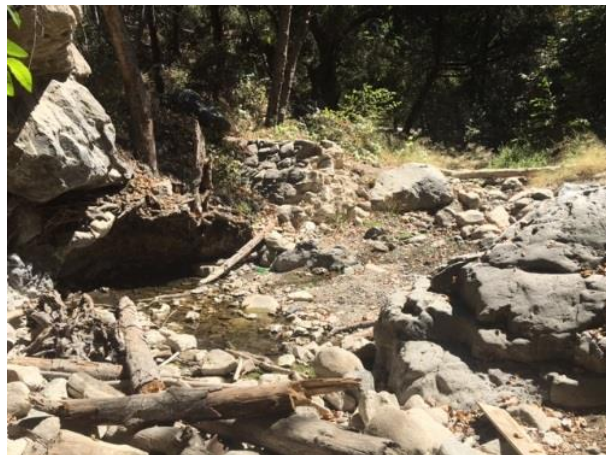
Downstream of dam – Aug 2016

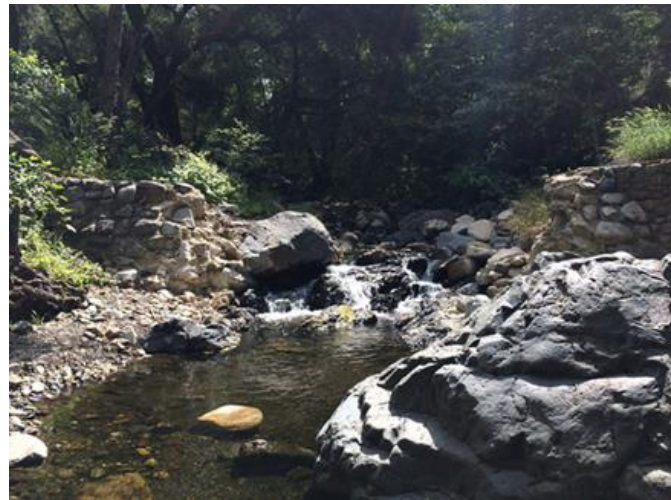
Downstream of dam – May 2017

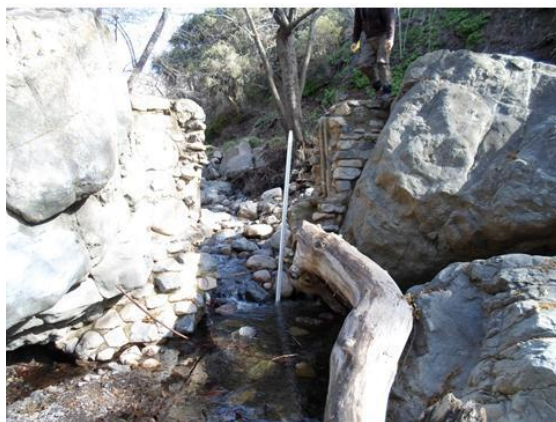
Site TCFD9 (UTM 11S 451294mE, 3726173mN)

Downstream of dam Feb 2013

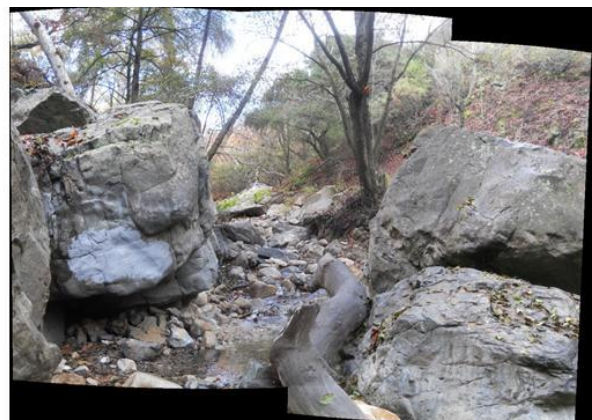
Downstream of dam after demo 19 Dec 2014

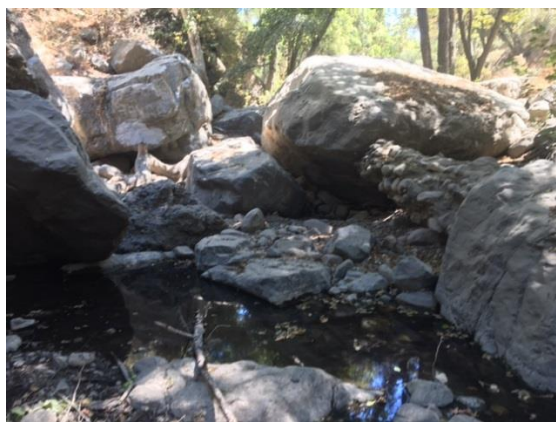
Downstream of dam after demo Aug 2016

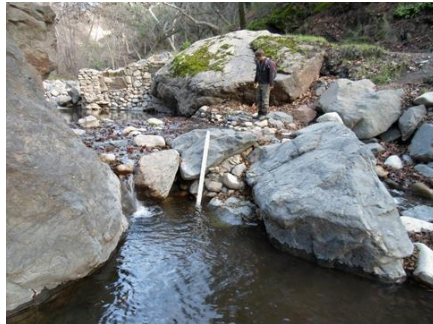
Site TCFD10 (UTM 11S 451312mE, 3726171mN)

Downstream of dam Feb 2013

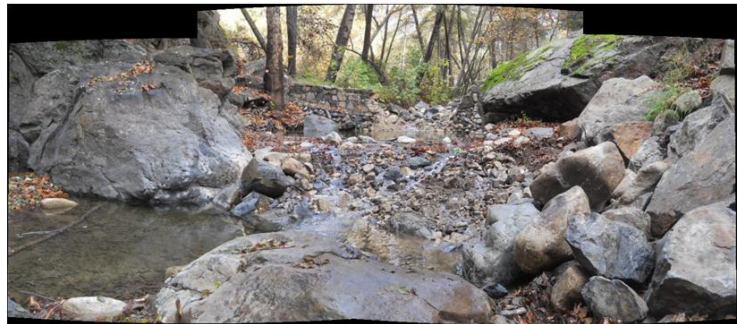
Downstream of dam after demo 19 Dec 2014

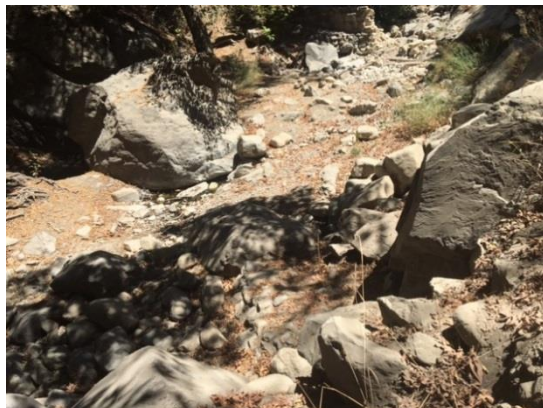
Downstream of dam after demo Aug 2016

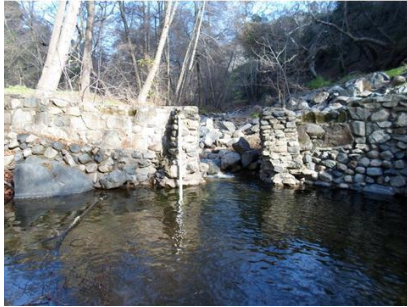
Site TCFD11 (UTM 11S 451326mE, 3726175mN)

Downstream of dam Feb 2013

Prior to removal, TCFD11 had a jump height of 1.5ft. After removal of the dam the jump height has been reduced to 0ft.

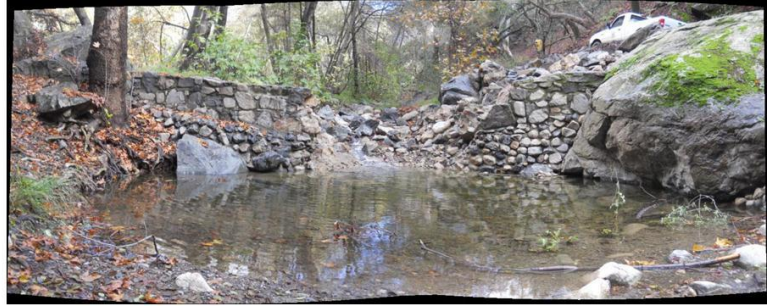
Downstream of dam after demo 19 Dec 2014

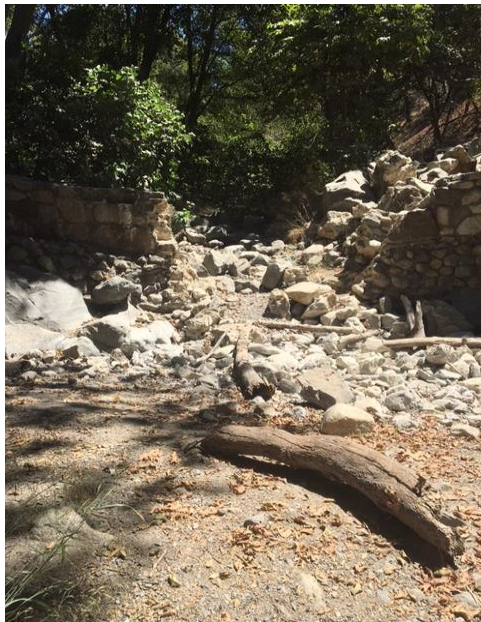
Downstream of dam - Aug 2016

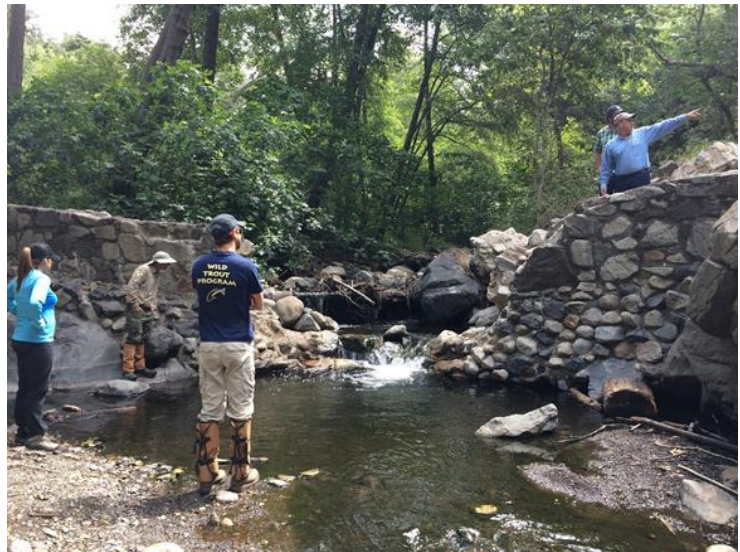
Downstream of dam – May 2017

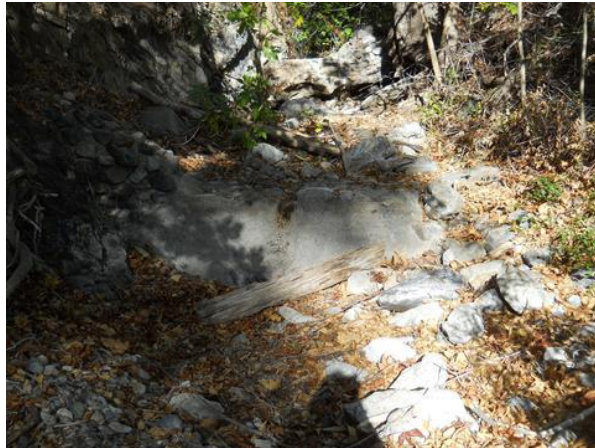
Site HJFD6 (UTM 11S 452201mE, 3727162mN)

Downstream Feb 2014

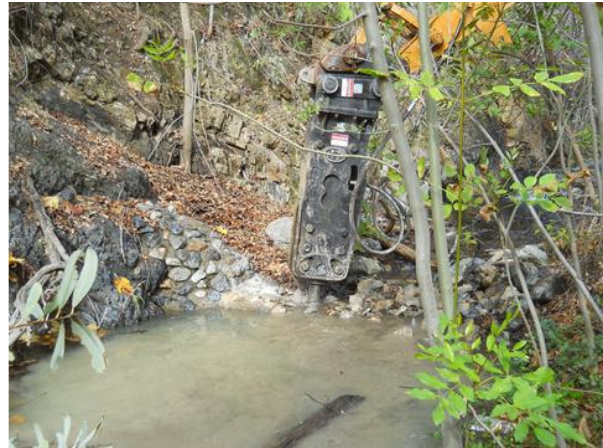
Downstream during demo 19 Dec 2014

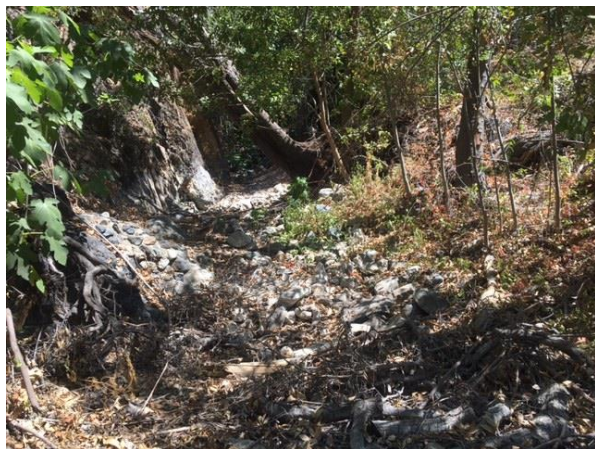
Downstream of dam after demo Aug 2016

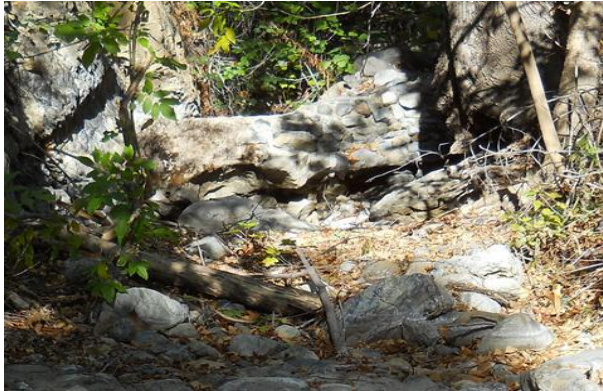
Site HJFD7 (UTM 11S 452199mE, 3727164mN)

Downstream Feb 2014

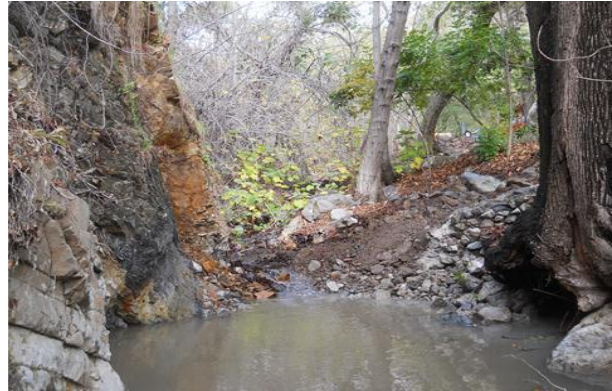
Downstream after demo 19 Dec 2014

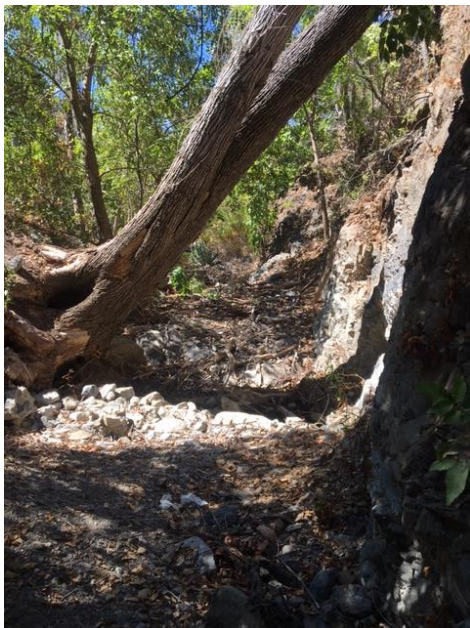
Upstream of dam after demo Aug 2016

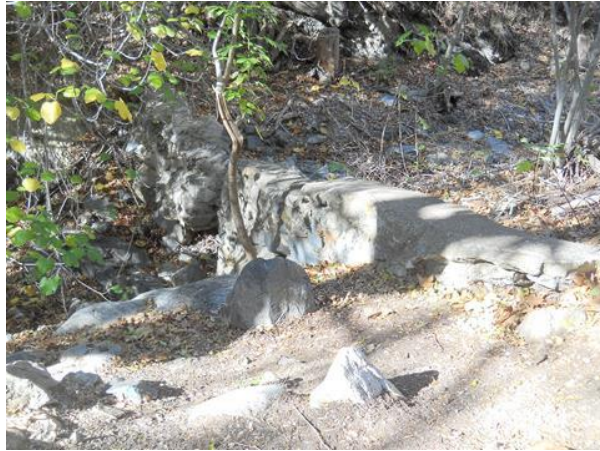
Site HJFD8 (UTM 11S 452215mE, 3727183mN)

Downstream Feb 2014

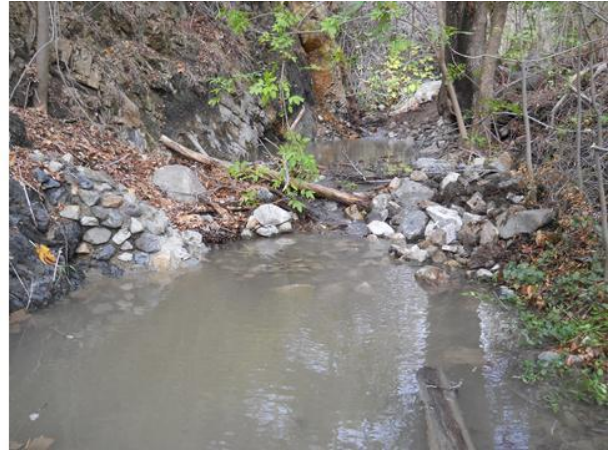
Downstream after demo 19 Dec 2014

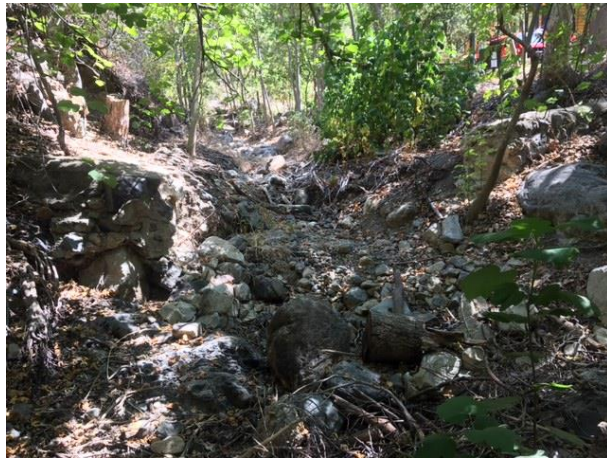
Downstream after demo Aug 2016

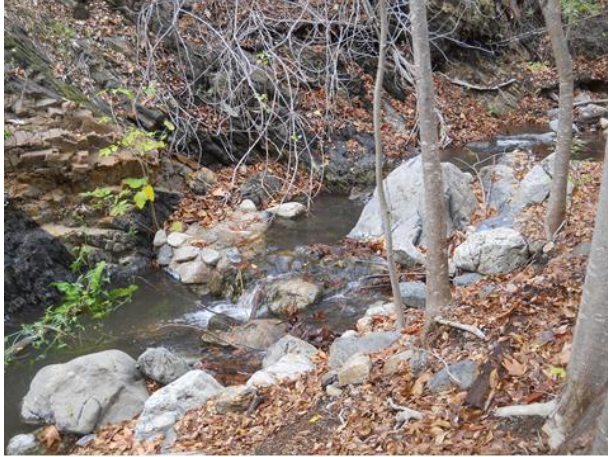
Site HJFD9 (UTM 11S 452212mE, 3727208mN)

Downstream before demo Feb 2014

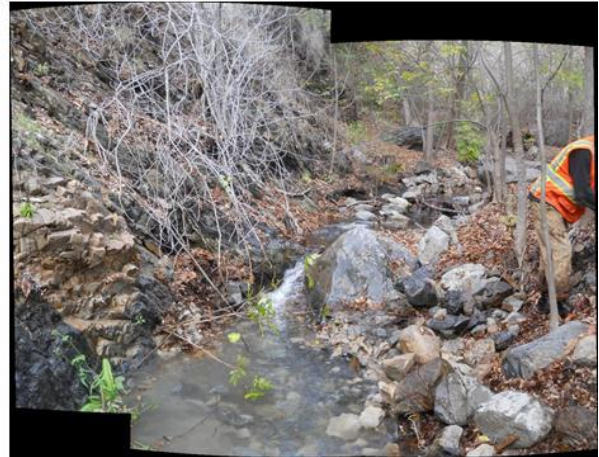
Downstream after demo 19 Dec 2014

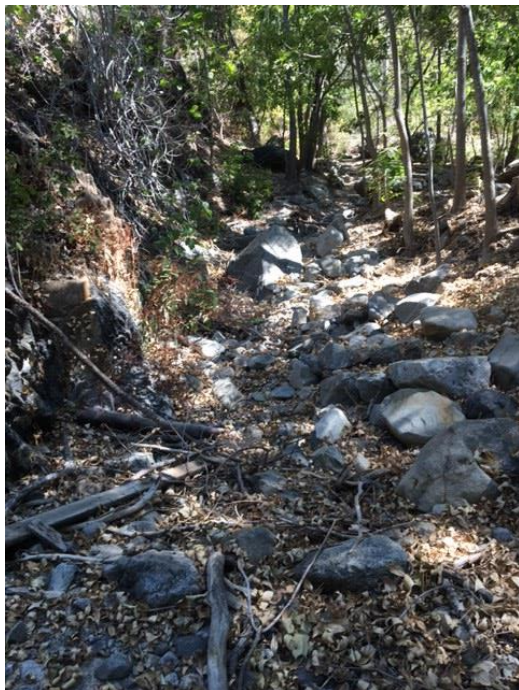
Downstream after demo Aug 2016

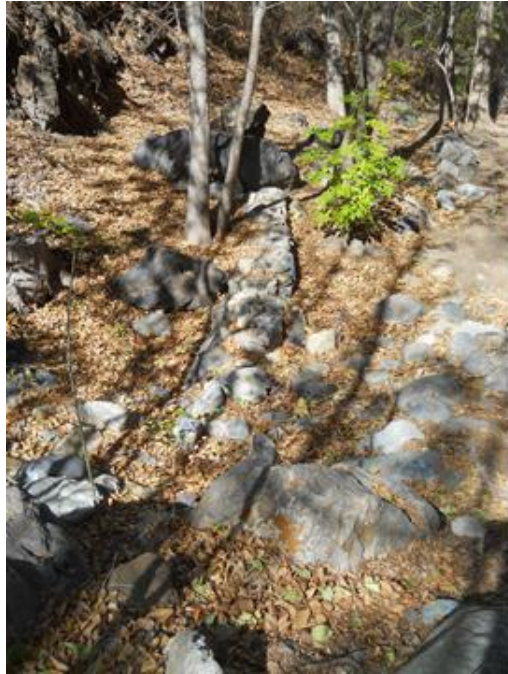
Site HJFD10 (UTM 11S 452222mE, 3727205mN)

South Bank Feb 2014

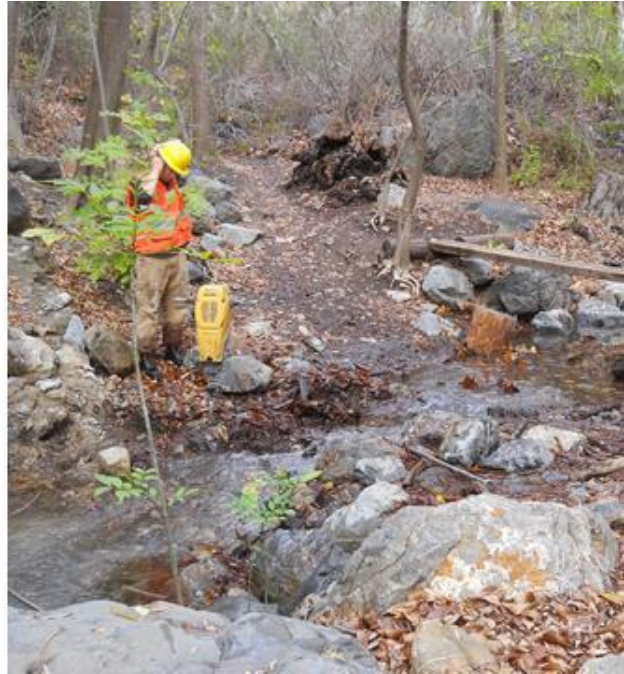
South Bank after demo 19 Dec 2014

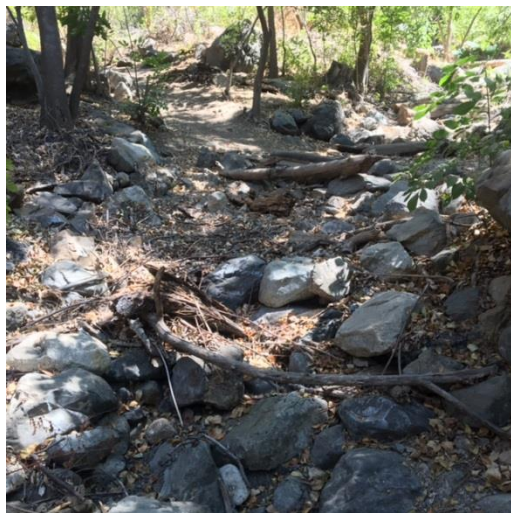
South Bank/Down Stream after demo Aug 2016

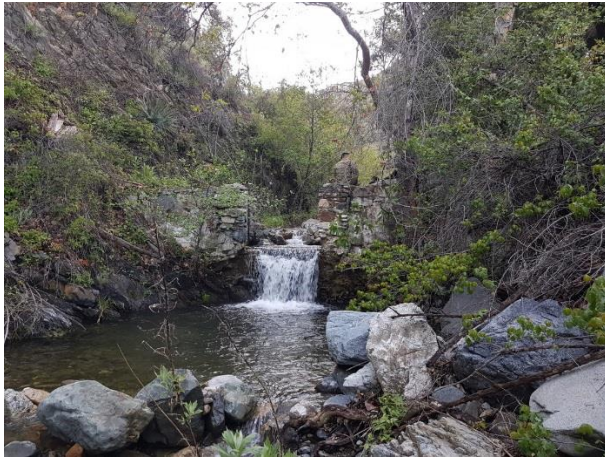
Site HJFD15 (UTM 452495mE, 3727688mN)

Looking U/S before demo March 2017.

Prior to removal, HJFD 15 had a jump height of 4.2 feet. After removal of the dam the jump height has been reduced to 0 feet.

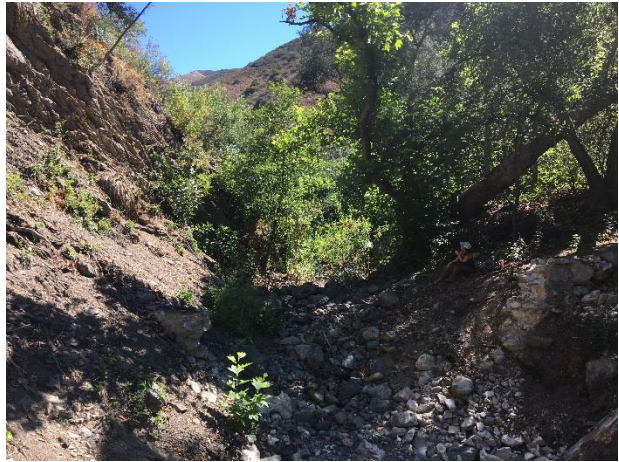
Looking U/S post demo August 2017

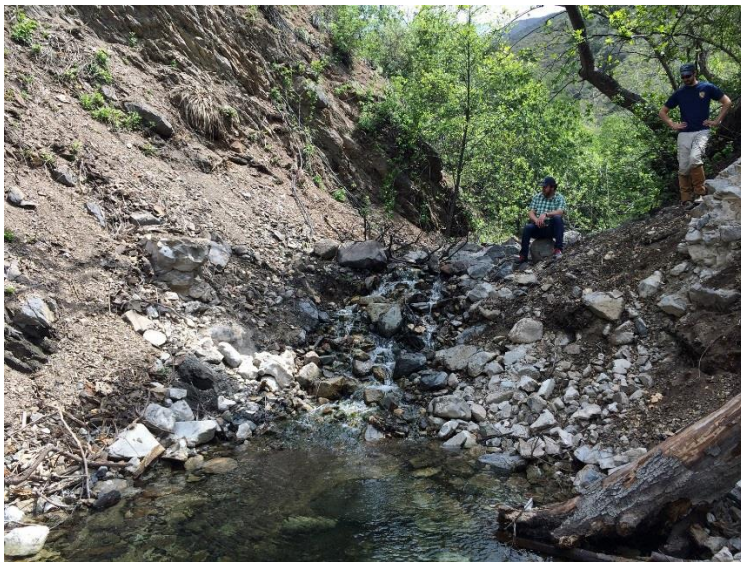
Looking upstream, May 2017

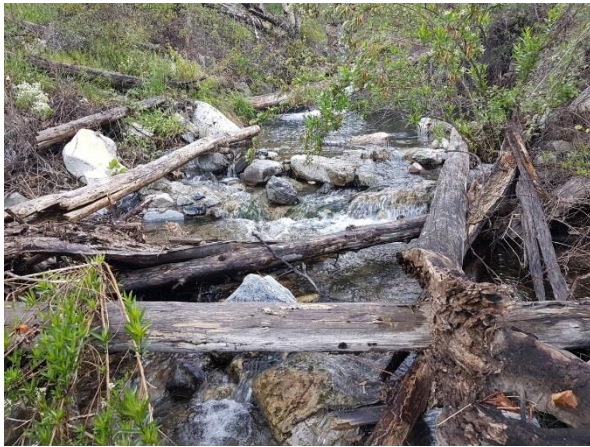
Site HJFD16 (452558mE, 3727766mN)

Looking U/S before demo March 2017

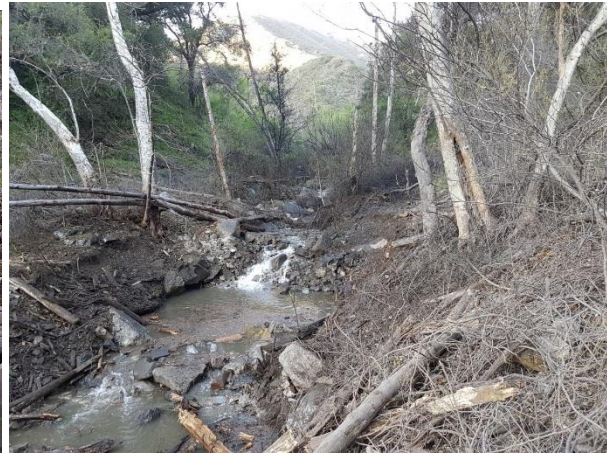
Looking U/S directly after demo March 2017

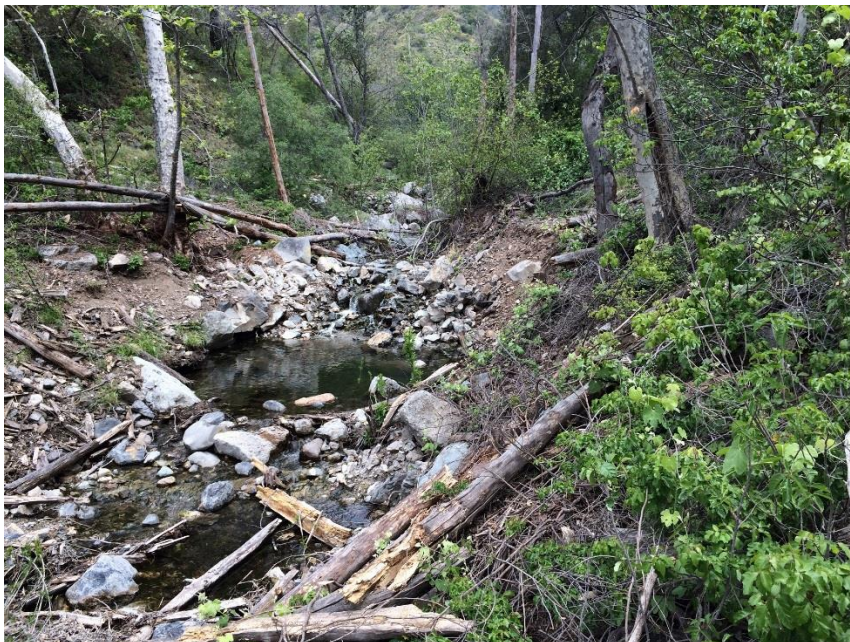
Looking upstream, May 2017 (shows dams 16 and 17)

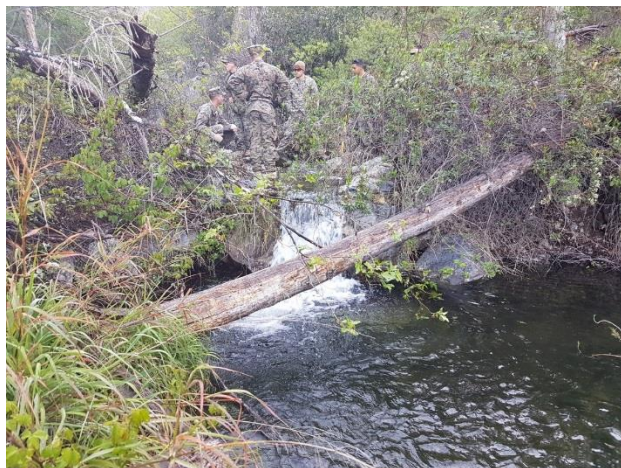
Site HJFD17 (UTM 452560mE, 3727774mN)

Looking U/S before demo March 2017

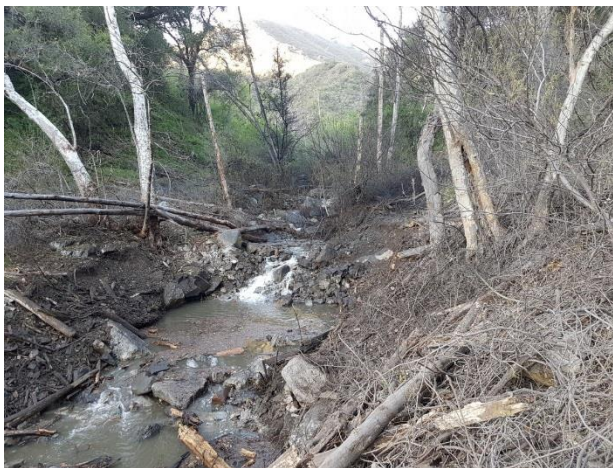
Looking U/S directly after demo March 2017

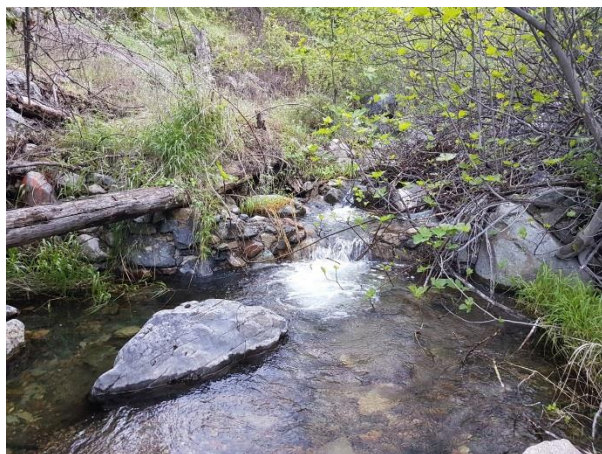
Site HJFD18 (UTM 452568mE, 3727790mN)

Looking U/S before demo March 2017

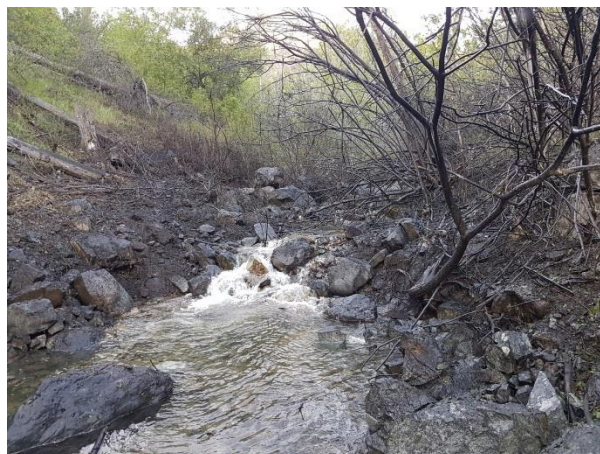
Looking U/S directly after demo March 2017

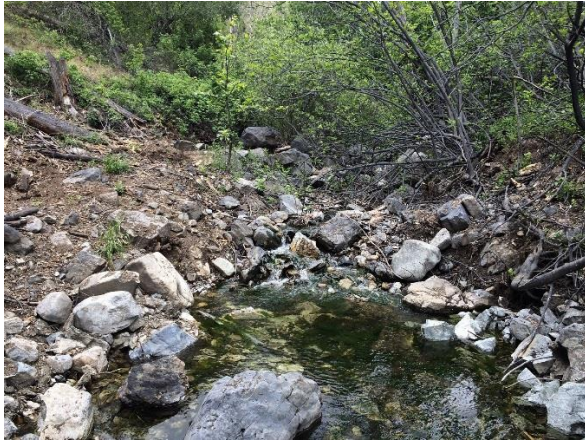
Looking upstream – dam 18 – May 2017

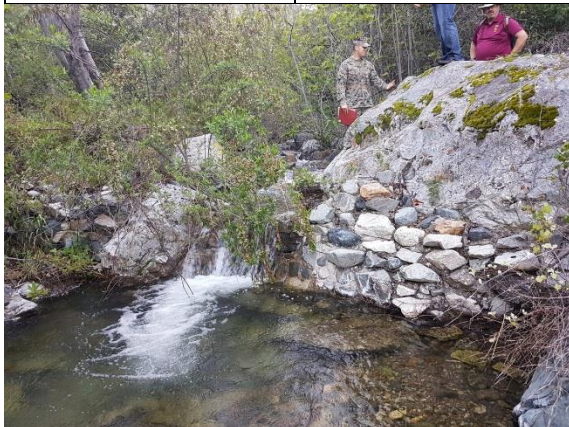
Site HJFD19 (UTM 452572mE, 3727808mN)

Looking upstream before demo March 2017

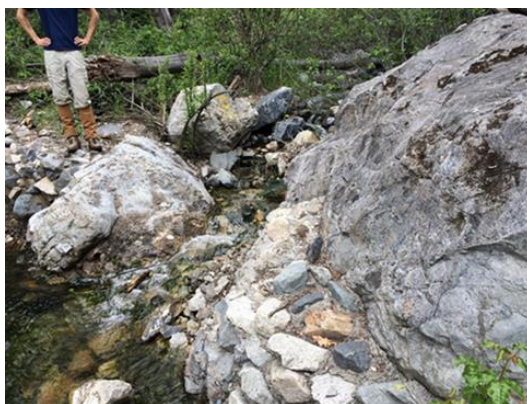
looking upstream after demo May 2017

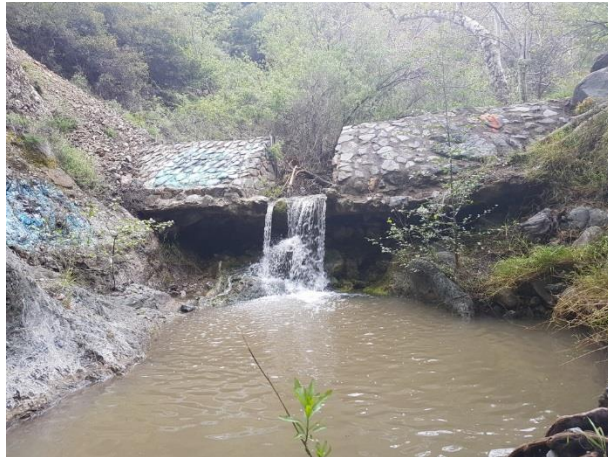
Site SCFD7 (UTM 447105mE, 3734737mN)

Looking U/S before demo March 2017

Prior to removal Silverado dam 7 had a jump height of 7 feet. After removal, the jump height has been reduced to 0 feet.

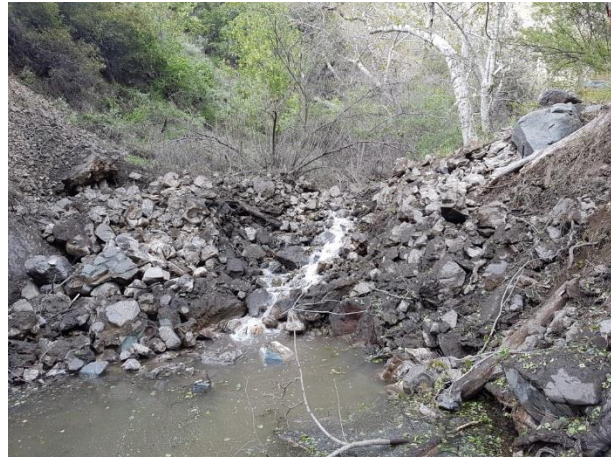
Looking U/S directly after demo March 2017

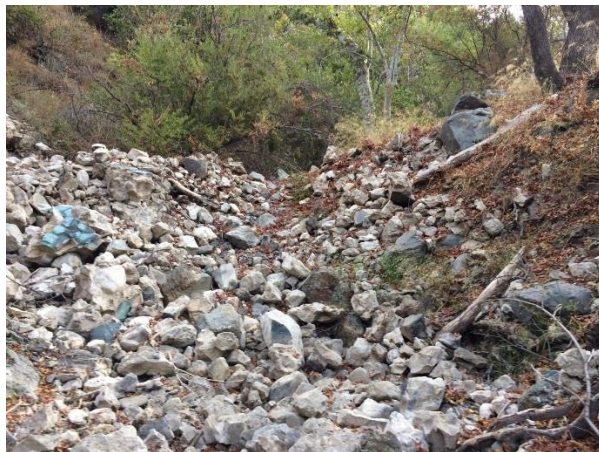
Looking upstream after demo Sept 2017

Right bank upstream: vulnerable (with vegetation)  
Right bank downstream: vulnerable (with vegetation)  
Left bank downstream: stable (bedrock)

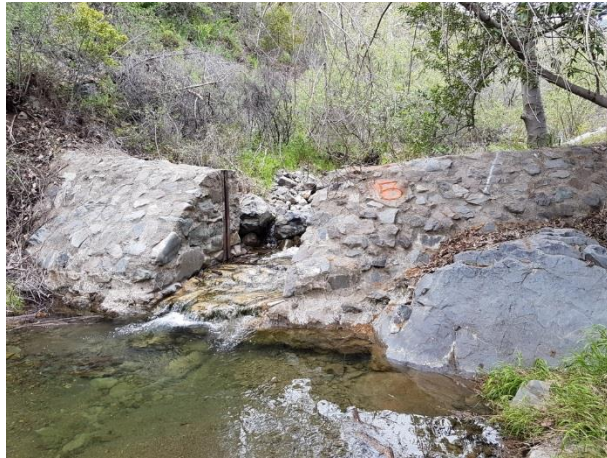
Site SCFD8 (UTM 447115mE, 3734767mN)

Looking U/S before demo March 2017

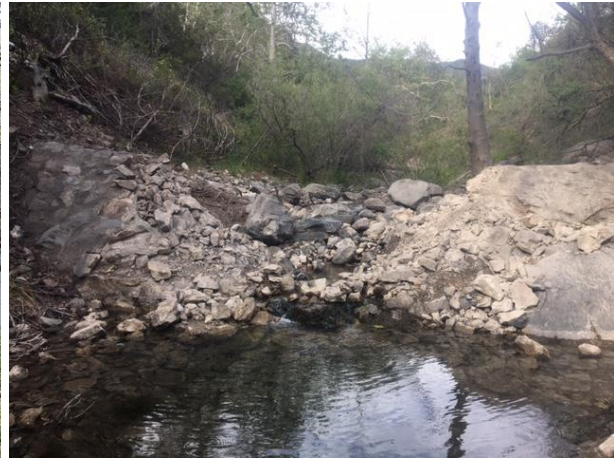
Looking U/S directly after demo March 2017

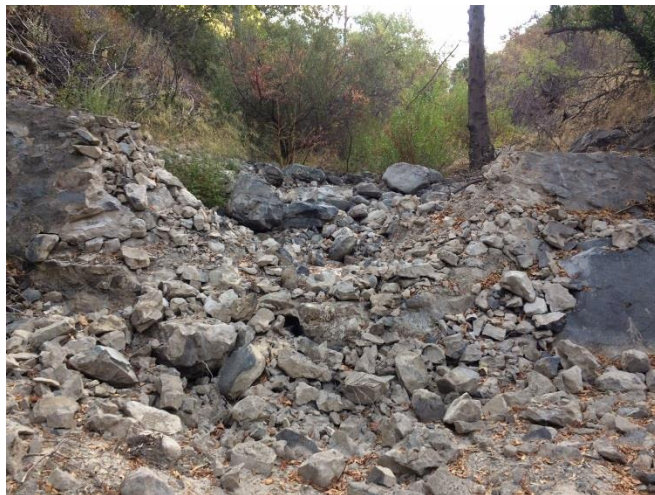
Looking upstream after demo – Sept 2017

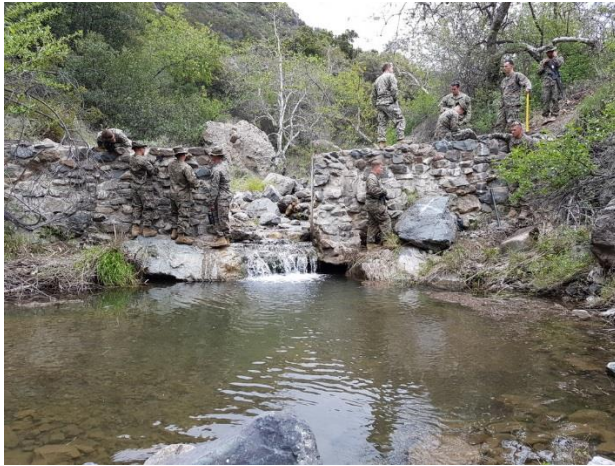
Site SCFD10 (UTM 447163mE, 3734795mN)

Looking U/S before demo March 2017

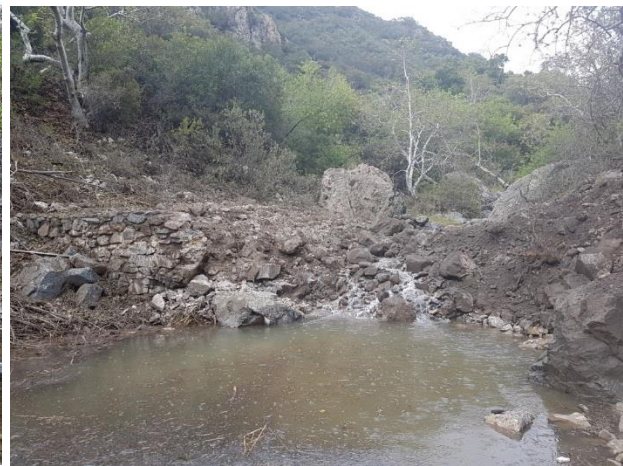
Looking U/S directly after demo March 2017

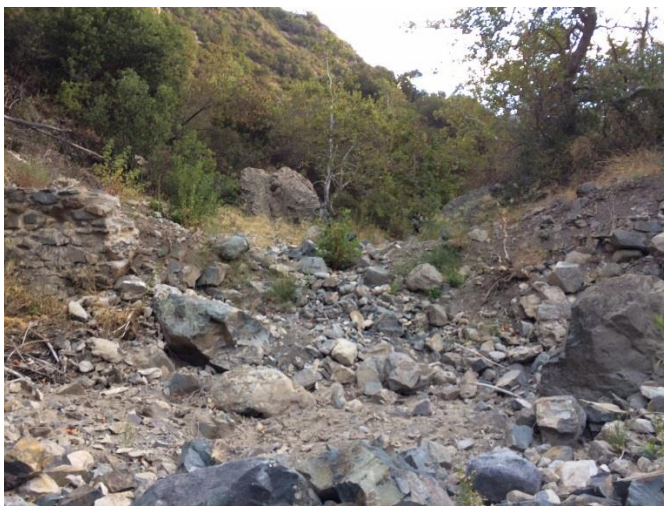
Looking upstream after demo Sept 2017

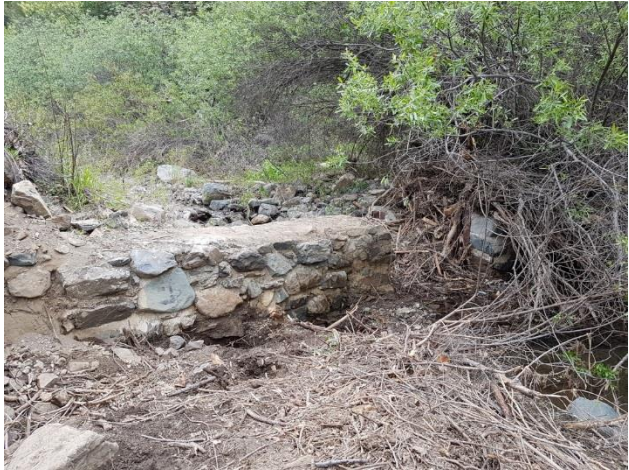
Site SCFD12 (UTM 447386mE, 3734829mN)

Looking U/S before demo March 2017

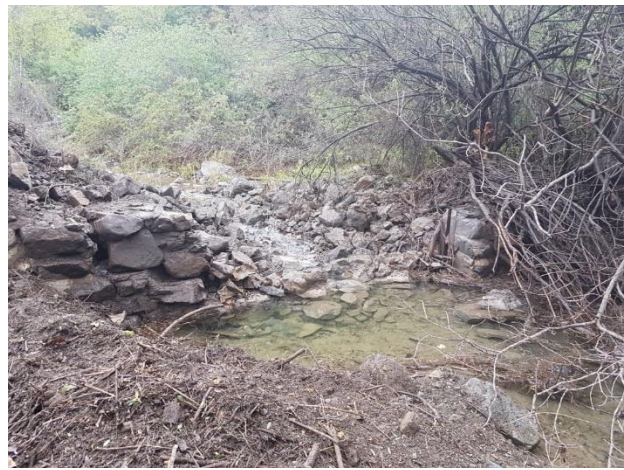
Looking U/S directly after demo March 2017

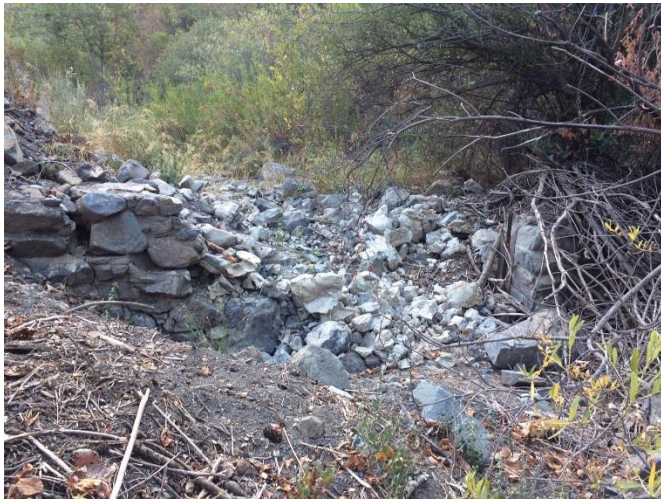
Looking upstream after demo Sept 2017
