Corrosion of Air Tankers by Fire Retardants

By James B. Davis and Clinton B. Phillips

A Report for

California Air Attack Coordinating Committee

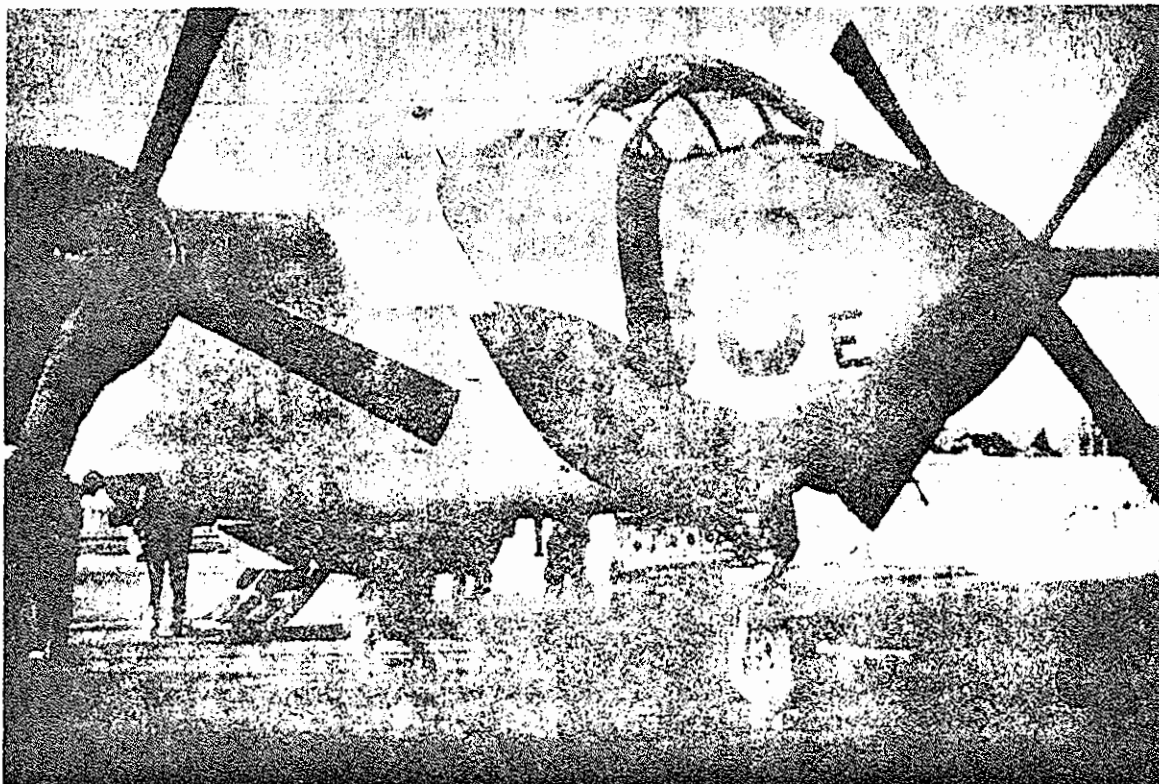
Figure 2.--The inspection team closely checked all visible parts of the

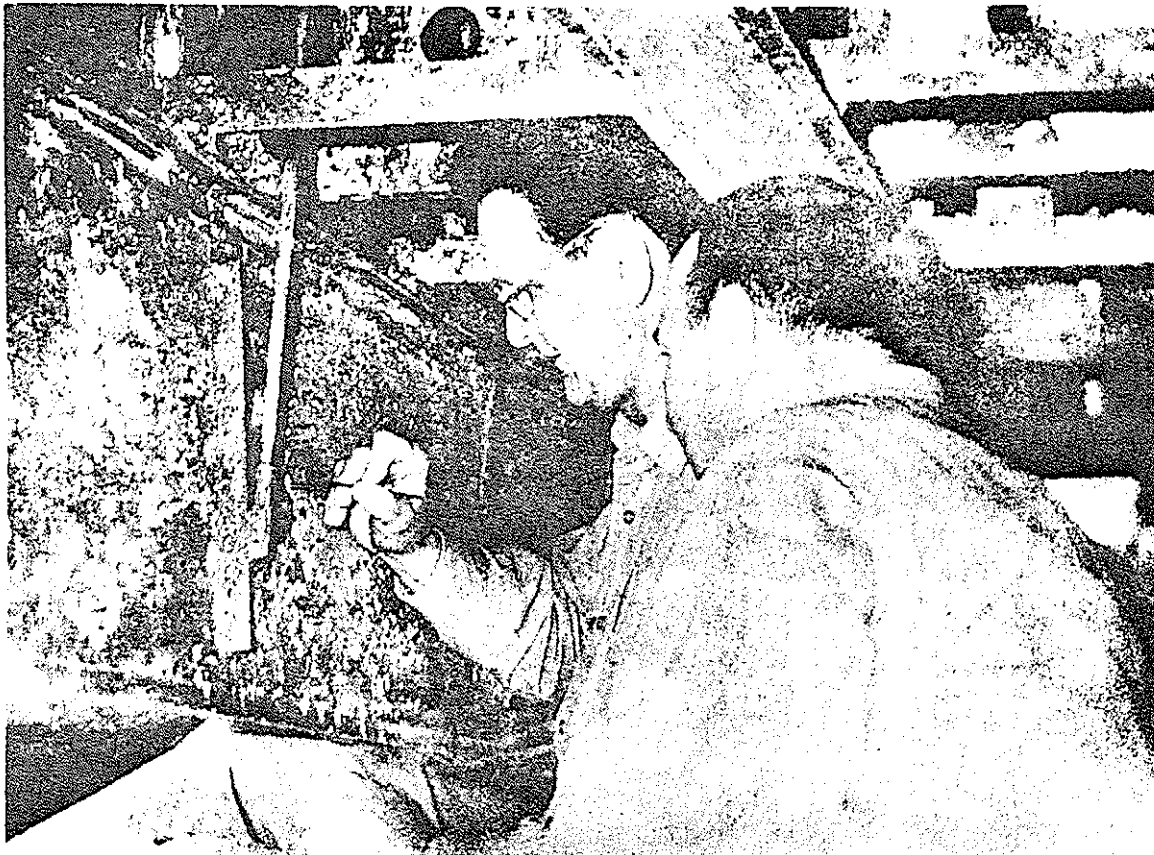
Figure 7.--Exfoliation of aluminum tank gate of an air tanker is pointed out by an inspector. White area being examined is caused by corrosion occurring between grains within the aluminum alloy.

4. EXFOLIATION CORROSION A form of intergranular corrosion in which the surface grains or layers of a metal are "lifted"-up by the force of expanding corrosion products occurring at the grain boundaries below the surface. It is most often seen on extruded sections of metal where the metal grains have been greatly elongated in one direction (fig. 7). It can also result when the heat treatment is too short or is at too low a temperature. Exfoliation corrosion can also be the result of alloy segregation. After rolling or extrusion, the corrosion will follow these layers of segregated alloys.

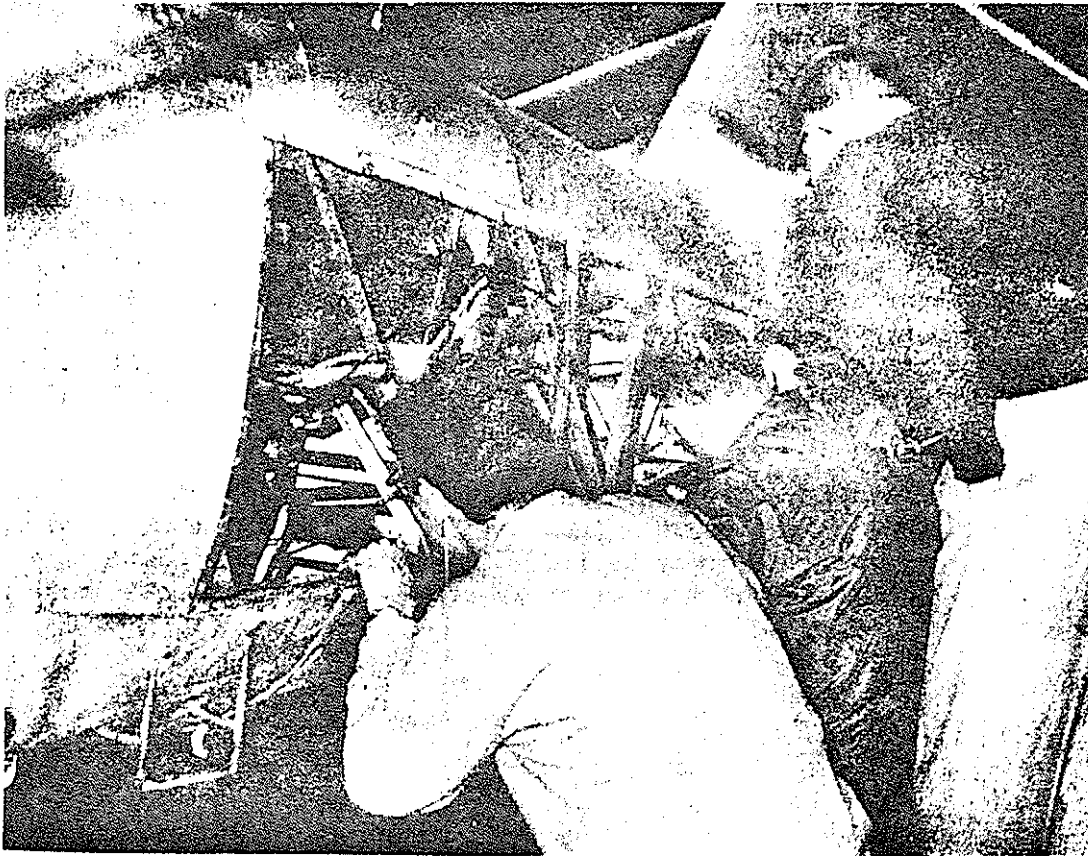
Figure 9.--Some air tankers showed virtually no corrosion--largely because of high quality maintenance.

During the course of the inspection trip, we found a great deal of variation in maintenance and good housekeeping practices (fig. 9). While some air tankers were spotless, others contained a thick deposit of dried retardants layer on layer much like that in geological formations. These layers served to show the life history of the air tanker for the past fire season or two.

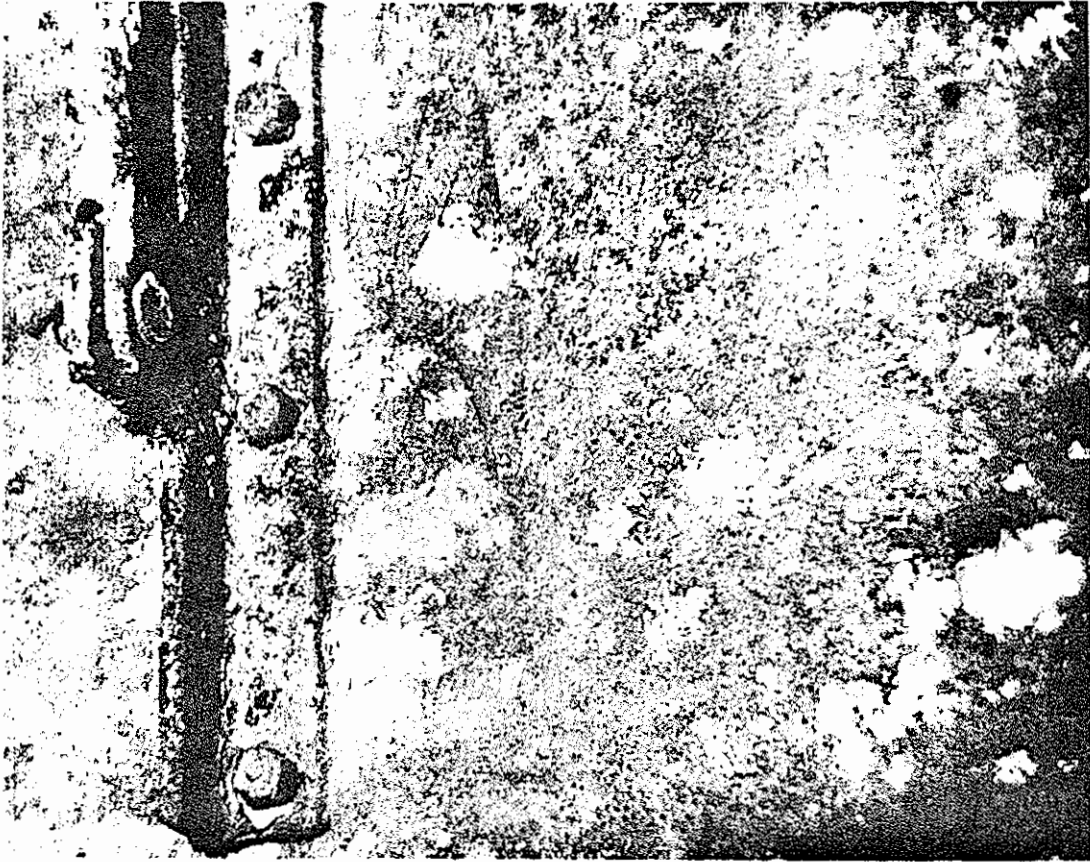
Evidence was strong that the worst corrosion noted in tanks and gates was caused by algin gel. By far the worst example of corrosion was on an air tanker, E-68, that had carried algin gel almost exclusively in 1964. In two or three other cases of extensive tank and gate corrosion, the aircraft had carried several loads of algin gel during the 1964 fire season. These findings tended to confirm those of the corrosion tests conducted in 1963 by the Forest Service's Equipment Development Center (U.S. Forest Service, 1965).

Algin gel without corrosion inhibitors appears to cause serious corrosion damage to aluminum alloys (fig. 10). Exfoliation-type corrosion and pits as much as 70 mils deep developed during one year in air tanker E-68, that carried mainly algin gel. The Arcadia retardant tests showed stress-corrosion cracking in aluminum alloy 2024-T4 after continued exposure of about 300 days to algin gel. The material appeared to be more corrosive to this aluminum alloy than any other retardant tested. Algin gel is now being phased out of the air tanker program by all forest fire control agencies in California.

Figure 10.--Deep pits and exfoliation appeared on the gates of this air tanker after it had carried algin gel for one fire season.
