**TECHNICAL BULLETIN
052813**

TITLE: RADIO PRE-WIRE CABLE PROTECTION BEFORE RADIO INSTALLATION

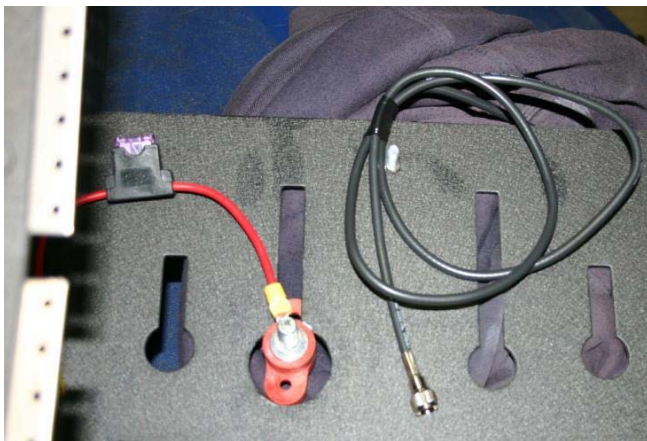
Before

This bulletin is in response to a possible safety hazard found in Wildcat 643U Models manufactured between January 2010 and May 2013. This hazard is only found when a radio is not installed.

If a radio is not installed, or has been removed, use high quality electrical tape to cover the end of the Mini-UHF Coaxial radio pre-wire cable to prevent contact with the positive terminal found in the Console of the apparatus. Contact with this terminal could cause a short and a possible fire. A picture of this condition before and after corrective action is included in this bulletin.
