U.S. Department of Agriculture

Forest Service

Culvert Scour Assessment

Prepared by: Inter-Fluve, Inc., for U.S. Forest Service San Dimas Technology & Development Center San Dimas, CA

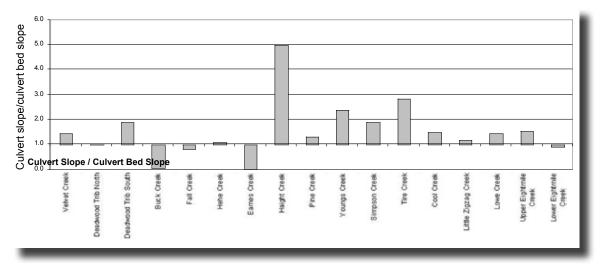
Figure 3.4-1. Ratio of culvert slope to culvert-bed slope. Culvert slope is the slope of the actual culvert structure. Culvert-bed slope is the slope of the thalweg profile through the culvert.

A common condition found at many of the sites is the adjustment of the channel bed post installation. Survey measures indicate that many sites have culvert beds that have a flatter slope than the culvert structure itself. Assuming that culvert beds were originally constructed at the same slope as the culvert structure, these sites have adjusted since installation through inlet scour, aggradation in the downstream portion of the pipe, or a combination of the two. At many sites, bed degradation at the upstream portion of the pipe and aggradation of material in the downstream portion were clearly visible. Figure 3.4-1 shows the incidence of culvert-bed flattening among all sites.

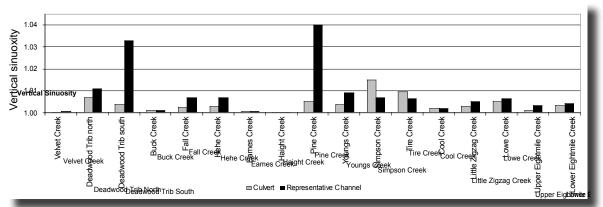
Vertical sinuosity and residual depth. Vertical sinuosity in the natural channel was consistently greater than that in the culvert except for Simpson Creek and Tire Creek, where culvert-bed sinuosity was greater (figure 3.5-1). This indicates that, in nearly all cases, the culvert beds reviewed have less complex bed topography than their corresponding natural channels. Values generated in the profile complexity analysis are included in appendix A.

Figure 3.5-1. Vertical sinuosity in the culvert and natural channel at each study site. For sites with more than one reference segment, the vertical sinuosities were averaged. Reference channel values are significantly greater than the culvert values using a one-tailed paired t-test ($\alpha = 0.05$).

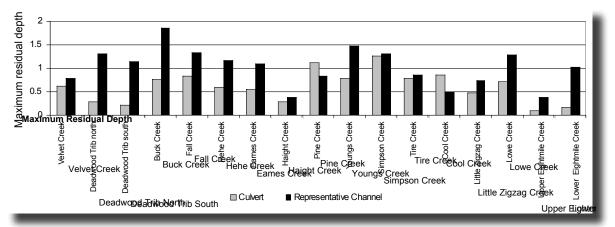
Figure 3.5-2. Maximum residual depth in the culvert and natural channel. For sites with more than one representative natural channel segment, the residual depths were averaged. Values for culverts and reference channels are significantly different using a paired t-test at $\alpha = 0.05$.

Maximum residual depth is greater in the natural channel than in the culvert for all but two sites; Pine Creek and Cool Creek (figure 3.5-2). On average, maximum residual depth in the culverts reviewed was about 0.6 that of the natural channel. This is consistent with the results of the vertical-sinuosity assessment. Greater pool depths would generally be associated with greater vertical sinuosity. Values generated in the residual-depth analysis are included in appendix A. Factors contributing to similarities and differences in residual depths at individual sites are discussed in the site evaluations in appendix A.

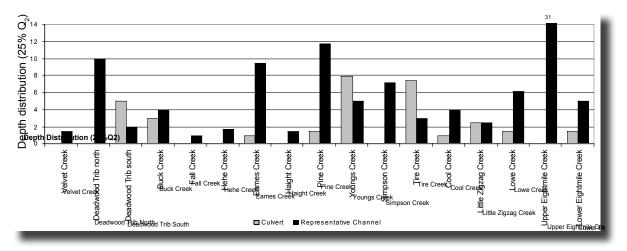
Figure 3.5-3. Depth distribution results for all sites. Bars depict the number of cross-section increments with depths less than 0.3 feet.

Depth distribution. At the 25-percent Q_2 , the depth distribution analysis showed that at least one cross section in the culvert had less available shallow water habitat at 13 of 17 sites. The following sites had at least one cross section with depth-distribution values within or greater than the range found in the natural channel: Tire Creek, Buck Creek, Little Zigzag Creek, Deadwood Tributary South, Fall Creek, Lowe Creek, Lower Eightmile Creek, Pine Creek, and Youngs Creek.

Four sites had both culvert values within or greater than the range of the channel (Tire, Deadwood Tributary South, Fall, and Youngs). In order to look at broad trends in depth distribution between the culvert and the natural channel, a comparison was made between averaged depth-distribution measures of culvert cross sections and channel cross sections. These comparisons indicate a strong influence of culverts on the availability of shallow flow areas (figure 3.5-3). At 13 of the 17 sites, the natural channel has a greater abundance of shallow channel margin habitat at the 25-percent Q_2 . Values generated in the depth-distribution analysis are included in appendix A. Individual depth-distribution measures are presented and discussed further for each site in the site evaluations in appendix A.

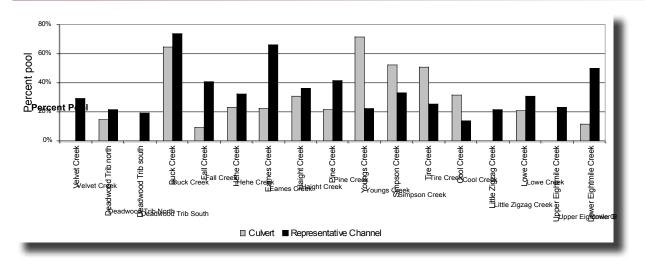
Channel units and LWD. The distribution of channel-unit types differs between culverts and natural channels. In general, pools and steps are more common in natural channels, riffles are about equally as common in natural channels and culverts, and glides are more common in culverts. Percent pool values for all sites are displayed in figure 3.5-4. Percentage of pools is greater in natural channels for 13 of 17 sites. Total habitat-unit composition results for all sites are included in appendix A.

These results are consistent with the results of the vertical-sinuosity analysis, which shows that vertical sinuosity is greater in natural-channel reaches. Culverts tend to be dominated by riffle and glide habitat, which is more uniform and shows less vertical variation and complexity.

Figure 3.5-4. Percent pool (as percent of total stream-surface area) of natural channels and culverts for all sites. For sites with two representative natural channel segments, percent pool values were averaged. Natural channel values are significantly greater than culvert values using a paired t-test (one-tailed) at α =0.10.

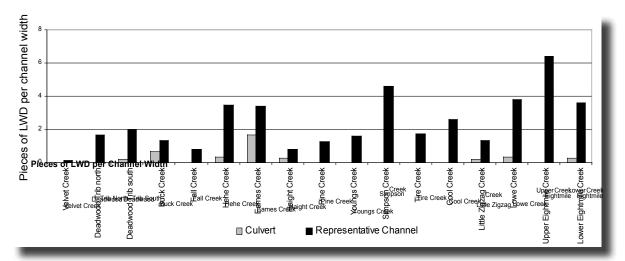
Figure 3.5-5. Counts of LWD per channel width for culverts and natural channels. For sites with two representative natural-channel segments, LWD and channel-width values were averaged.

LWD loading is considerably different between the culverts and natural channels. In all cases, LWD per channel width is greater in representative channel segments (figure 3.5-5). The data from the LWD analysis is provided in appendix A. An LWD loading of two pieces per channel width is considered "good" according to the Washington State standards (WFPB 1997). Natural-channel segments in only six sites exceed this target, although several other sites have between one and two pieces per channel width. Wood is absent in most culverts, with only one or two pieces counted at seven of the sites.

Low wood counts in culverts are no surprise considering the absence of channel banks, riparian forests, and road maintenance activities. In some culverts, fluvially transported wood had accumulated within the pipe. LWD that is retained in culverts may not be viewed favorably, because wood can create debris jams that plug culverts or create footing scour. Nevertheless, a lack of wood demonstrates that channels at culvert crossings are not functioning like their natural counterparts. The prevalence of riffle-and-glide habitat in culverts may be partially due to a lack of wood that is available to form steps, create scour pools, and generally increase channel complexity.

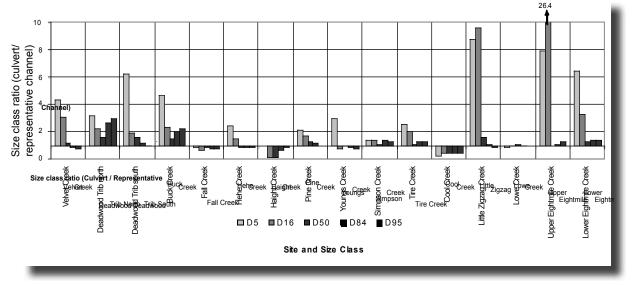
Figure 3.6-1. Size-class ratios for each site (culvert/representative natural channel). Data from pools are excluded.

Grain-size distributions. Pebble-count data for each site are included in the site evaluations (appendix A). When analyzed together, pebble-count data showed some interesting trends. In order to look at broad trends among sites, size-fraction ratios were developed by dividing the size for each size class in the culvert by the size for the same size class in the representative channel. A summary of these ratios for all sites is included in figure 3.6-1. The larger values in the chart indicate that the material in the culvert is larger than the natural channel for the given size fraction. On average, material in culverts is bigger than material in the channels. This is especially true for the smaller size classes. For most sites, the culvert has larger material for the smaller size fractions. This was further analyzed by averaging the ratios for each size class (figure 3.6-2). There are large differences in sizes for the smaller size classes (D_5 and D_{16}) but little differences for the large size classes (D_{84} and D_{95}). The D_{50} shows a moderate difference, with culverts having, on average, about 50 percent larger D_{50} s. D_5 and D_{16} s, however, average more than three times larger in the culvert, indicating that culverts typically have fewer particles in the smaller size classes, which is indicative of armored bed conditions. Results of a paired one-sample t-test show significantly greater values for the culvert for the D_5 and D_{16} size classes ($\alpha = 0.05$) but not for the D_{50} , D_{84} , or D_{95} . The complete substrate data are included in appendix A.

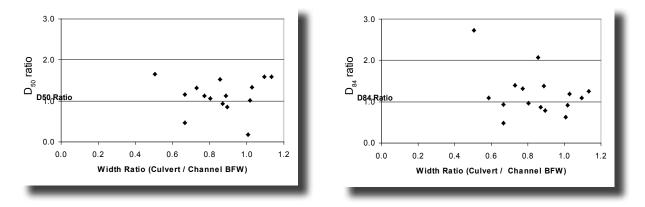
Substrate size ratios were compared to stream width ratios to see if culvert width had an impact on the size of material in the culvert. The width ratio did not appear to impact the size of the D_{50} or D_{84} (figure 3.6-3).

Figure 3.6-3. Effect of width ratio (culvert/natural channel bankfull width) on the D_{50} (left) and D_{84} (right) ratios. There are no significant correlations. Upper Eightmile Creek was removed as an outlier from the D_{50} analysis because of the effect of a large sand deposit on the D_{50} for the natural channel. Pebble-count data in pools are not included in these data.

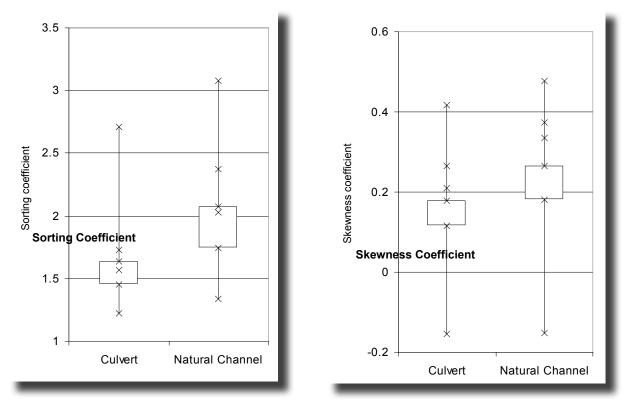
Figure 3.6-4. Box plots of sorting coefficients (left) and skewness coefficients (right).

Sorting and skewness. In order to look at broad trends in bed-material sorting and skewness among all sites, the values for each location (natural channel or culvert) at each site were averaged and ratios were developed for each site. The sorting and skewness coefficients are displayed in table 3.6-1. Guidelines for evaluating these coefficients are included in table 3.6-2 and table 3.6-3. Box plots are also included that show the range of data (figure 3.6-4). Culverts tend to have lower sorting coefficients than the natural channels. This corresponds to a greater degree of sorting; that is, culvert beds tend to be more "well-sorted" than the natural channel. This implies a narrower size range of particle sizes in
