San Pedro Parks Wilderness

Fisheries, Arizona Willow and Water Quality Monitoring

Annual Monitoring Report

Santa Fe National Forest Surveyed: 2001 to 2002 Submitted: May 2004

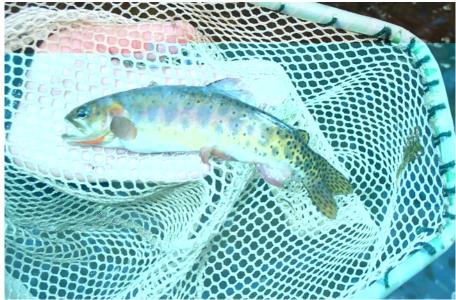
A noticeable white fungal growth was observed on fins of RGCT in Rio de las Vacas and Cecilia Creek (see Photo 2). Fungal growth is usually a flag for a disease that has attacked an individual fish. Speculation from the NMG&F fish pathology lab (Doug Eib, personal communication, 2001) is that this is possibly related to natural stresses from the recent drought or water quality concerns. A major pathological assessment would have to be made to make definitive conclusions. At this time, we will monitor the populations on an annual basis for die-off or further development of disease.

Photo 2. Rio Grande cutthroat trout with white fungal growth on scales and fin along back.

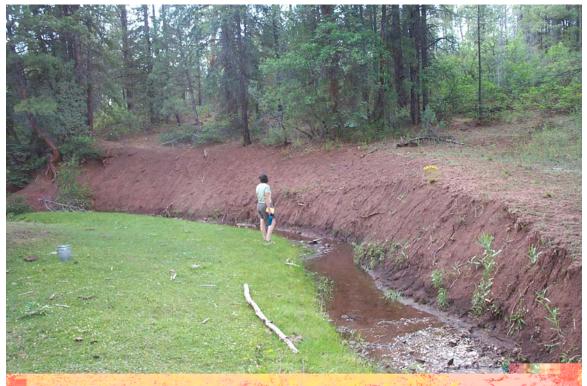
Photo 5. Extensive grazing damage on Capulin Creek: Loss of riparian woody and herbaceous vegetation, decreased plant vigor, increased sediment loading, unstable banks, and increased solar radiation on stream (17 July 2002).

In 2002, the fisheries team noted concerns for water quality, riparian and stream condition as related to grazing. These areas were in the Chama Watershed portion of the wilderness, most notably in Capulin Creek (see Photo 5 and stream summary). Jemez Mountains were suffering from an extreme drought in 2002, which further complicated these conditions. Despite this, it was apparent that overgrazing was causing damage to water quality, riparian and stream conditions. We encourage that these areas be re-visited and be rested if they have not recovered from those impacts.

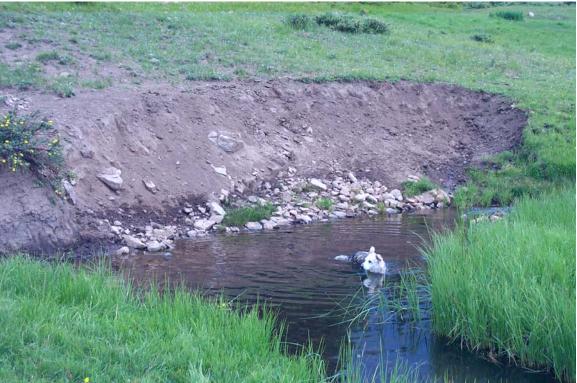
Photo 6. Stretches of Rio de las Vacas near Rito Anastacio had raw, unstable banks and loss of undercut habitat. (Note: Seepy banks; July 2001)

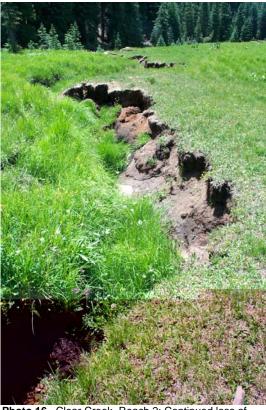
Photo 16. Clear Creek, Reach 2: Continued loss of undercut bank and increased sedimentation (Note: Stubble height)

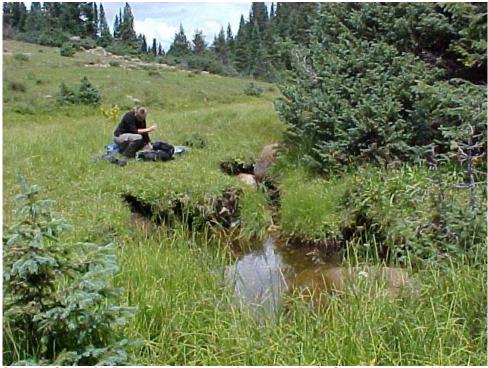
Photo 21 Site #3: Rio Puerco segment sampled for water quality. (13S 0334106, 3997584) Note: Unstable banks. Point bar (in foreground) is indicative of increased sediment load. Stream is not able to transport high sediment load.

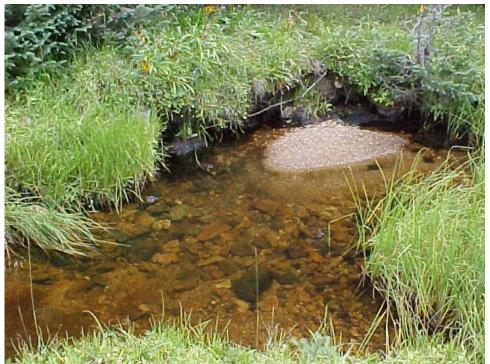
Photo 22. Site #3: Up close view of point bar from previous photo (Rio Puerco). Stream is embedded with fine sand and silt. Fish were present in this stream.

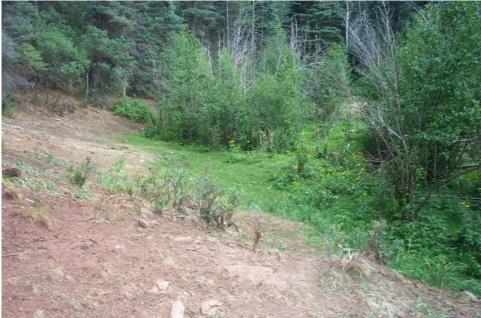
Photo 40. Cattle damage due to grazing and trailing in the upper riparian zone of Dove Creek (15 July 2002).

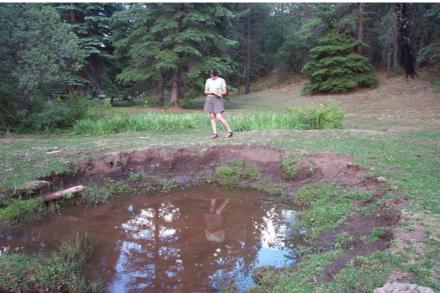
Photo 42. Sarah Eddy with a pool on the lower Capulin Creek. Slumping banks and low grass height are due to intense grazing. Pool substrate is 100% sediment. Two sub-adult rainbow trout were observed in the pool (17 July 2002)

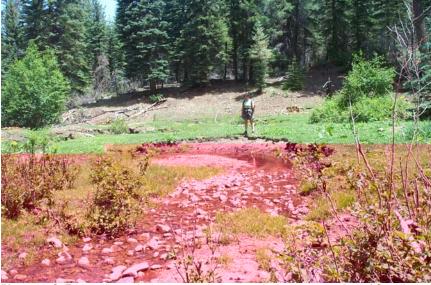
Photo 44. S. Eddy with a typical open meadow system in the upper reaches of Capulin. Note: Lack of woody riparian vegetation (17 July 2002).

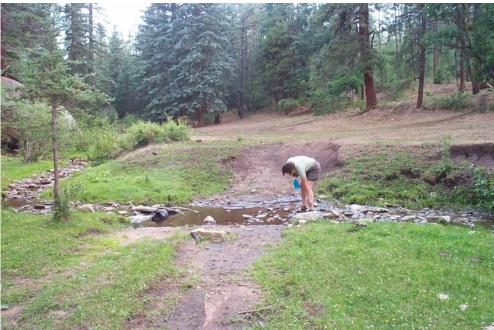
Photo 47. A user-created spur from FS Road 1161 increases the wetted width as well as erodes the banks increasing the already sediment-dominated substrate (17 July 2002).

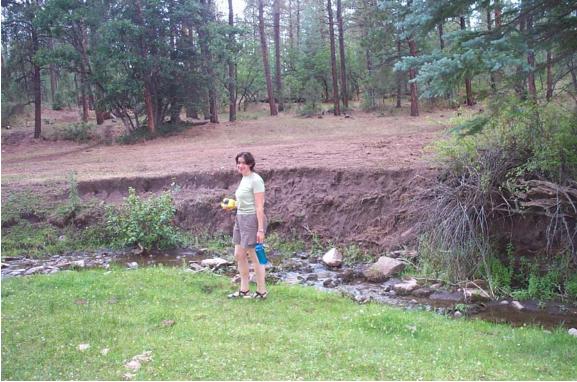
Photo 48. Bank instability on Capulin Creek caused by heavy grazing and recreation on a spur of FS Road 1161 (17 July 2002).

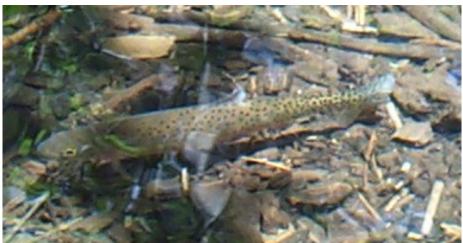
Photo 50. RGCT observed in Cecilia Creek above wilderness boundary (18 July 2002). Note: white fuzzy fungal growth on dorsal fin.

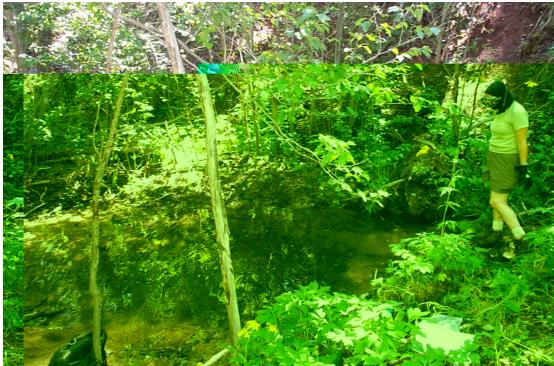
Photo 52. Sarah Eddy observed 4 Rio Grande Cutthroat Trout. White fungus from stressed conditions was found on several fins of the cutthroat in this pool (July 17th, 2002).

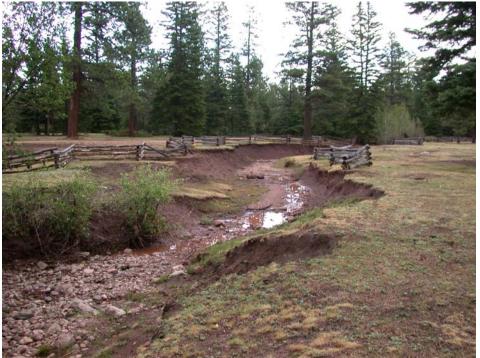
Photo 56. Herrera Ditch as it flows through Resumidero Campground, July 2002. Note, lack of flow and reduced stubble height.

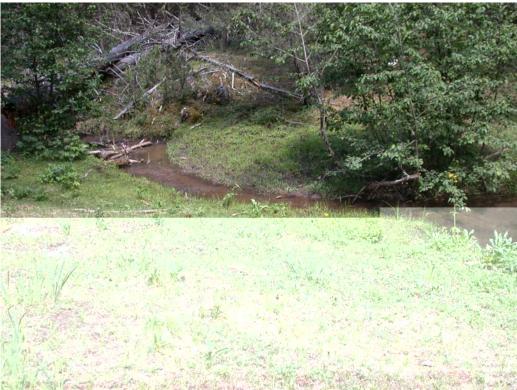
Photo 62. Typical habitat immediately above beaver ponds. Note: heavy sediment loading on stream bottom (17 July 2002).
