Cedar Creek Fire - Central Washington Fire Recovery 2021

## Cedar Creek Burned Area Summary 2500-8 Burned Area Report

Cedar Creek and Cub Creek 2 Fires Okanogan County, Washington

WASHINGTON GEOLOGICAL SURVEY WALERT Report September 8, 2021

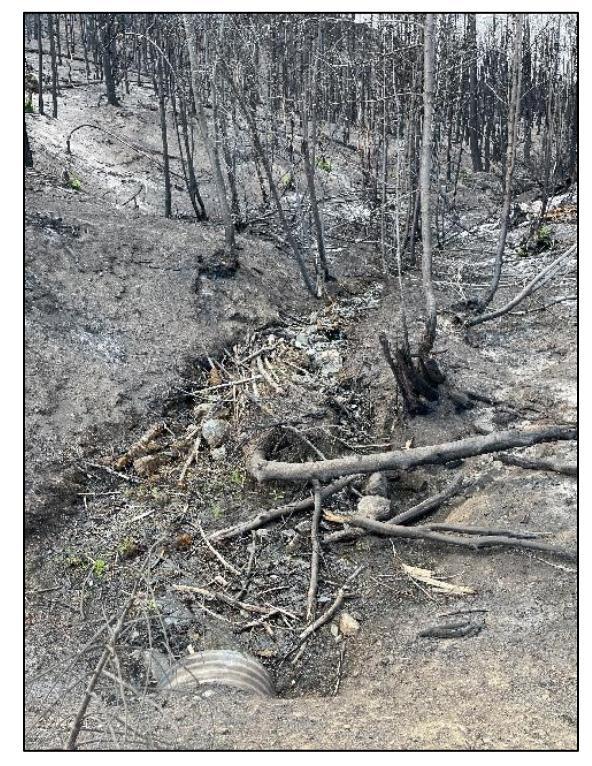
Watershed response will likely include an initial flush of ash and fine sediment, rill and gully erosion in headwater drainages and in small, steeper drainages within the burned area, debris-laden flash floods (Figure 2) and debris flows in response to high-intensity rain events, as well as elevated snowmelt peak flows.

Figure 2 Debris in burned channels is easily mobilized by rain and increased flows.

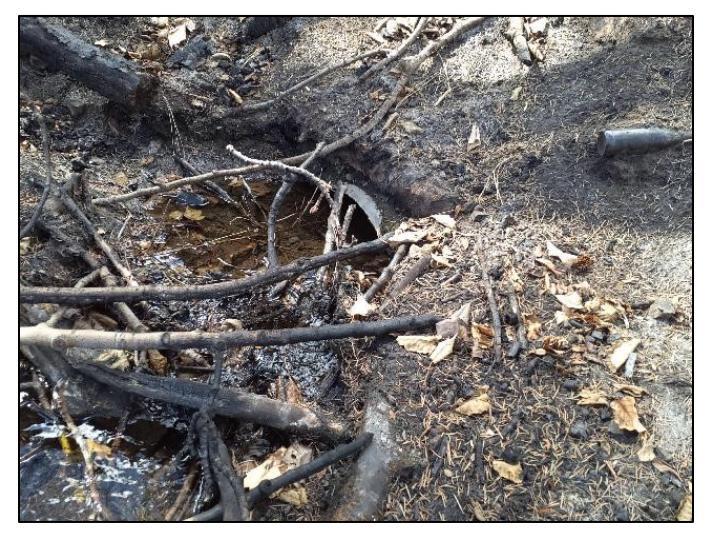
The watersheds burned in the Cedar Creek Fire are predicted to exhibit varying degrees of response through increased runoff, and debris and sediment transport. This creates a future concern for roads, culverts (Figure 3), bridges, and channels along the drainage paths of the burned watersheds in that they may be plugged, overtopped, or washed away more frequently than experienced under pre-fire conditions.

While there are no known Forest Service owned or maintained bridges or large culverts at risk from the, there are other public and private at-risk bridges and culverts that should be evaluated for channelway adequacy (often included in bridge inspection reports), abutment condition and exposure, vegetation content on banks upstream and downstream of the structure, adequacy of culvert inlet (basins, headwalls, bevel), existence of livestock stream-fencing, or any other factors that impact the hydraulic and debris-passing capacity of the structure.

Figure 3 Burned debris can quickly plug undersized culverts.

The proposed treatments include signs warning travelers of the increased danger, construction of dips and armored dips to facilitate drainage, installation of drop inlets to ensure drainage functions remain intact with added debris, cut off damaged section of pipes to ensure free drainage, clean inlets, catch basins and outlets to restore functional drainage, and regular storm inspection and response.

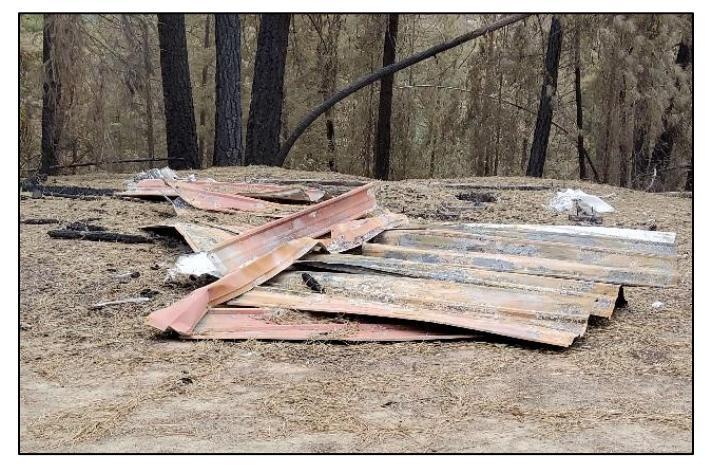
Trailheads and Trails: The Wolf Creek trailhead was burned over resulting in loss of infrastructure and the presence of hazard trees. Because the trailhead is a location for congregation of the public and administrative personnel, there is a high risk to life and safety due to the threat of overhead hazards from hazard trees. The toilet (Figure 4) burned leaving an open vault containing human waste, resulting in high risk to life and safety. Recommended treatments include temporary closure of the trailhead and treating or pumping the toilet and sealing the open holes to prevent them from filling with water and snow.

Figure 4 All that remains of the Wolf Creek TH toilet is the metal roof.

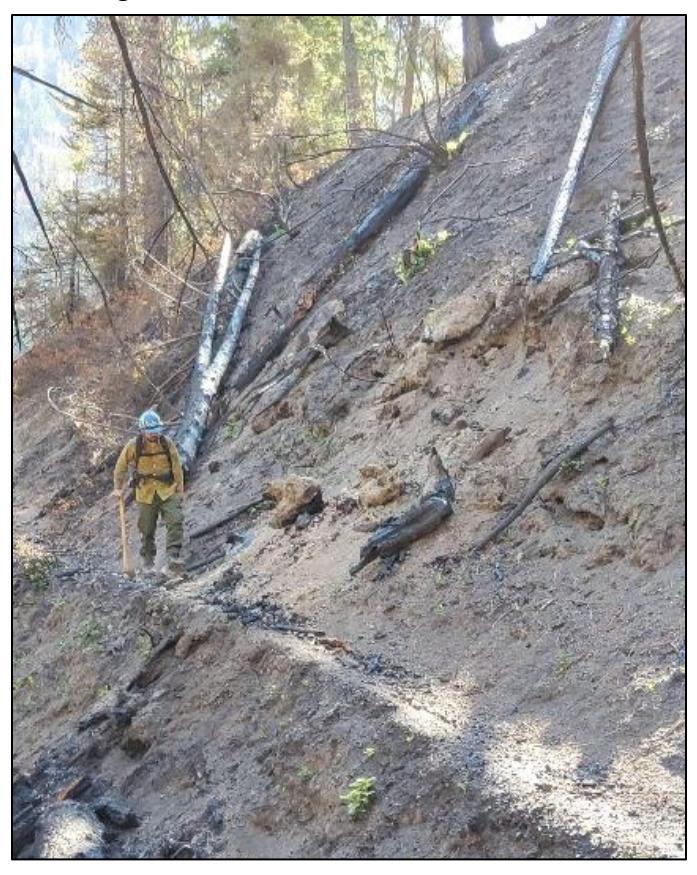
The Cedar Creek trail (476 – Figure 5), Wolf Creek

trail (527), and some trails in the Chickadee area, including Thompson Ridge trail, experienced moderate to high burn severity. These trails are high or medium use trails that were in good condition prior to the fire. Due to post fire threats, these trails have a very high level of risk for infrastructure damage or failure. These trails are recommended for treatment to stabilize, stormproof, or mitigate the anticipated impact of post-fire storm events.

Figure 5 Cedar Creek Trail damage may get worse with eroding hillslopes.

Additional recommended treatment includes temporary closure of the Cedar Creek trail (476), Wolf Creek trail (527), and some trails in the Chickadee area, including portions of the Thompson Ridge trail. These are the highest use and most impacted trails.

Trail conditions and hazards should be reassessed in the spring or summer of 2022, and thereafter as needed, to determine if risks have been reduced to an acceptable level to reopen closed trails.

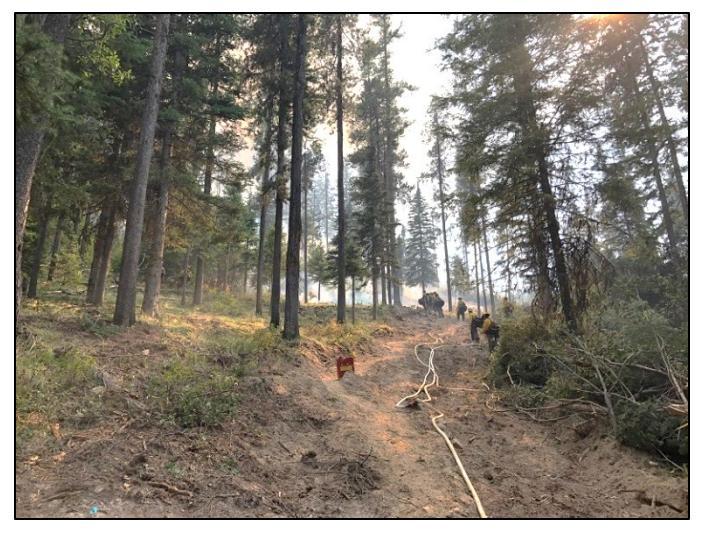
Approximately 43 miles of dozer line and 8 miles of handline (Figure 6) were constructed outside and within the burn perimeter. In addition to

causing an increase in weed invasion, the disturbances caused by dozer lines are expected to create accelerated erosion and soil compaction that may also inhibit the recovery of native plant populations. The Cedar Creek fire overlapped with five different fires that have occurred on USFS land within the past 35 years. It is expected that 109 acres of shrub steppe communities, and 23,215 acres of dry and hot forested plant communities that reburned within the past 35 years will face impacts given the invasion of cheatgrass, knapweed, dalmatian toadflax and whitetop that are changing the ecological response and fire resiliency of these ecosystems. It is also expected that the 10 acres of riparian communities that burned at moderate to high severity are vulnerable to establishment of noxious weeds from off forest wind dispersed species. If weed infestations are not detected and controlled within the first year post-fire, these previously intact native communities will likely type-convert into exotic species dominance.

Figure 6 Newly dug firelines are good host locations for invasive weeds.

The Forest recommends a treatment of Early Detection, Rapid Response (EDRR) to monitor for noxious weed infestation and expansion. In areas disturbed due to mechanical suppression activity (approximately 360 acres) and burned areas prone to new noxious weed infestations (120 acres), weed technicians will perform regular surveys and treat new infestations.

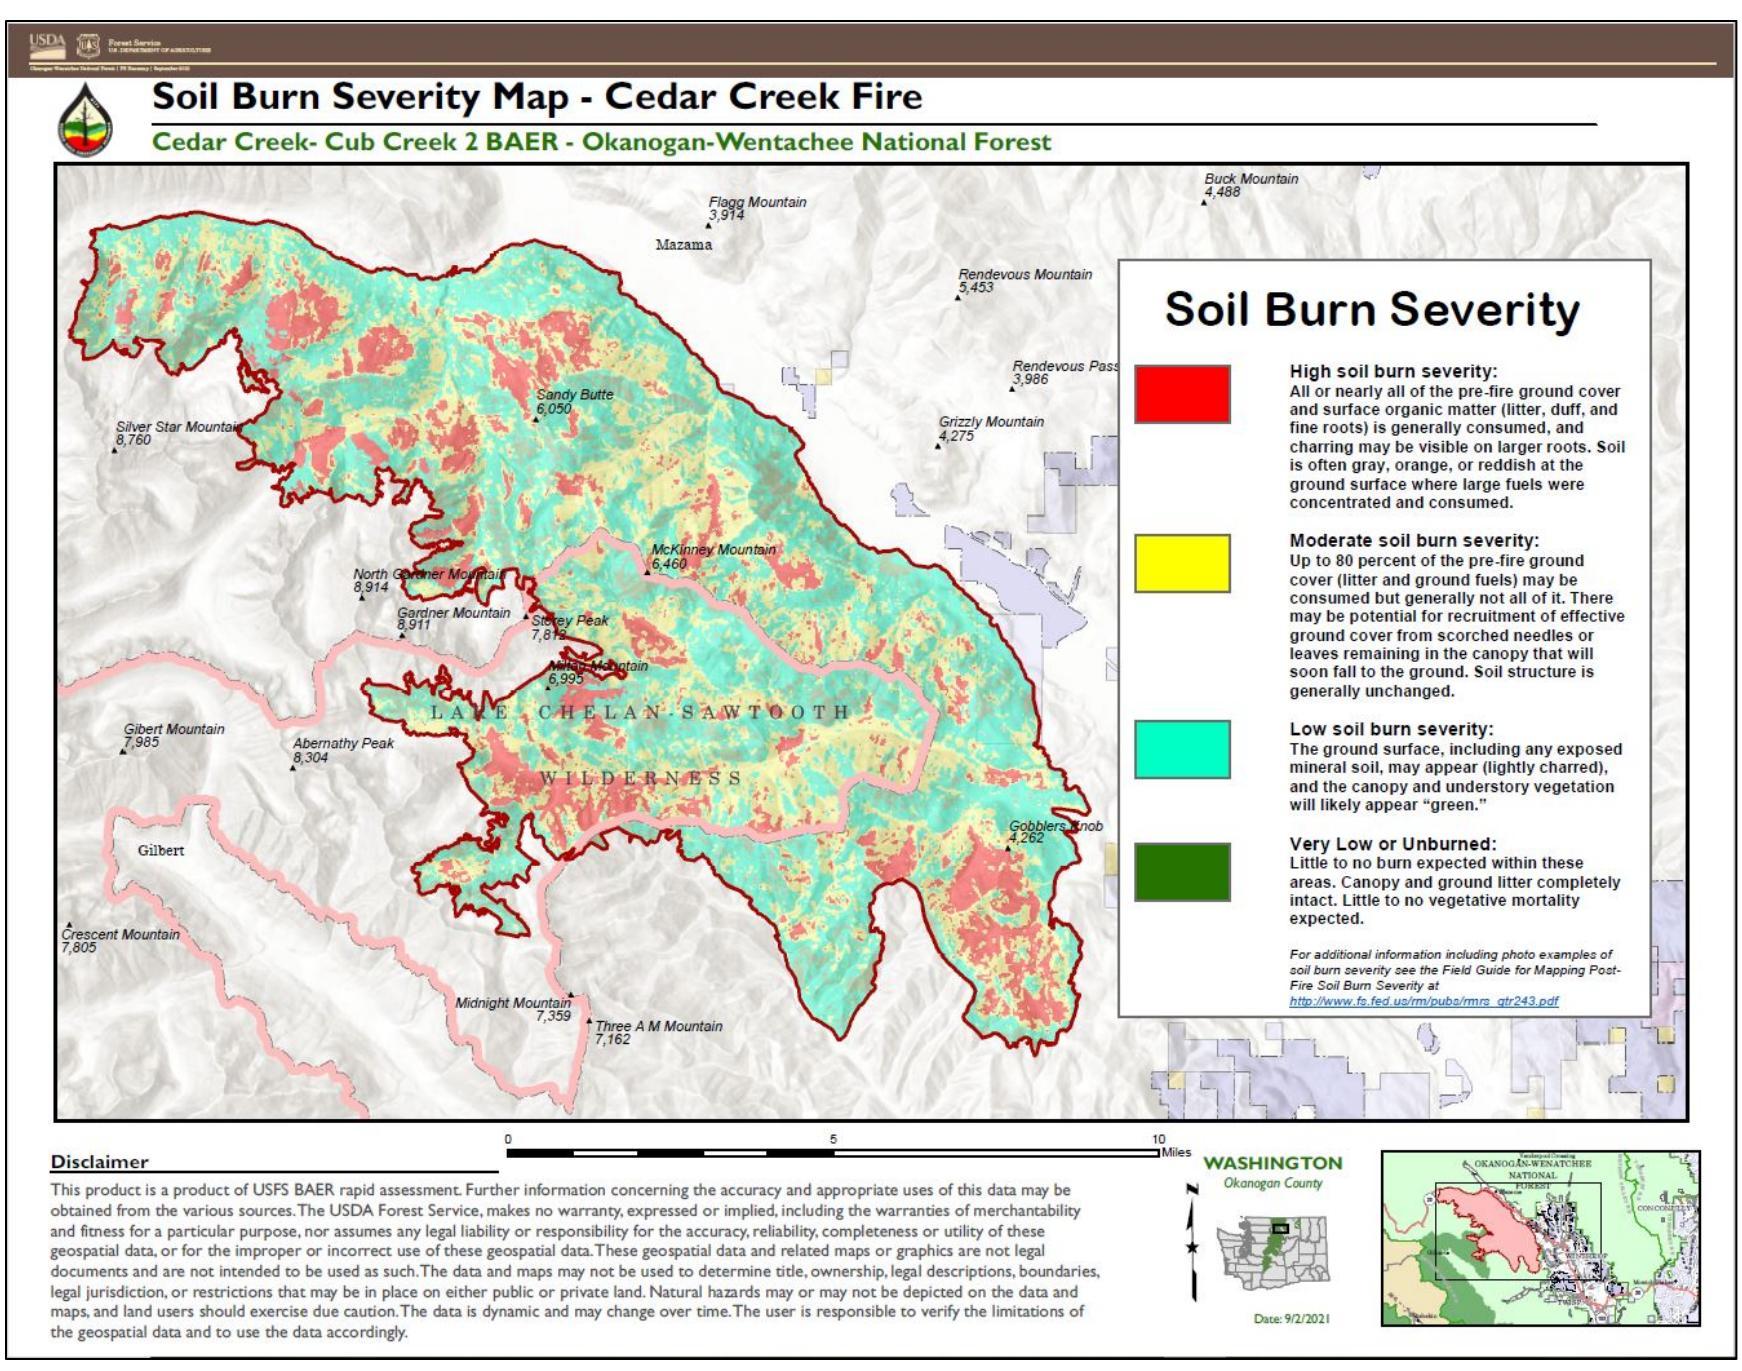
Figure 7 Soil burn severity map of the Cedar Creek Fire.

An estimated 48% of the burned area within the Cedar Creek Fire exhibit high or moderate soil burn severity and may have developed water repellent soils as a result (see map on page 7). Like the Cub Creek 2 Fire, vegetation mortality in the moderate and high soil burn severity areas ranged from 80 - 100%.

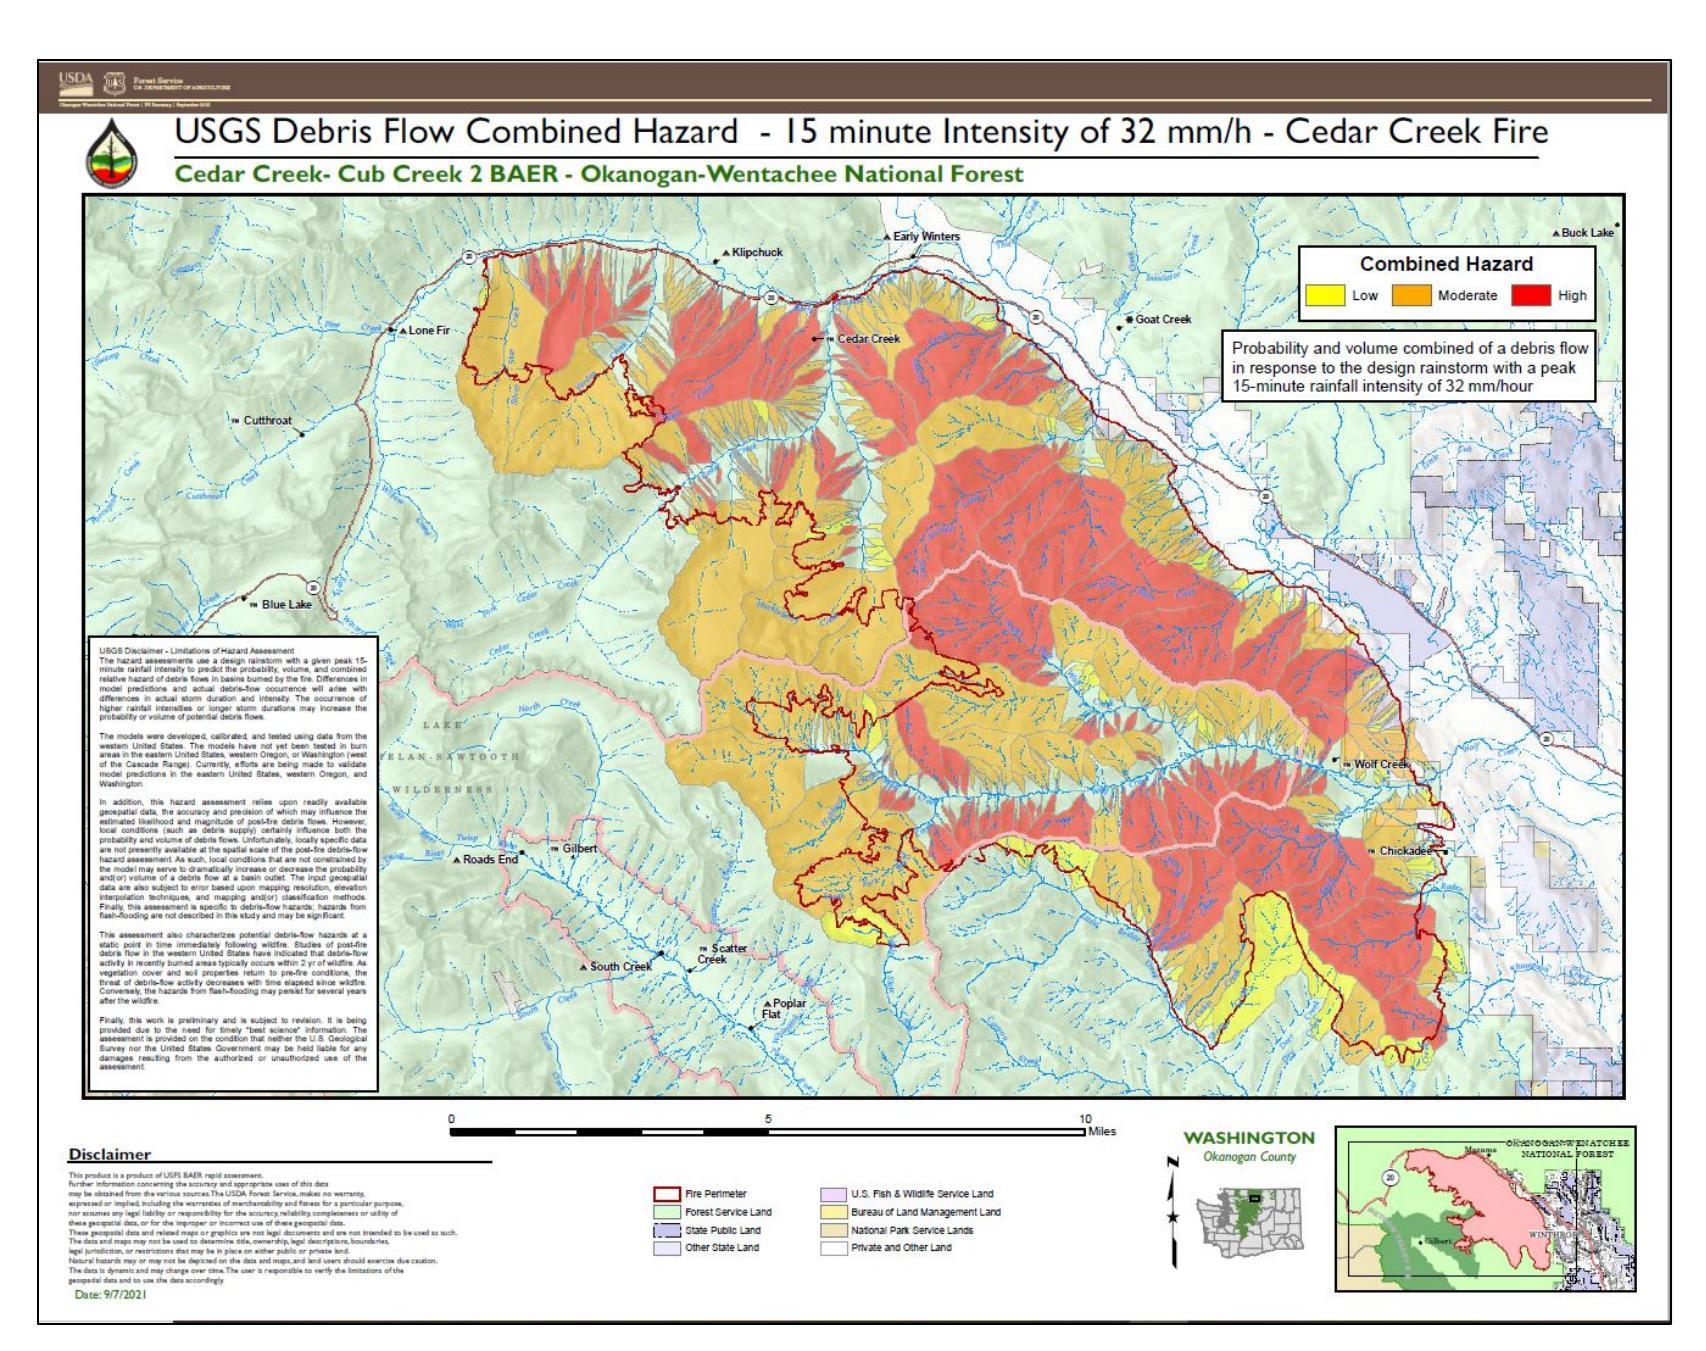
Figure 8 Debris flow hazards for the Cedar Creek Fire

A storm event of 32 mm/h (about 0.3 inches in 15 minutes) was predicted to have greater than 80% probability of debris flows in several drainages, including but not limited to many of the tributaries to Wolf Creek, several tributaries to the Methow River, several tributaries to Early Winters Creek, and two tributaries to Little Bridge Creek in the Twisp River drainage.

The probability of debris flows is even higher in the Cedar Creek burned area in response to a 15minute intensity of 40 mm/h (about 0.4 inches in 15 minutes), a rain event with roughly a 10-year recurrence interval.

Most of these watersheds are roughly estimated to produce more than 1,000 m<sup>3</sup> of debris, resulting in a high debris flow hazard.

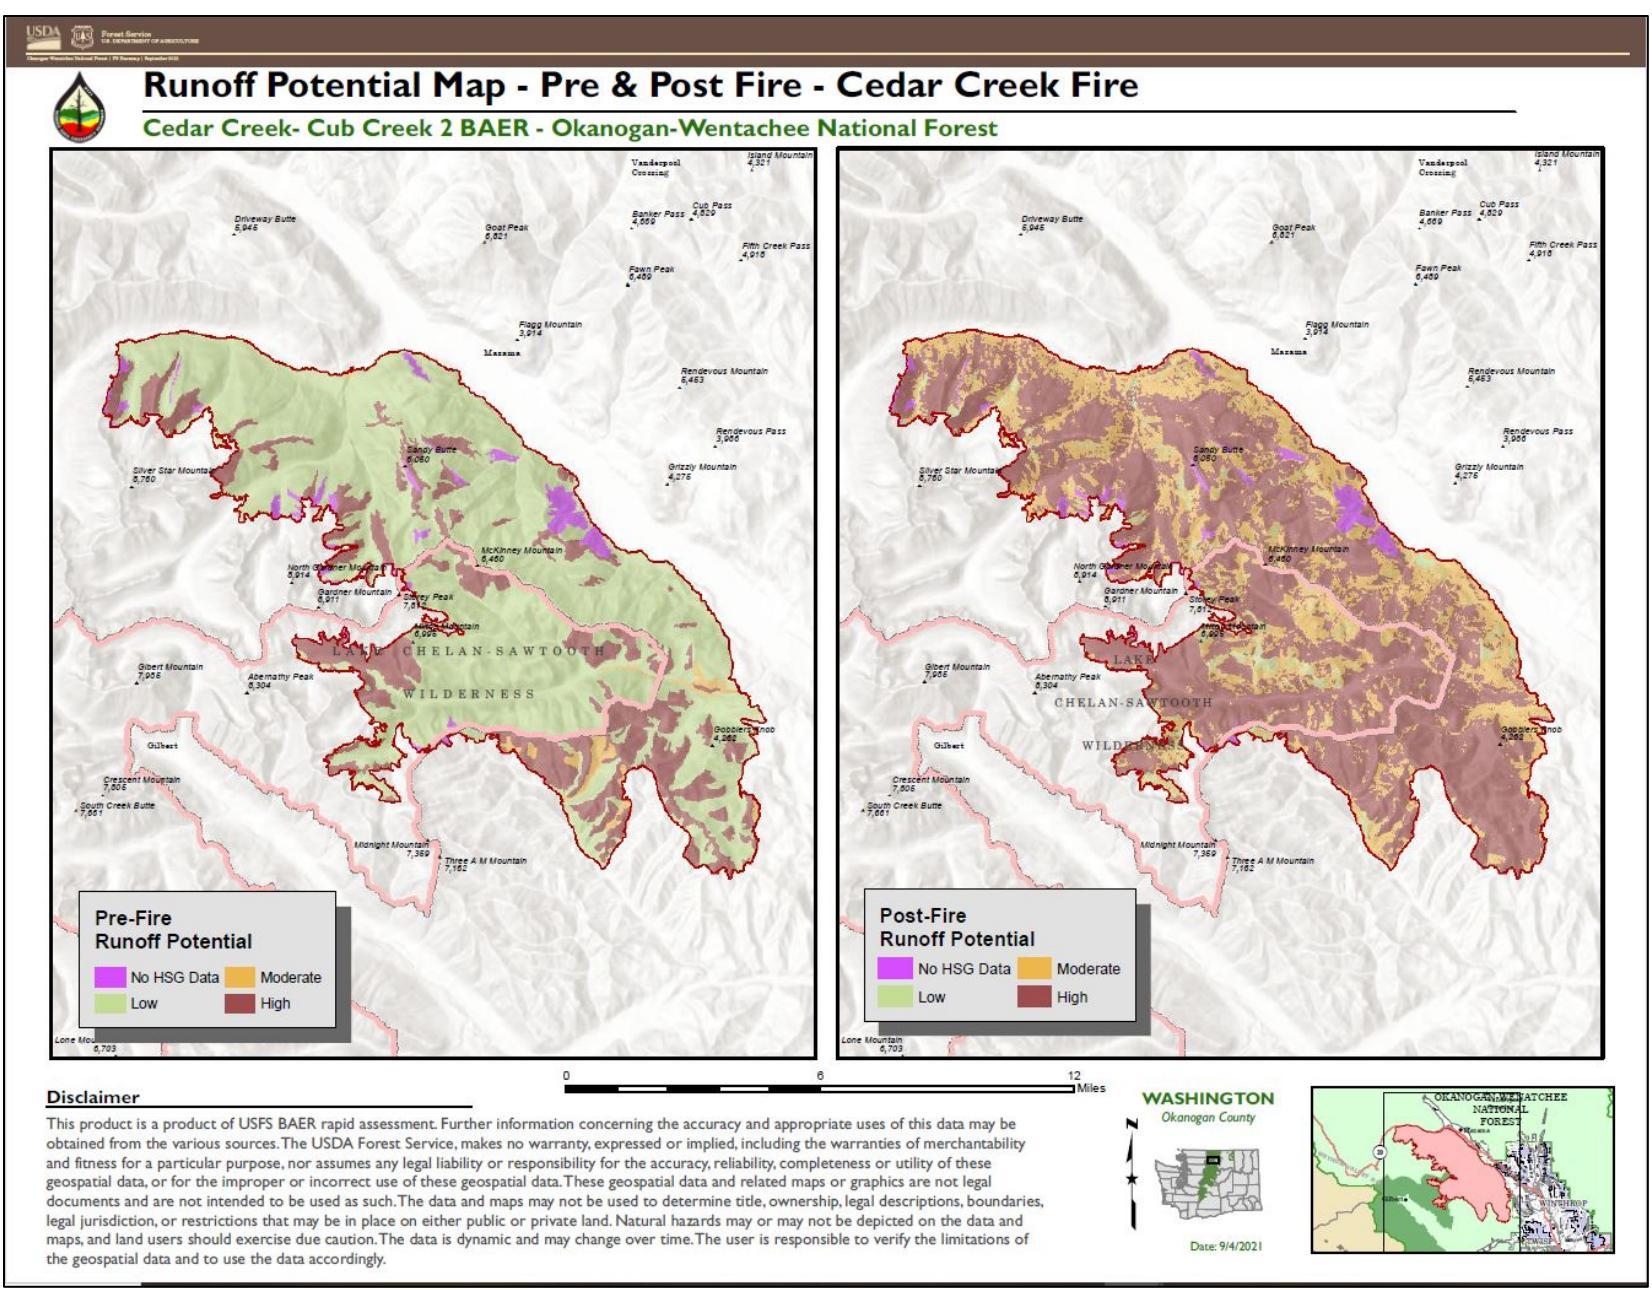
Figure 9 Maps showing pre- and post-fire modeled runoff potential.

Preliminary hydrologic modeling indicates flow increases in many headwater channels of >100x the pre-fire flow rates for a given storm. Water quality

will be diminished during seasonal peak runoff, as well as after high-intensity summer rains, due to elevated ash, fine sediment, and nutrient loading. Elevated post-fire response will gradually diminish over time as vegetation and groundcover levels recover over the next several years, although some impacts are likely to persist for a decade or longer (see map on page 9).

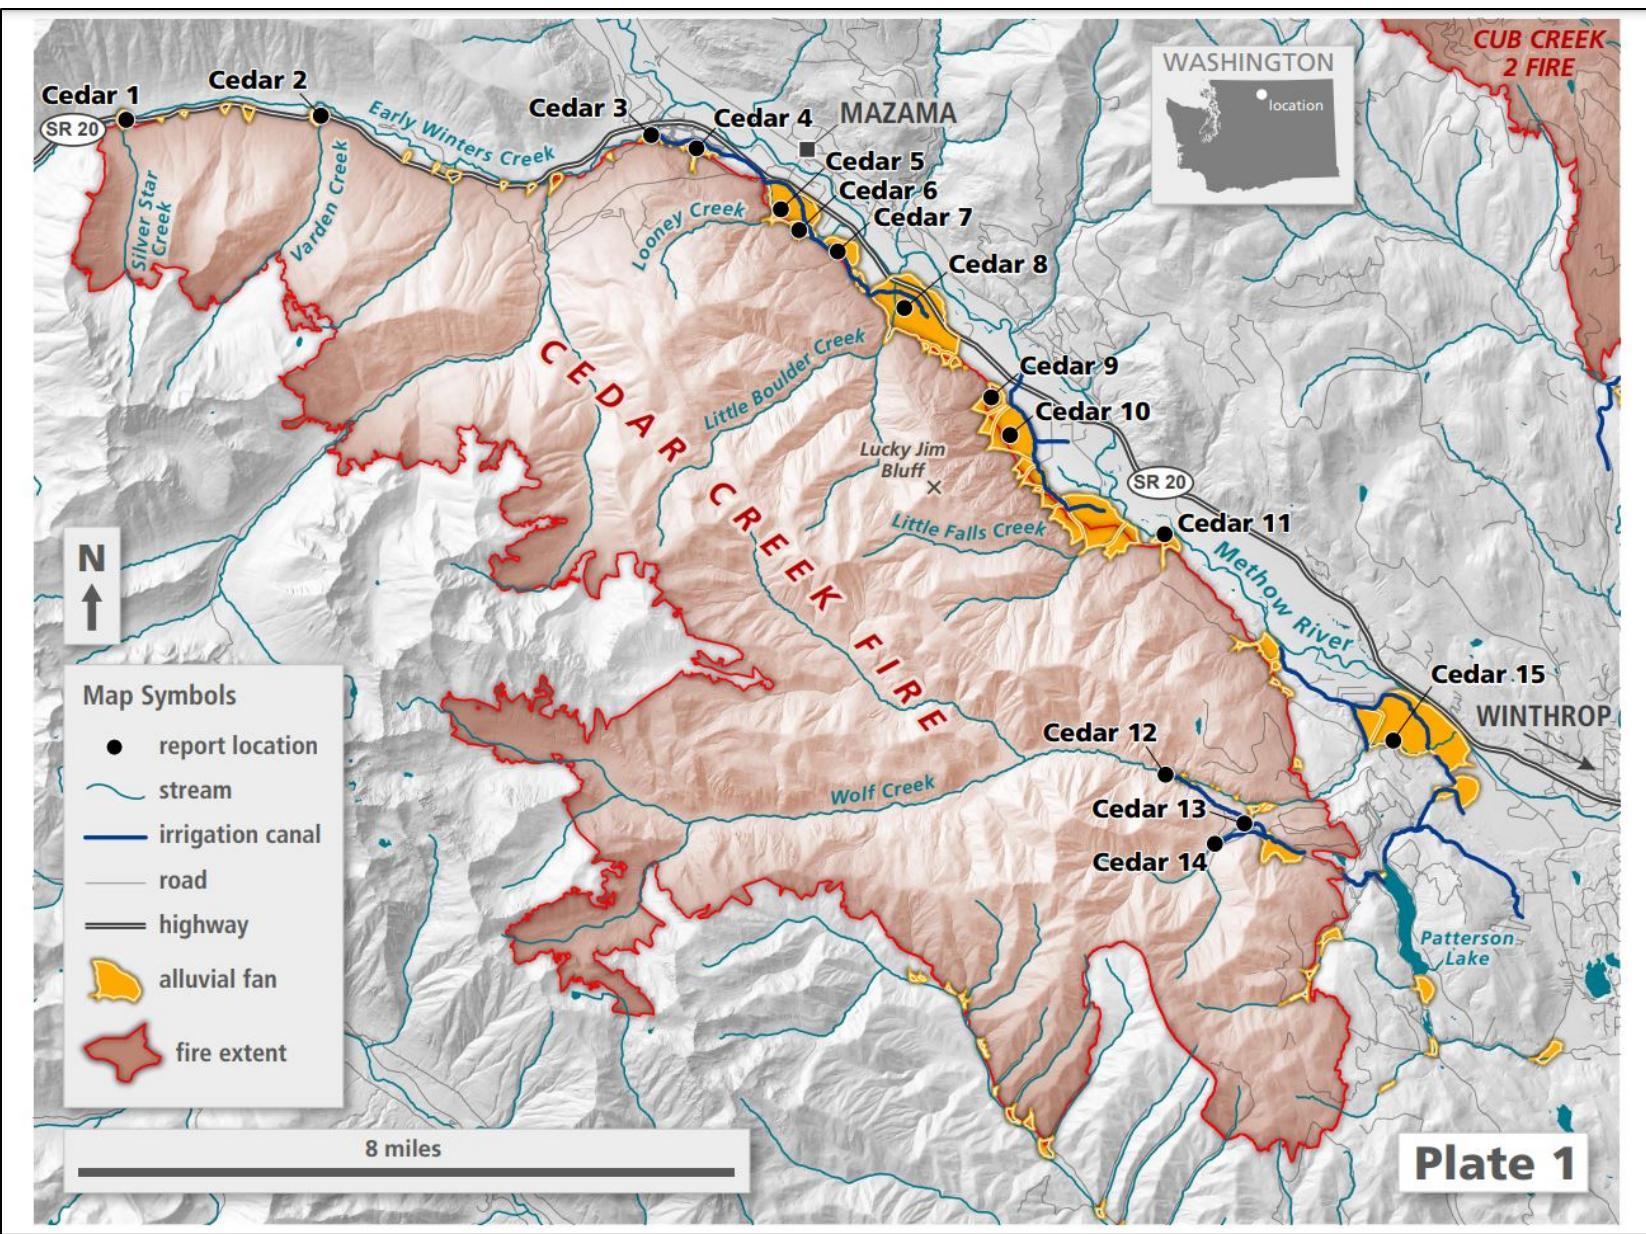
Figure 10 Map of alluvial fans in the vicinity of the Cedar Creek Fire.

Non-FS values within and downstream of the burned area may also be threatened by inundation from flooding and debris flows, including but not limited to homes on debris fans along the northeast face of the fire, homes on the Wolf Creek debris fan and on fans south of Wolf Creek, and State Highway 20 (see map on page 8). The Washington Geological Survey's full Wildfire-Associated Landslide Emergency Response Team Report (WALERT) can be found at <u>https://www.dnr.wa.gov/publications/ger\_hazards\_1</u> <u>andslide\_walert\_report\_cedar\_cub\_2021.pdf</u>. A map showing alluvial fans on the edge of the fire perimeter from their report is duplicated on page 10 of this summary.
