**PROPER FUNCTIONING CONDITION ASSESSMENT  
OF THE  
RUBY MOUNTAINS, ZONE 1**

**James C. Hurja, Andrew Kelher, Brendan Waterman  
August/September 2010**

**Humboldt-Toiyabe National Forest  
Ruby Mountains/Jarbidge Ranger District  
140 Pacific Avenue  
Wells, Nevada 89835  
Gar Abbas, District Ranger**

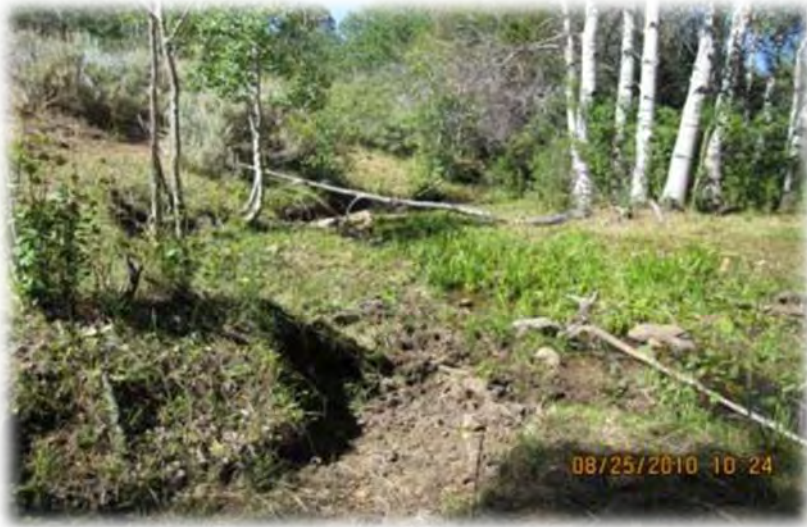
Carville Creek - Reach 1  
Functional – At Risk,  
upward trend

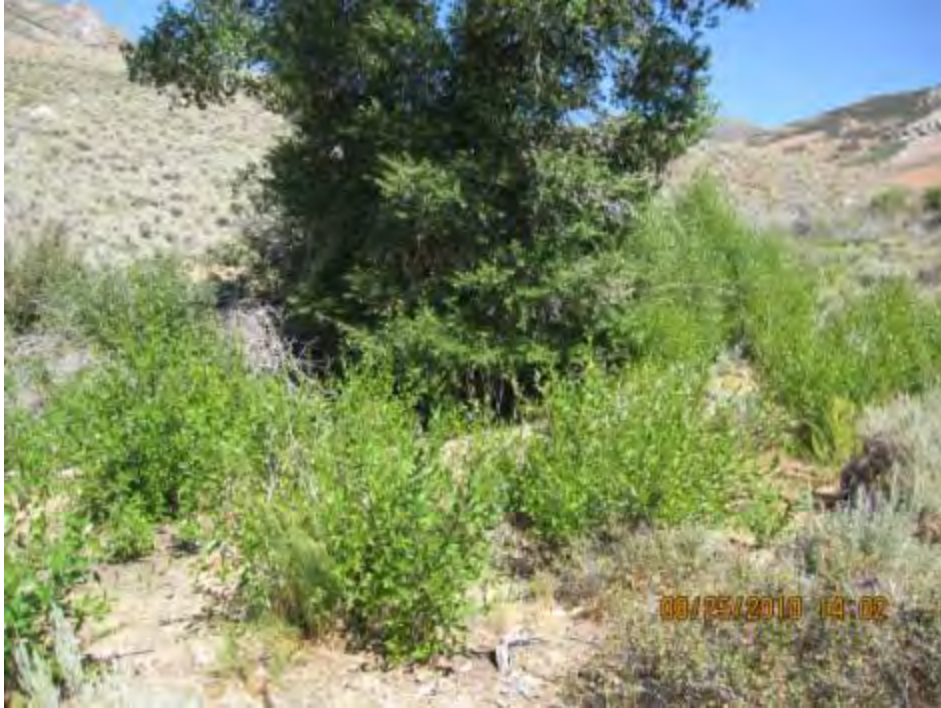
**Carville Creek: Reach 3.  
Functional – At Risk.  
Downward trend.  
Dropping water table  
resulting in a drier  
community and loss of  
obligate species.**

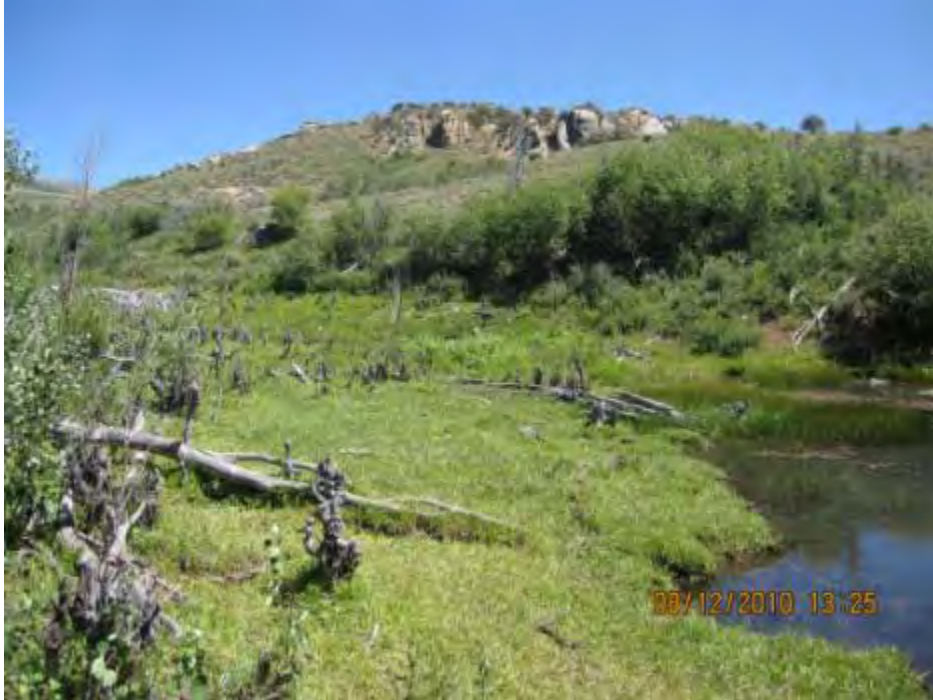
**Middle Fork Green  
Mountain Creek – Reach 1.**

**Functional – At Risk. No  
apparent trend. Lacking  
large woody communities.**

1. Middle Fork Green Mountain Creek: An offsite water source be made available.
2. Middle Fork Green Mountain Creek- Headwaters: Use strategic felling of dead aspen to minimize use on riparian meadows/bogs.

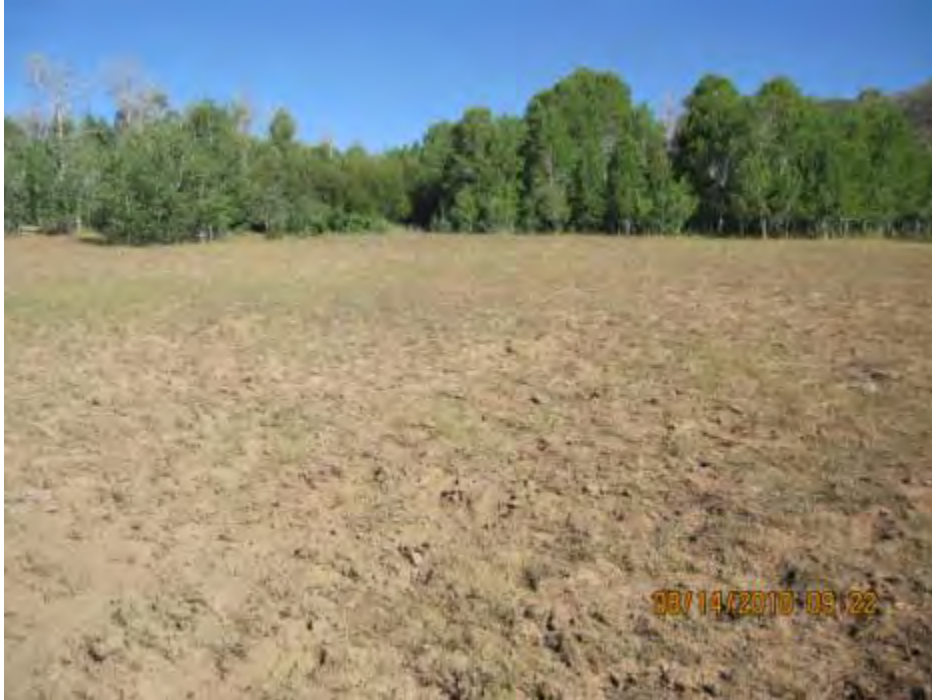
**South Fork Green Mountain  
Creek – Reach 1**

**PFC – With isolated areas of  
concern**

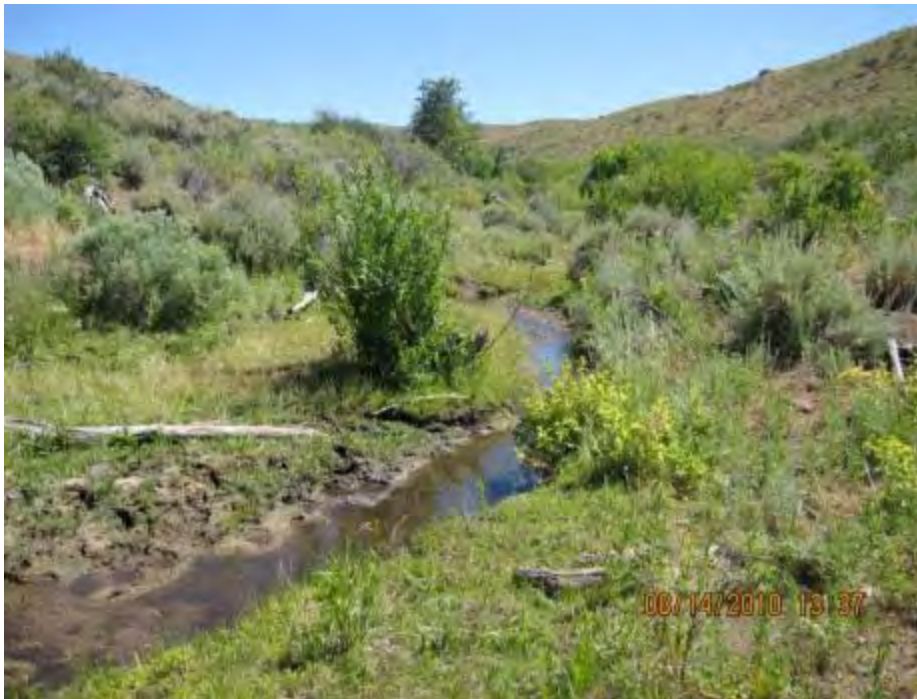
**South Fork Green Mountain  
Creek – Reach 2**

**Functional – At Risk  
Downward trend**

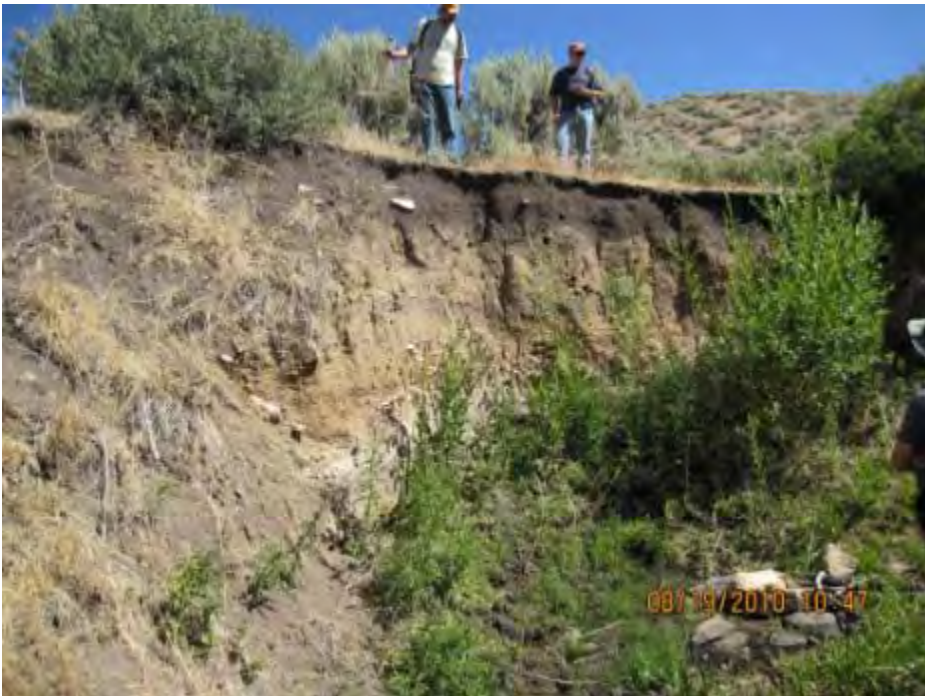
**South Fork Green Mountain  
Creek – Reach 4  
Functional At Risk. Upward  
Trend**

3. Green Mountain Creek: Fence to restrict use of stream along reach 3.
4. Green Mountain Creek: Treatment of Medusahead and scotch thistle along reach 4.

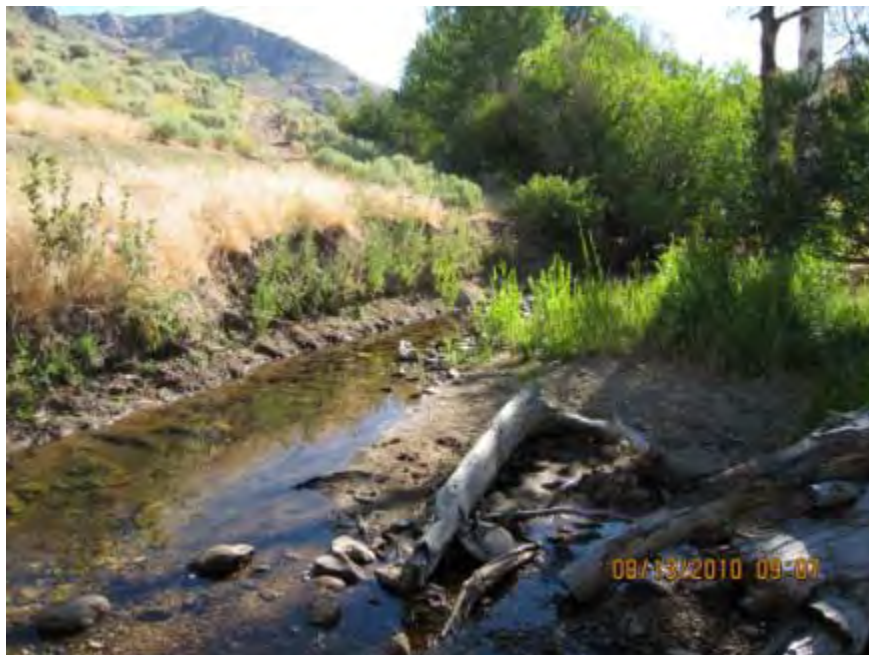
**Green Mountain Creek –  
Reach 2**

**Functional – At Risk  
Upward Trend**

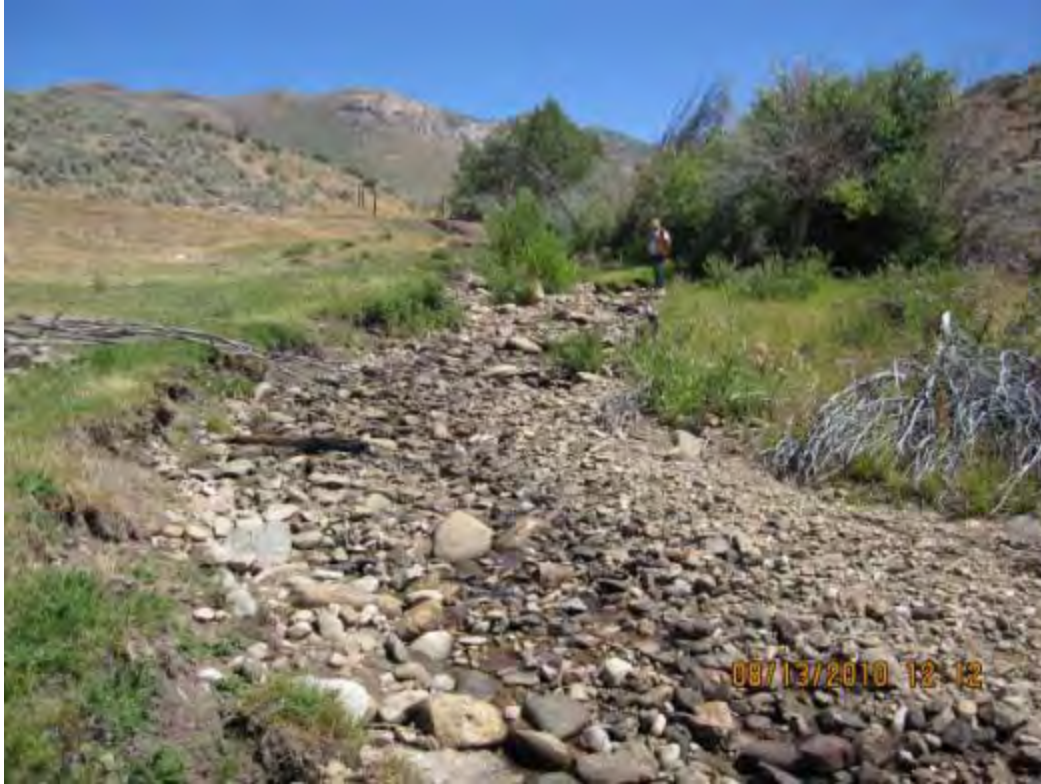
**Green Mountain Creek –  
Reach 3**

**Functional – At Risk**  
**Downward trend**

**Lacking riparian  
vegetation**

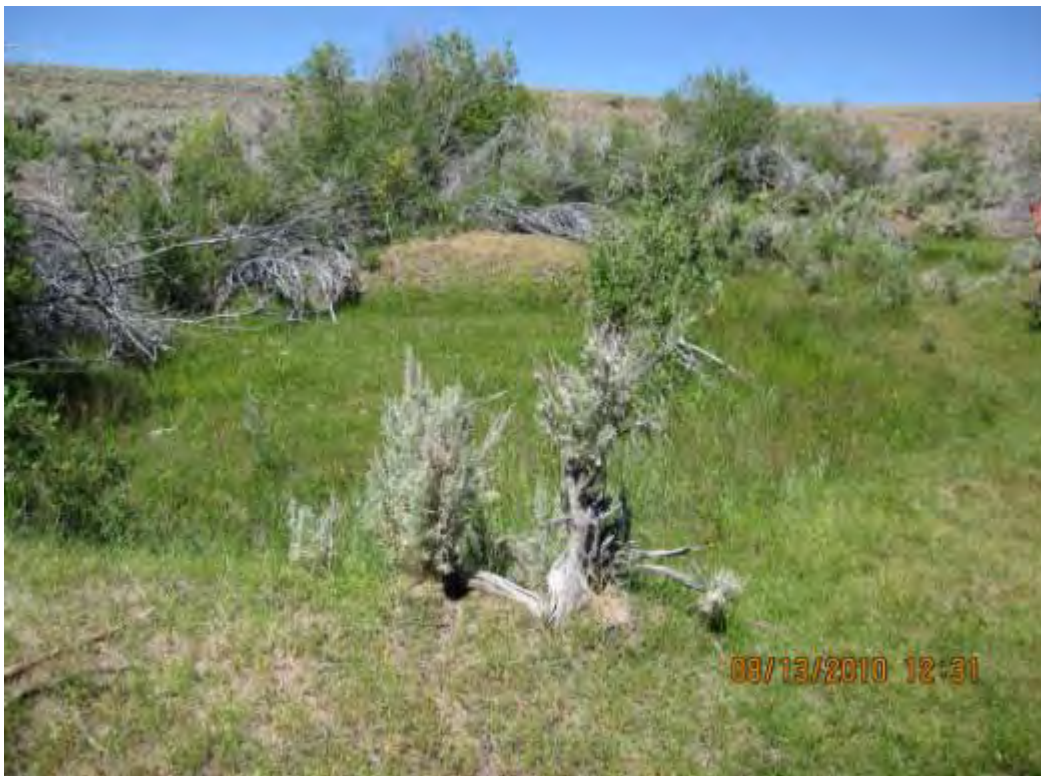
**Green Mountain Creek –  
Reach 3**

**Functional – At Risk**

**Few sedge communities  
and low vigor**

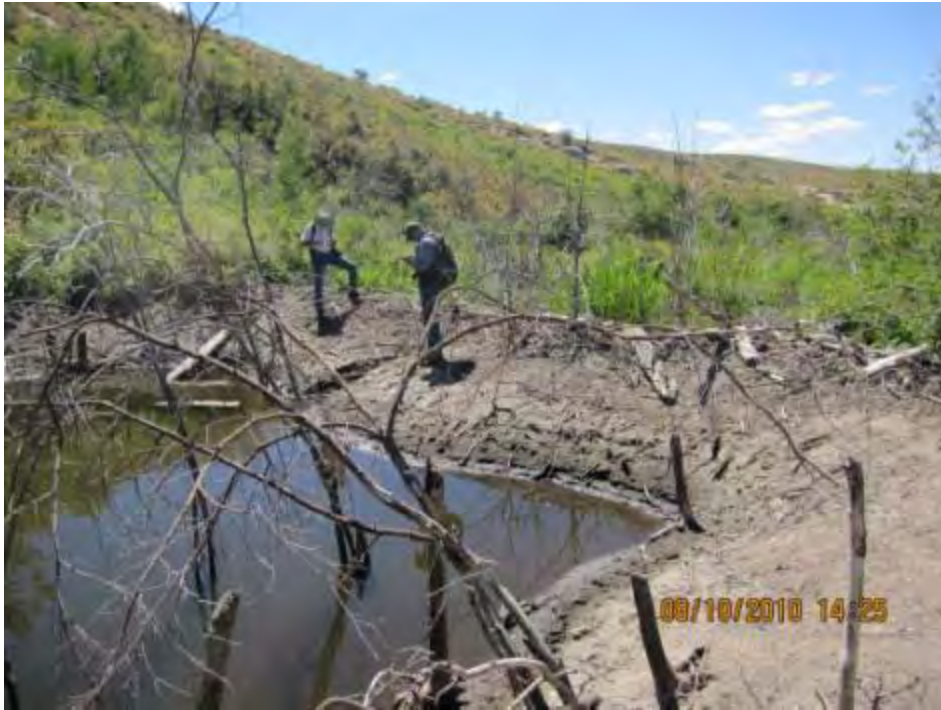
**Toyn Creek Reach 2**  
**Functional – At Risk Lentic**  
**Reach 30% Lotic, 70%**  
**Lentic**

5. Corral Creek change permittee rotations and season of use.
6. Corral Creek: Repair road crossings. Remove or clean out culverts.
7. Toyn Creek: Repair electric fence to make a riparian pasture.

8. Toyn Creek: Install sediment barriers on trail that parallels creek.
9. Toyn Creek: Address unauthorized motorized use of trail that parallels creek.

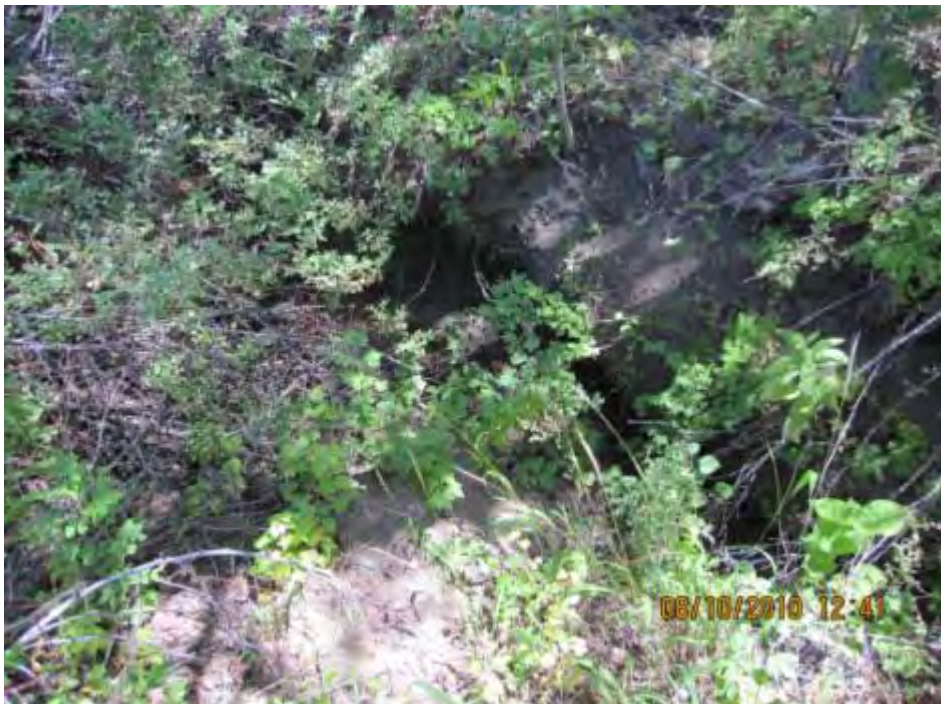
**Toyn Creek Reach 2**  
**Lotic - Non Functional**

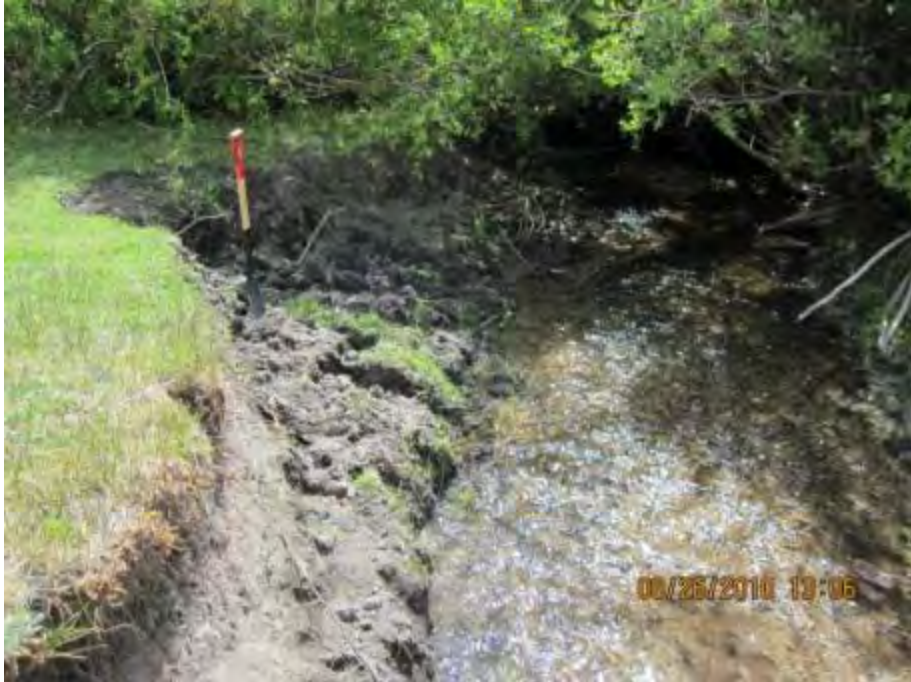
**Corral Creek Reach 2**  
**Functional – At Risk**  
**Trend not apparent**

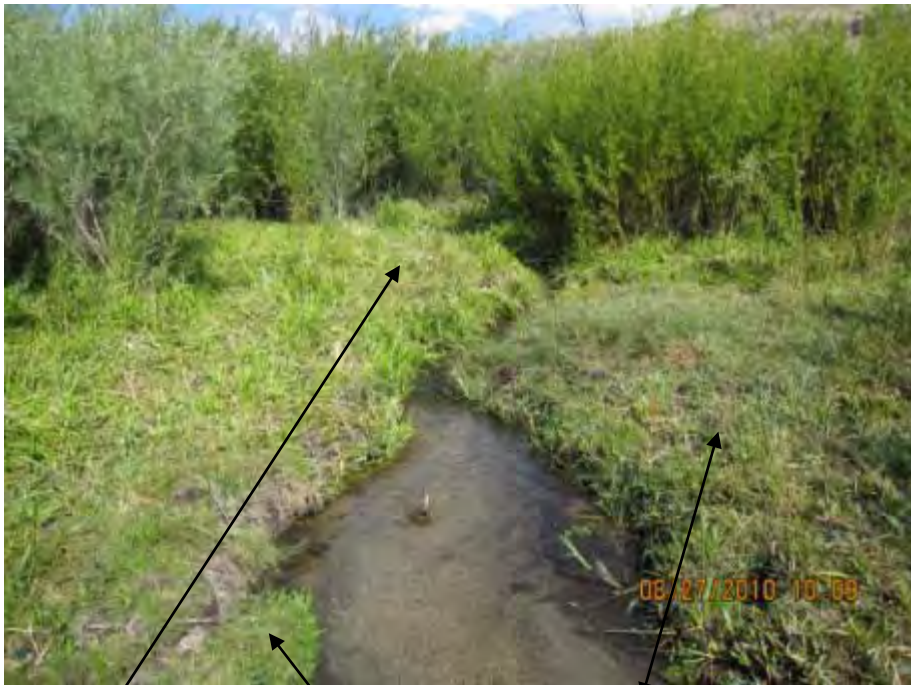
The reasons for Functional – At Risk and Nonfunctional ratings vary by drainage. In reaches 1 and 3 of Pearl Creek and lower Corral Creek, reaches 3 and 4, the loss of beavers in those reaches resulted in the old dams losing integrity, the active stream blowing out the dam and causing severe downcutting, therefore putting those reaches at risk. In reaches 2 and 3 of Green Mountain Creek old beaver dam remnants indicate that they may have been historically blown up resulting in the degradation of the stream channel. In 1984 and 1992, heavy winter snowpacks rapidly melted in the spring causing significant flooding. Pearl Creek and Lindsey Creek still show the effects of those floods. Historic and/or current grazing practices and management appear to be contributing factors in the remaining reaches rated as either Functional – At Risk or Nonfunctional.

**Corral Creek Reach 3**  
**Functional – At Risk**  
**Downward Trend due to**  
**amount of bank**  
**trampling and**  
**hummocking**

**Conversion of meadows**  
**and riparian areas to a**  
**drier community types**  
**and lack of maintenance**  
**of beaver dams also a**  
**concern.**

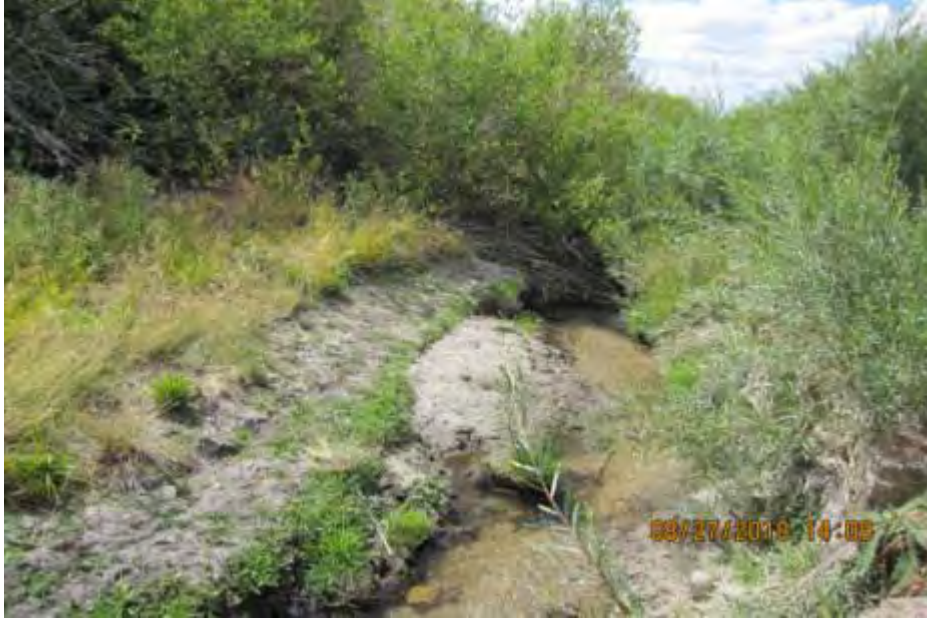
**Corral Creek Reach 4**  
**Functional – At Risk**  
**Upward Trend**

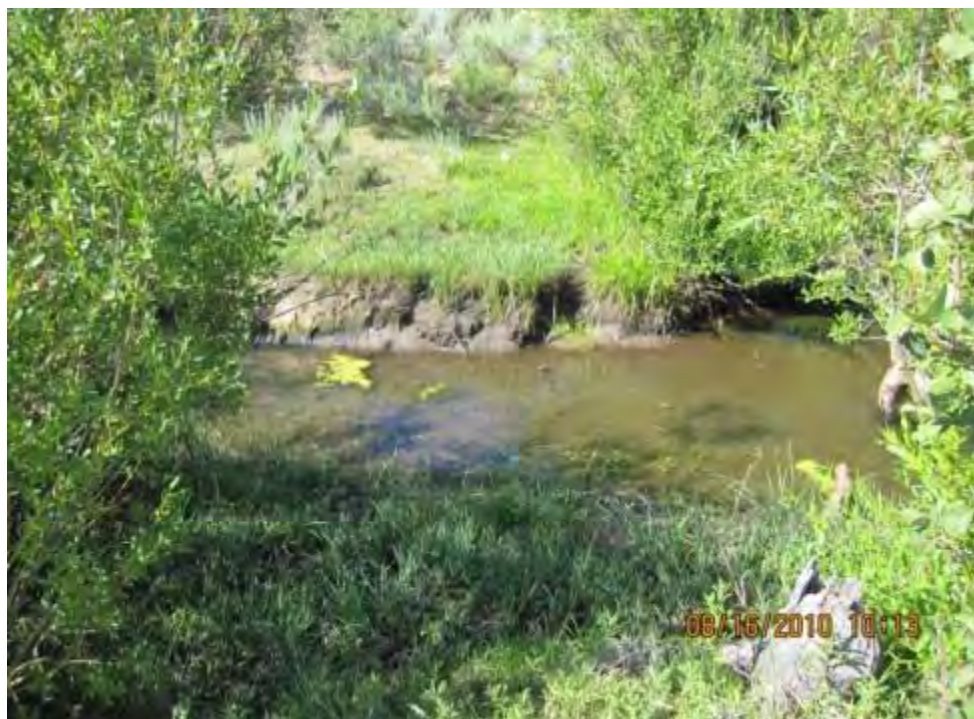
**Pearl Creek Reach 1**  
**Functional – At Risk**  
**Upward Trend**

13. N. Fork Lindsey Creek: Physical restoration of spring and stream.
14. Pearl Creek: Strategic falling of juniper and dead aspen to limit access to watering points along creek.

15. Pearl Creek: Create hardened designated watering points.
16. N. Fork Mitchell Creek: Create exclosure around springs and heritage resources.
17. S. Fork Mitchell Creek: Fence spring and stream above pond/reservoir.

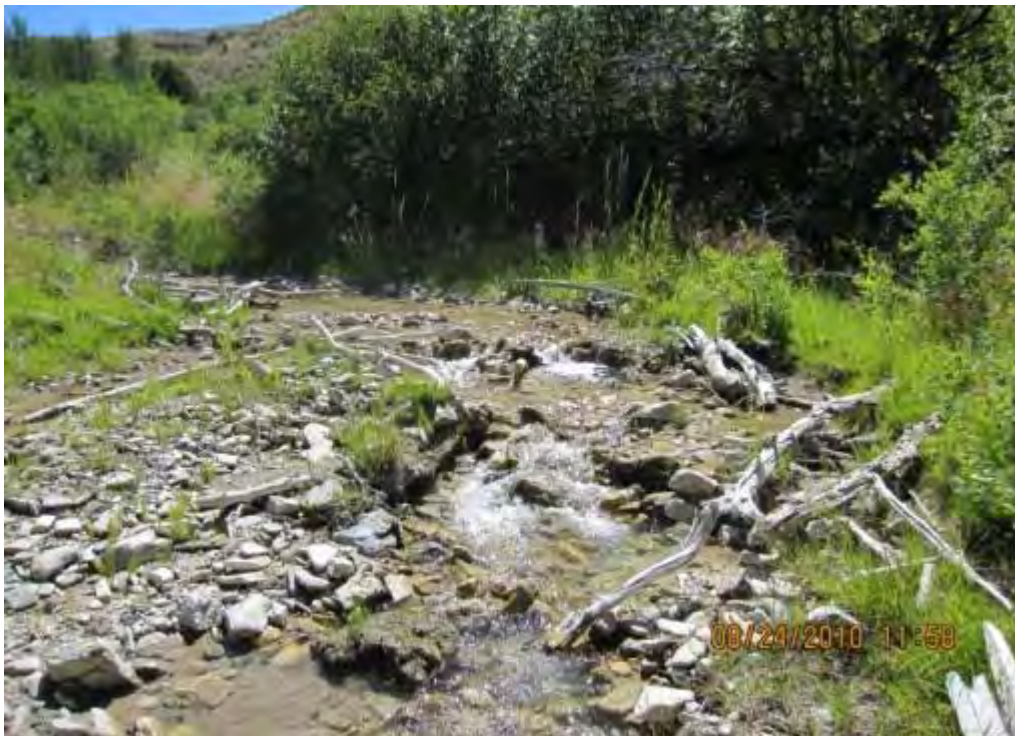
**Pearl Creek Reach 3**  
**Functional – At risk**  
**Upward Trend**

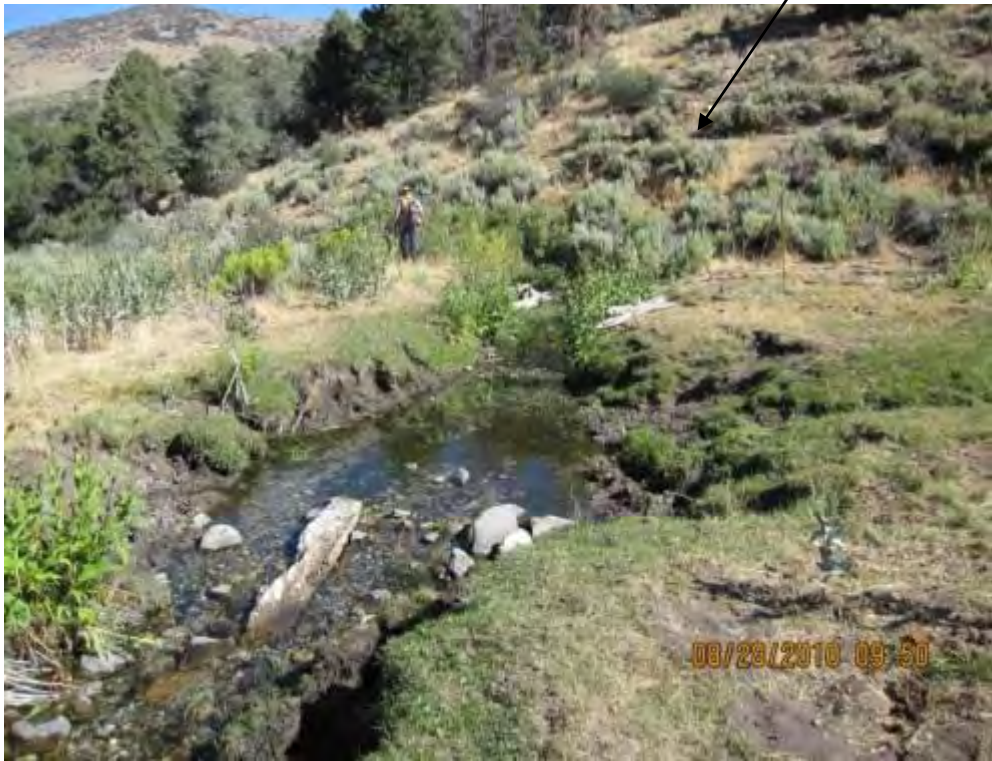
North Fork Lindsey Creek is the only creek that we identified as being Nonfunctional. In addition to the floods, the proximity of the road next to the creek causing sedimentation and

concentrated flow, grazing impacts and old decomposed and blown out beaver dams are all contributing to the non-functional rating. Appendix 1 displays a map each drainage and their respective PFC rating(s).

**North Fork Lindsey Creek  
Reach 1  
Non-functional**

10. N. Fork Lindsey Creek- Source spring: Fence meadow and spring source.
11. N. Fork Lindsey Creek: Move and/or close road paralleling creek.
12. N. Fork Lindsey Creek: Strategic felling of juniper to limit access of stream.

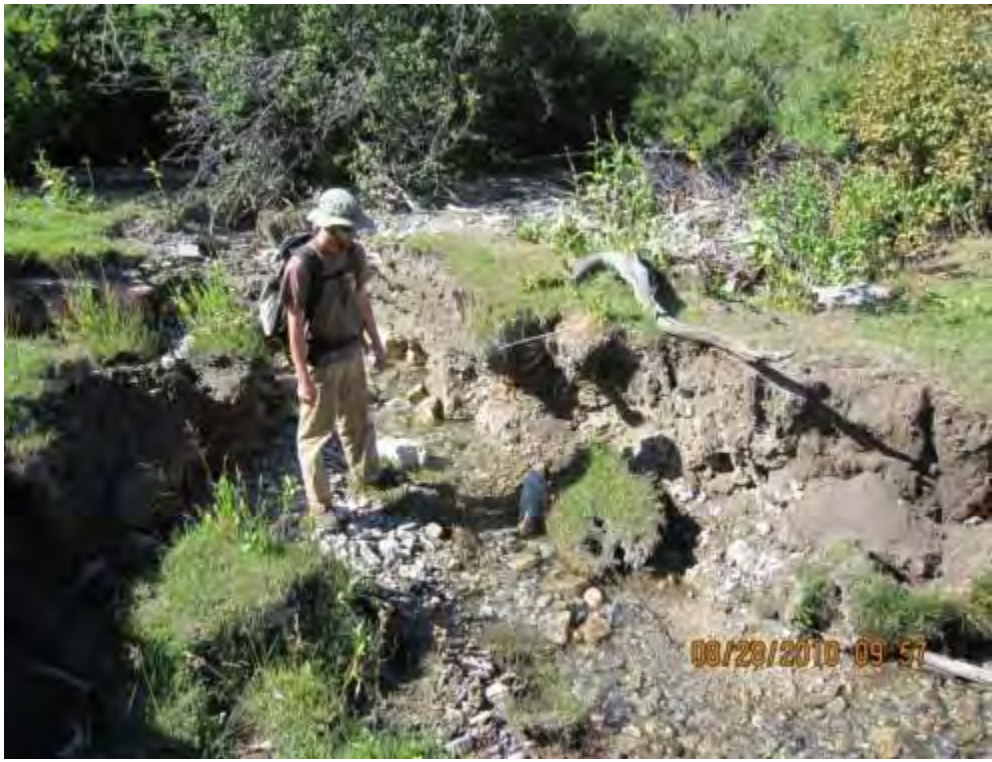
**North Fork Lindsey Creek  
Non-Functional**
