Ecological condition of the East Fork of the Gila River and selected tributaries: Gila National Forest, New Mexico

Abstract.-Ecological condition of riparian habitats along the East Fork of the Gila River, Main Diamond Creek, lower South Diamond Creek, and Black Canyon Creek are all in very heavily degraded condition. Channel cross-sections show extensive entrenchment, high width-to-depth ratios, and numerous reaches where banks are sloughing into the stream, especially on the East Fork of the Gila River. Species of floodplain vegetation typifies degraded channel conditions. Absence of woody species disallows bank stabilization except where entrenched to large cobble. Data from channel cross-sections and vegetation sampling validate these conditions.

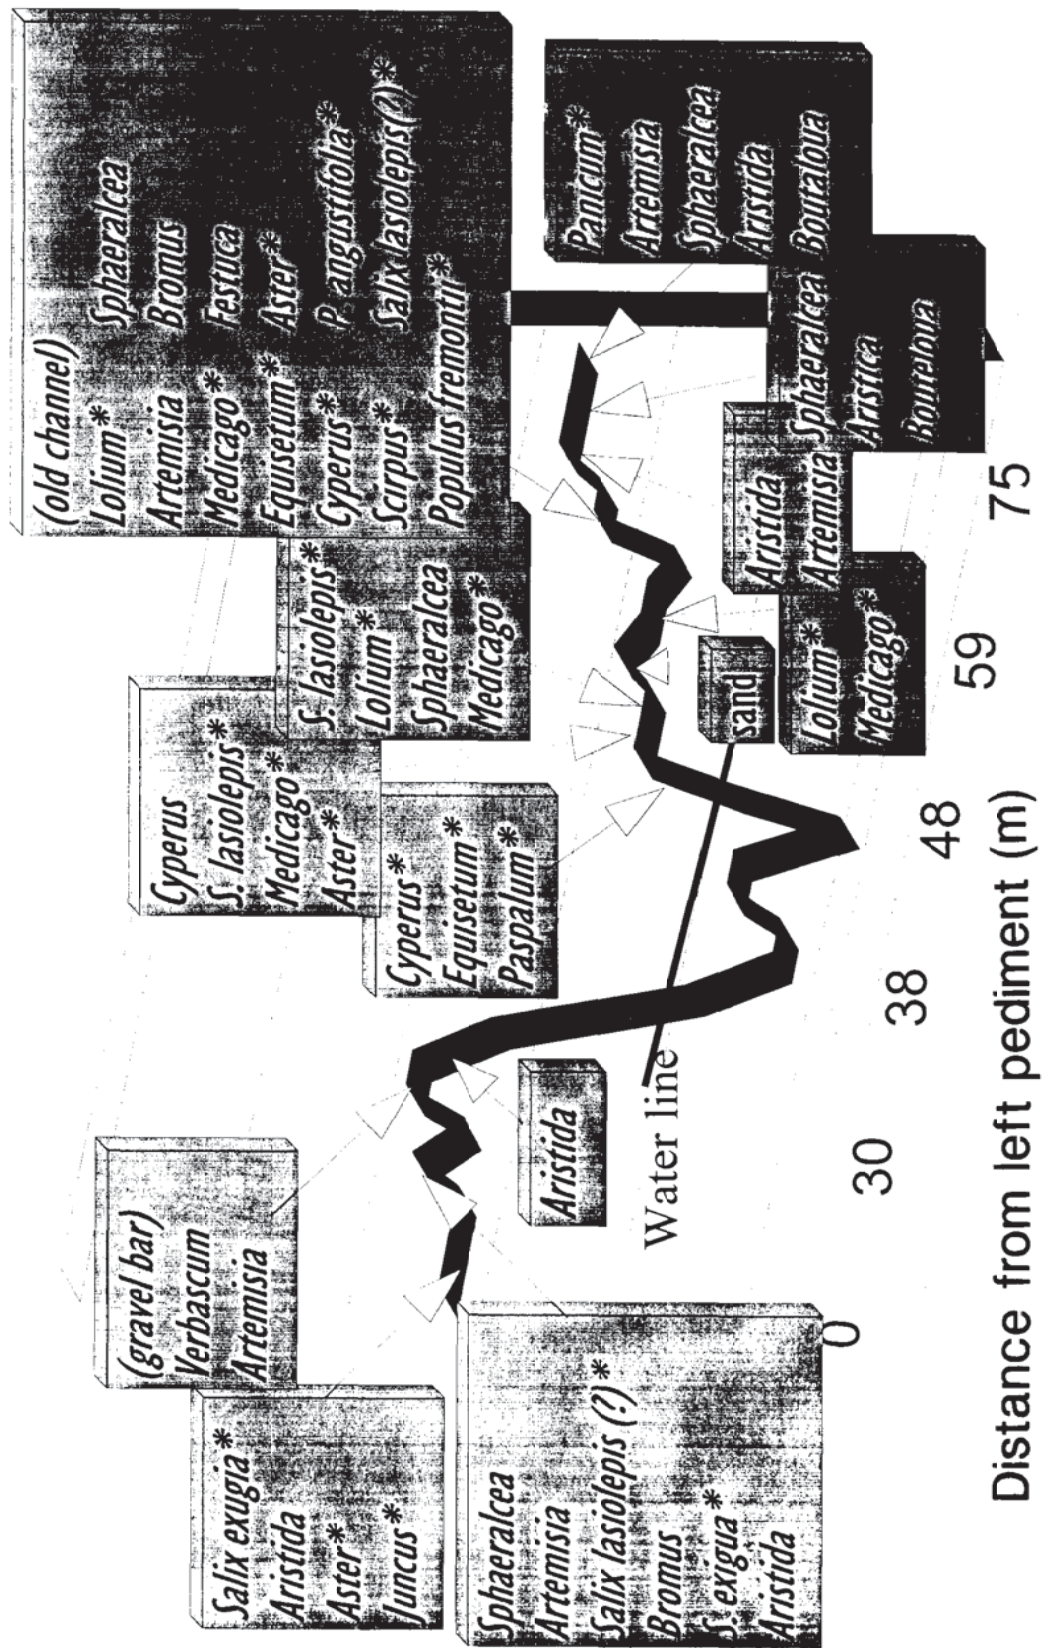
The floodplain was subdivided into 13 segments from left to right along the cross-section (fig. 1). Each segment represents an area either where there was major topographic or vegetational change across the floodplain. In figure 1 it can be seen that the river (old channel) had moved toward the left pediment about 26 m. The left bank is a high gravel bar and supports scattered nonriparian plant species. The right bank and segments up to and including the old channel are presently the primary floodplain and of the 26 species in these segments, 22 are riparian plant species.

Channel incisement has lowered the water table across the floodplain, consequently, second terraces (two leftmost segments and three rightmost segments) seldom receive overbank watering and groundwater table recharge except in large flood events. Of the 20 species occurring in these segments only 6 were riparian species. Vine mesquite (*Panicum obtusum*) occurred as a relict producing occasional seed heads. Willows (*Salix* spp.) reached their maximum densities in the outermost segments near the mountain pediments where soil moisture levels are maintained by surface runoff. Numerous upland species have invaded these segments.

Figure 1. Plant species distribution along a cross-section of the East Fork of the Gila River, Gila National Forest, New Mexico.
