Hemlock Cliffs

Sustaining a Priority Hoosier Landmark

Hoosier National Forest | Great American Outdoors Act | Trail No. 112.10

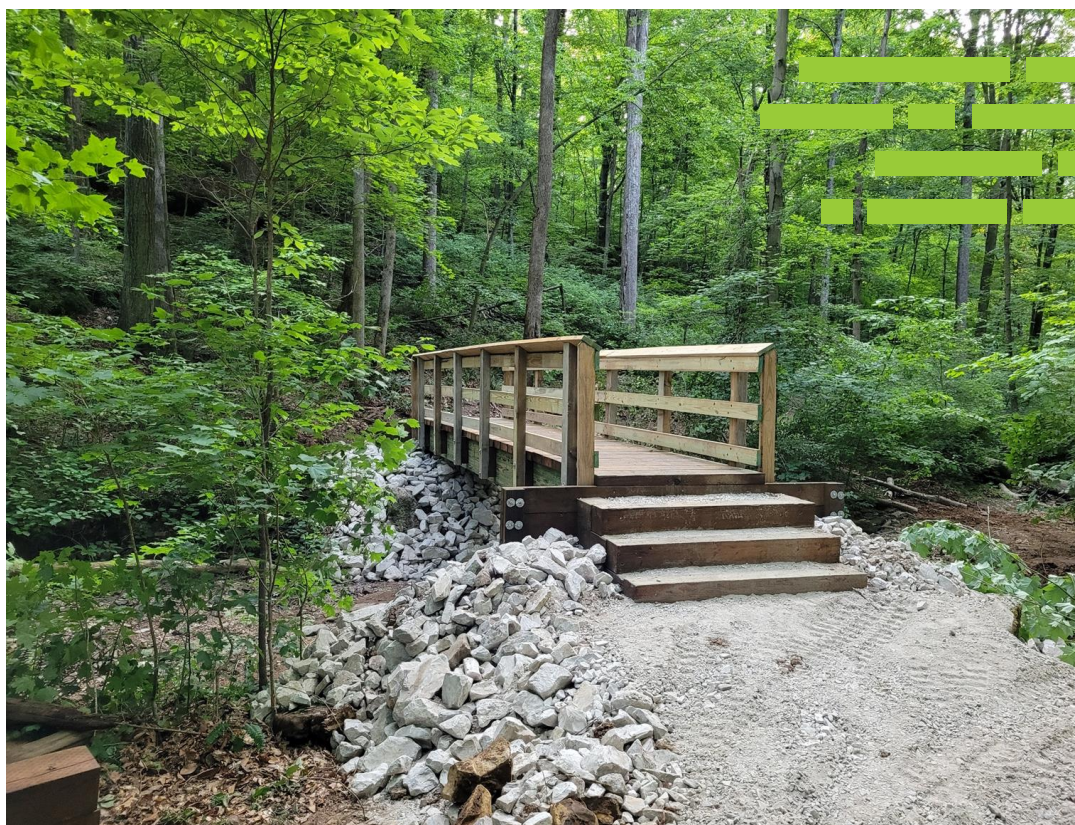
Approaching the new bridge from the western trailhead.

The base sat only a few feet above the streambed. Though infrequent, flooding waters through the stream could reach or even overtake the bridge's walking surface. To solve this, engineering staff from the Eastern Regional Office proposed a new design. The replacement bridge has a higher clearance to allow water or debris to safely pass below it. The new bridge is longer to accommodate the clearance, with sturdy stone abutments included in the new construction.

The new trail bridge at Hemlock Cliffs is longer, taller, and more robust. Steel beams were replaced with a stronger, longer lasting glulam support structure.

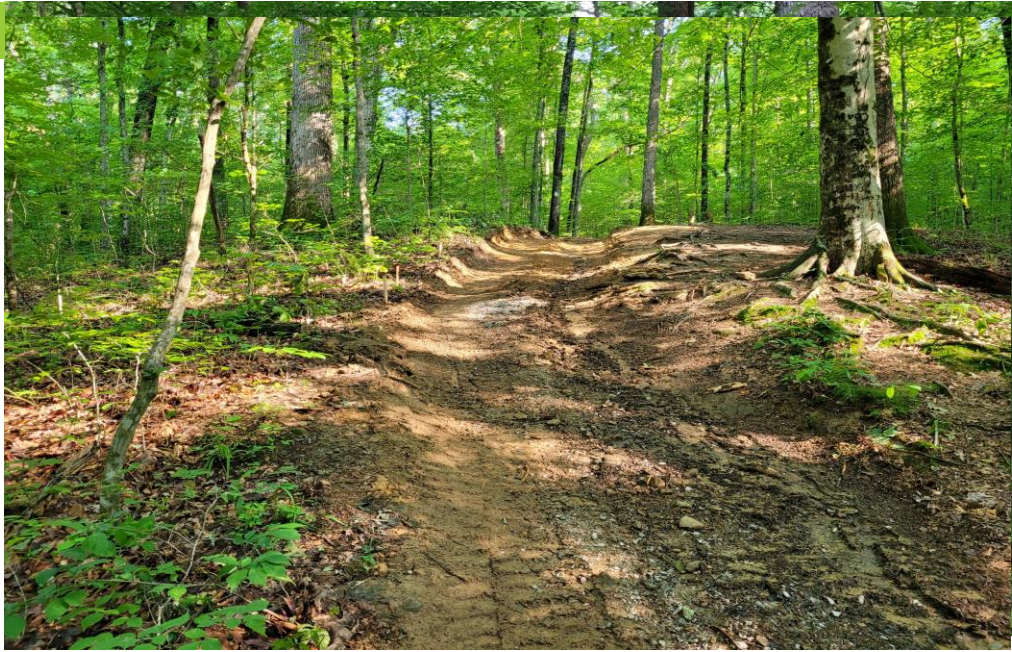
Moving large amounts of material to the existing bridge required careful collaboration between contracted personnel and their equipment. Beams, some longer than 20 feet had to be carried between two machines working in total unison.

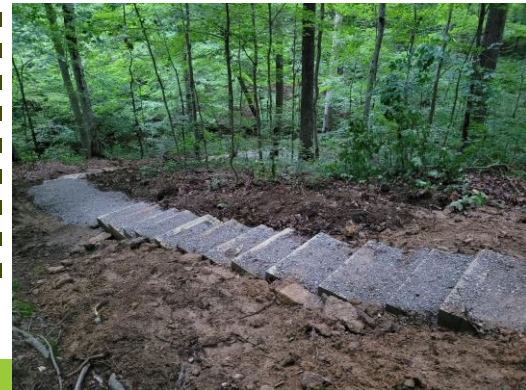
Above: An area where stairs were removed to accommodate equipment travel. Below: New stairs still under construction in an incised section of trail.

To accommodate the move, existing stairs were removed at the start of the project. They were reconstructed with new materials after the bridge was completed. The stairs were filled with new aggregate to provide a solid walking surface. Some of the old wood was recycled; incorporated into drainage structures where possible.

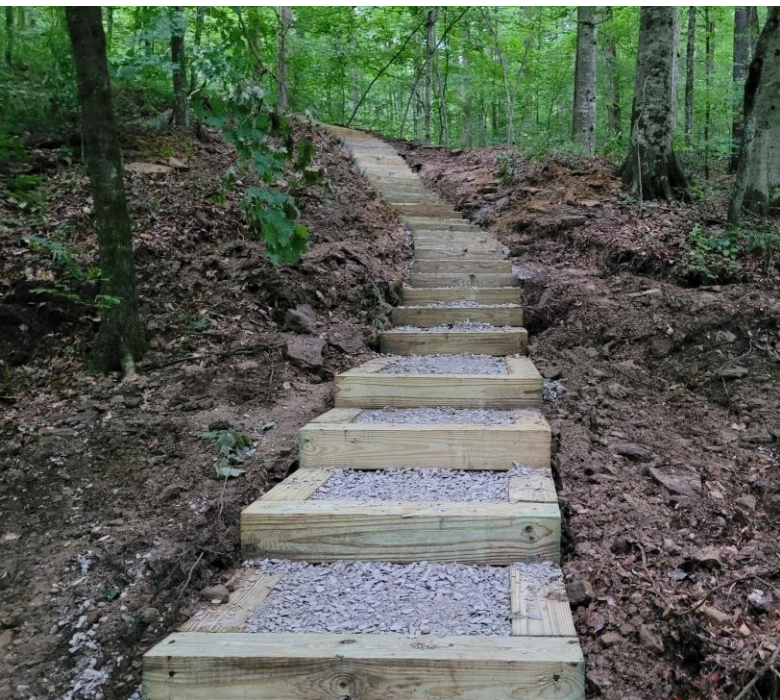
Newly constructed stairs filled with new aggregate to match the rehabilitated trail tread.

Not only were existing stairs reconstructed--a new flight of stairs was added in an area of trail heavily incised from erosion and visitor use. When a trail is incised, water cannot exit to the adjacent hillside. Over time, this type of trail begins to act like a funnel. When water cannot escape, it flows directly down the trail causing further erosion and damage. Hikers would have difficulty navigating this area unless conditions were completely dry.

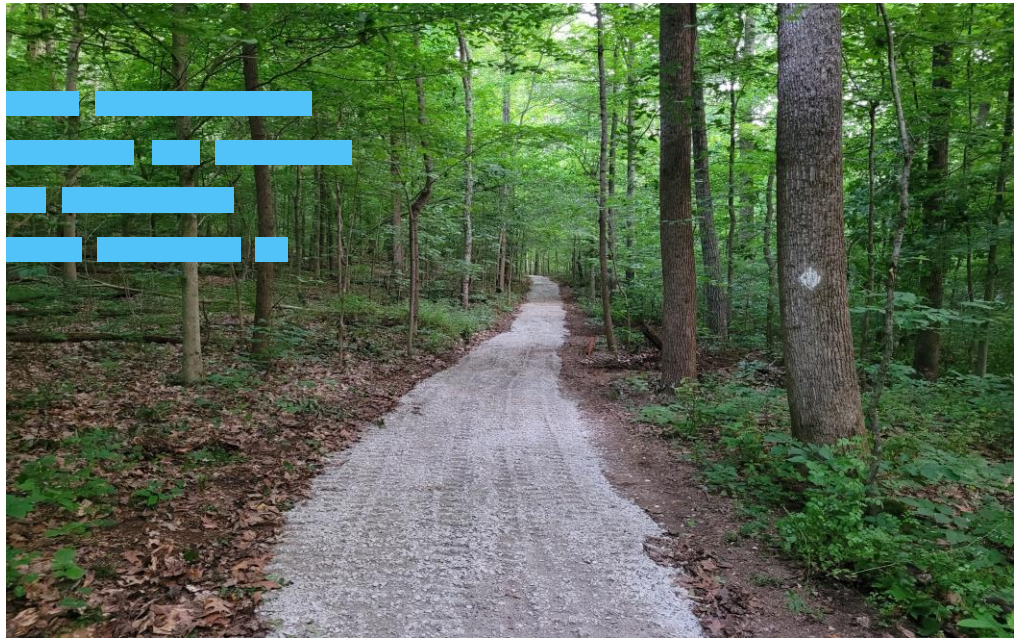
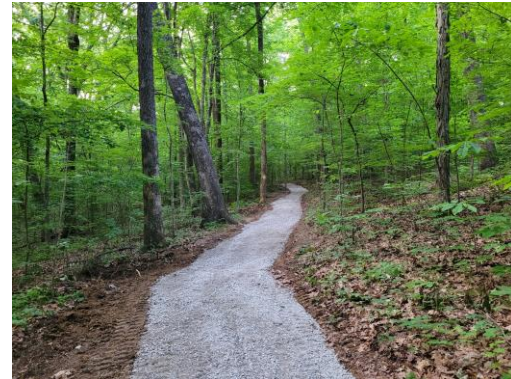
Limestone Crush: Many years and many thousands of visitors have gradually widened the trail at Hemlock Cliffs. What was once a three-foot-wide trail has now become six or seven feet in some areas. Contractors added 200 tons of crushed limestone aggregate to provide a durable, more sustainable hiking surface. Now only three to four feet wide, the trail still provides plenty of space to walk two to three people across. Contractors seeded the extra width of the corridor to allow native vegetation to reclaim the exposed soil.

Above and below: Sections of the existing trail with newly placed aggregate. The trail now has more defined edges which should help prevent widening over time.
