Legacy Roads and Trails Monitoring Project

Road Decommissioning in the Lolo Creek Watershed

Clearwater National Forest

May 2011

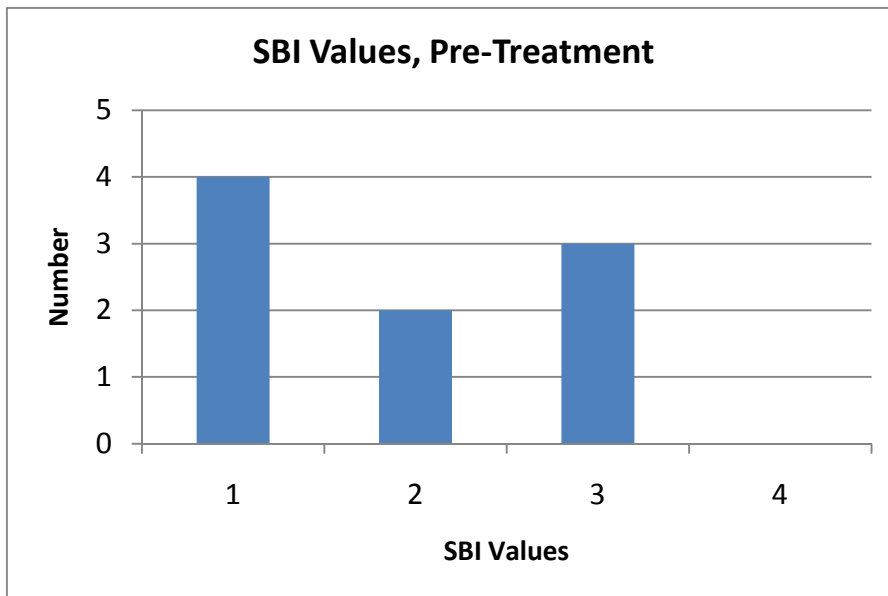
Figure 9. Distribution of Stream Blocking Index values for pre-treatment stream crossings. Values were zero after treatment.

The SBI values for the pre-treatment stream crossings were low to moderate with an average value of 1.9 for the nine stream crossings (Figure 9). This is out of a range of 1 to 4, where 1 suggests no risk of blockage. All nine stream crossing pipes were removed during decommissioning, which completely eliminated the risk of pipe plugging. Thus, the post-treatment SBI score was zero at all crossings.

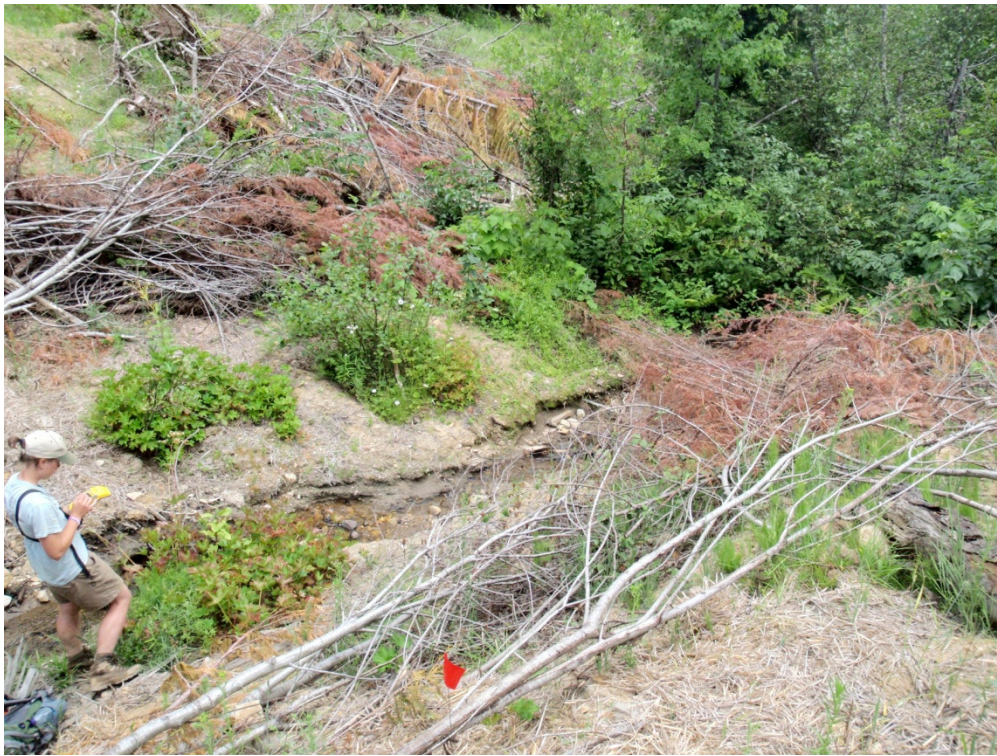
Figure 10. Excavated stream crossing on road 5105 (Yakus). Note the channel incision and living vegetation on the side slopes. This represents a “typical” excavated stream crossing for these roads.

m³ to 10.4 m³, with a mean of 3.2 m³). Finally, it was observed that most (8 of 9) excavated stream crossings had side slopes that were well-vegetated with grasses, forbs, and/or woody plants (Figure 10).

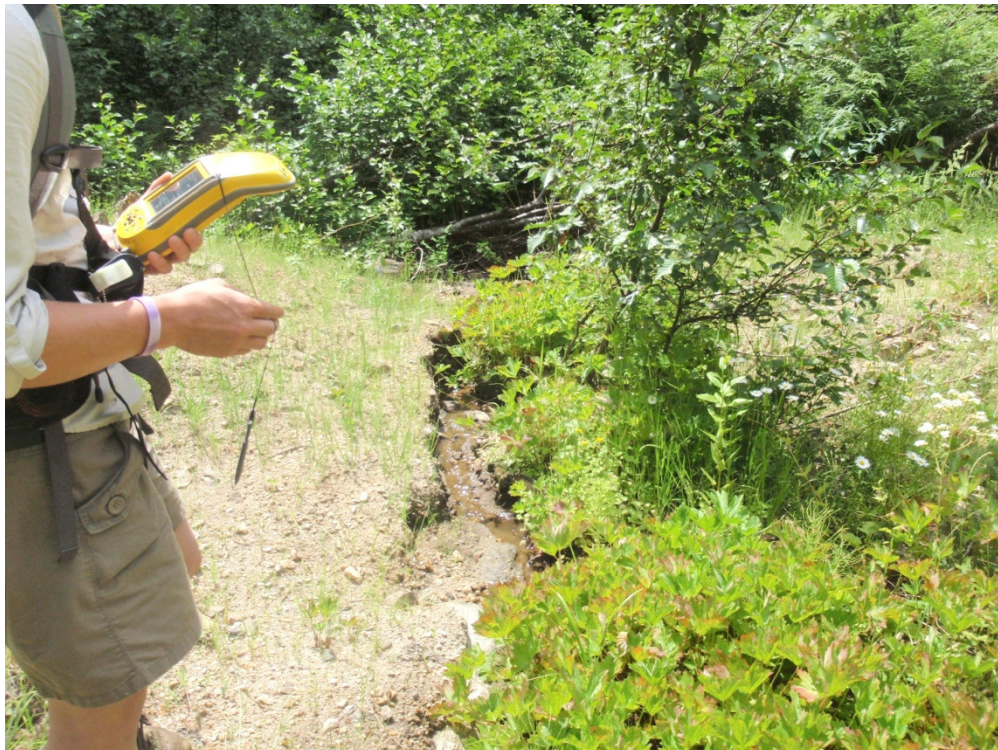
Figure 11. Fill erosion at a waterbar on road 5105 (Yakus). The erosion here is caused by the interception of discontinuous runoff and groundwater.
