Legacy Roads and Trails Monitoring Project

Road Decommissioning in the Mammoth Creek Watershed

Dixie National Forest

August 2012

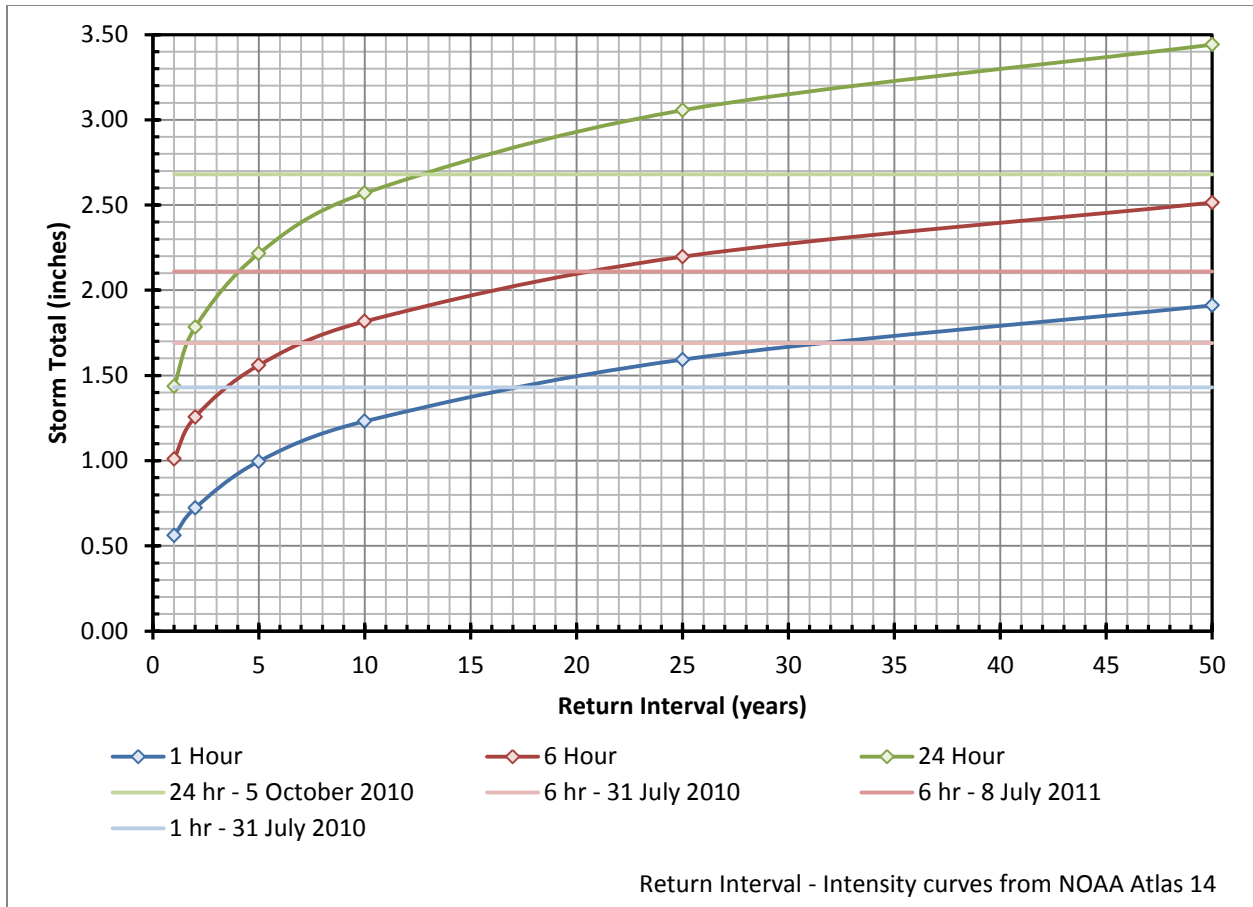
Figure 3: Precipitation intensity curves and intensities from the three storm events that hit the Mammoth Creek site.

The Mammoth Creek site recorded three precipitation events exceeding the 7-year return interval threshold (Figure 3). The first of these storms occurred on July 31, 2010, before crews could arrive to conduct the post-treatment inventory and only days after treatment work was completed. Rain started at 2:00 in the afternoon and stopped around 3:30 pm with a few sprinkles until 4:30 pm. This storm delivered 1.43" of rain in the first hour and a total of 1.69" by 4:30 pm, exceeding the precipitation intensity thresholds for both 1 and 6 hour events. An intensity of 1.43" per hour has a return interval of approximately 17 years; the threshold for a seven-year, six hour storm is 1.62" in six hours. This storm was responsible for causing much of the damage on treated roads; few areas not damaged by this storm were damaged by the subsequent storms.

The next storm was a 24 hour event in October that delivered a peak intensity of 2.68" in 24 hours (approximately 12.5 year return interval). Between the morning of October 4 and the evening of October 5, the area received a total of 3.82" of rain. The last event was a 6 hour event that occurred during the evening of July 8, 2011. This series of thunderstorms delivered 2.11" of rain to the area between 5:00 pm and 11:00 pm; a storm of this intensity has a return interval of approximately 20.5 years.

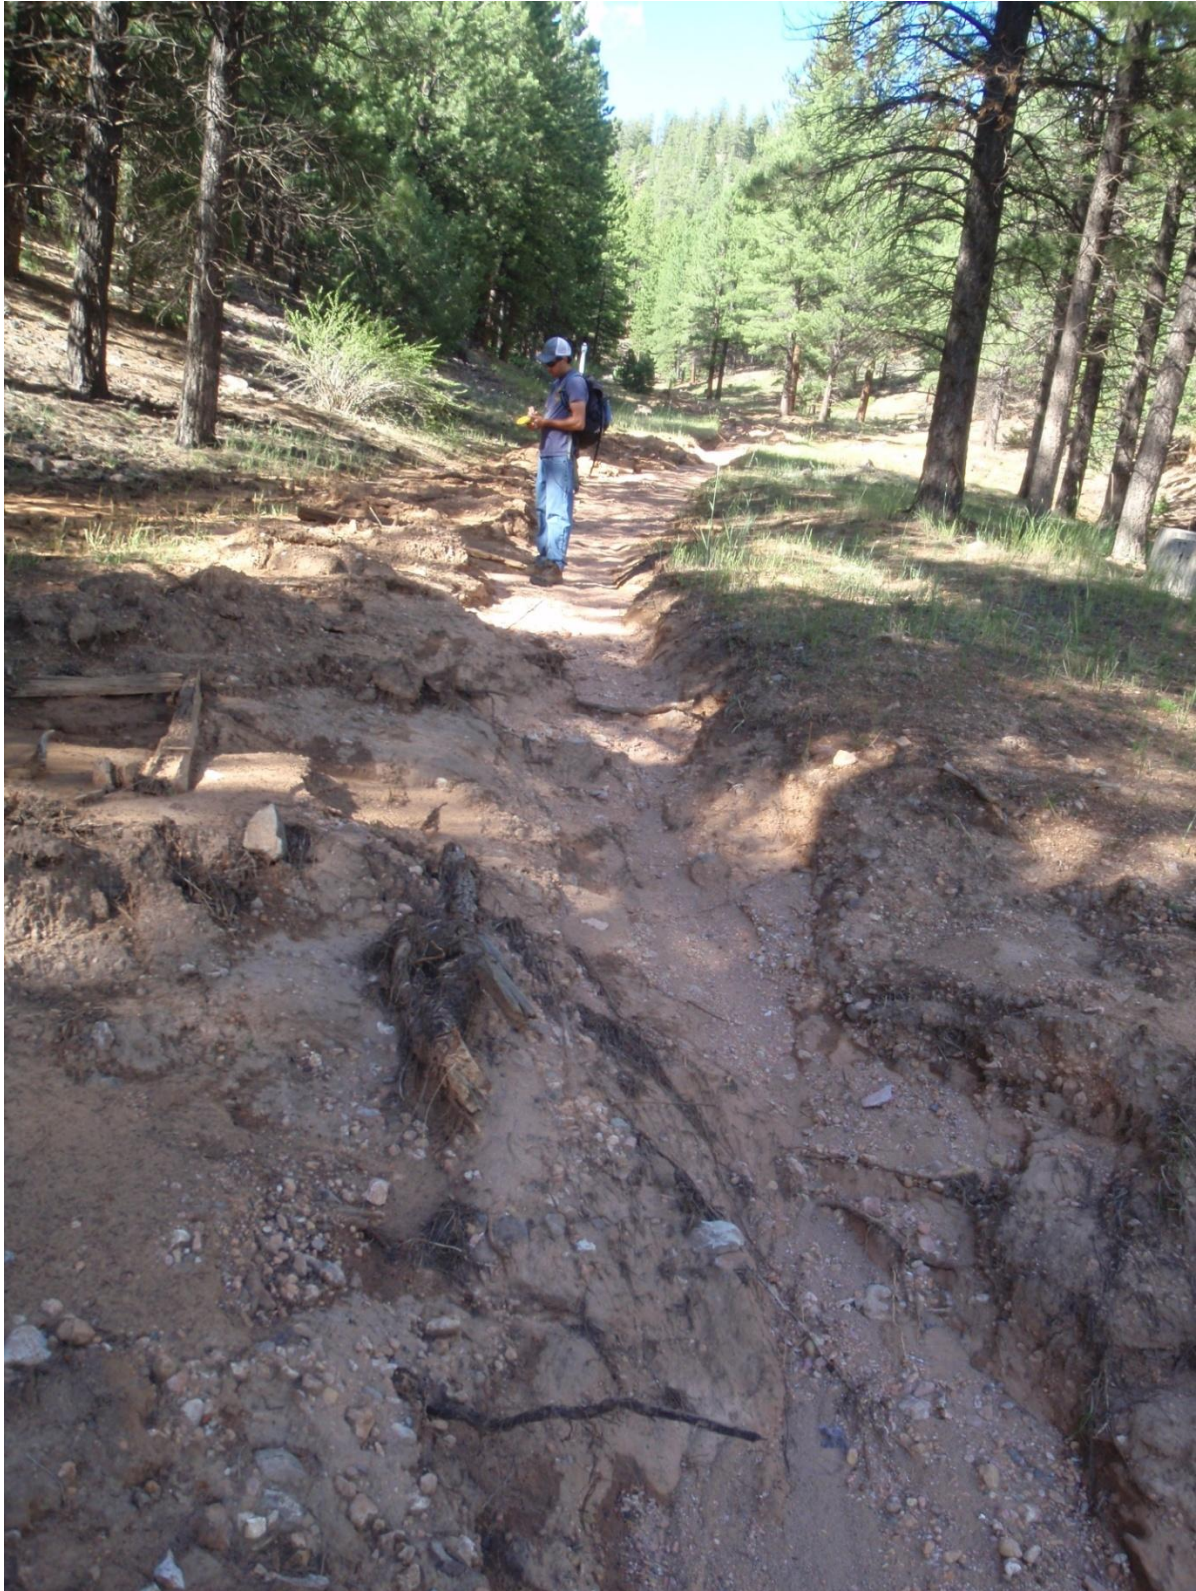
Figure 4: Storm damage on tilled road surface. The road intercepted flow in an intermittent stream channel.

Most of the storm-related damage along the treatment roads was caused by the first storm. While the damage along the treatment roads tends to be more dramatic, it is far less extensive than the damage found along the control roads. The most obvious and dramatic damage occurred on a tilled section of the road just east of the Mammoth Creek campground. Flash floods associated with the first rain event were diverted onto the freshly tilled road surface, rapidly eroding a channel more than six inches deep (Figure 4). Other damage caused by this storm included erosion at intermittent stream crossings (Figure 5) and gullies that crossed the treated road (Figure 6). The later storms generally did not cause damage in new areas, but did exacerbate the damage caused by the first storm (Figures 7 and 8).

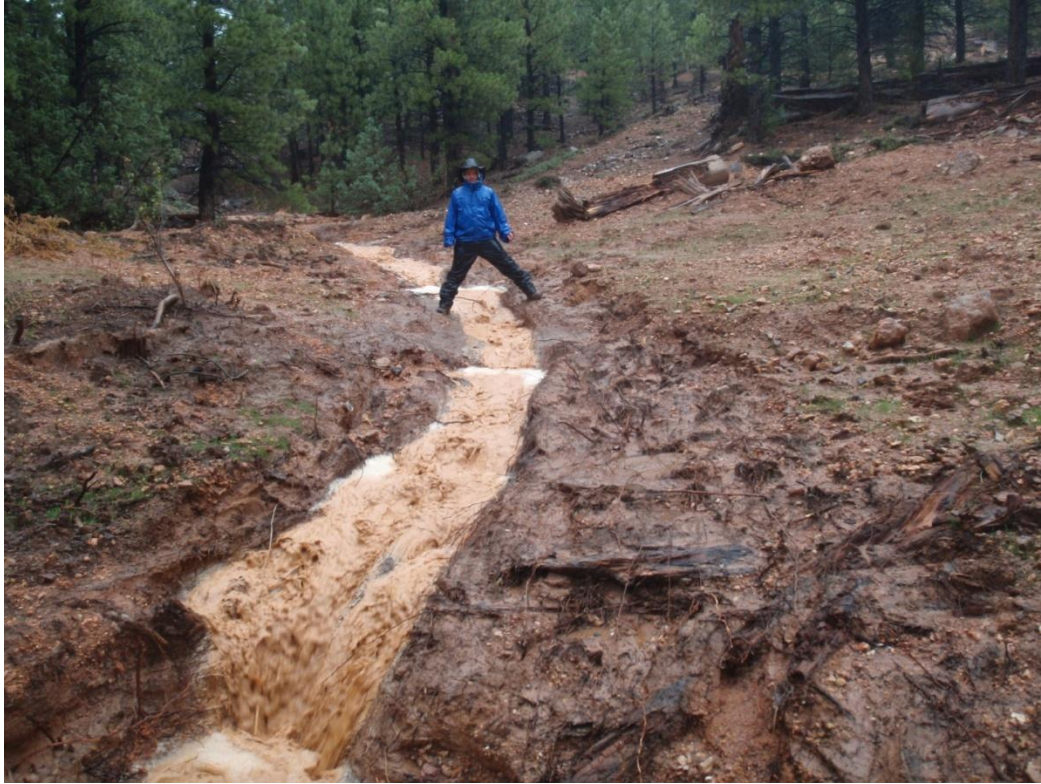
Figure 5: Erosion at intermittent stream crossing, erosion extent is wider than Scott's height. Pictured flood flow generated by 0.20" of rain in 30 minutes.

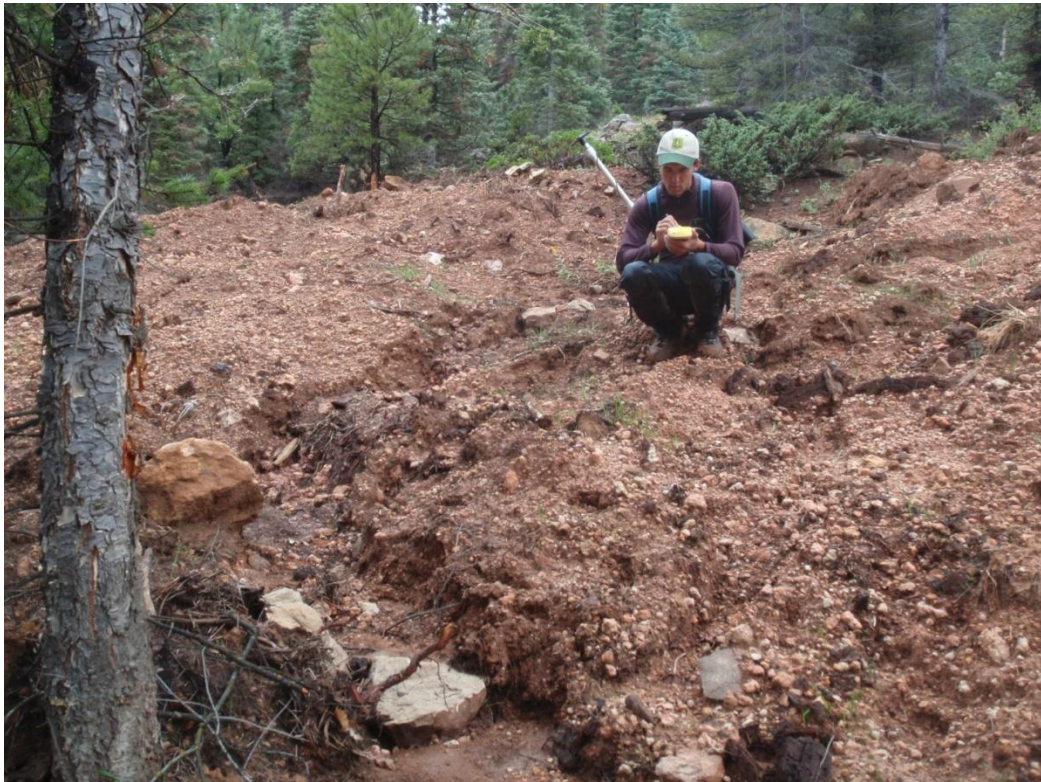
Figure 6: Hillslope gully crossing recontoured road.

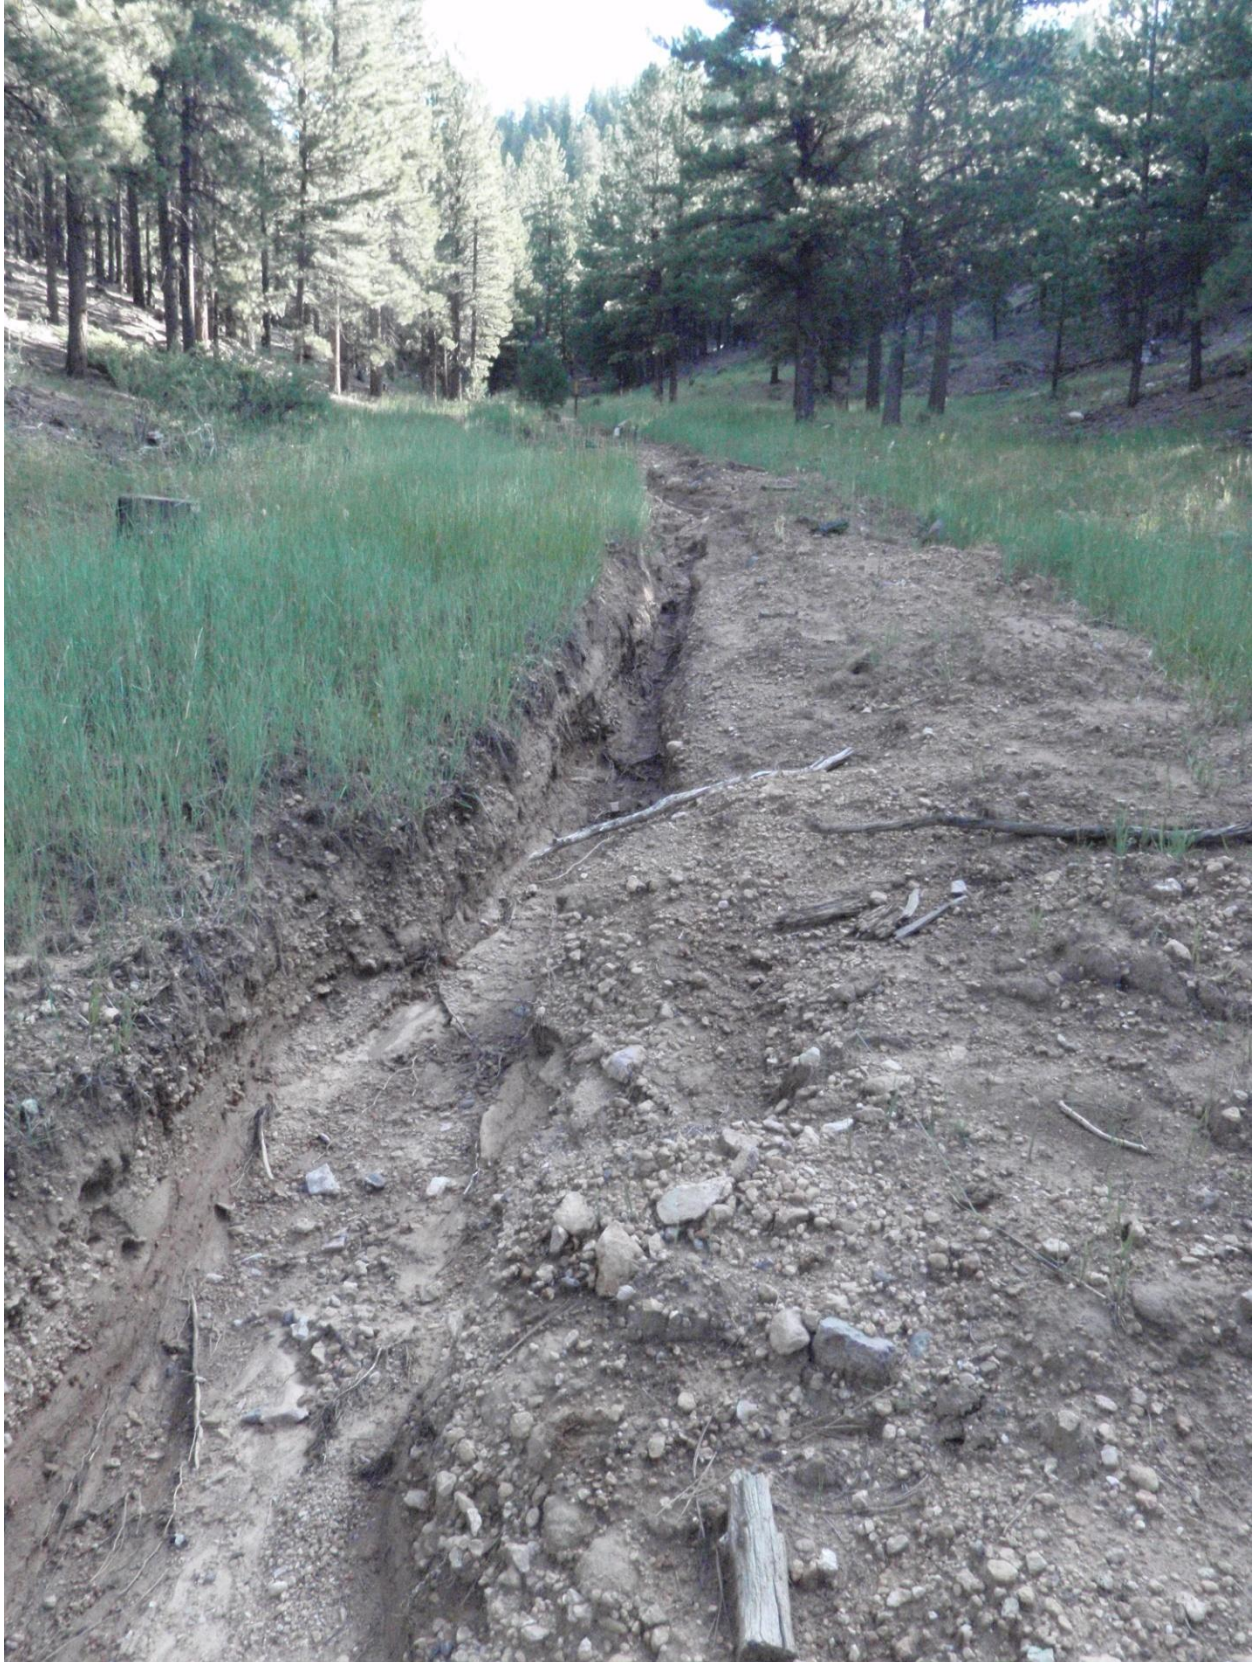
Figure 7: Stream course incised into tilled road.

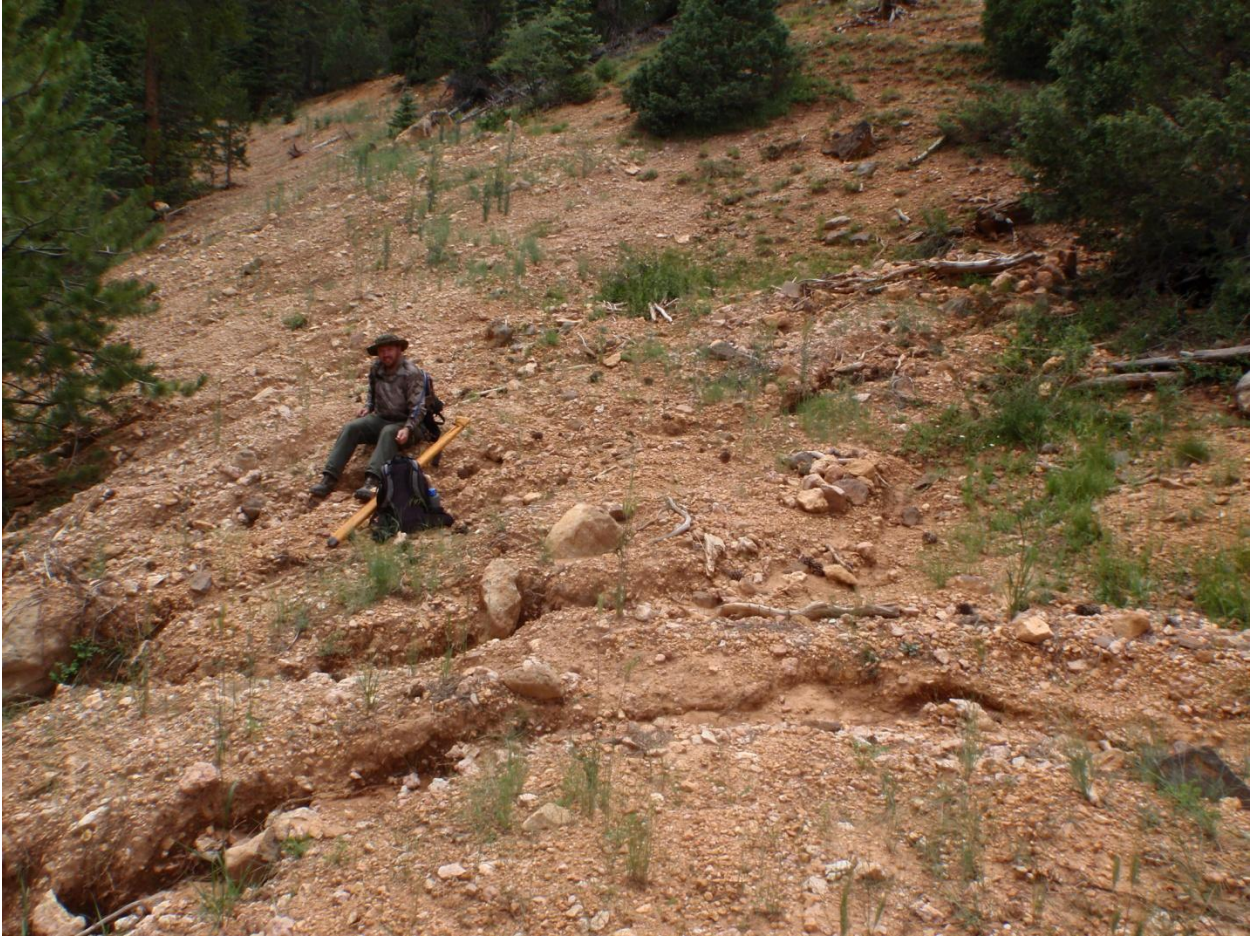
Figure 8: Gullies crossing recontoured road.

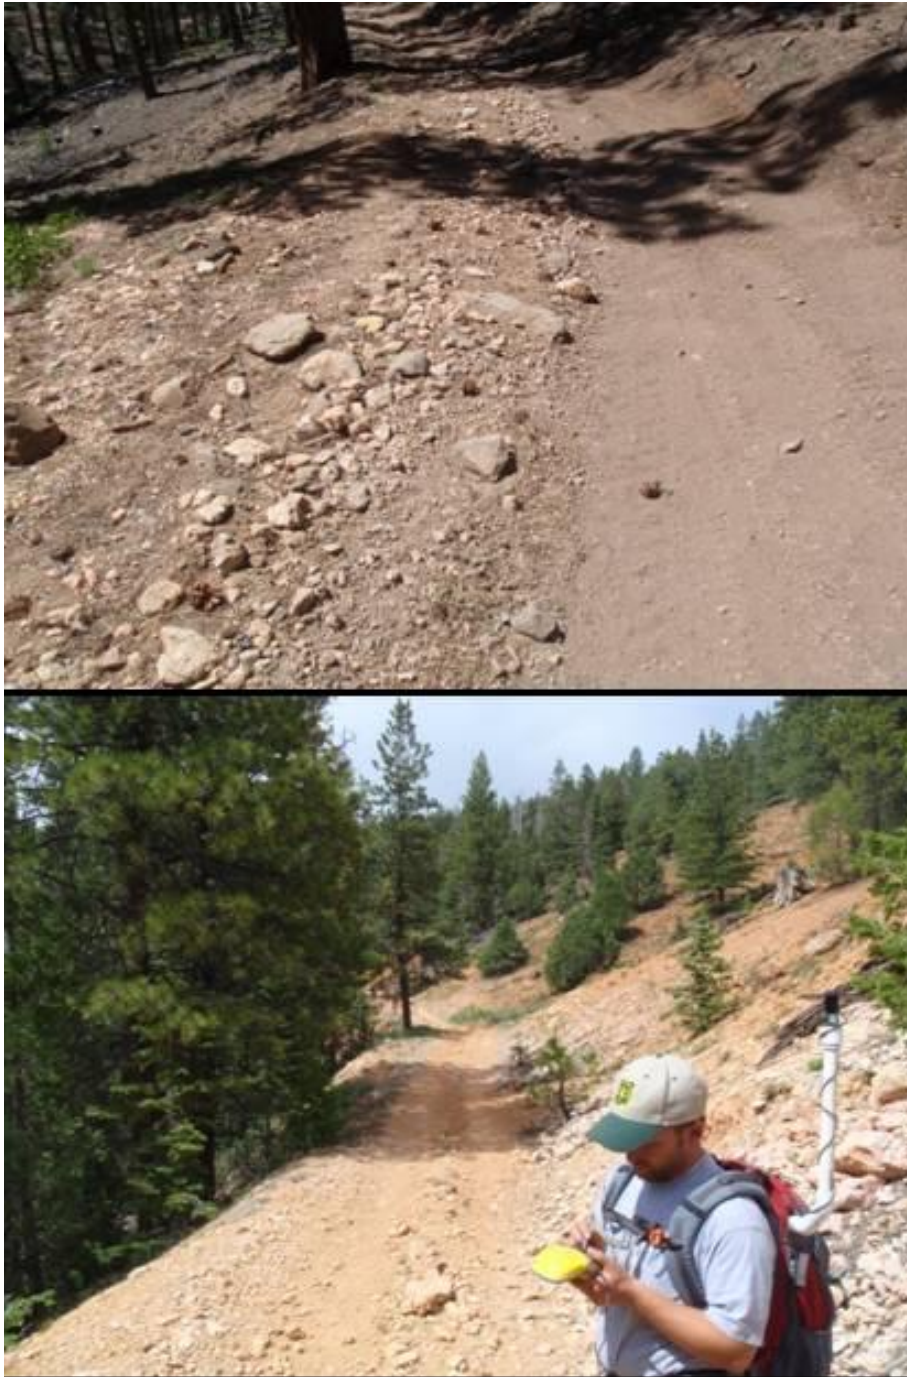
Figure 9: Typical pre-treatment road conditions.

Pre-treatment roads were found to be in generally poor condition, though 16% of the roads were found to be in good condition. Thirty percent of the roads were rilled or eroded, 29% were rutted, and 26% were rocky; rocky roads may result from erosion of finer road materials. All but a few road segments were surfaced with native material; the few exceptions had an armored surface most likely the result of natural processes. Figure 9 provides examples of typical road conditions.

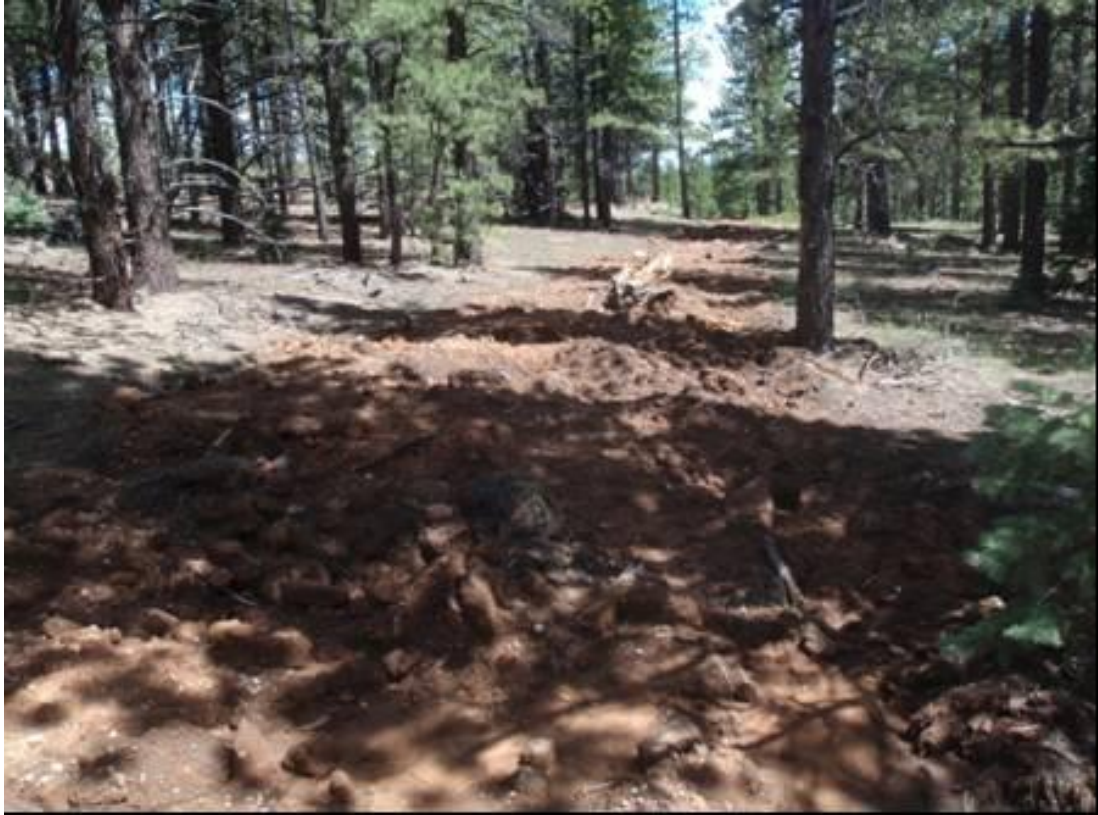
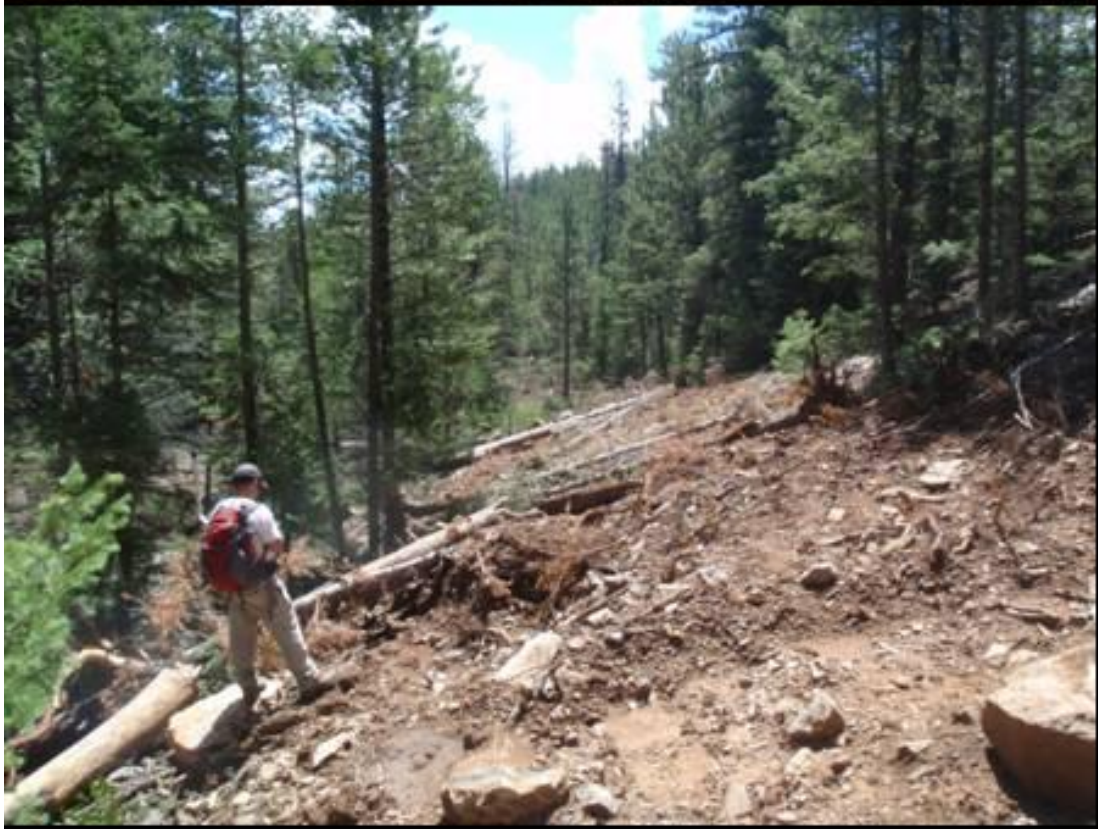
Roads in the Mammoth Creek project area were decommissioned using a combination of recontouring and tilling treatments, which were applied to about 95% of the treated roads. Typical treatments are shown in Figure 11.

Figure 11: Typical post-storm road conditions. Tilled road on top; recontoured road on bottom.

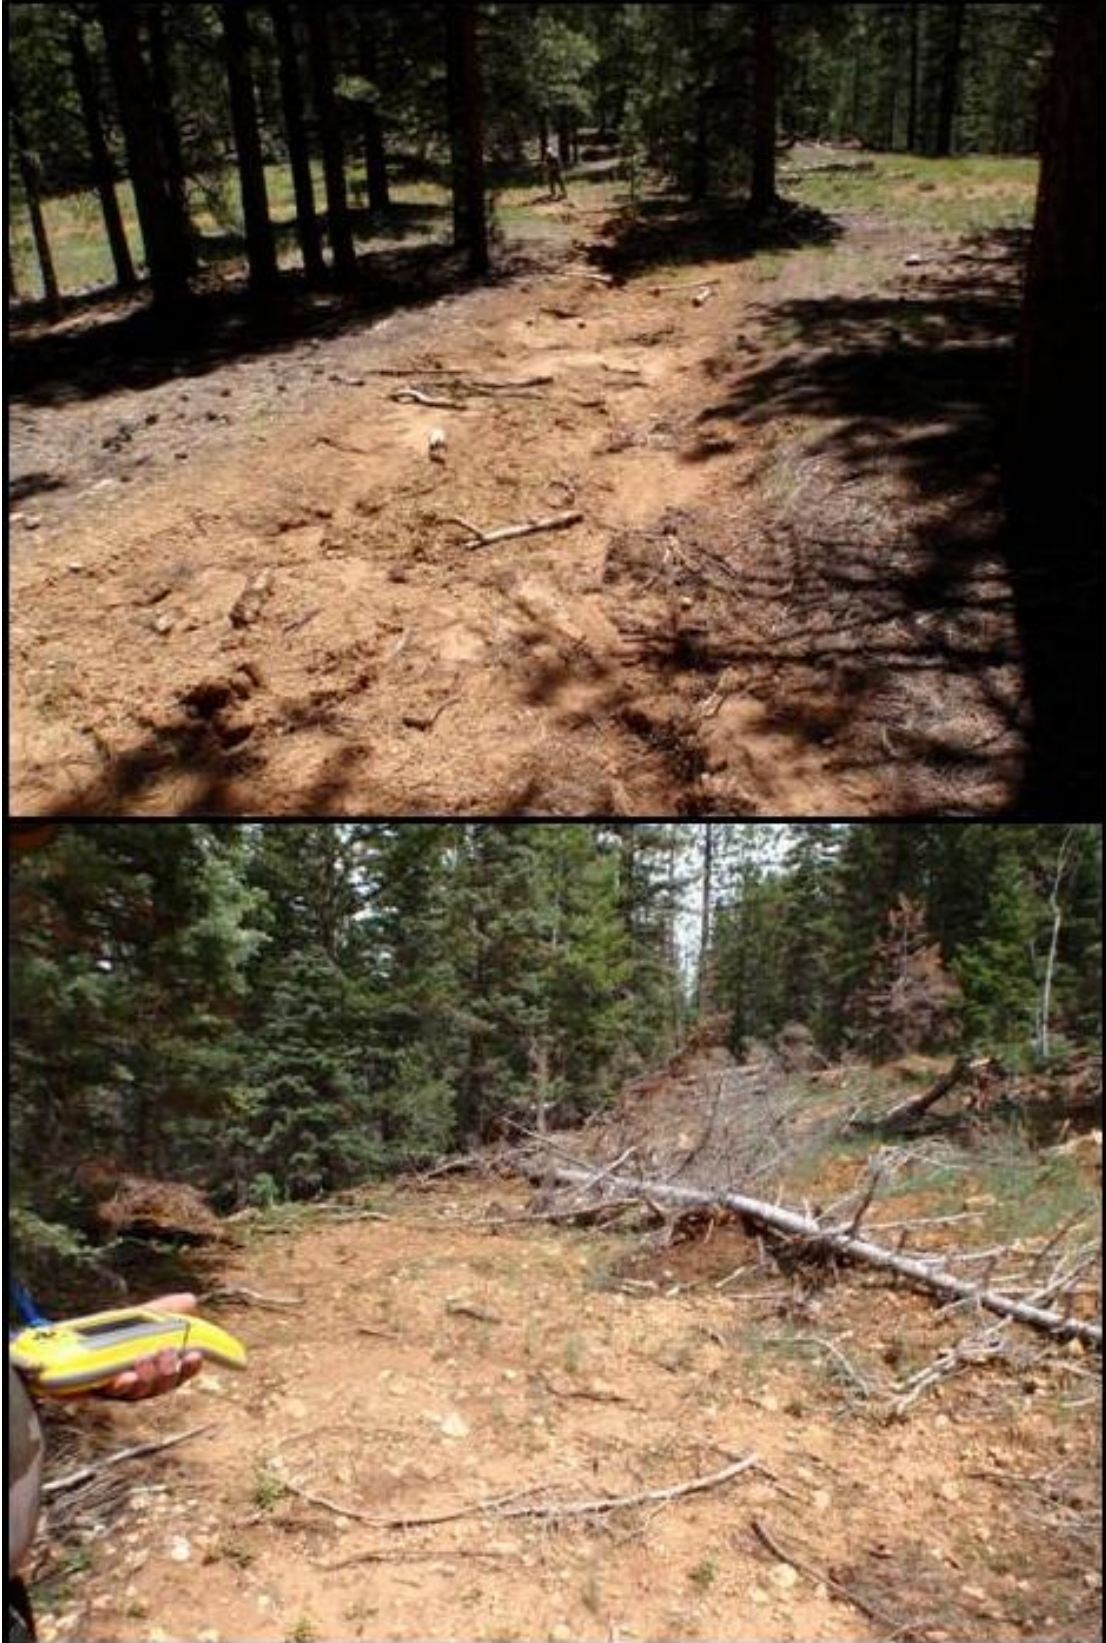
Figure 13: Typical road conditions during the post-season inventory.

One year after the post-storm inventory, a crew re-inventoried the treatment and control roads. Local storm damage was limited to areas damaged before the post-storm inventory, though further erosion likely occurred in these areas. Typical conditions are shown in Figure 13.

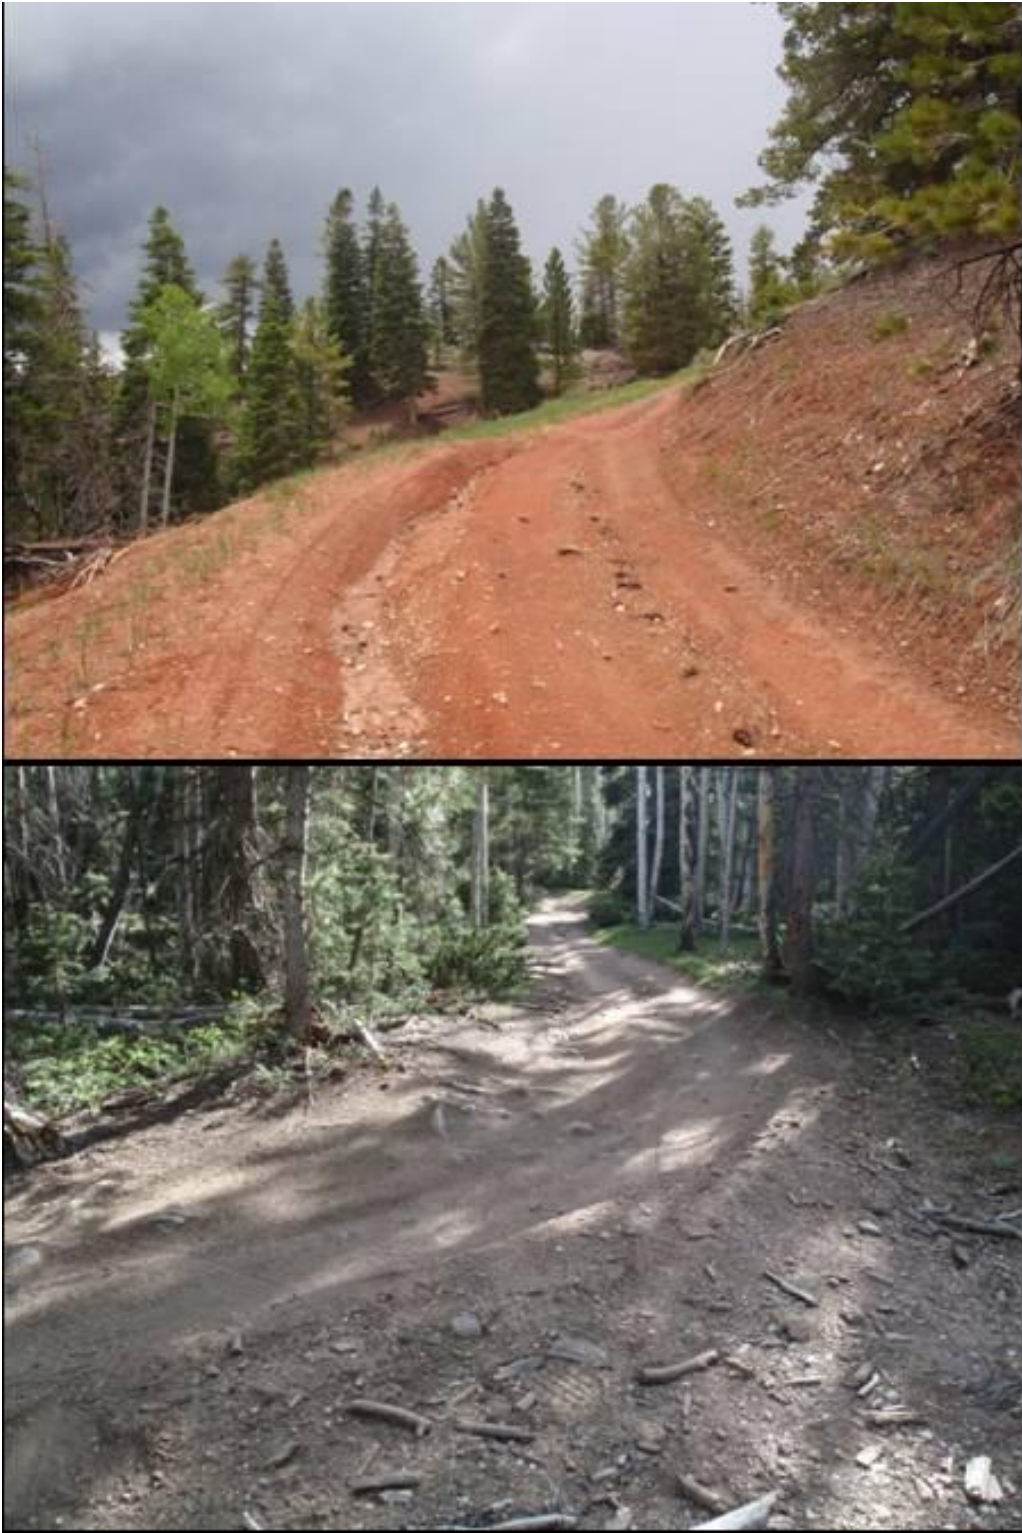
Figure 15: Typical control road sections, pre-storm.

The control roads were selected and first inventoried at the same time the pre-treatment inventory was conducted. The initial survey found that 49% of the road was in good condition, 29% was rilled or eroded, 16% was rocky, and 7% was rutted. Figure 15 shows examples of general road conditions.

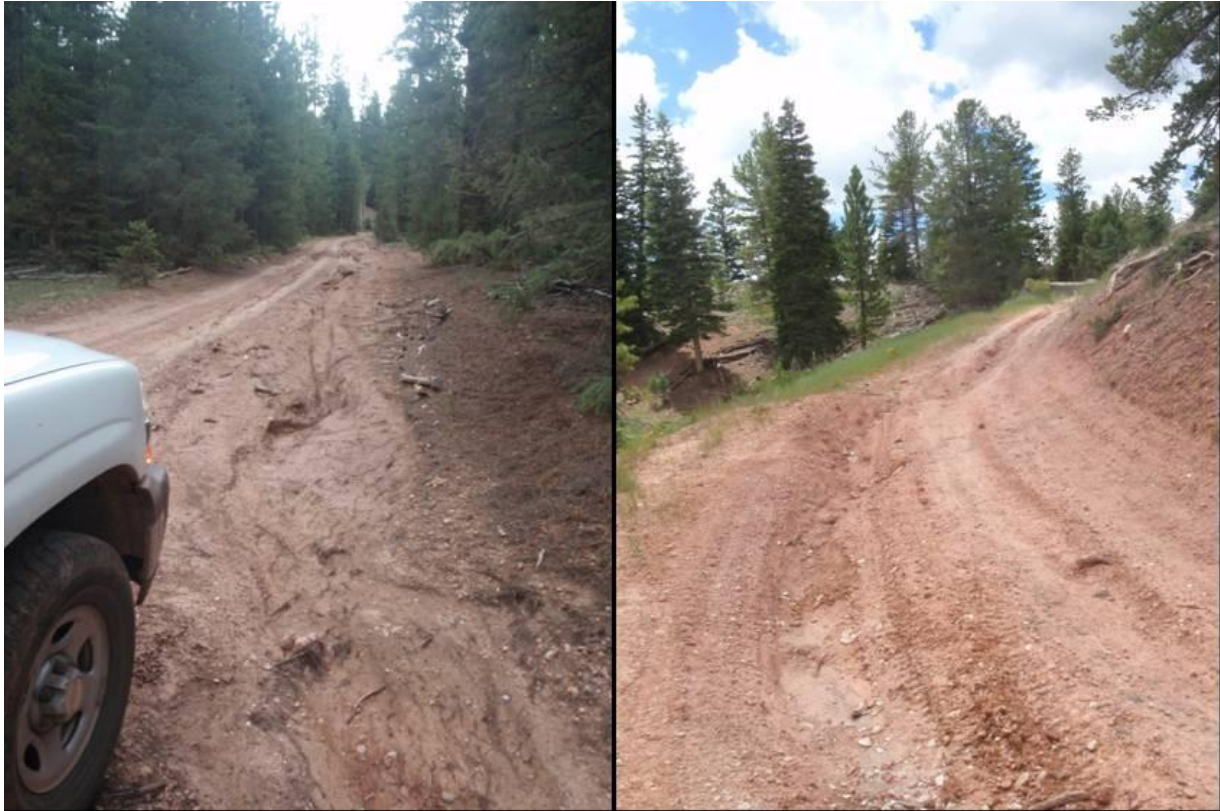
Figure 17: Typical control road conditions, post-storm.

The post-storm inventory took place in August, 2010. Sixty-three percent of the road was reported to be rilled or eroded, 17% was rocky, 13% was in good condition, and 8% was rutted. Typical conditions are shown in Figure 17.

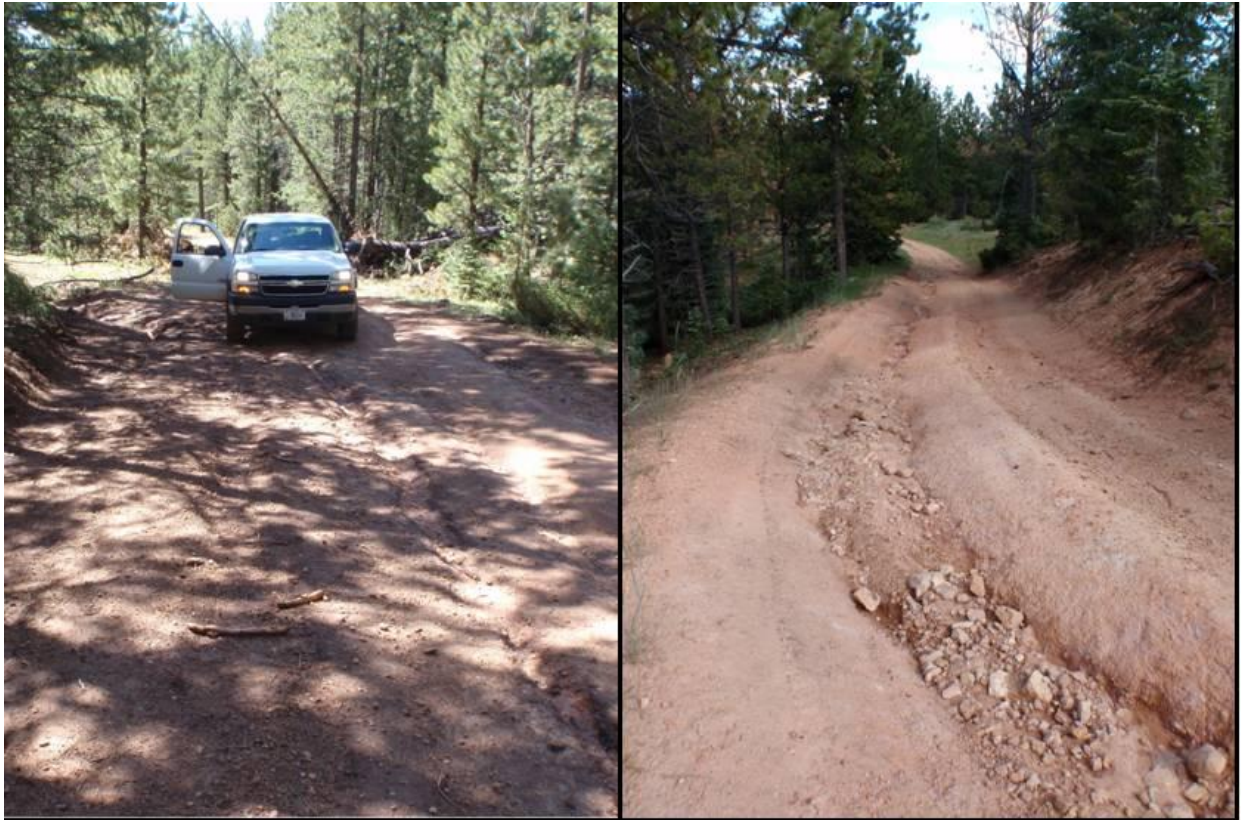
Figure 19: Typical control road conditions, post-season.

The post-season inventory took place in August, 2011. Fifty-one percent of the roads were found to be rilled or eroded, 46% were in good condition, 2% were rocky, and 1% were rutted. Typical conditions are shown in Figure 19.
