# Legacy Roads and Trails Monitoring Project

## Road Decommissioning in the Skokomish River Watershed

### Olympic National Forest

August 21, 2009

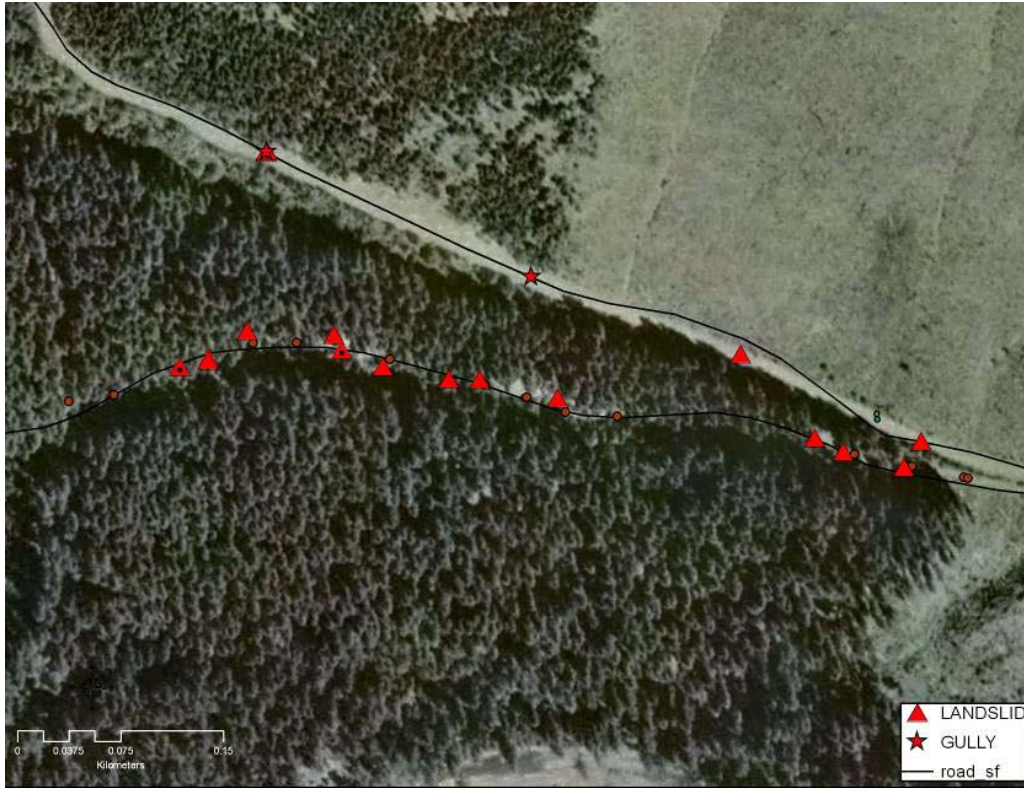
**Figure 4.** Landslide locations on road 2355-100. These were caused by several upslope roads that routed water and sediment through gullies.

The Skokomish area has a high incidence of shallow landsliding due to the combination of steep slopes and high rainfall. Landslide volume was estimated for all landslides visible from the road that are greater than a minimum threshold of 6 feet in slope length and slope width. The pre-treatment road inventory recorded 33 road related landslides: 12 cutslope failures with an estimated volume of 8,000 yd<sup>3</sup>, 19 fillslope failures totaling 92,000 yd<sup>3</sup> and a single hillslope failure that generated 39,000 yd<sup>3</sup>. One road contained the majority (13) of the landslides in the decommissioning study area. Many failures were related to gullies, landslides and diverted drainage from the two upslope roads, much of which occurred during the last decade (R. Stoddard personal communication) (Figure 4).

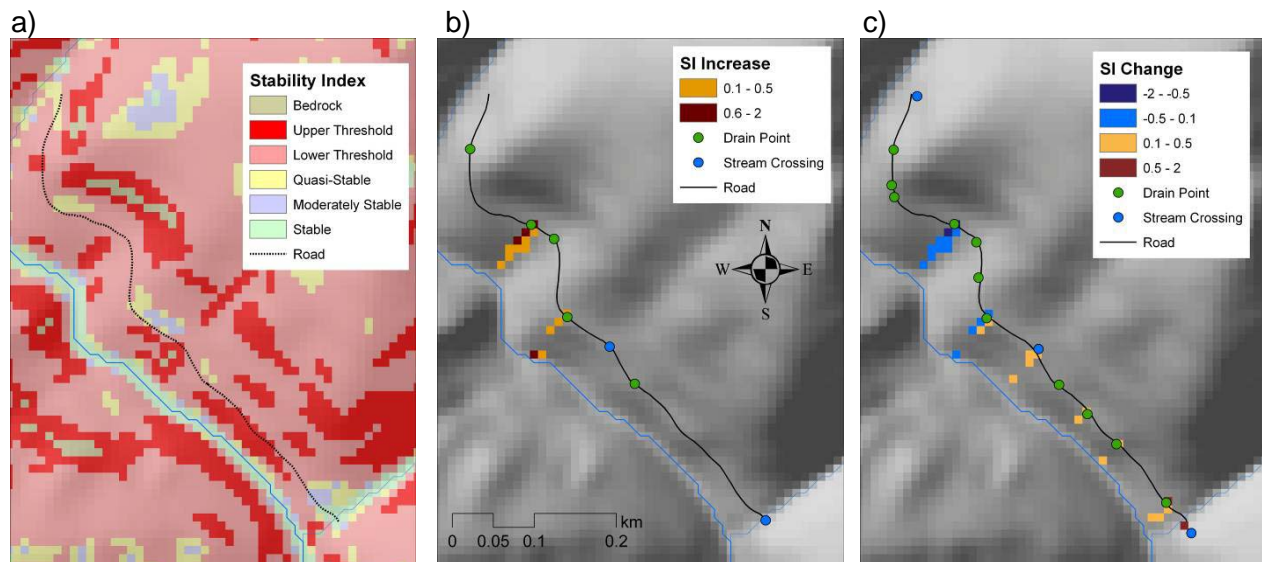
**Figure 5.** Stability index for hillslopes in the vicinity of road 2354-200.

a) SI values in an un-roaded condition. b) Increases in SI due to the addition of drainage from the original road. c) Difference in SI values between the original and decommissioned road. Orange and red colors indicate increased risk. Blue colors indicate lower risk.

The risk of shallow landslide initiation is predicted using SINMAP 2.0 (Pack et al., 2008, <http://hydrology.neng.usu.edu/sinmap2/>), modified to account for contributions of road runoff. An example from the 2354-200 road is shown in Figure 5 to illustrate the change in risk in an area where the inherent landslide risk is high. SINMAP was run initially to determine the intrinsic stability of the slopes over which the road traverses and to identify locations that are at high risk of failure without a road (Figure 5a).

A second stability index (SI) run was performed to address the effects of road water contribution to drain points on the original road network. The grid cells with increased risk of landsliding due to the original road drainage are shown in Figure 5b. This example illustrates the redistribution of intercepted groundwater to a waterbar that discharges to a swale. The swale location (shown in orange and red) was previously mapped as within the area of highest risk and the additional drainage expanded the area at risk of failure. Further down the road there was a non-engineered drainage feature that discharged to a concave slope position with high SI values. Below this point on the road there were two stream crossings and a non-engineered drain point that did not discharge enough water to change the stability. The landsliding risk was not increased in these areas because the water was mostly routed from the road directly to the channel, without impacting the hillslope.

A third model run was performed to illustrate the change in risk of shallow landsliding with the modified road drainage system resulting from the restoration treatments (Figure 5c). Three waterbars were added to the road above the high risk swale location. This resulted in a net reduction in risk at the pre-existing, non-engineered point due to a reduction in discharge. Further down the road, the addition of four new waterbars resulted in small localized increases in SI values as more water was added to steep locations. The net effect of the decommissioning treatments, which increased road drainage frequency, achieved the goal of reducing risk at the two highest risk locations in the sample area. However, risks were slightly increased in other locations because in steep, dissected terrain, it is difficult to redirect discharge from one location without elevating the risk in others. These findings are consistent with Madej (2001), who concluded that decommissioned roads in high risk areas commonly experience failures after treatment because their effects cannot always be fully mitigated.
