# Legacy Roads and Trails Monitoring Project

## Road Decommissioning in the Mill Creek Watershed

### Gallatin National Forest

April 2011

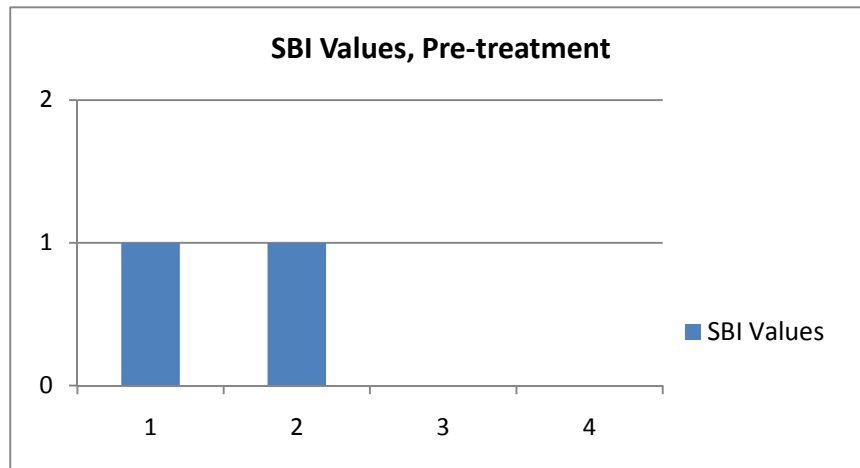
**Figure 10.** Distribution of Stream Blocking Index values for pre-treatment stream crossings. Values were zero after treatment.

The SBI values for the pre-treatment stream crossings were low to moderate with an average value of 1.5 for the two pre-treatment stream crossings (Figure 10). This is out of a range of 1 to 4, where 1 suggests no risk of blockage. Both stream crossing pipes were removed during decommissioning, which completely eliminated the risk of pipe plugging. Thus, the post-treatment SBI score was zero at all crossings.
