Legacy Roads and Trails Monitoring Project

Road Storage Treatment in the Suiattle River Watershed

Mount Baker-Snoqualmie National Forest

January 2011

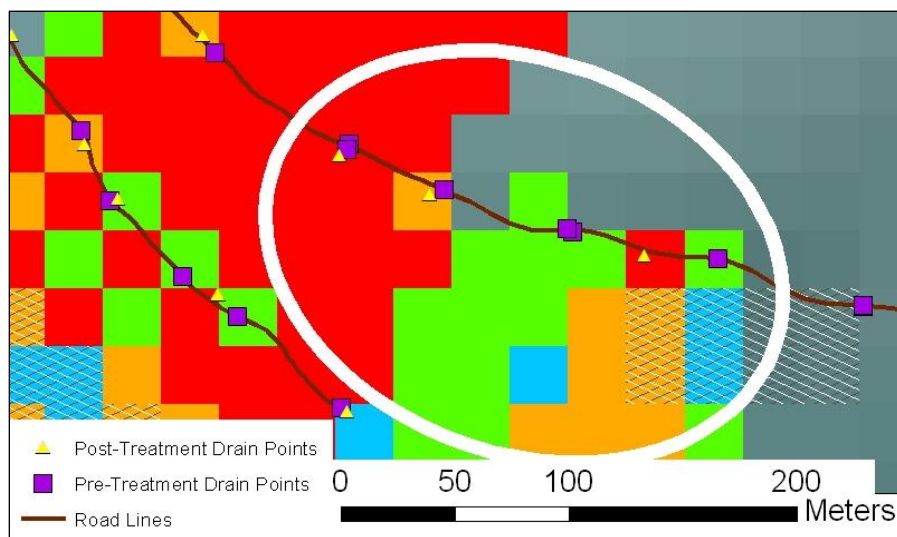
Figure 9. Portion of the 2650 lower road where water was rerouted from a steep slope, and landslide risk was displaced (white circle). The green and blue area below the purple pre-treatment drain points is where risk was lowered by the elimination of drain points by the treatment. The red and orange area below the yellow post-treatment drain points is where that water was rerouted to by the treatments. Most of this area fell into the stable category without considering any road drainage.

In locations such as this, where terrain is steep and landslide risk is already high without considering the additional water from the road, it is very difficult to fully mitigate the risk of landslides by adding or removing drain points. For example, on the 2650 lower road, a section of road was insloped to direct water away from an especially steep slope (Figures 9 and 10). This achieved the goal of reducing the risk to that portion of the slope, but the risk below the next drain point down, which drained the rerouted water from above, increased significantly.

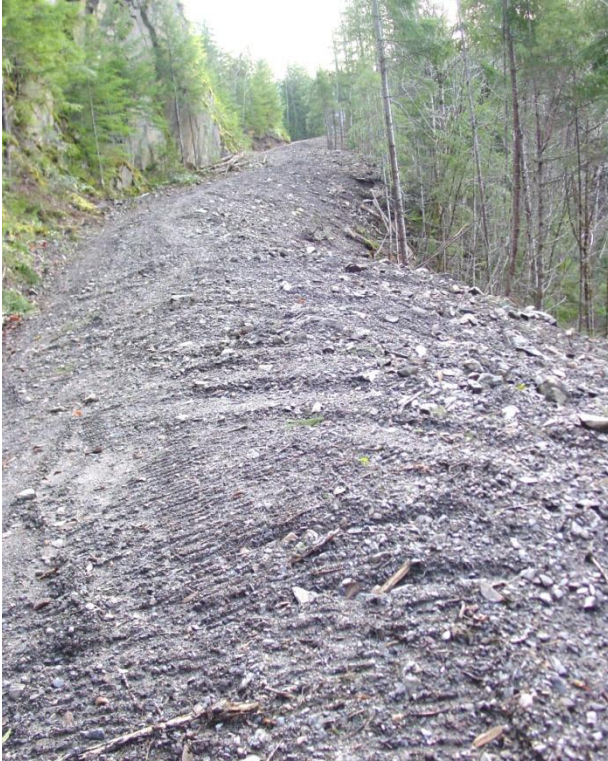
Figure 10. Insloping on Rd 2650, at the location shown in Figure 9, above.

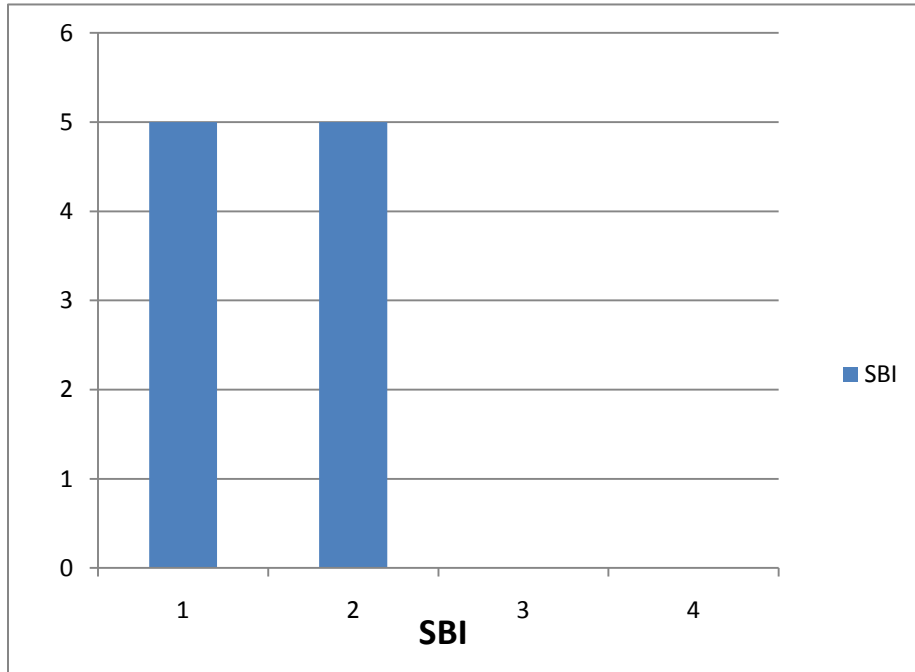
Figure 12. Distribution of Stream Blocking Index values for pre-treatment group.
