# Legacy Roads and Trails Monitoring Project

Storm Damage Risk Reduction in the Skokomish River Watershed

Olympic National Forest

July 12, 2011

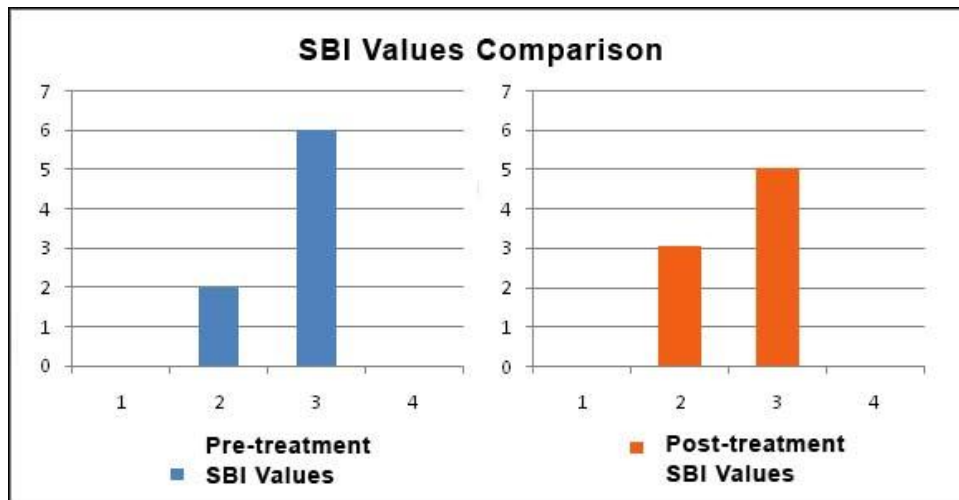
Figure 12. Distribution of Stream Blocking Index values for pre- and post-treatment groups.

The SBI values for the pre-treatment stream crossings were relatively high with an average value of 2.8 for the eight stream crossings (Figure 12). This is out of a range of 1 to 4, where 1 suggests no risk of blockage. The stream crossings with values of 3 all had culvert to channel width ratios of  $<1$  (the channel is wider than the culvert). Post-treatment SBI values were improved slightly, with one stream crossing that experienced a reduction in SBI from 3 to 2 through the installation of a larger culvert (24" diameter pre-treatment to 36" diameter post-treatment). On the 2361-600 road, a stream crossing culvert was upgraded from 48" to 72" (though the channel is still wider than the culvert), and an overflow culvert was installed at another. SBI only takes the largest culvert into account if there is more than one, so, although there is a likely reduction in overtopping risk, the SBI remains unchanged. This site also had a ditch dam and broad based dip installed, addressed below.

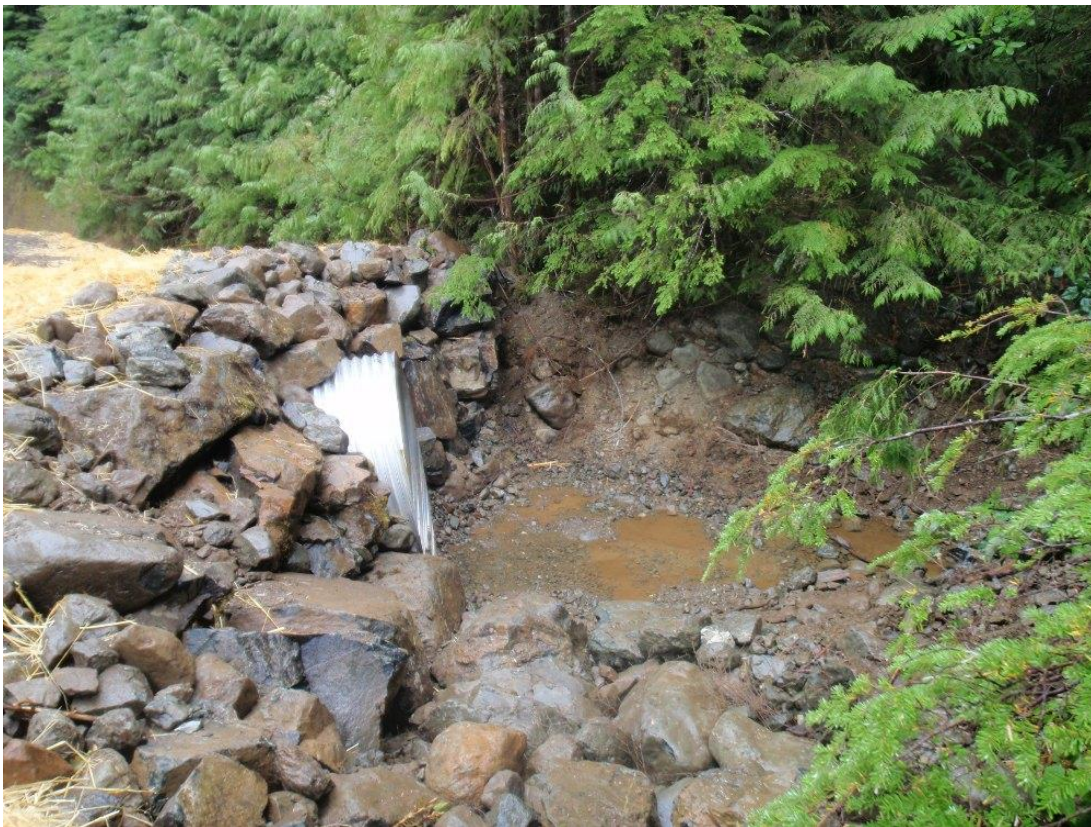
**Figure 13.** Stream crossing with large clast rip rap preventing the stream from diverting down the ditch.

potential to divert in two directions. At this site, 75% (6 of 8) of the stream crossings had the potential to divert streamflow down the road in at least one direction. In some locations, the road grade was modified to prevent flow from moving very far down the road, but since there is still potential for some reduced down-road flow, the diversion direction remains the same. At these locations, future diversions may discharge back into the native stream valley and into the stream, as opposed to discharging into a neighboring valley or swale, which could result in much more erosion as the stream water creates a new channel. At one stream crossing, large clasts were added on the downhill side of the crossing in the ditch to reduce the risk of diversion in the ditch (Figure 10). The diversion direction at this location is unchanged, because, in an overtopping event, the stream would ultimately flow down the road. However, it is likely that the diversion risk is nonetheless reduced by this treatment. Post-storm monitoring may verify this risk reduction as compared to untreated roads.
