Legacy Roads and Trails Monitoring Project

Road Decommissioning in the Granite Creek Watershed

Umatilla National Forest

April 2012

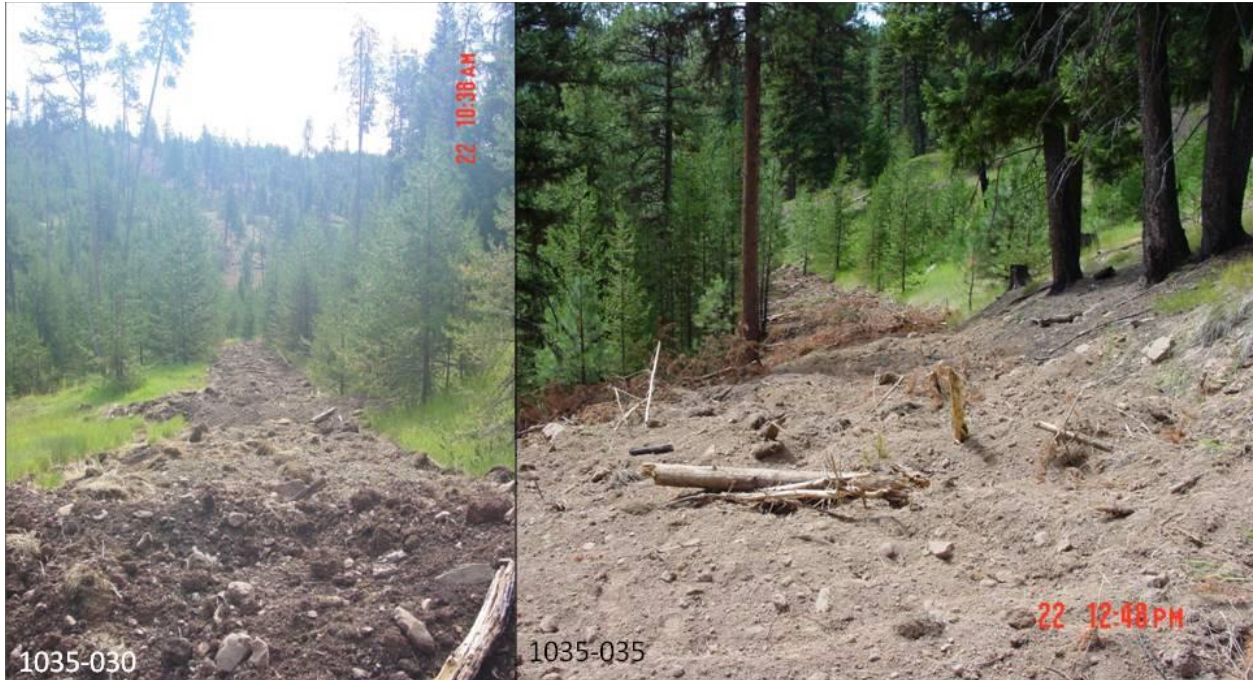
Several types of treatments were used to decommission roads in the Granite Creek watershed. About 83% of the treated roads was recontoured, 7.5% was ripped, and a further 8.8% was tilled. In addition, culverts were removed at stream crossings and ditch relief sites, and some water bars were constructed along ripped or tilled road sections. Typical treatments are shown in Figure 8.

Figure 8: Post-treatment road conditions. Ripped / tilled road on left; recontoured road on right.

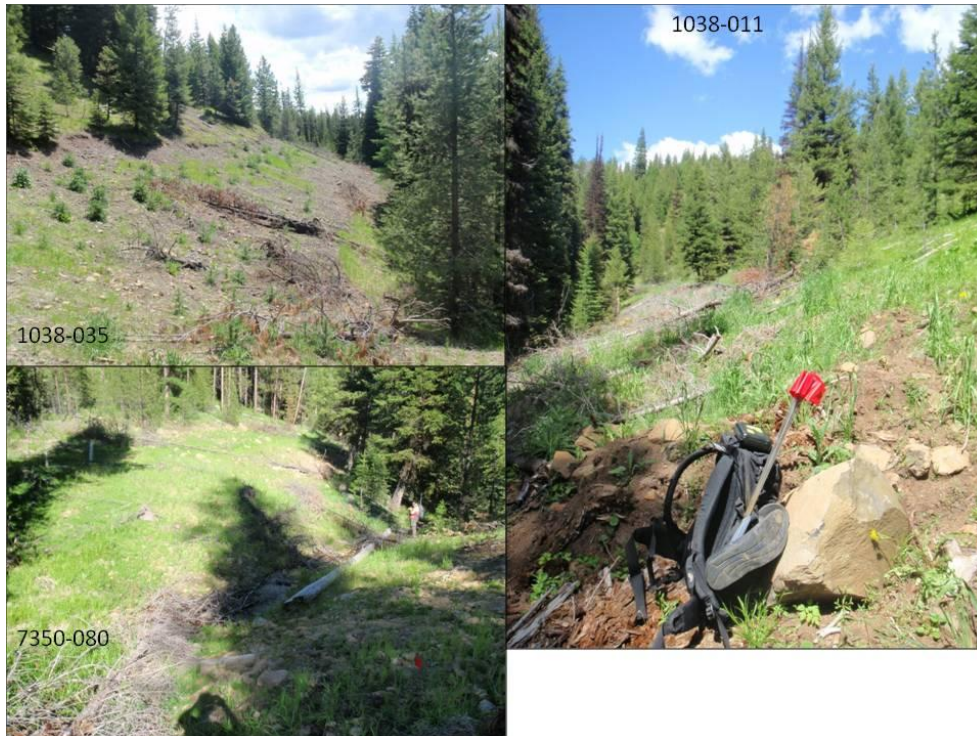
Following the storm event at the beginning of June, 2010, a crew re-inventoried the treatment and control roads. Increased vegetation cover likely contributed to reduced sediment production to 6.4 Mg/yr, though connectivity remained relatively high (16%). Typical conditions are shown in Figure 10.

Figure 10: Typical road conditions during the post-storm inventory. The section of the 1038-011 shown here (right) was connected to the stream during treatment.

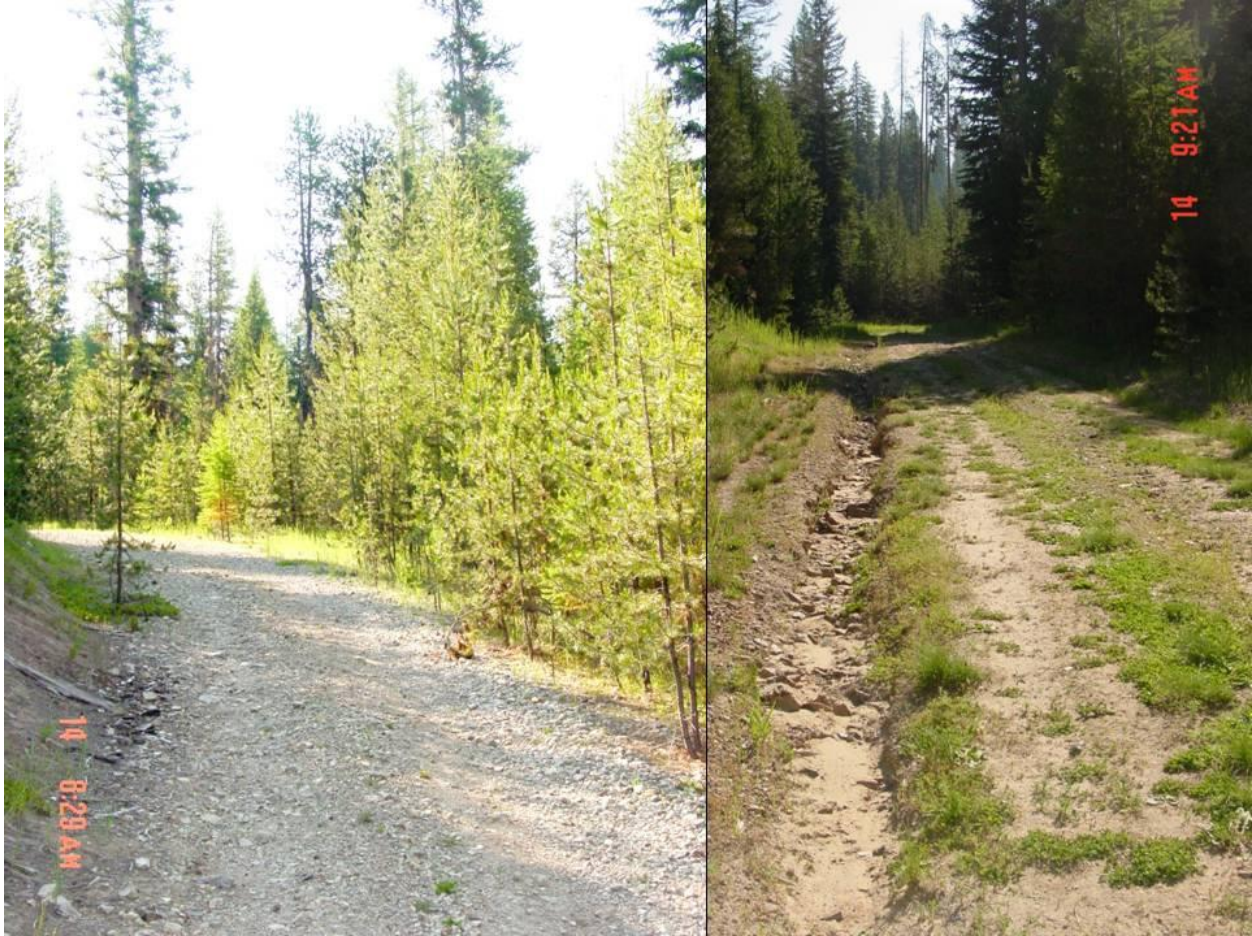
The control roads were selected and first inventoried at the same time the pre-treatment inventory was conducted for the treatment roads. The initial survey found that the majority (64%) of the road was in good condition; the rest was rutted (19%), rocky (12%), or rilled/eroded (5%). The majority (73%) of the road had a crushed rock surface; 26% of the road had native soil for surfacing and 1% was covered with herbaceous vegetation. Figure 12 shows typical conditions along the 7355-020 road; the 1038-031 had more vegetation.

Figure 12: Typical control road sections, pre-storm. Crushed rock surface on left; native surface with gullied wheel track on right. Both pictures from the 7355-020 road.

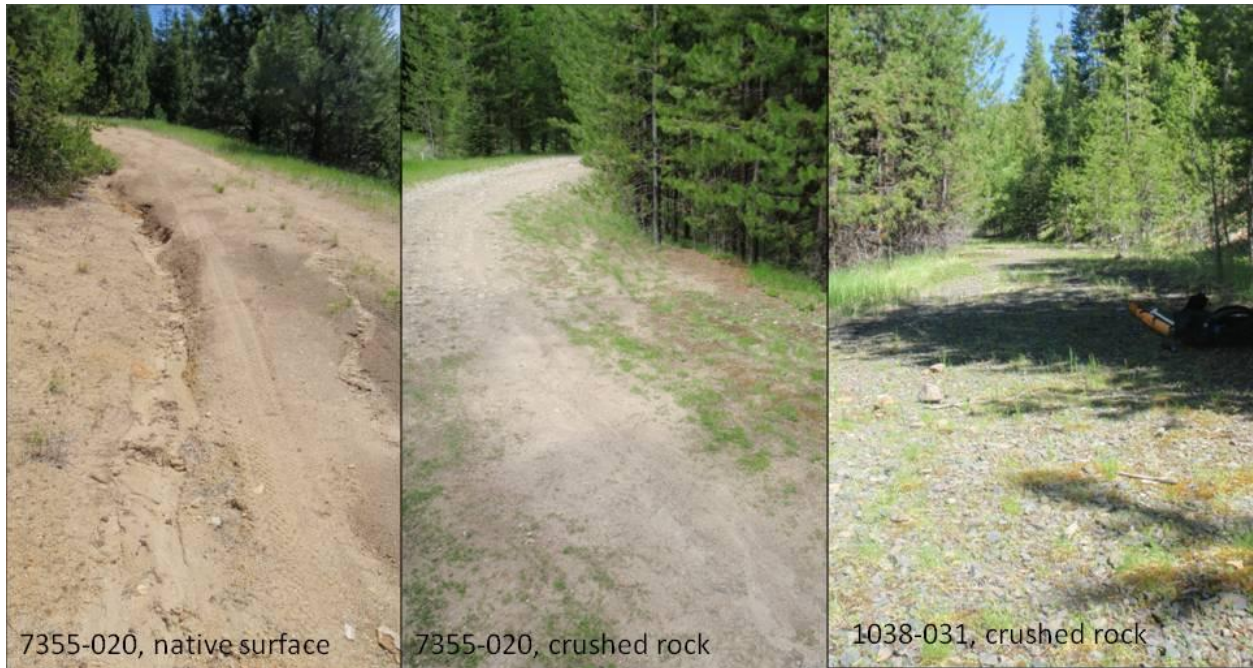
Figure 14: Typical control road conditions, post-storm.

The post-storm inventory took place in June, 2010. Sixty-five percent of the road surface was found to be crushed rock, with the remaining 35% surfaced with native soil. Eighty-seven percent of the road was reported to be in good condition, with 9% rilled/eroded and 4% rutted. Typical conditions are shown in Figure 14.

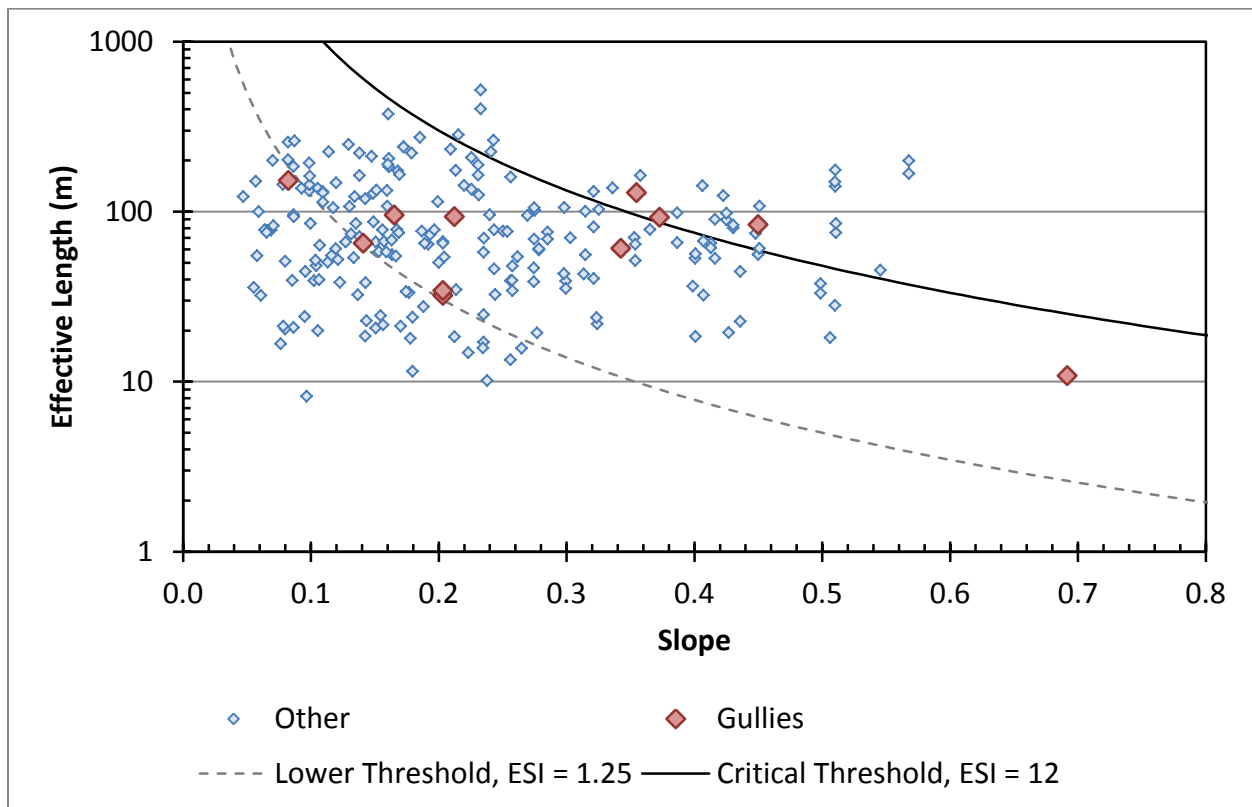
Figure 20: Slope-length plot showing gully risk and possible thresholds.

When calibration data for a site fits the expected pattern of longer contributing road length and hill slope at each drain point leading to a higher frequency of gullied drain points, ESI values for each drain point are calculated and compared to a critical ESI threshold (ESI_{crit}) to identify areas with a high risk of gully formation (i.e., where $ESI > ESI_{crit}$). ESI_{crit} is empirically-derived for each study area using inventoried gullies, and is the ESI value above which the risk of gully formation increases significantly. Data from the decommissioning project and the SDRR project, located in the same area, were used to determine the ESI_{crit} value for this study area, as both sites are intermingled. Diffuse drains, stream crossings, and orphan drainpoints are excluded from the ESI_{crit} determination. At this site, an ESI of 12 was determined to be the critical threshold; a lower threshold of 1.25 marks where gully formation becomes possible in locations that are pre-disposed to gully formation (Figures 20 and 21). There is an approximately 5% gully rate for drainpoints with ESI values between 1.25 and 12; above an ESI value of 12, the gully rate is approximately 10%.

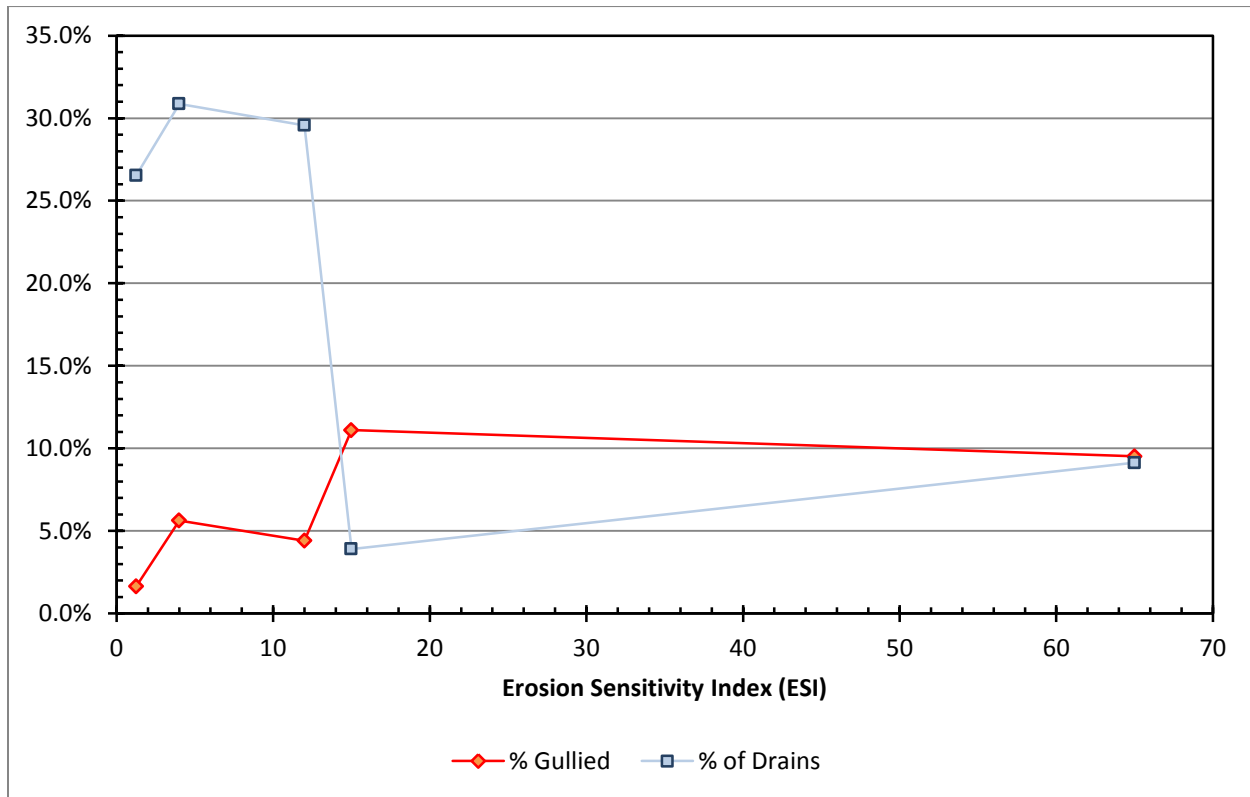
Figure 21: Percent of gullied drains and percent of all drains plotted against ESI. Note stepped behavior of percentage of drainpoints with gullies.

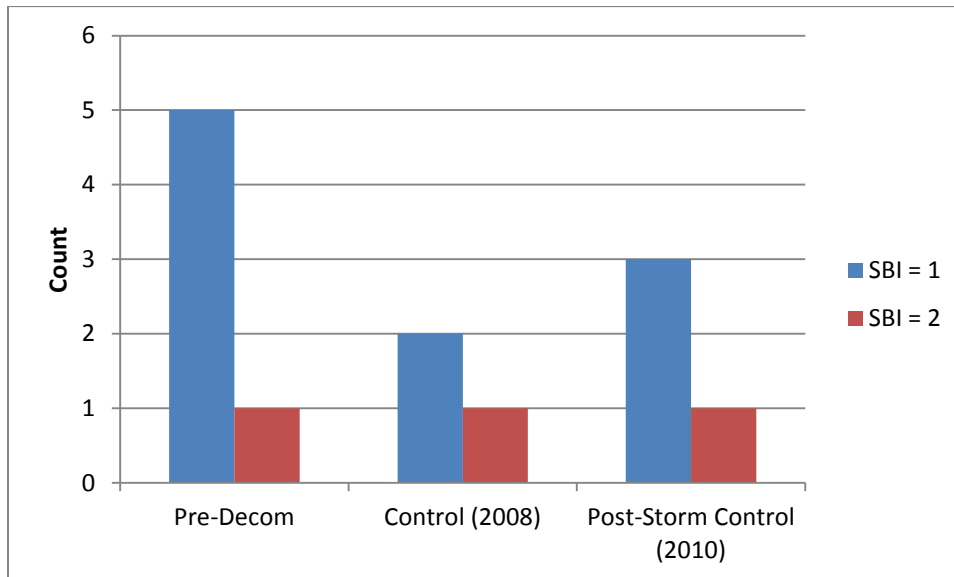
Figure 22: SBI values for pre-treatment and control roads.

The SBI values for the pre-treatment stream crossings along the treatment roads were low with an average value of 1.2 for the 7 pre-treatment stream crossings (Figure 22). SBI has a range of 1 to 4, where 1 suggests no risk of blockage. SBI only applies when there is an open culvert present; the one log culvert was already plugged with woody debris. All stream crossing culverts were removed during decommissioning treatments, which completely eliminated the risk of pipe plugging. Thus, the post-treatment SBI score was zero at all crossings. Average SBI values at stream crossings along the control roads were 1.33 in 2008 and 1.25 in 2010; in 2010 one additional crossing was identified with an SBI of 1 while the SBI values at the other three crossings remained the same.

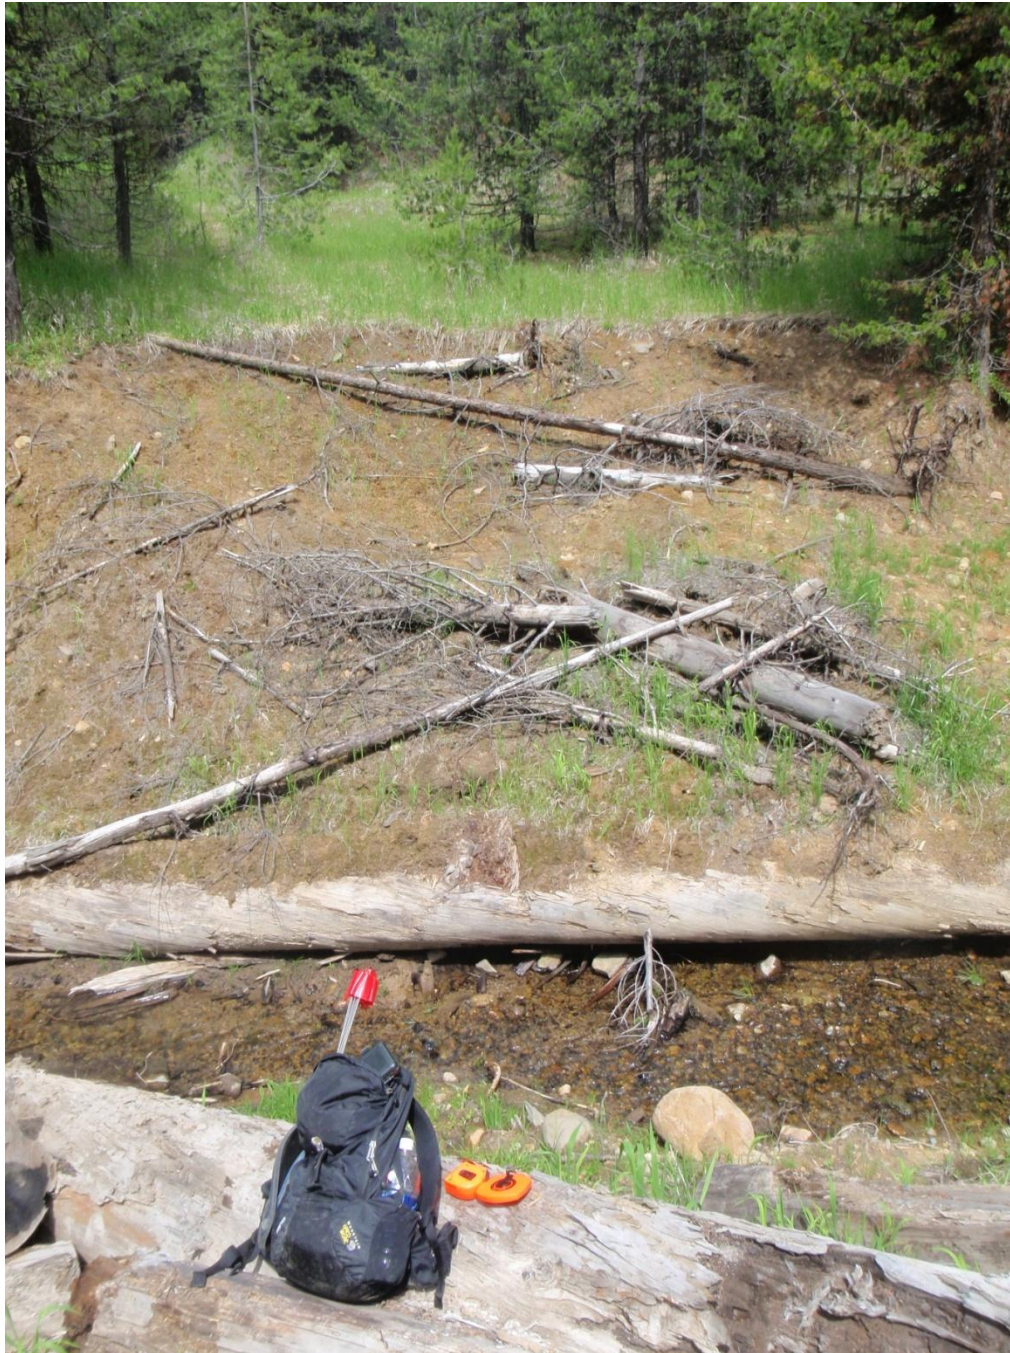
Prior to treatment, non-engineered drains and stream crossing culverts were observed to have the highest rate of problems (86% and 29%, respectively), while diffusely drained road segments were least likely to have problems (Table 13). While no problems were reported during the post-treatment inventory in 2008, one of the excavated stream crossings had a problem with a landslide in the sideslope of the excavation following the storm event (Figure

23). One water bar had caused 19 ft³ of fill erosion following the storm event. The overall problem rate dropped from 11% (pre-treatment) to 2% (post-storm).

Figure 23: Excavated stream crossing with log placed to prevent erosion. The field crew recorded a landslide in the sideslope of the excavation at this location.
