# Monitoring Road Decommissioning in the Mann Creek Watershed Payette National Forest

April 27, 2010

US Forest Service  
Rocky Mountain Research Station  
322 East Front Street, Suite 401  
Boise, Idaho, 83702

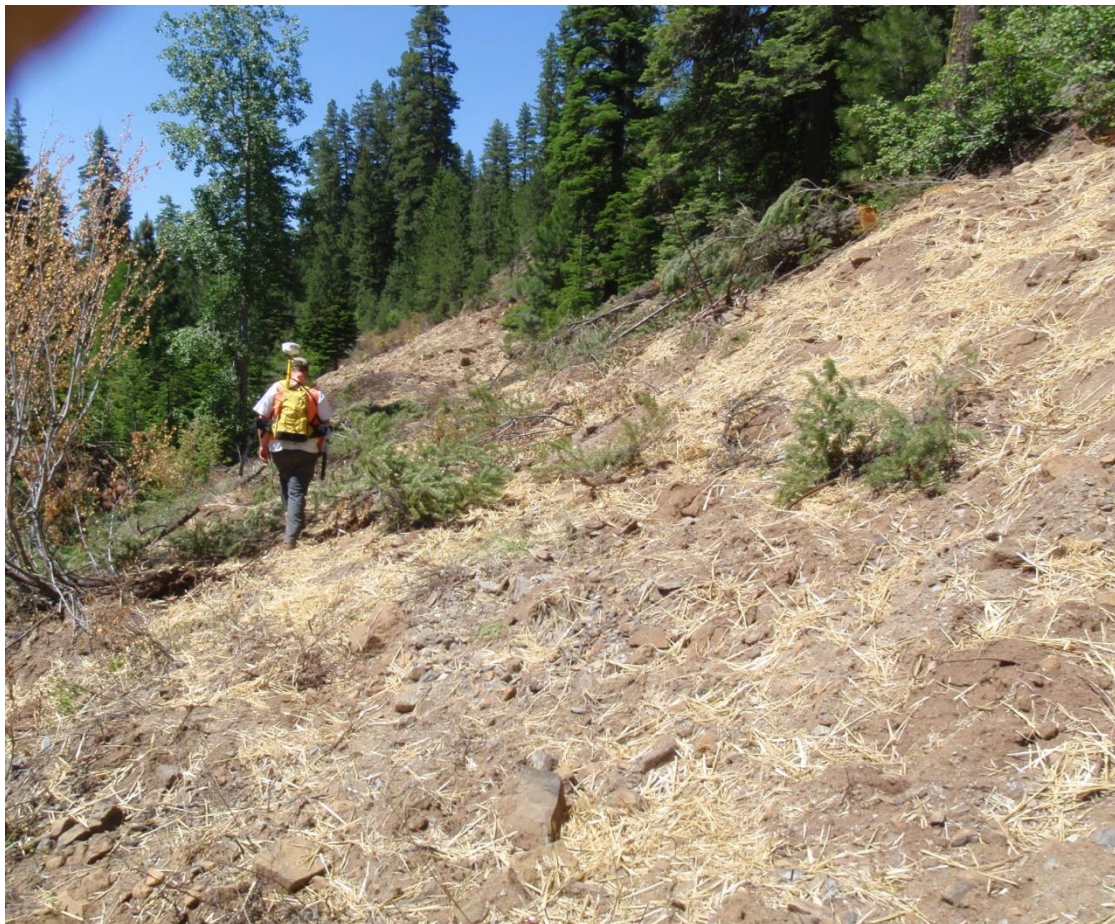
**Figure 4.** Photo of a typical rocky, fully recontoured road with straw mulch.

Decommissioned roads in the Mann Creek watershed were, for the most part, recontoured (Figure 4), though some short sections were tilled. The recontoured surface is intended to mimic the natural hillslope hydrology and result in increased infiltration and diffuse flow and minimized surface drainage from the road. A heavy application of straw was applied in addition to the use of locally available organic matter and transplant material. The disturbed, recontoured surface is likely to generate higher sediment production prior to revegetation; however, the disturbed surface is substantially disconnected from the stream network. Without the previous stream connections, the decommissioned roads do not deliver nearly as much sediment (Table 4). Nineteen (29%) of the drain points were found to be connected to the stream network. However only five of these nineteen drain points are likely to actively deliver sediment due to the redesign and treatment; the other fourteen are orphans. The total sediment delivered is reduced to 1 tonne/year (2% of the sediment delivered before treatment).

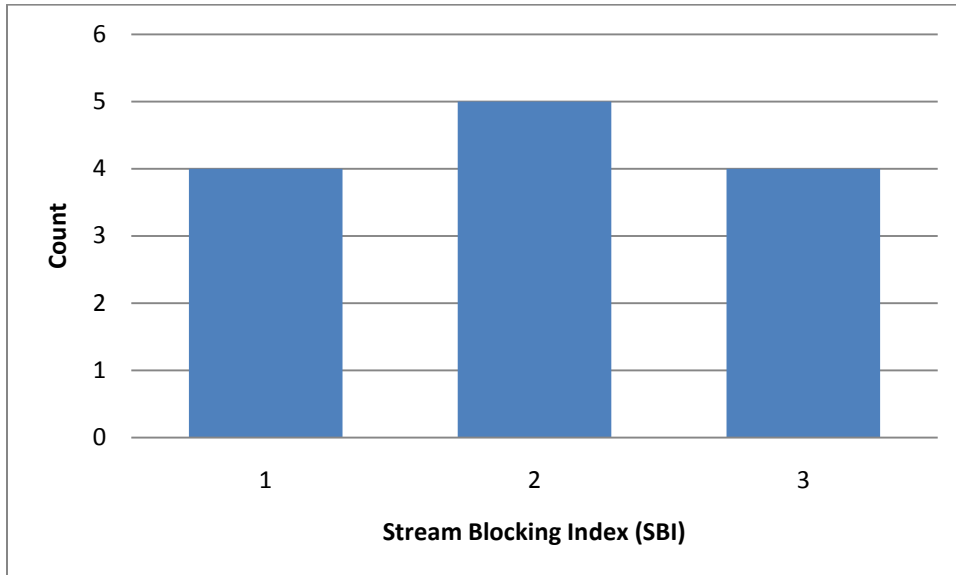
**Figure 7.** Distribution of Stream Blocking Index values for pre-treatment group. Post-treatment values were zero for all sites.

The SBI values for the pre-treatment stream crossings were relatively high with an average value of 2 for the 13 stream crossings (Figure 7), not counting one excavated crossing. This is out of a range of 0 to 4, where 0 suggests no risk of blockage and values of 3 or 4 indicate a high

risk of blockage. The stream crossings with value of 3 all had culvert to channel width ratios of <1. All 13 stream crossing pipes were removed during decommissioning, which completely eliminated the risk of pipe plugging (Figure 8). GRAIP calculates an SBI of 0 for crossings without a pipe.

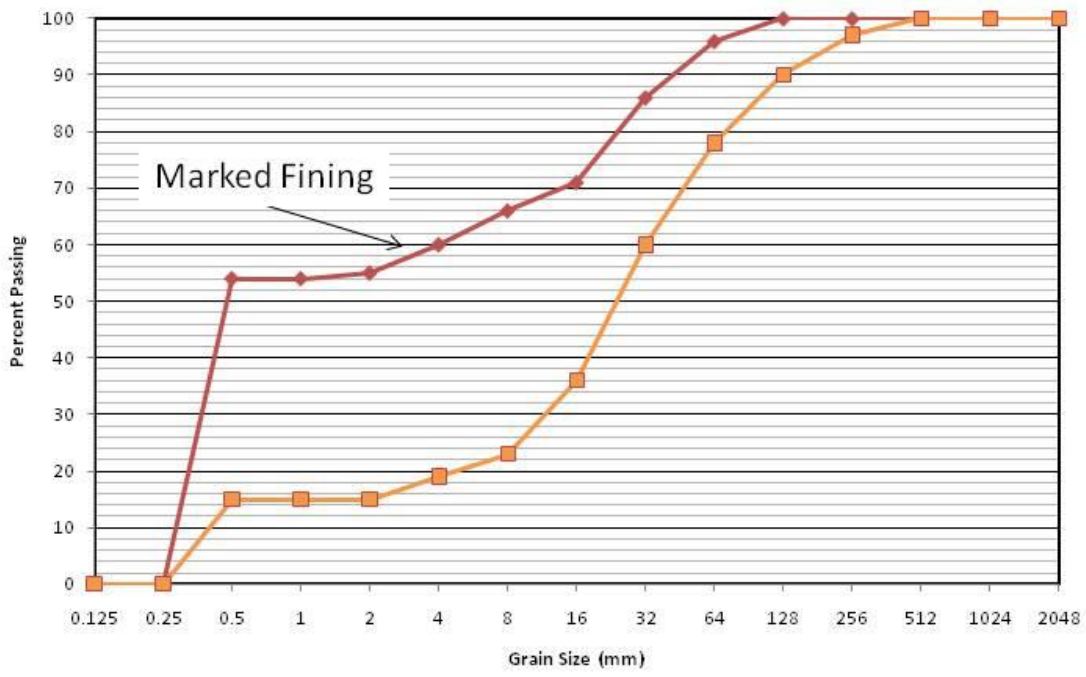
**Figure 9.** Examples of stream bed grain-size distributions. Top: The crossing shows marked fining of sediments compared to the upstream reach. Bottom: Possible armoring occurring with marked fining.

Measurements of channel slope and sediment characteristics can be used to evaluate how well the excavated crossing mimics the natural channel characteristics. Most of the excavated crossings show some fining of bed materials compared to the upstream reach (Table 7; Figure 9), though the D84 increased at four of the stream crossings. Since the material at these excavated crossings appears the same as on adjacent recontoured road segments, it is likely that the armoring effect is not intentional; armoring may prevent excessive incision or lateral erosion at the crossing. We would expect that over time, grain size distributions will shift toward those recorded in upstream reaches as fine sediment is removed.

Three of the crossings were found to have channel slopes that differed from upstream channel slopes by 5% or more. In all three cases, measured slopes in the crossing are less than those observed upstream. Such crossings may be prone to greater amounts of incision as the stream adjusts its bed.

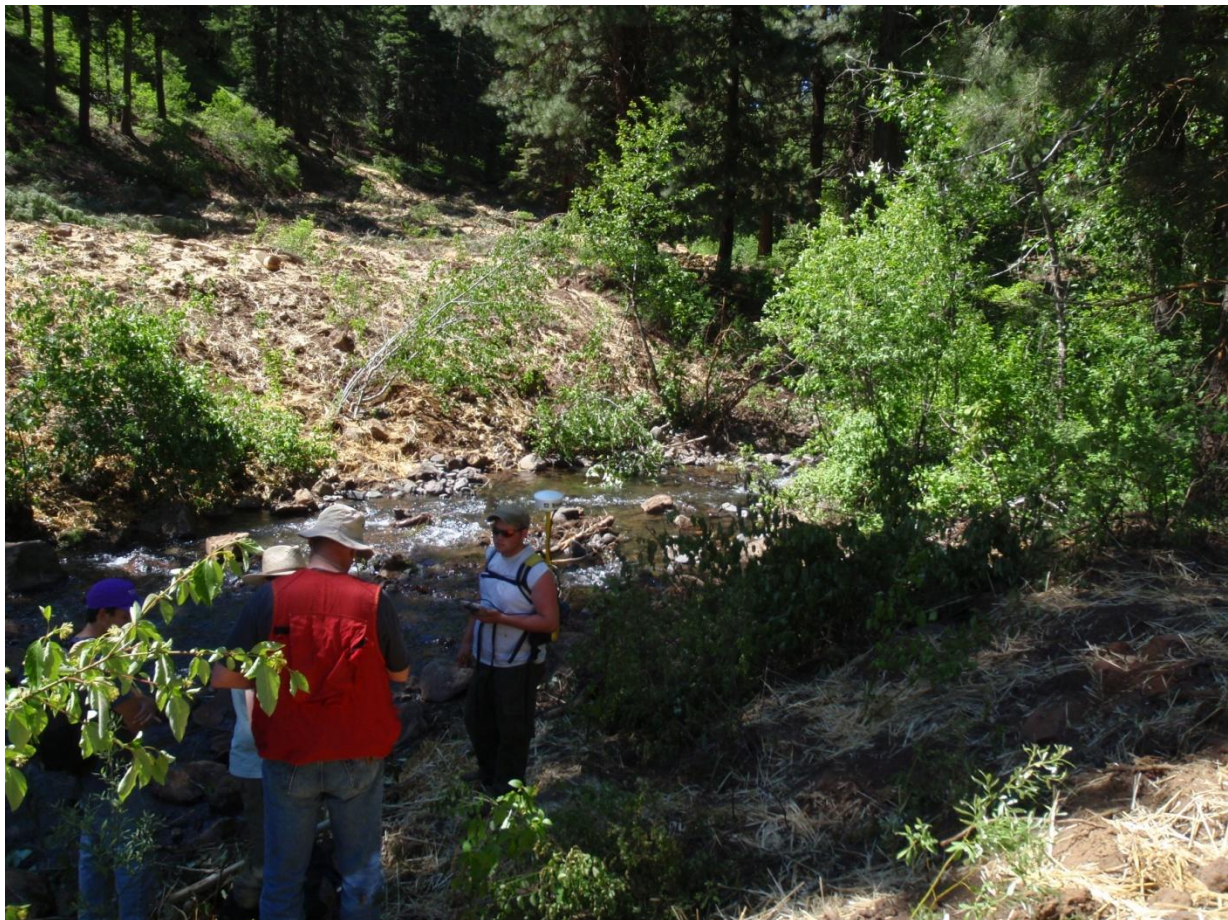
**Figure 10.** Example of an excavated stream crossing.

GRAIP field crews also took more detailed measurements at excavated stream crossings during the post-treatment assessment. These metrics include the length and grade of side slopes, Wolman pebble counts both in the crossing and in an upstream reach, and measurements of mass-wasting volumes, if any. These measurements are intended to provide baseline metrics against which the amount and type of future stream crossing adjustment can be gauged.
