# Monitoring Road Decommissioning in the Mann Creek Watershed: Post-storm Report Payette National Forest

February 14, 2011

Nathan Nelson<sup>1</sup>, Richard Cissel<sup>1</sup>, Tom Black<sup>1</sup>, and Charlie Luce<sup>2</sup>

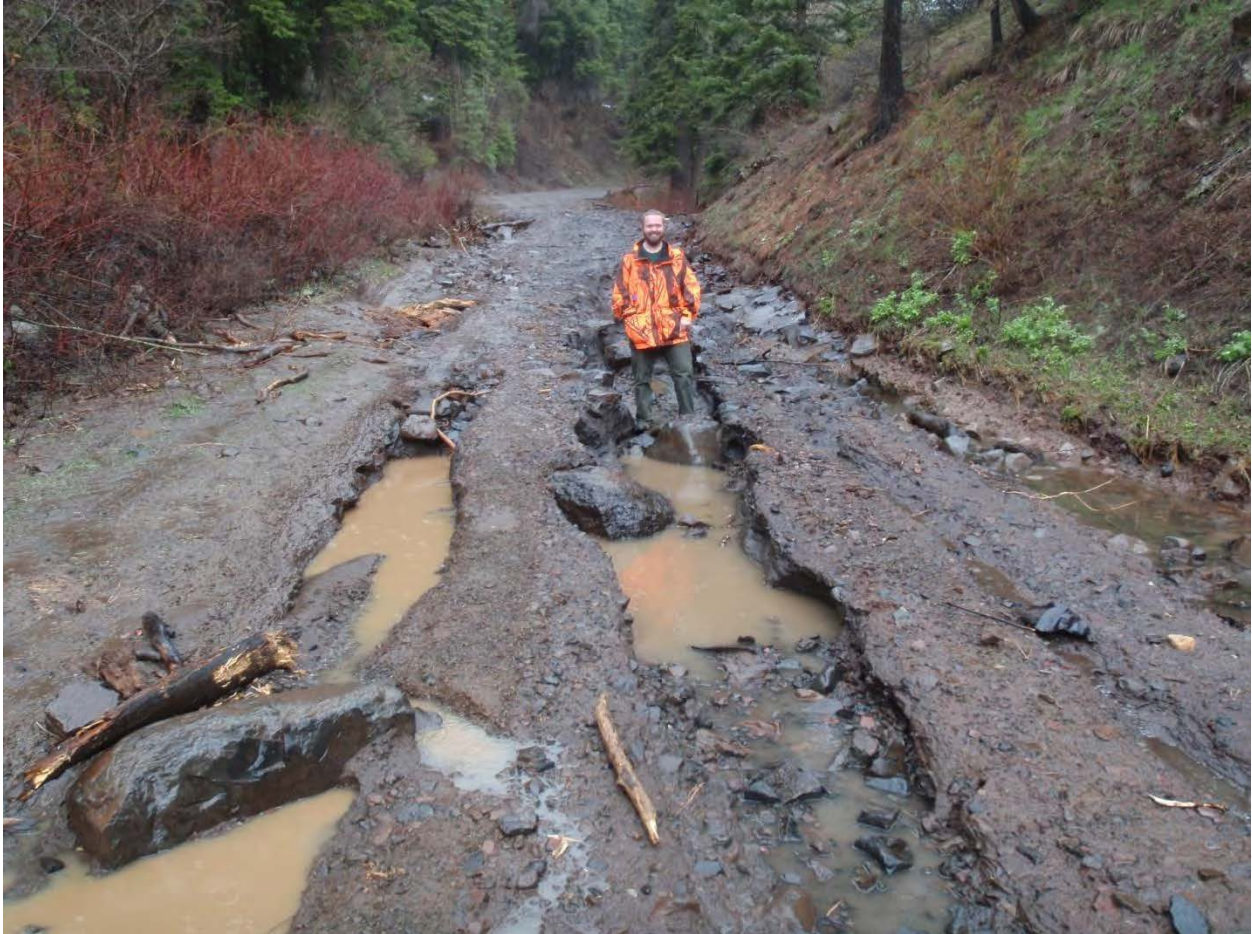
**Figure 3:** Damage from the April storms. The author is standing in a gullied wheeltrack where flood water was diverted down the road from the stream crossing behind the author's head.

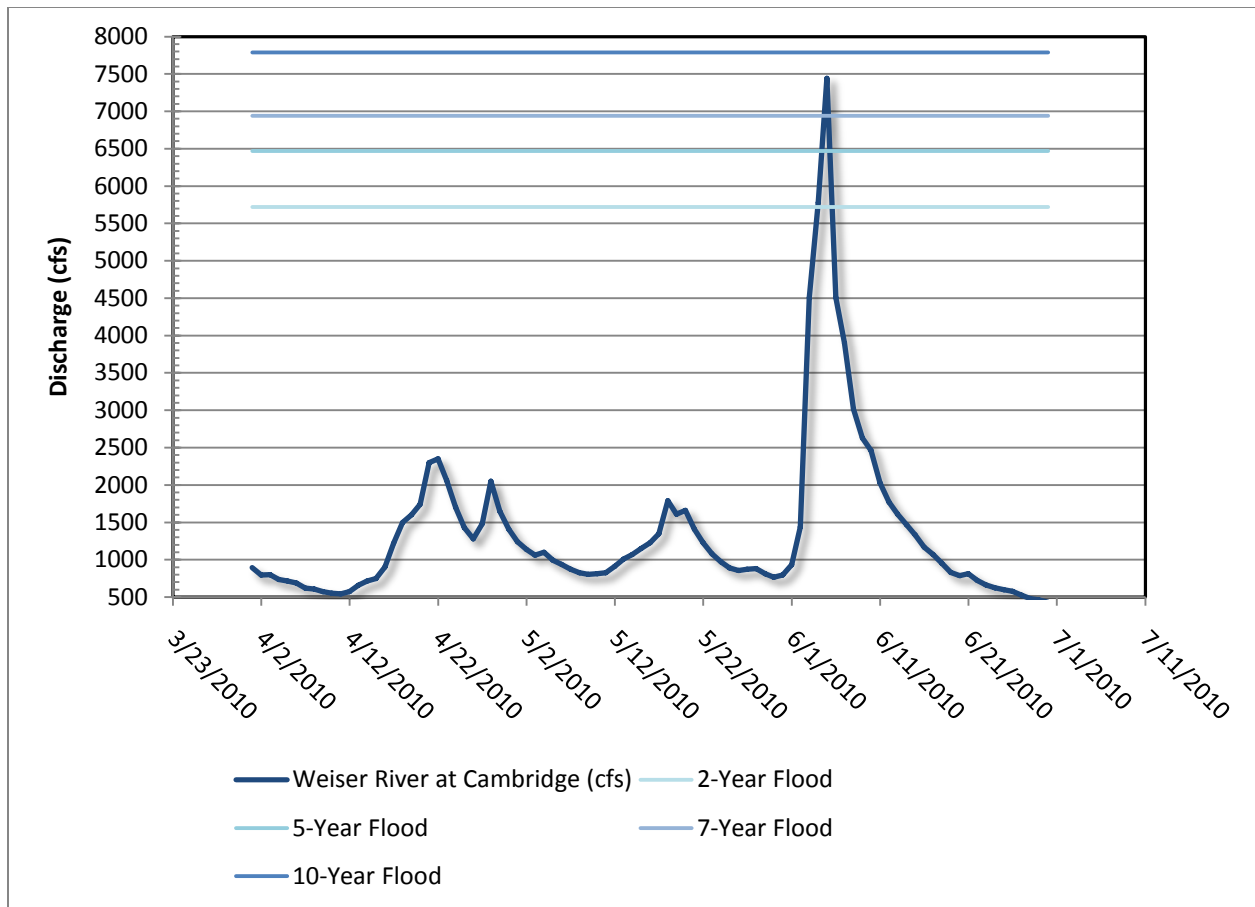
Figure 4: Wieser River hydrograph.

On June 2, 2010, a strong series of thunderstorms passed through the area. These storms brought heavy rains over a ripe snow pack, and even though the precipitation intensities have less than 5 year recurrence intervals, the resulting floods, measured at the USGS gage in Cambridge, Idaho, have a recurrence interval of ~8 years (Figure 4). The river crested at 7,440 cfs on June 5.

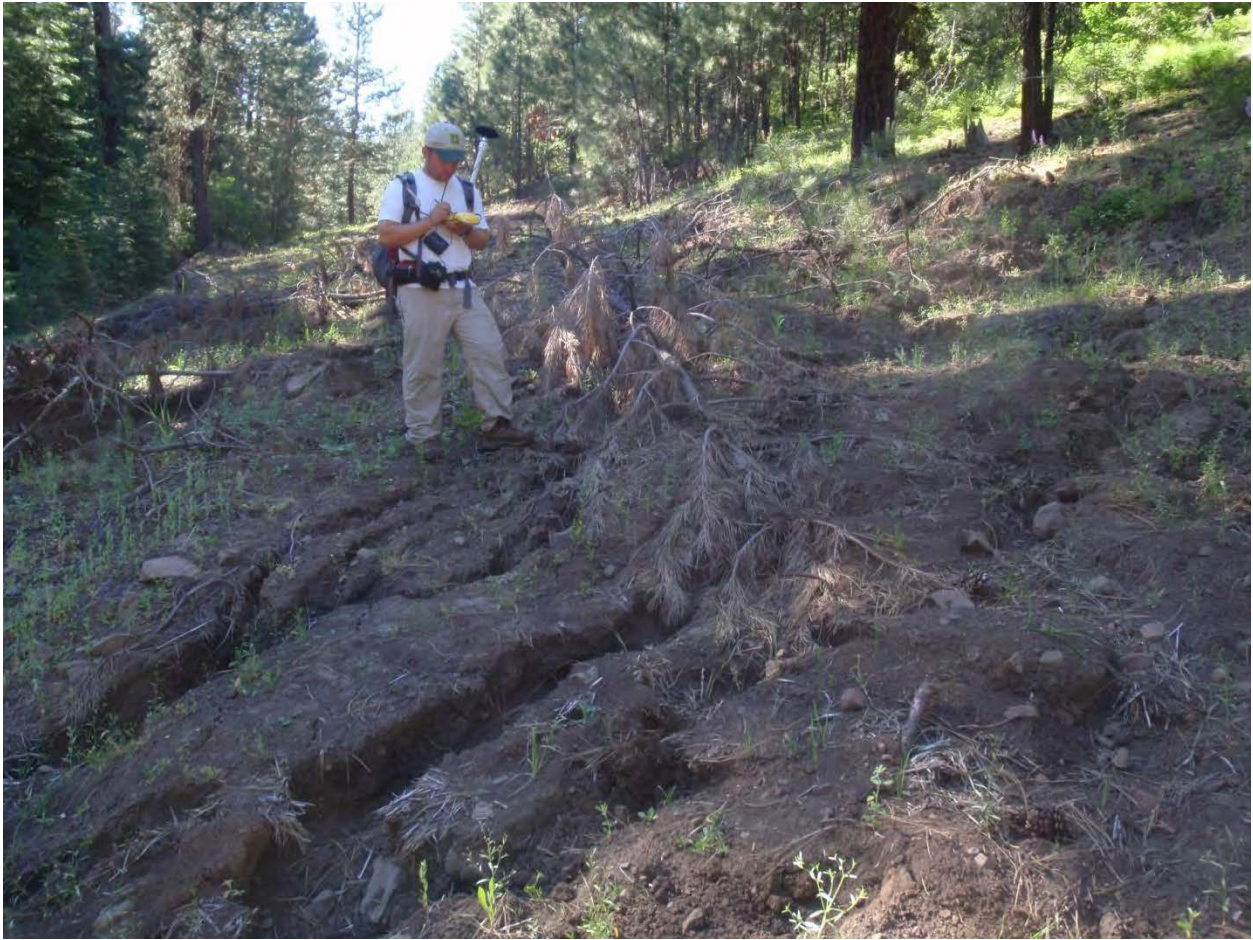
Crews surveyed the decommissioned roads in late June and early July to determine what changes were caused by the storms. Most storm-related damage consisted of rills and small gullies in the recontoured surface (Figure 5); these rills were, with few exceptions, limited to the fill material and did not extend onto the hillslope below the recontoured road. Where these met size criteria for gullies, eroded sediment volumes were estimated and recorded. Most of these rills and gullies were concentrated between 4,500 and 5,000 ft elevation. The estimated volume of these rills and gullies is 600 ft<sup>3</sup> (~28.6 metric tons). This type of erosion was expected given that the recontoured roads consisted of unconsolidated fill with less vegetation than surrounding hillslopes.

**Figure 5:** Rills and small gullies on the recontoured road surface.

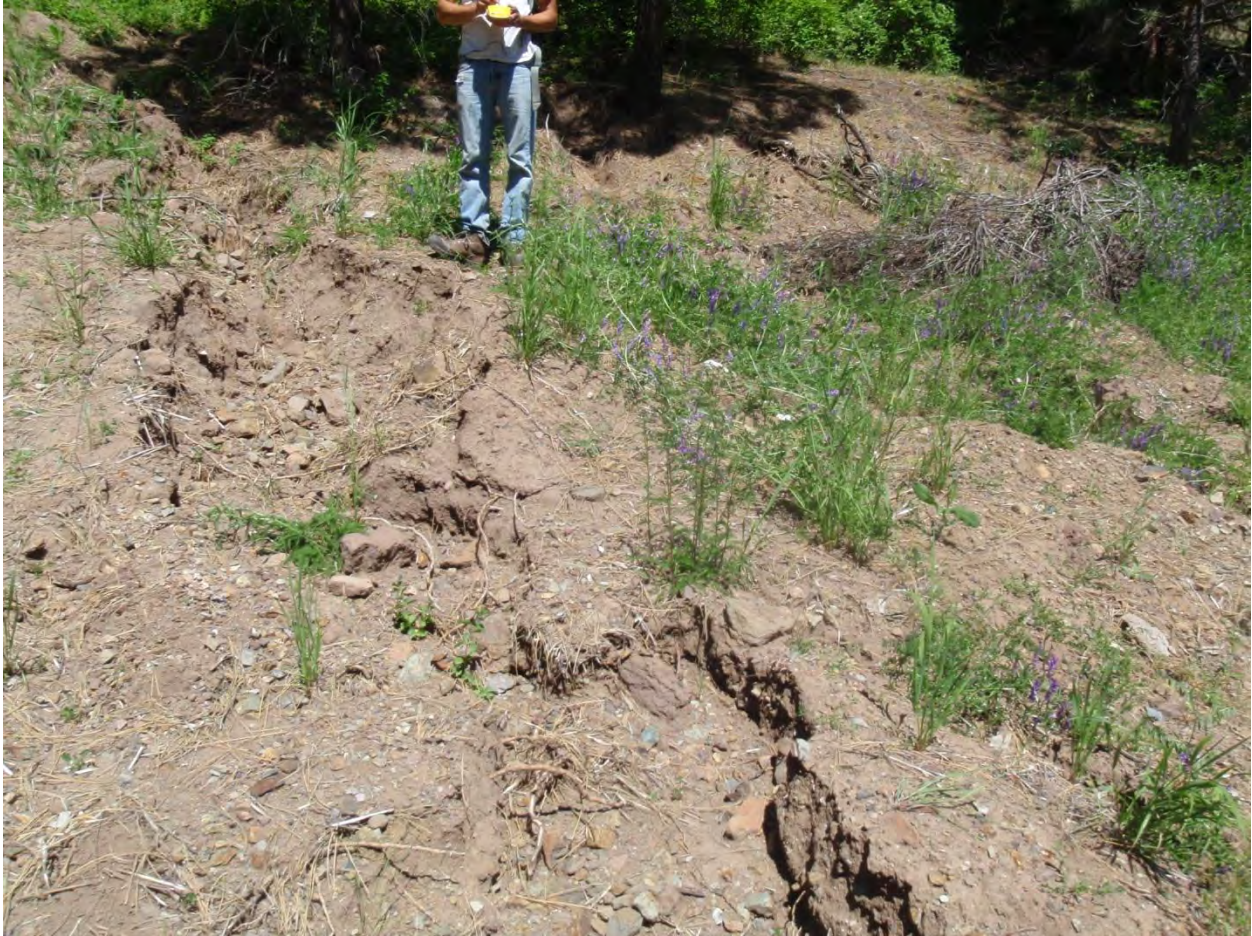
Crews found one gully that extended beyond the recontoured surface where the road crossed a swale (Figure 6). They also found two small landslides where recontoured fill had slumped

**Figure 6:** Gully crossing recontoured road.

Following the storm event, only one gully was located along the treated roads and nine gullies were recorded along the control roads. All of these were new gullies. The gully found along the treatment roads (along the decommissioned 50019) is located where a wet swale crosses the road and likely delivered concentrated flow during the storm event. This gully begins just

above the recontoured road and extends onto the hillslope just below recontoured road. It has a volume of  $\sim 17 \text{ ft}^3$ .

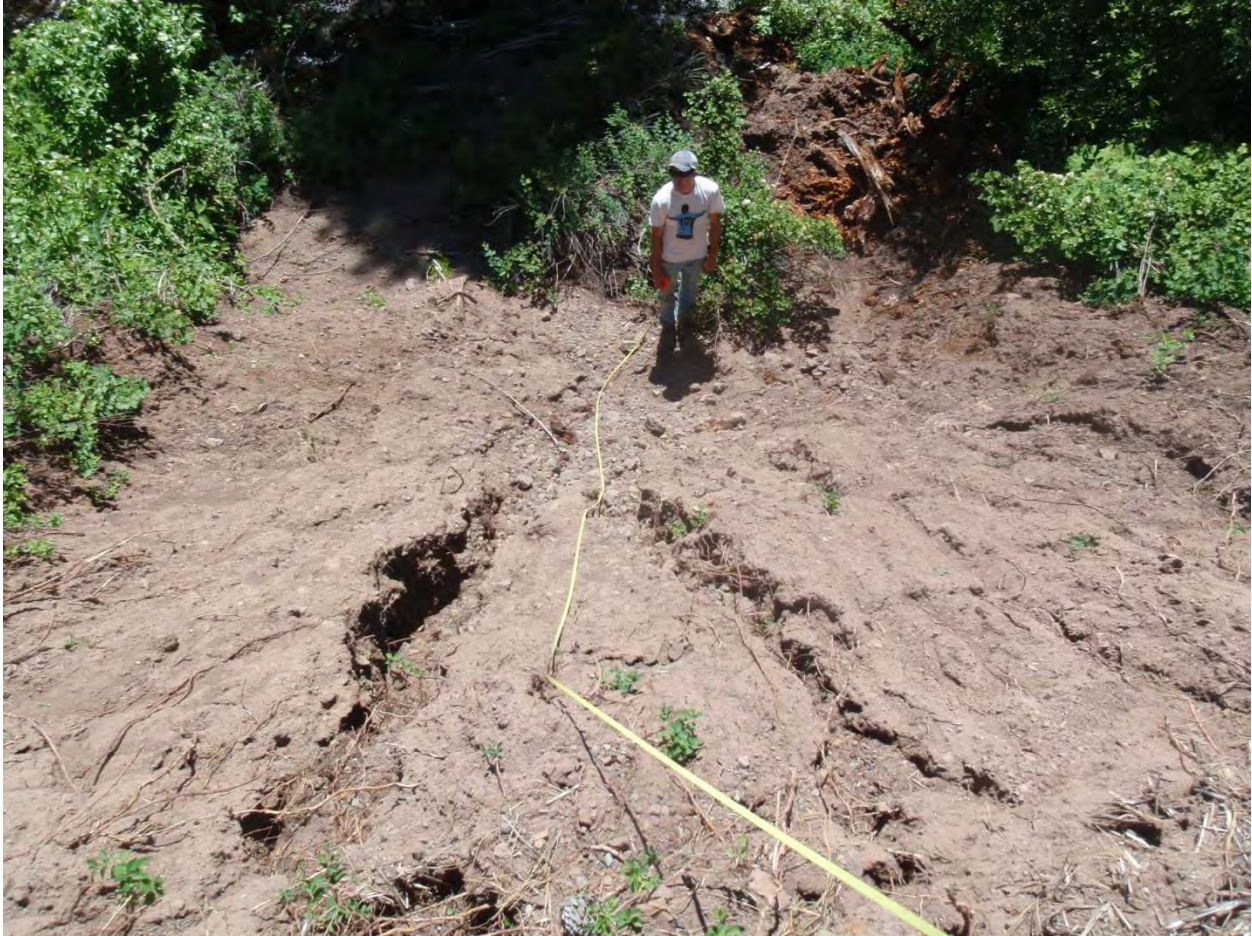
(Figure 7). The combined estimated volume of the gully and both landslides is  $\sim 6,000 \text{ ft}^3$  ( $\sim 286$  metric tons).

**Figure 7:** Slump in recontoured fill. View is from top of scarp.

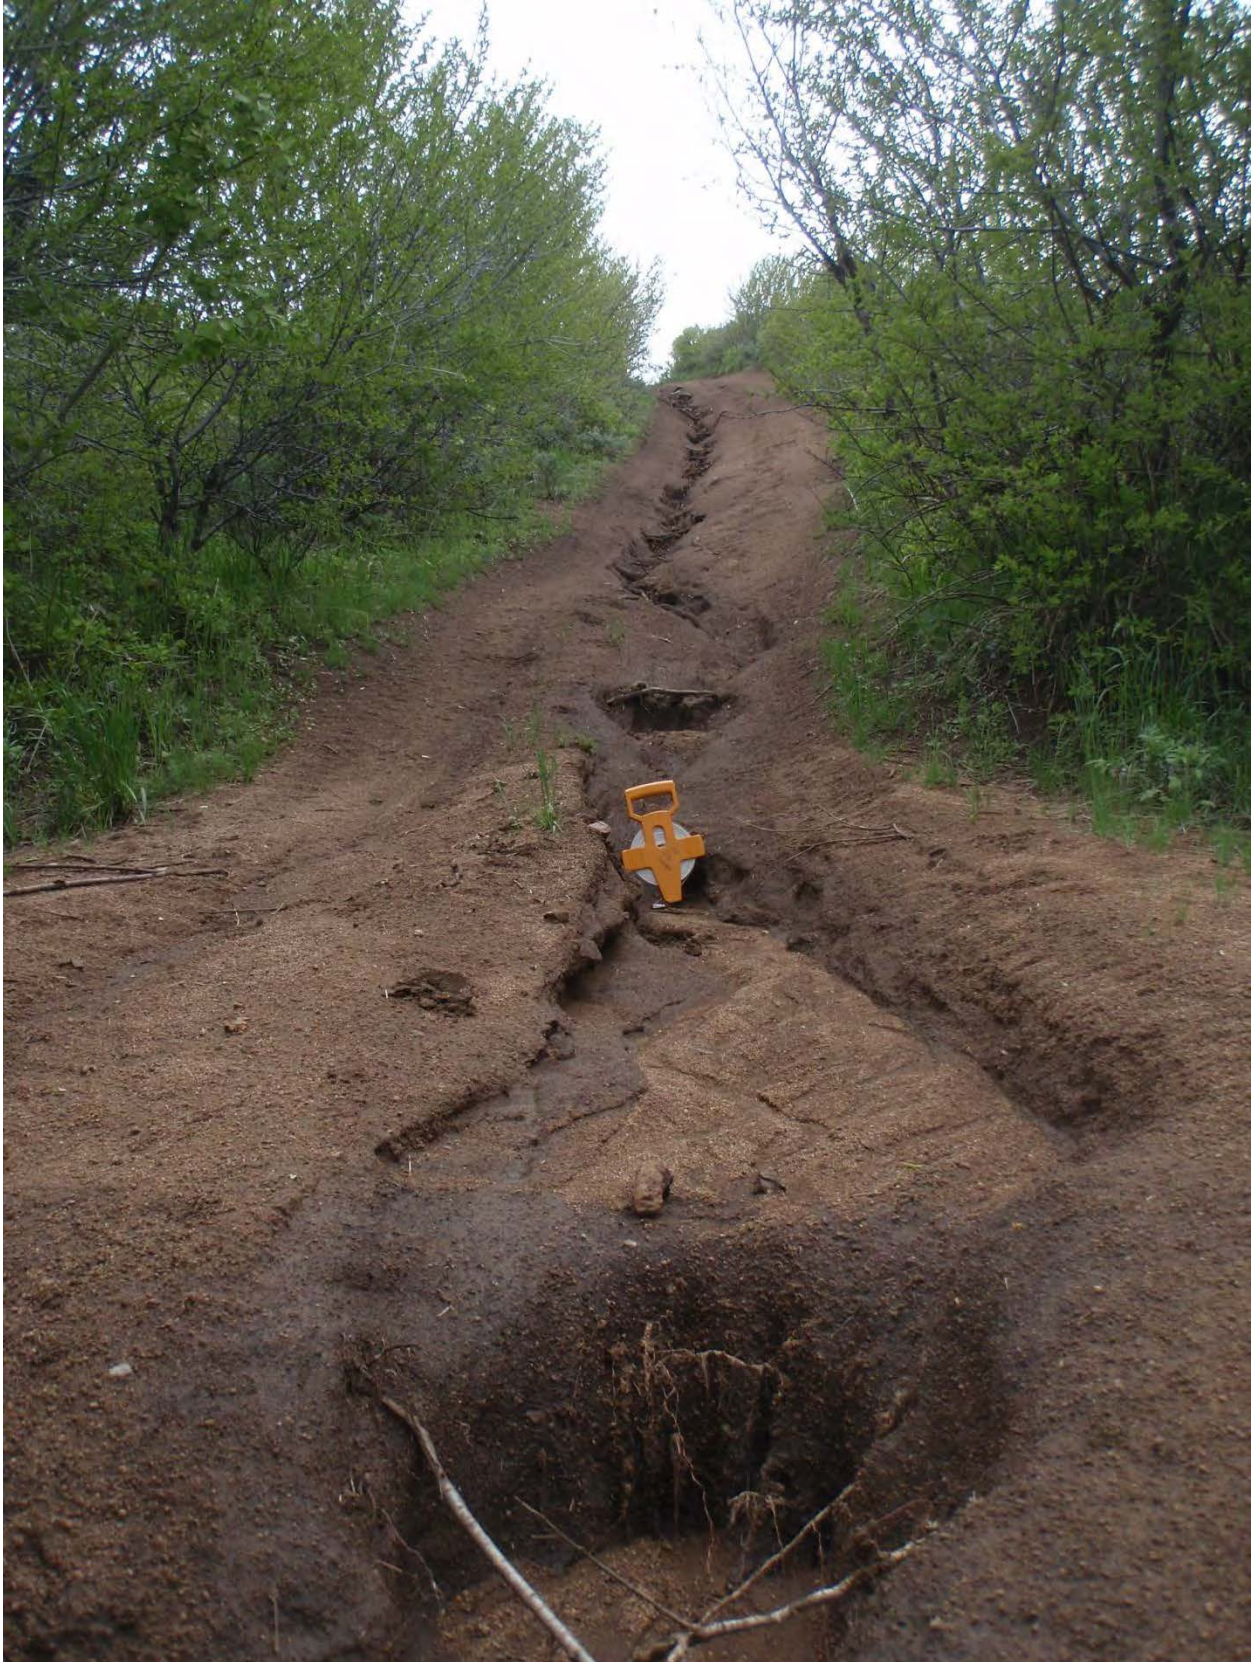
**Figure 8:** Gullied flowpath on control road 500100500.

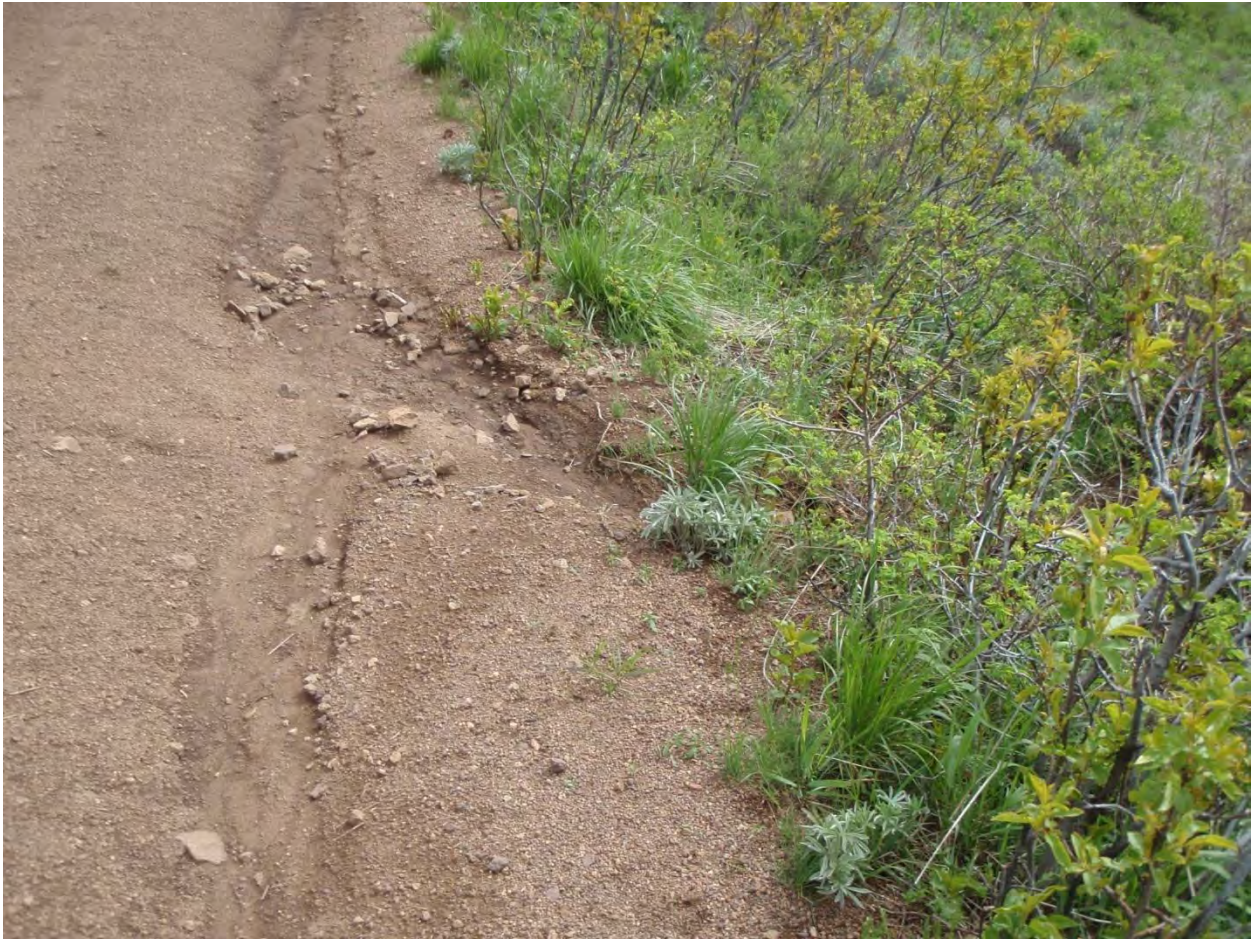
**Figure 9:** Non-engineered drain formed along control road.

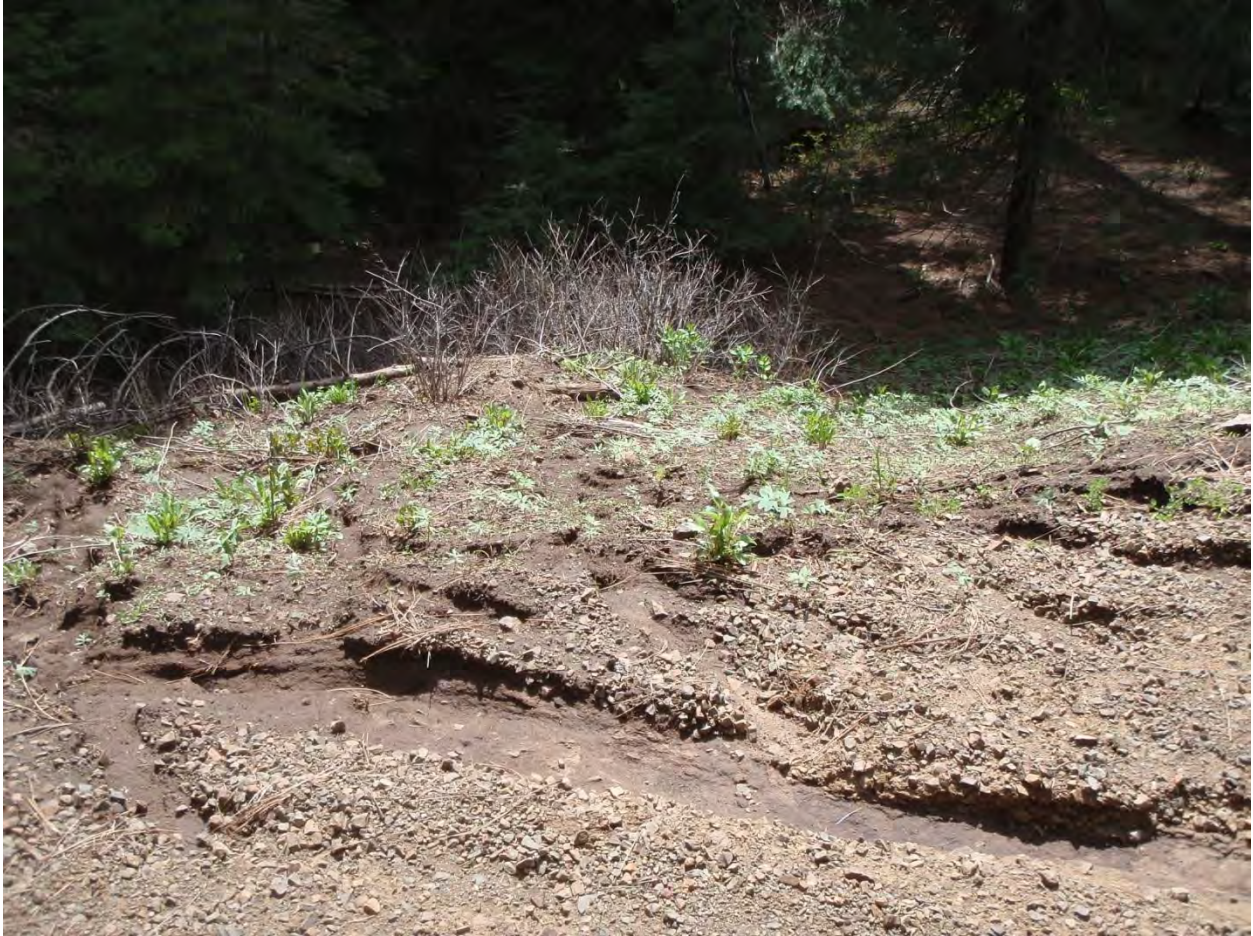
**Figure 10:** Gully and rills along control road. These extend from the road surface across the fill and onto the hillslope below.

Nine gullies were located along the control roads. All of these gullies extend across the road fill slope onto the hillslope below the road and initiate at drain points (two ditch relief culverts and seven non-engineered drains) along the road. The total volume of these gullies is  $\sim 103 \text{ ft}^3$ .

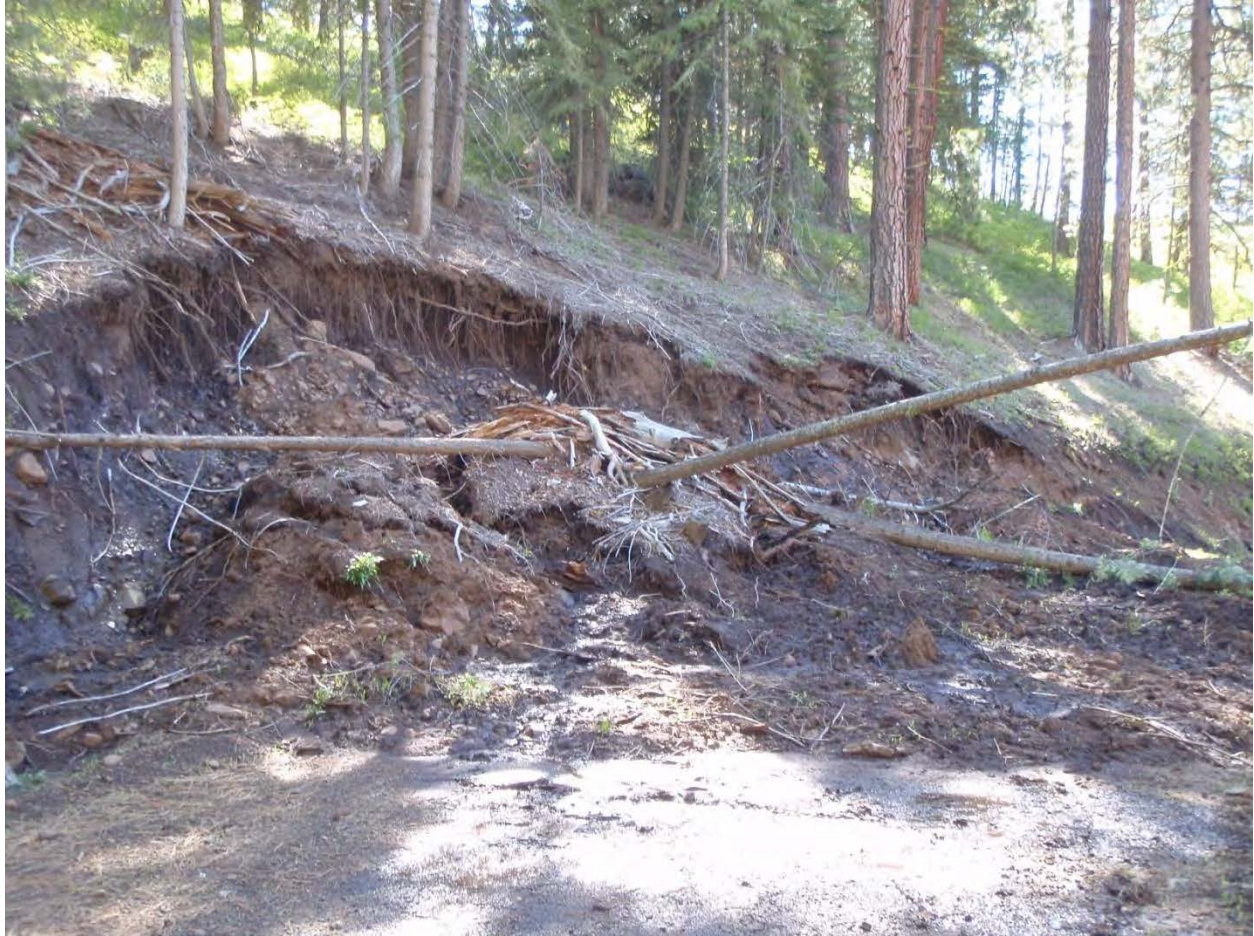
Nine gullies were found totaling  $100 \text{ ft}^3$ , or  $\sim 4.9$  metric tons, along with one large cutslope failure ( $\sim 35,600 \text{ ft}^3$  or  $\sim 1,700$  metric tons; Figure 11).

**Figure 11:** Cutslope failure along control road 50029/50473/50007?.

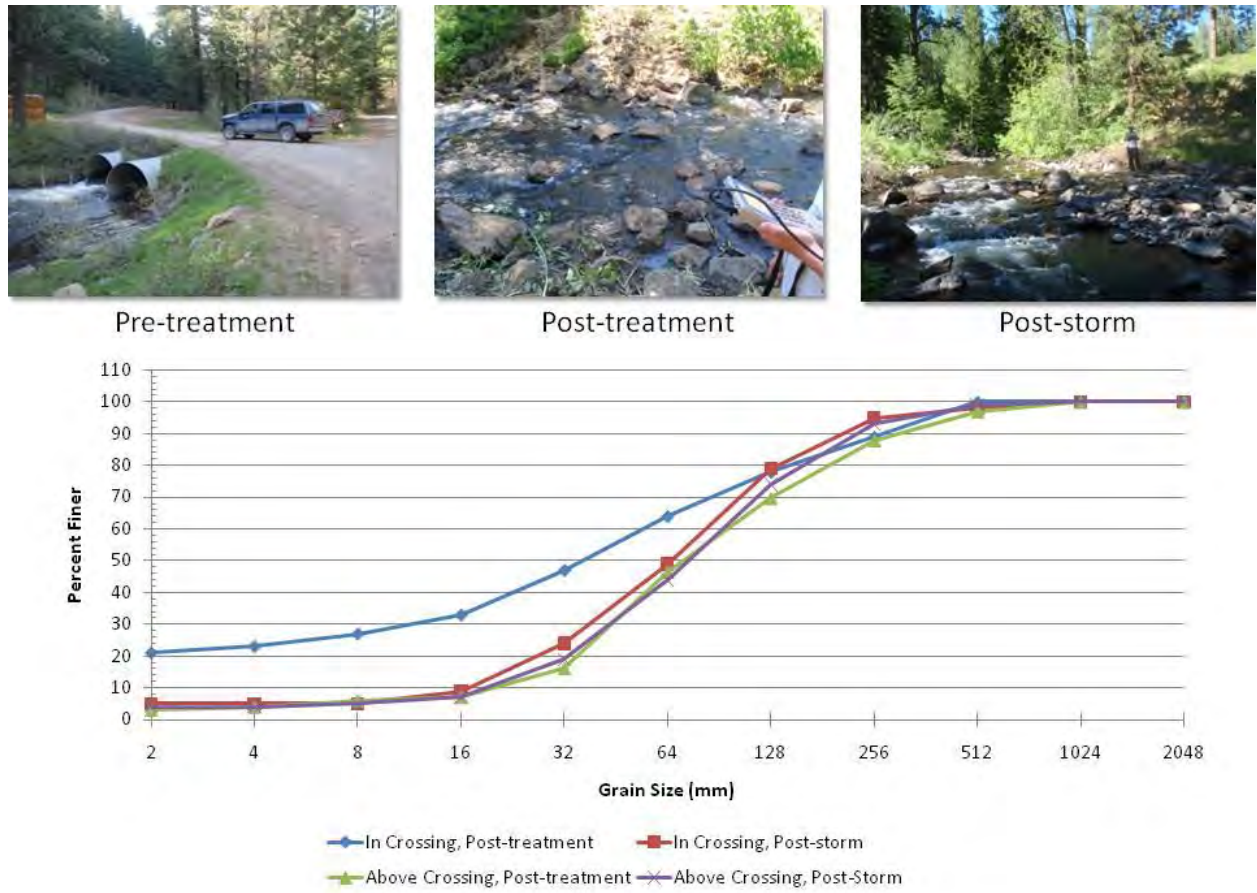
Crossing 1, along the main stem of Mann Creek, shows an example of a well-adjusted stream crossing (Figure 17). This crossing has rapidly adjusted by removing fines left behind following excavation of the fill and culverts. This is one of two 4<sup>th</sup>-order stream crossings in the study.

**Figure 17:** Grain size distributions for and pictures of crossing 1. Note the shift in the “in crossing” size distributions indicating removal of fine sediment and restoration of natural bed characteristics observed upstream.
