Monitoring Road Treatments in the Island Park Watershed Caribou-Targhee National Forest

December 9, 2010

Nathan Nelson¹, Tom Black¹, and Richard Cissel¹

US Forest Service
Rocky Mountain Research Station
322 East Front Street, Suite 401
Boise, Idaho, 83702

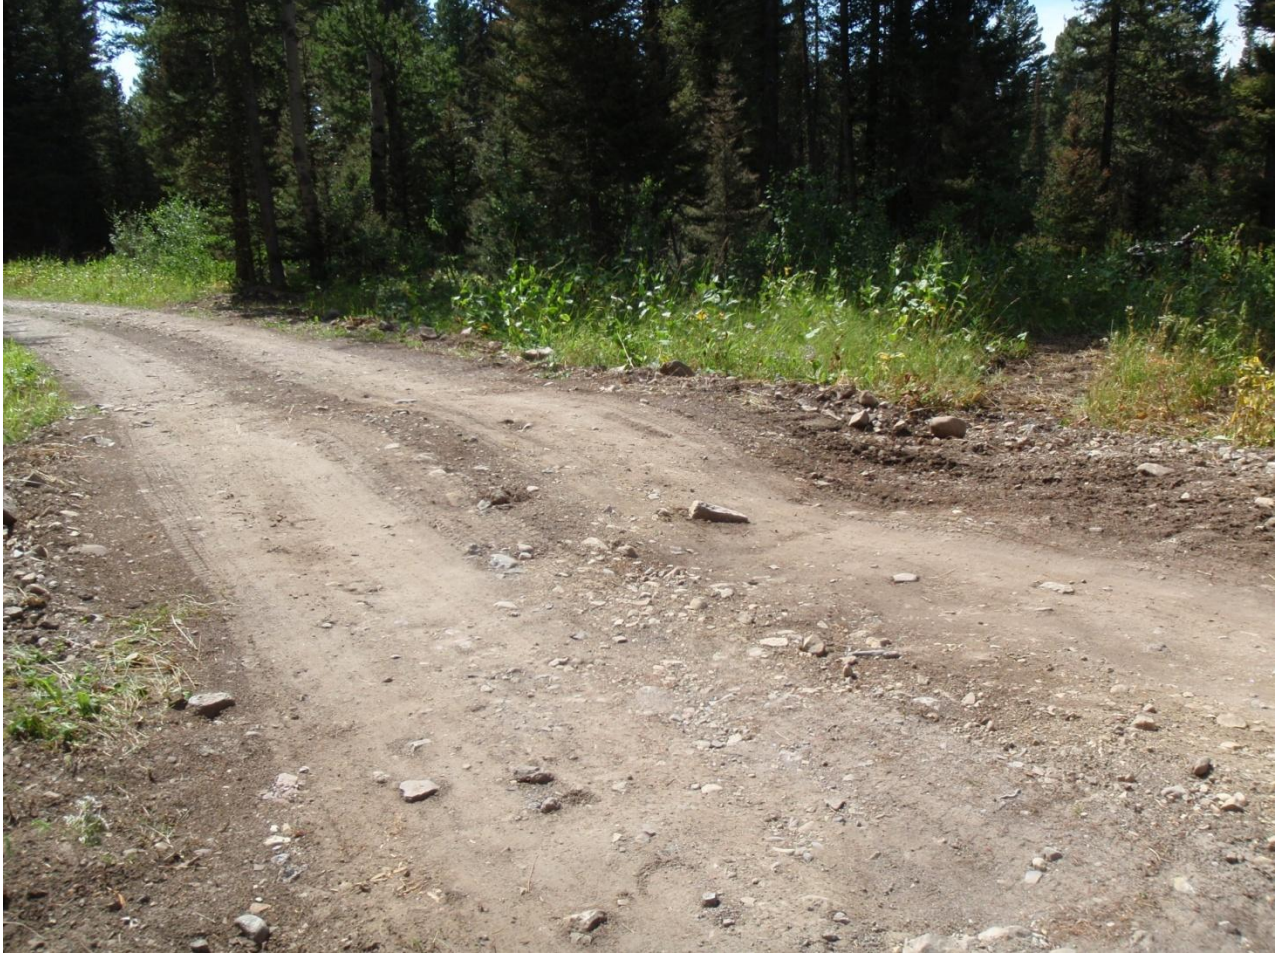
Figure 4. Example of new broad based dips added as SDRR treatments.

Roads in the Island Park watershed received two types of treatments. First, several roads received storm damage risk reduction (SDRR) treatments consisting predominantly of the installation of additional drainage features, mostly broad-based dips. Second, several roads in the 046 system received more intense treatments consisting of outsloping, ripping/tilling, and/or conversion to trail.

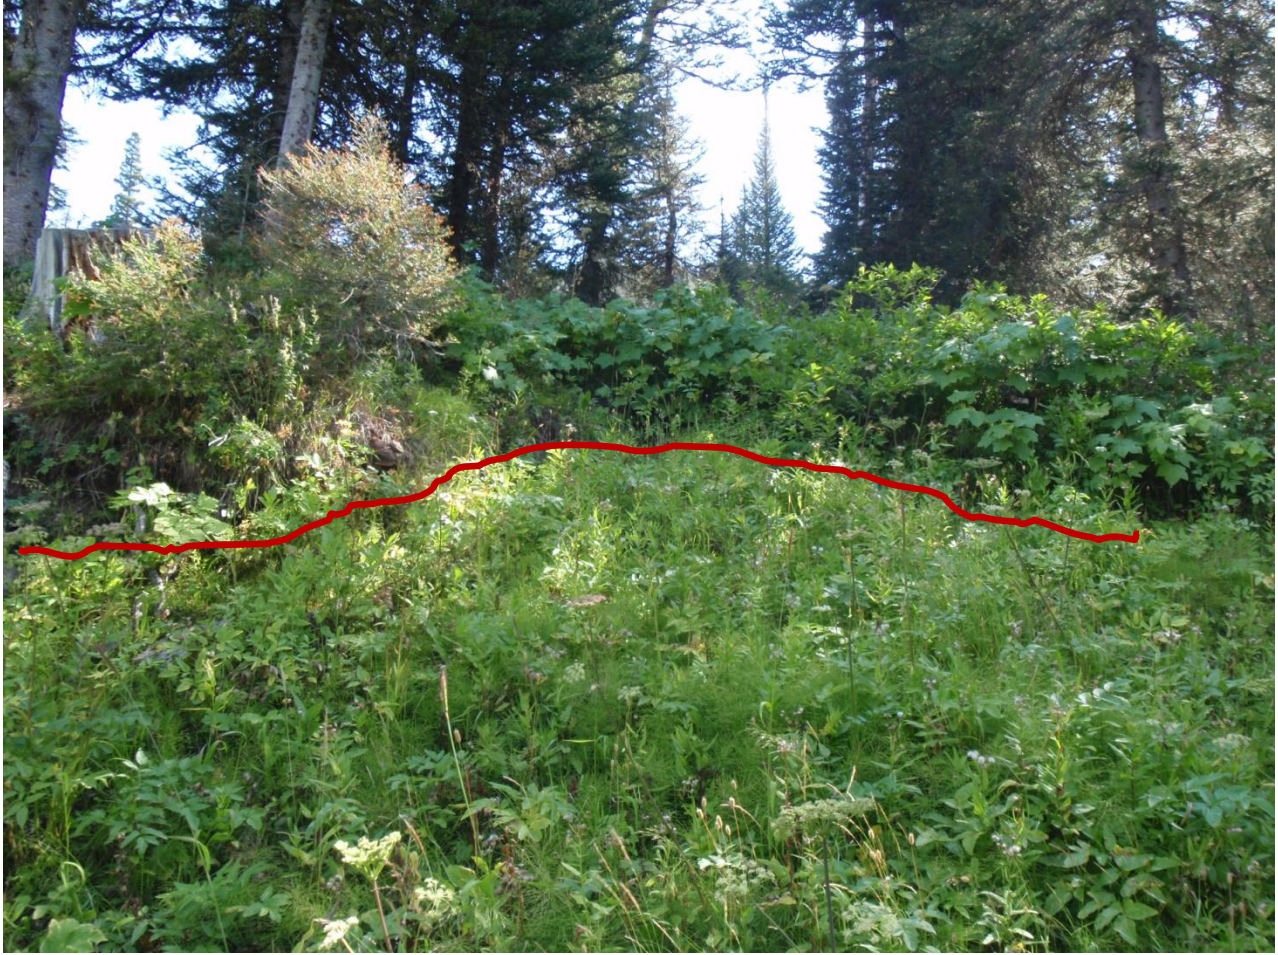
Figure 6. Slump in cutslope near the end of the upper 046 spur road. Red line indicates approximate scarp base.

Field crews recorded the presence of only one road-related landslide during the inventory process (Figure 6). This cutslope slump failure was located after decommissioning treatments had been applied along the upper 046 spur road, though it predates the treatments. The risk of shallow landslide initiation was predicted using SINMAP 2.0 (Pack et al., 2008, <http://hydrology.neng.usu.edu/sinmap2/>). SINMAP was run initially to determine the intrinsic stability of the slopes over which the road traverses and to identify locations that are at high risk of failure without a road (Figure 7).⁴

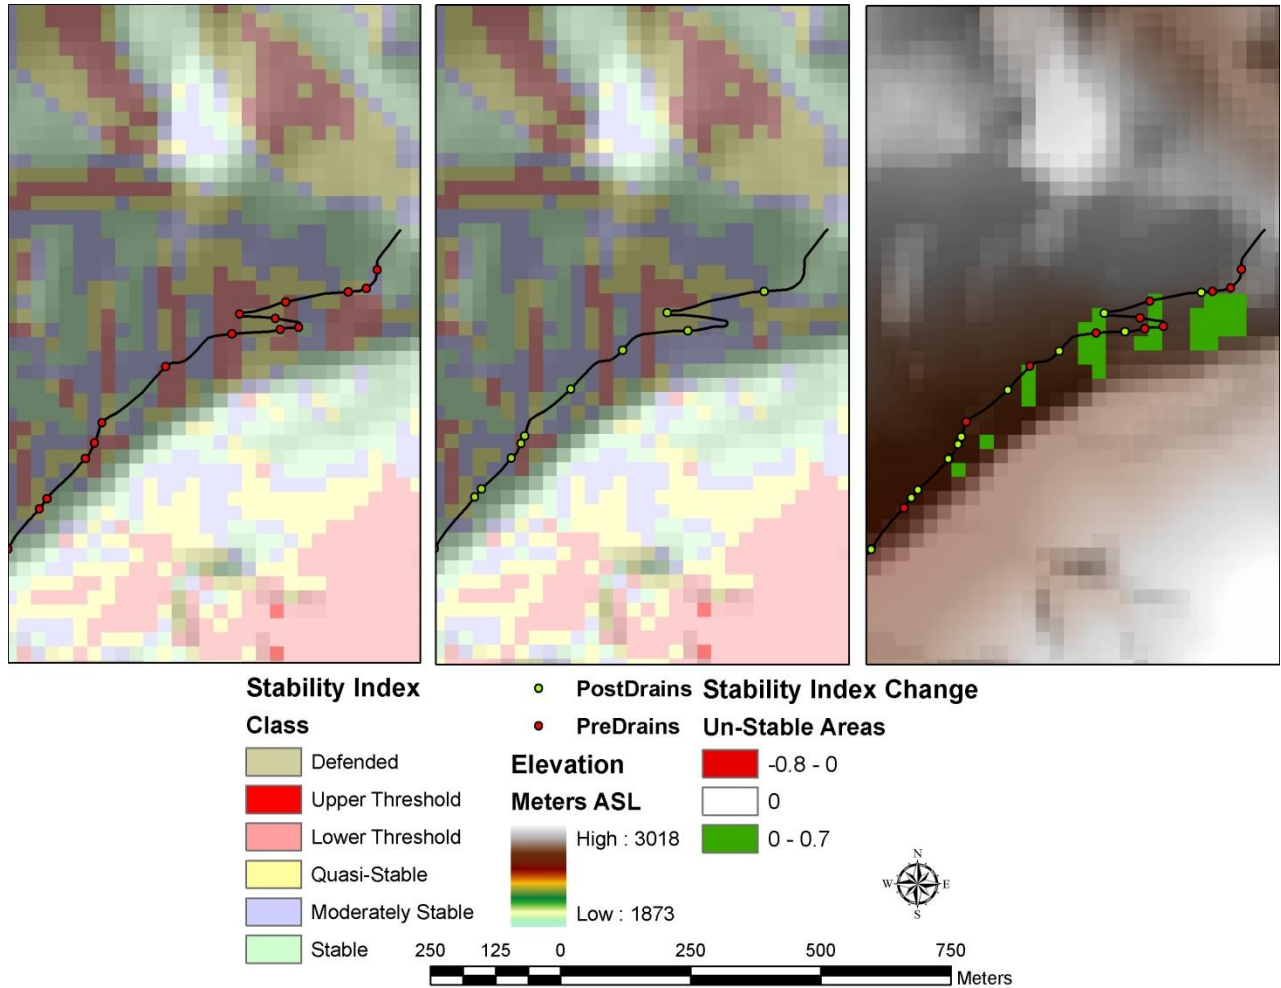
Figure 8. Stability index for hillslopes along the Tin Cup Creek section of the 046 road. Left: Stability Index classes prior to recontouring and trail conversion treatments. Center: Stability Index classes after treatment. Right: Amount of significant change (change in areas that were unstable before or after treatment) in stability index values between pre- and post-treatment. Positive values (depicted by a dark green color) indicate a predicted increase in slope stability following treatment.

A second stability index (SI) run was performed to address the effects of road water contribution to drain points on the original road network (Figure 8 left; Figure 9, top). A third model run was performed to illustrate the change in risk of shallow landsliding with the modified road drainage system resulting from the road treatments (Figures 8 and 9, center). Differences between these model runs were used to evaluate the changes in landslide risk that are due to the road treatments. Significant changes, those occurring in areas that were unstable before or after treatment, are shown as well (Figure 8, right; Figure 9, bottom). Figure 8 shows an area of more intense trail conversion and recontouring treatments; Figure 9 shows results of SDRR treatments.

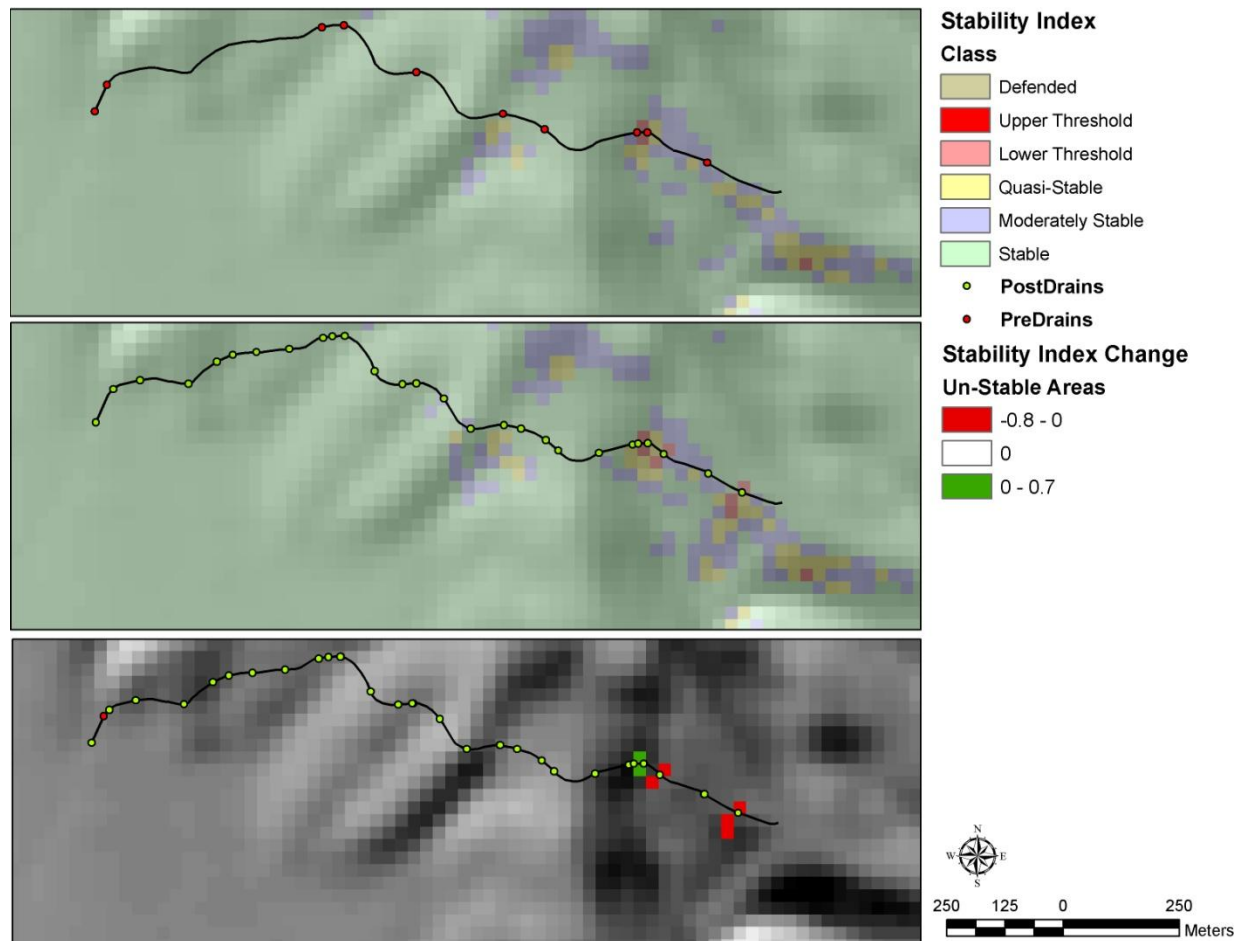
Figure 9. Stability index for hillslopes along the 047 road, SDRR treatment. Top: Stability Index classes prior to SDRR treatments. Center: Stability Index classes after treatment. Bottom: Amount of significant change (change in areas that were unstable before or after treatment) in stability index values between pre- and post-treatment. Positive values (depicted by a dark green color) indicate a predicted increase in slope stability following treatment.
