How Does Decommissioning Forest Roads Affect Hydrologic and Geomorphic Risk?

#EP41B-0693

Tom Black¹, Richard Cissel¹, Nathan Nelson¹, Charlie Luce¹, and Brian Staab²

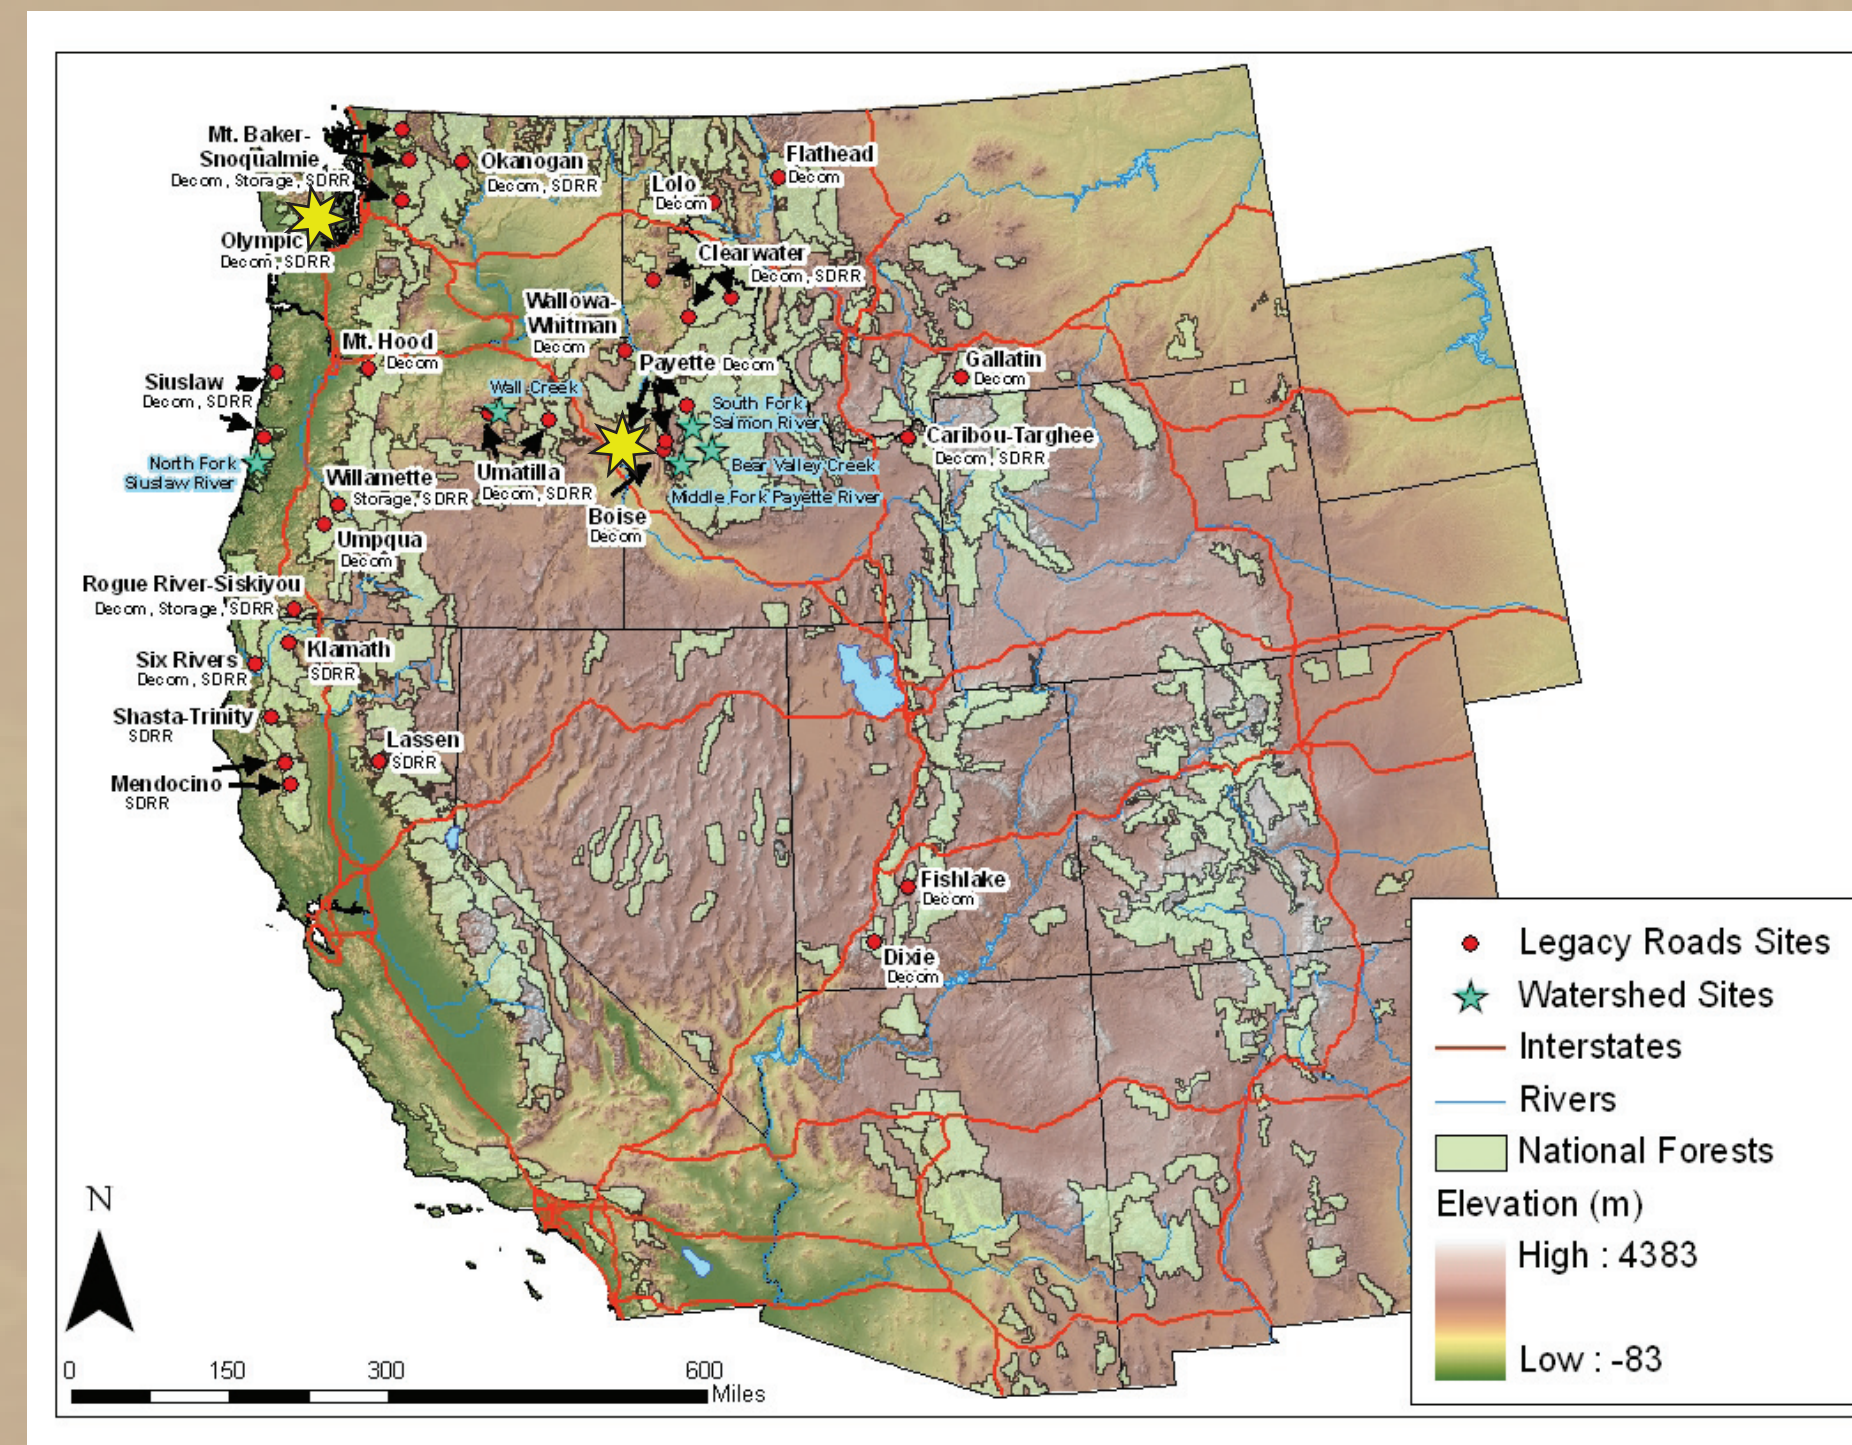
Figure 1. Locations of Legacy Roads Monitoring sites within the western U.S.

Forest roads are frequently a major source of fine sediment delivery and mass wasting in steep and wet landscapes. Compacted road surfaces generate direct runoff and infiltrated shallow subsurface flow from hillslopes. Roads discharge runoff through engineered and non-engineered structures, resulting in changes in sediment transport and delivery to hillslopes and channels, and can change the timing and location of runoff generation. The USDA Forest Service operates over 616,000 kilometers of forest roads in a wide variety of landscapes. The USFS Legacy Roads Program has been working to address the environmental impact of this large road network by decommissioning or upgrading roads that historically have caused water quality impacts. The Legacy Roads Monitoring Project has developed a method and is monitoring a sample of 46 of these projects in order to establish the efficacy of the treatments over time and in a range of environments (Figure 1).

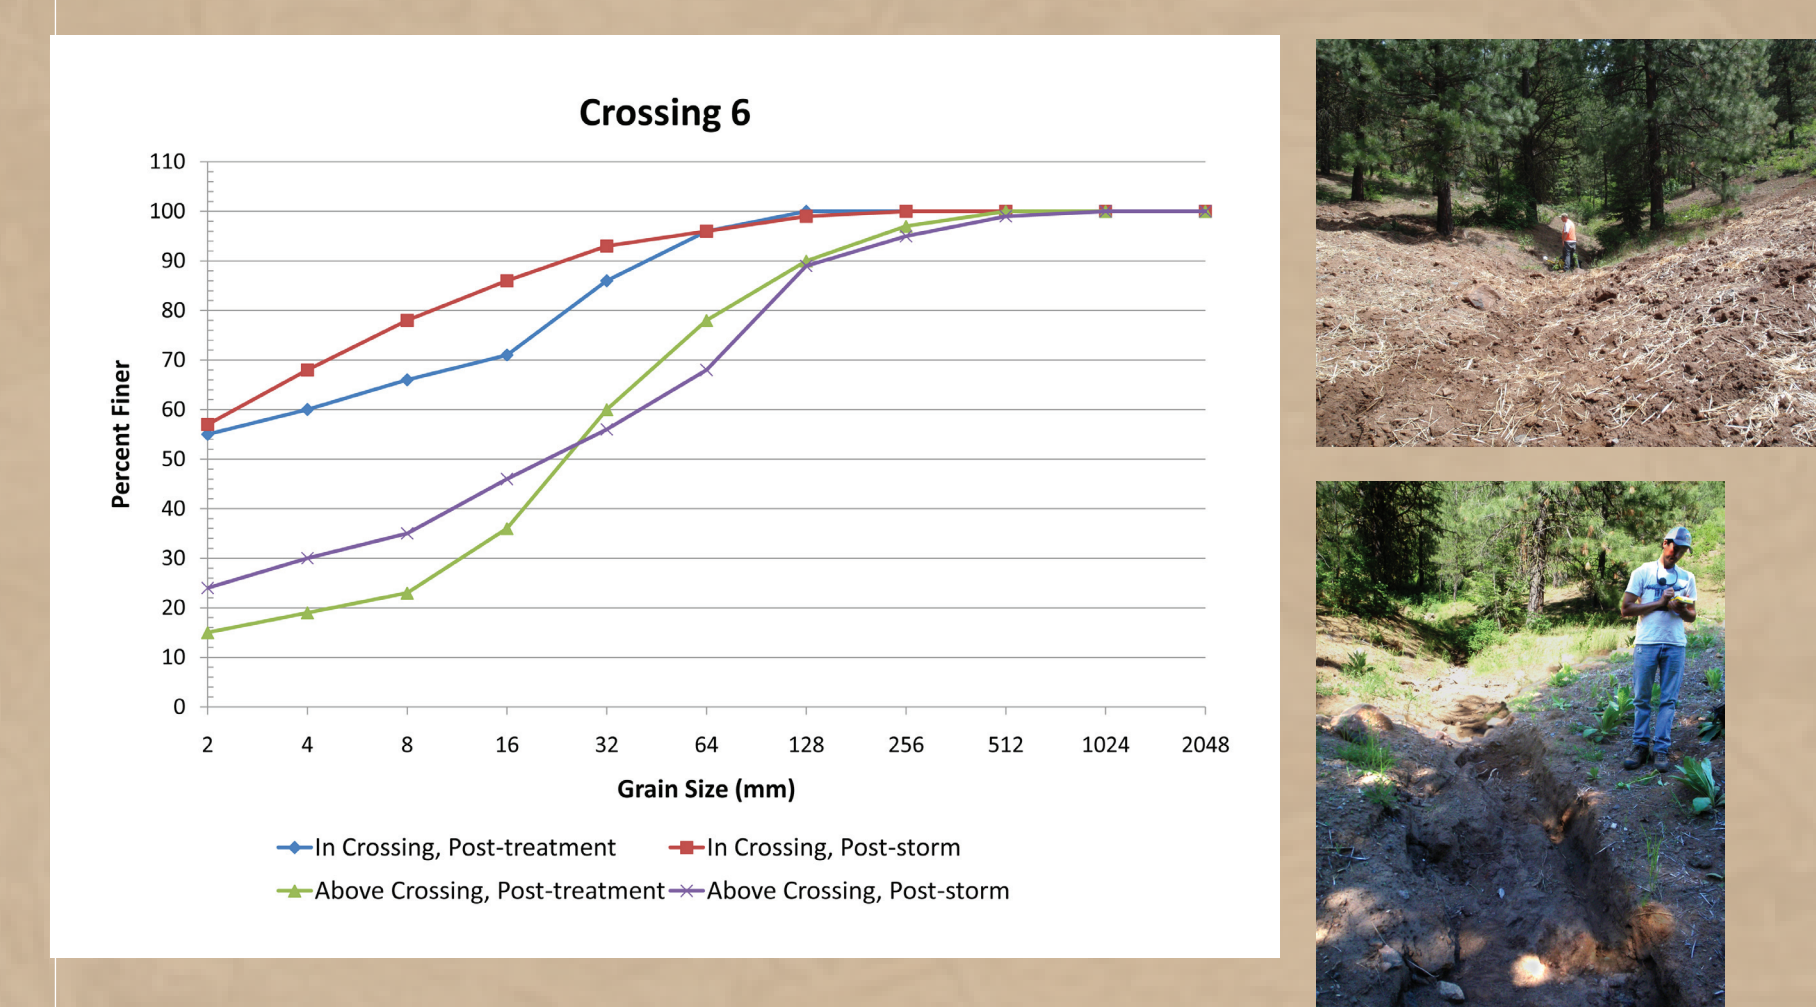
Figure 4. Grain sizes by % for a large stream crossing. Photo before treatment (top) and after treatment (bottom).

Pebble counts were conducted at each of the excavated stream crossings after the treatment was applied, and then again after the storm event. The crossings were at various states of adjustment following the storm event and spring runoff. The higher-order channels followed the expected response, where excess fines left in the crossing following excavation were being, or had been, removed. This indicates that the bedload more closely resembled that of the natural channel upstream of the crossing (Figure 4). Three of the 1st-order channels crossings showed an opposite pattern where the bedload had become significantly finer after the storm event, but also remained significantly finer than upstream reaches. Some likely reasons include a lack of significant adjustment, entrapment of fines by large anchor clasts, or scour through the disturbed sediment into undisturbed colluvium (Figure 5).

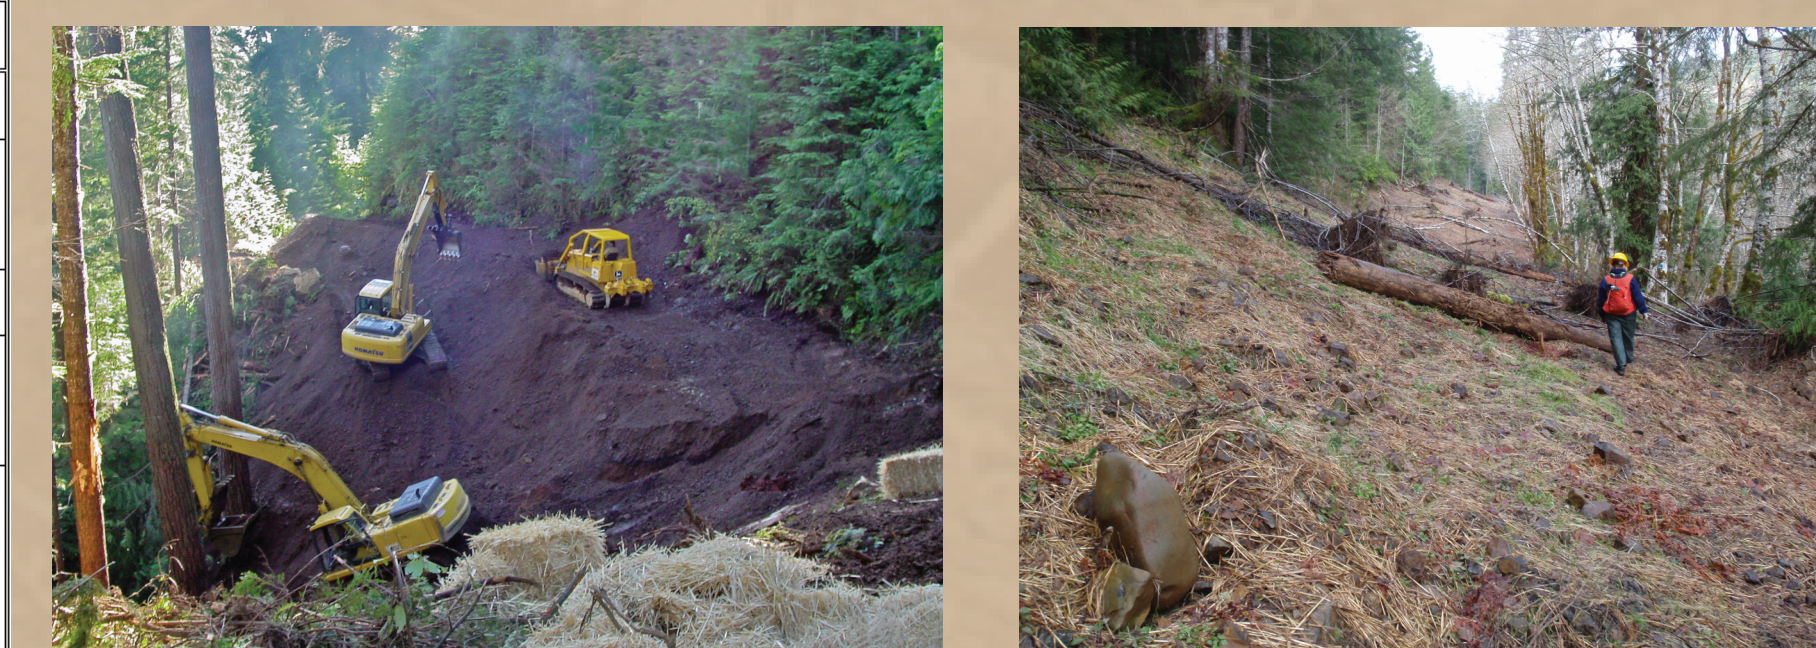
Figure 5. Grain sizes for a 1st order stream crossing. Photo after treatment (top) and after the storm event (bottom).

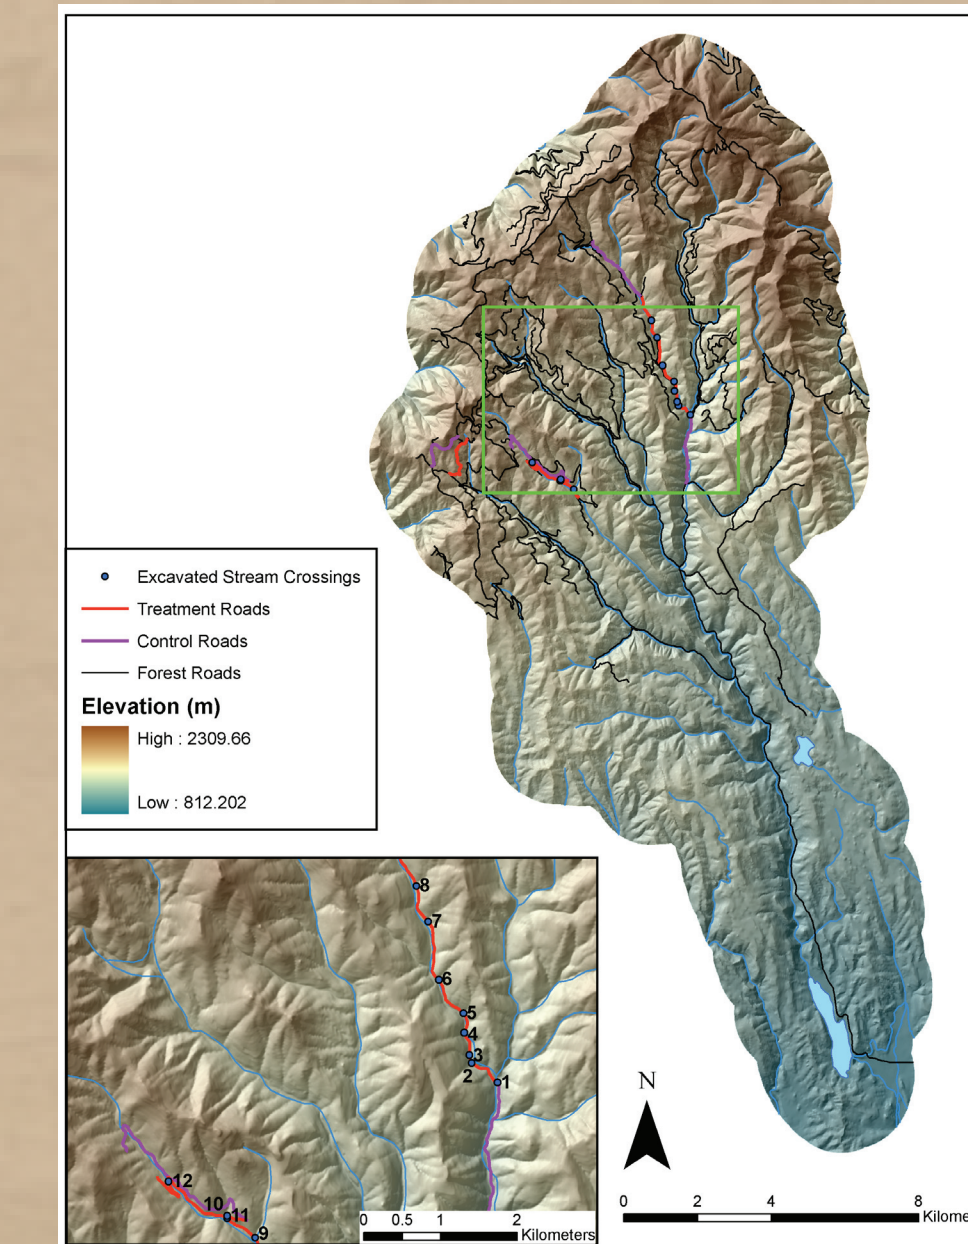
Figure 2. Mann Creek watershed, study locations.

This watershed is located in southwestern Idaho and flows into the Weiser River (Figure 2). A rain-on-snow event occurred on June 2, 2010 that resulted in an 8 year flood event in the nearby town of Cambridge, ID (Figure 3). Earlier events in the season affected an elevation band lower than these sites.

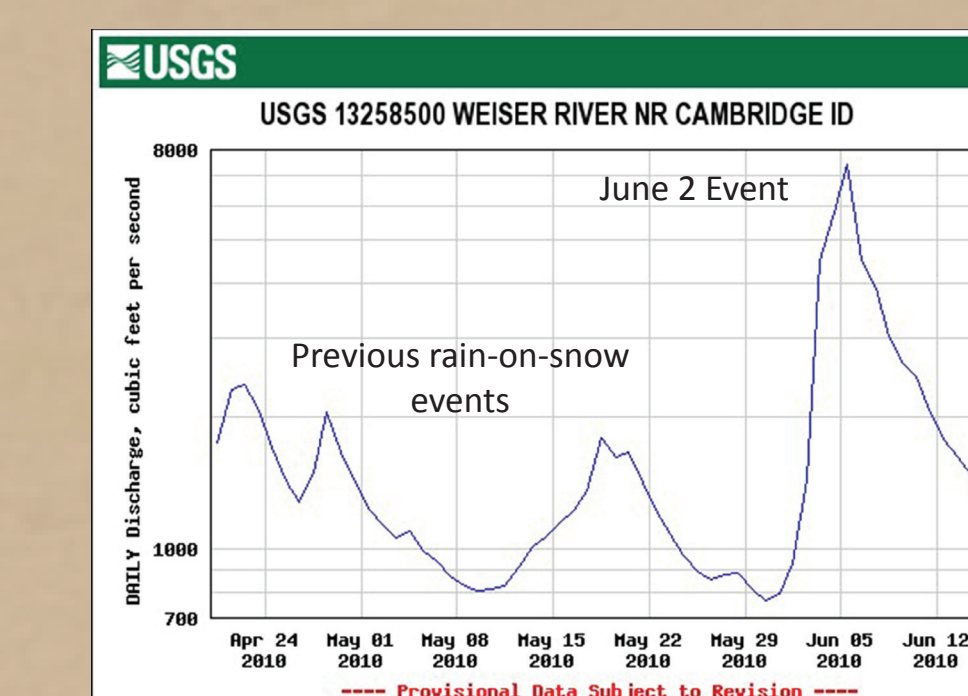
Figure 3. Stream gauge showing the major event on June 2.

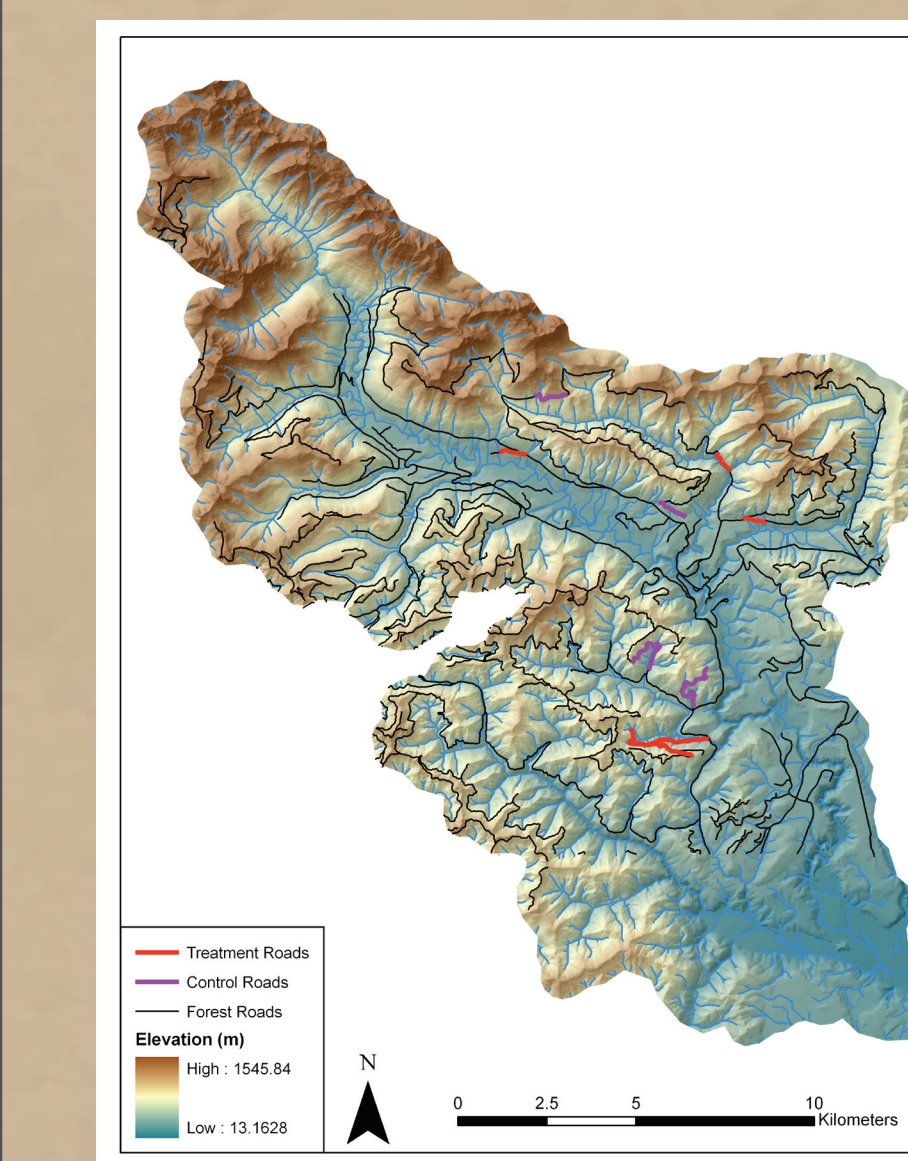
Figure 6. Skokomish River watershed, study locations.

This watershed is located on the southeastern section of the Olympic Peninsula in Washington state, and drains into the Puget Sound (Figure 6). Treatments for this site were applied in 2008.

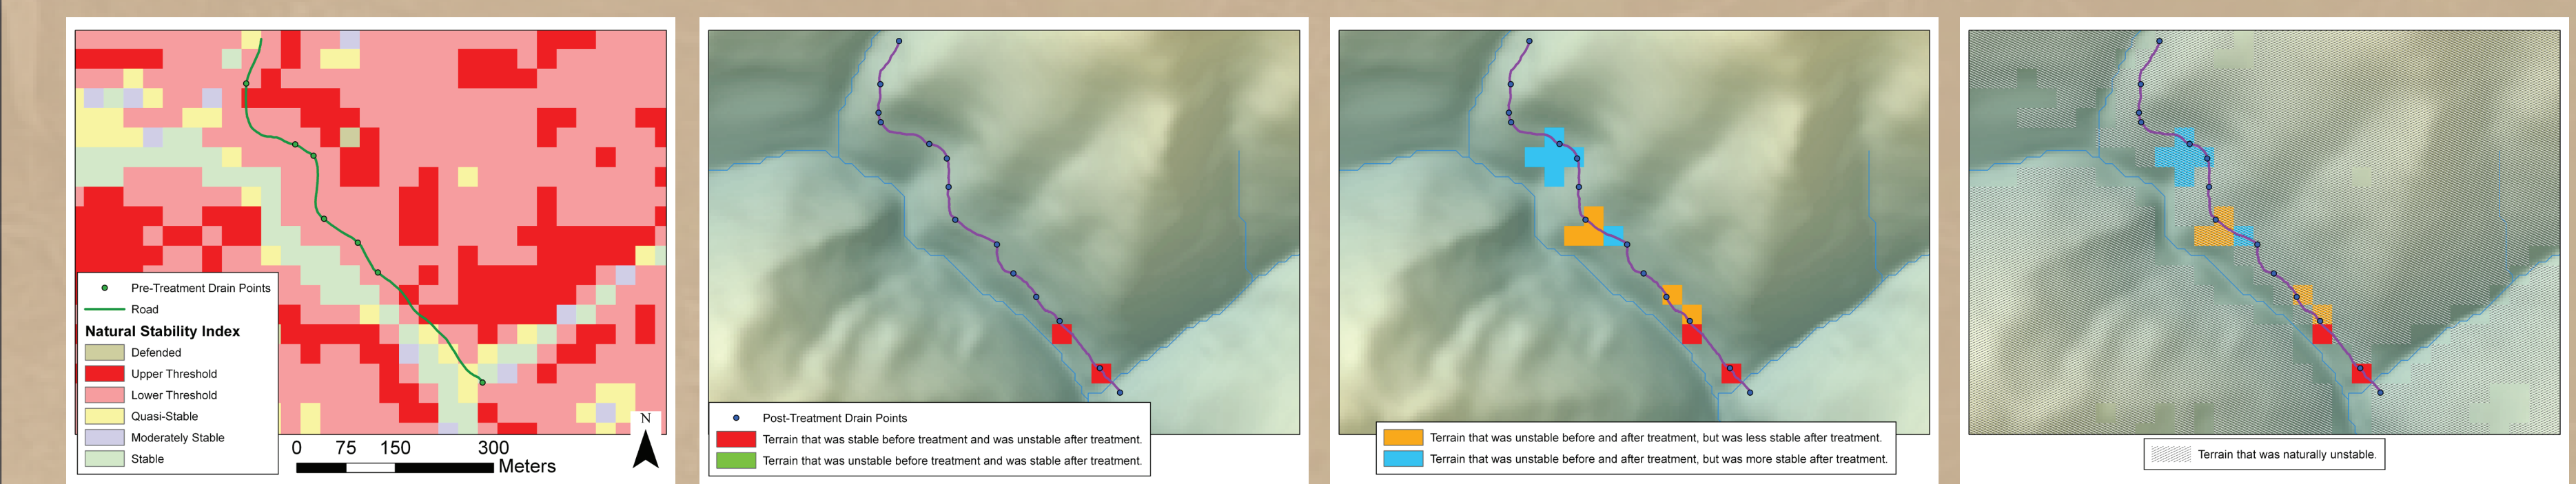
Figure 8. Changes in stability index risk due to decommissioning treatments.

Similarly, the high-intensity treatments applied at the Skokomish River have reduced watershed risks. Sediment delivery was expected to decrease by 81%, and the hydrologically connected road length by 70%. Slope stability risk was distributed over the hillslope, probably resulting in slightly lower risk. Uncertainty remains around gully risk. Risks associated with stream crossing were nearly eliminated.

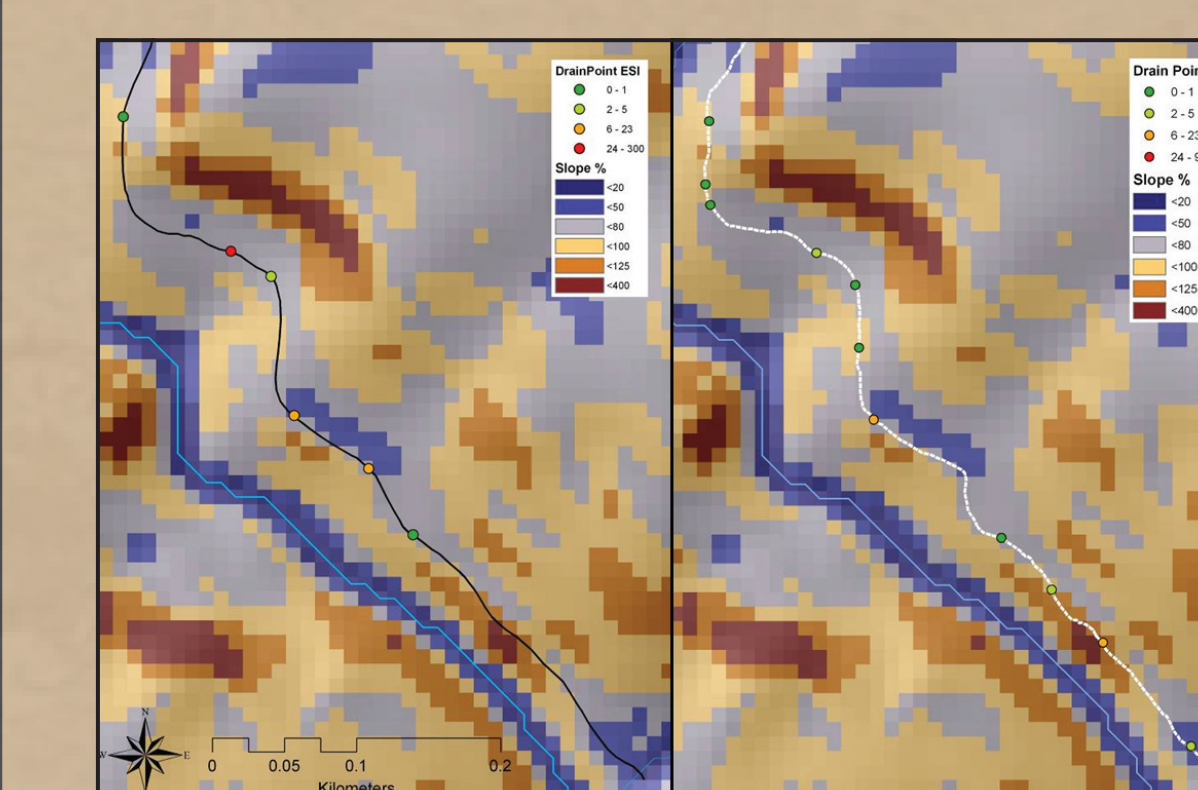
Figure 9. Risk of gulying below drain points, before treatment (left), and after treatment (right).

Before treatment, gully risk was elevated at 34% (29 of 85) of the drain points (Figure 9). The treatments increased drainage frequency resulting in 18% (32 of 179) of the drain points having elevated gully risk. Actual performance of the restoration treatments may exceed these predictions, as less runoff is expected on unconsolidated and outsloped surfaces.

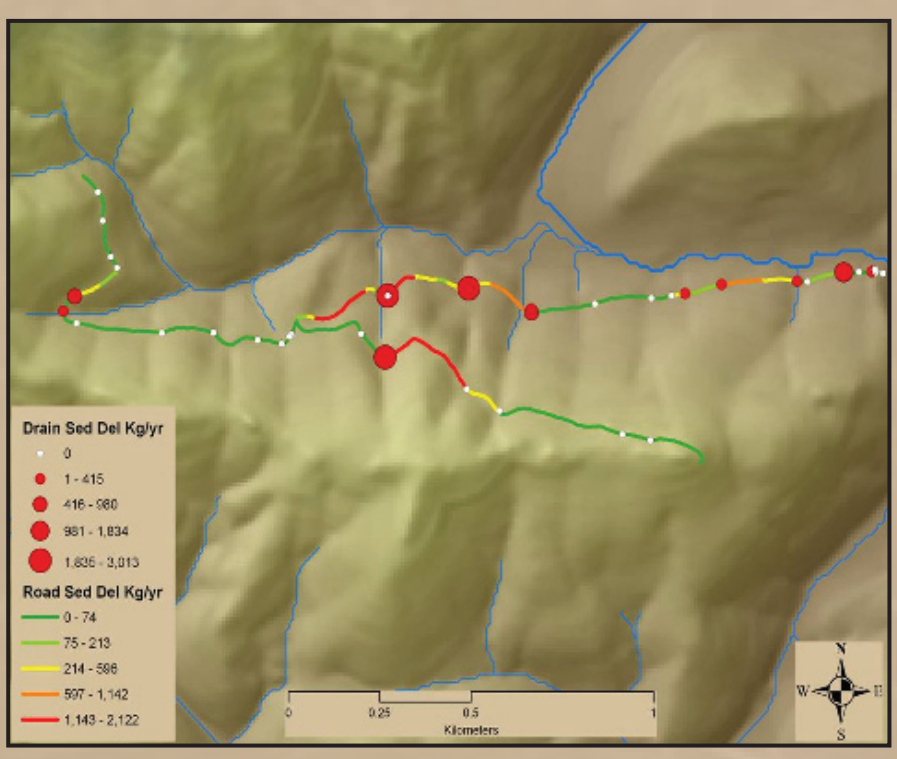
Figure 7. Fine sediment delivery to stream channels pre-treatment road.

Table 3.	Pre-Treatment	Post-Treatment	Change
Number of Drain Points	85	179	94
Sediment Production (tonnes/yr)	41	48	7
Sediment Delivery (tonnes/yr)	27	5	-22
% Sediment Delivery	65%	11%	-81%
% Delivering Road Length	49%	18%	-70%

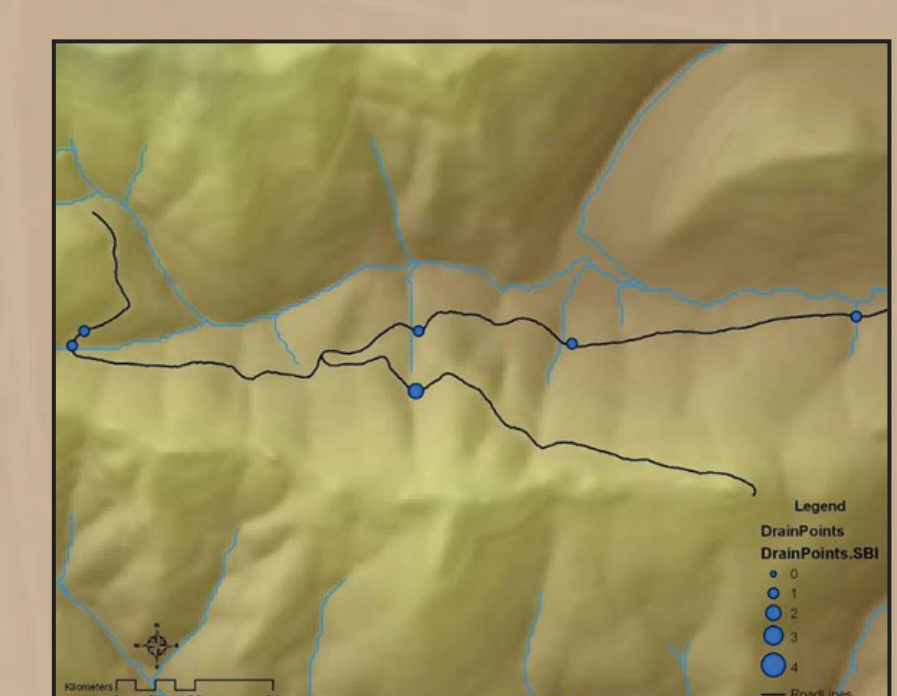
Figure 10. Risk of stream crossings being blocked by debris and overtopping, pre-treatment road. All risk was removed by the treatments.

Risk of stream crossing blockage and overtopping was eliminated at all crossings, as culverts and associated deep fills were removed. Over 4,000 m³ of stream crossing fill was removed during the decommissioning work.
