Moonlight Fire GRAIP Watershed Roads Assessment

Lights Creek and Indian Creek
Plumas National Forest, California

July, 2015

U.S. Forest Service
Rocky Mountain Research Station
322 E. Front St, Suite 401
Boise, ID 83702

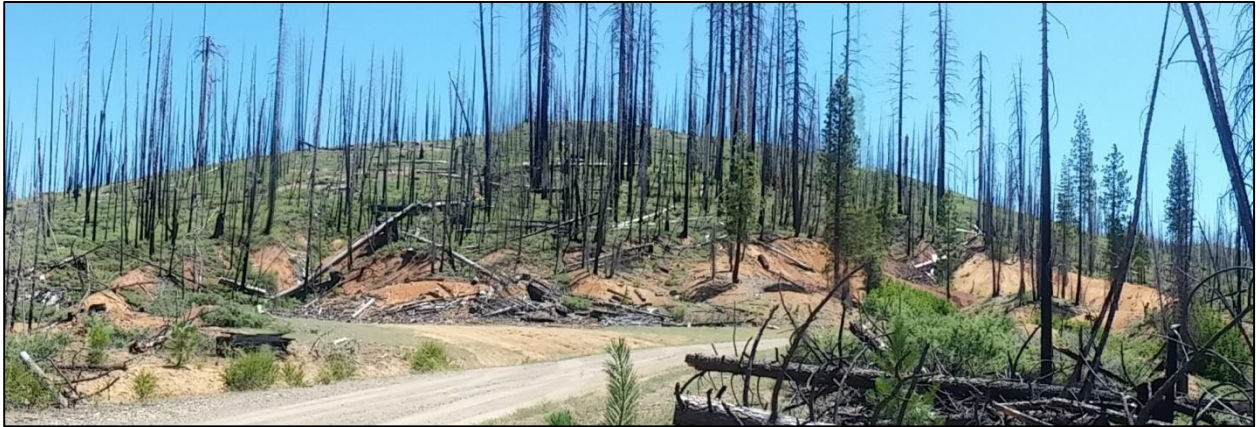
Figure 2. Photo showing red oxidized soil with lack of vegetation from severe burn intensity on old mining features along 28N30 in West Lights Creek.

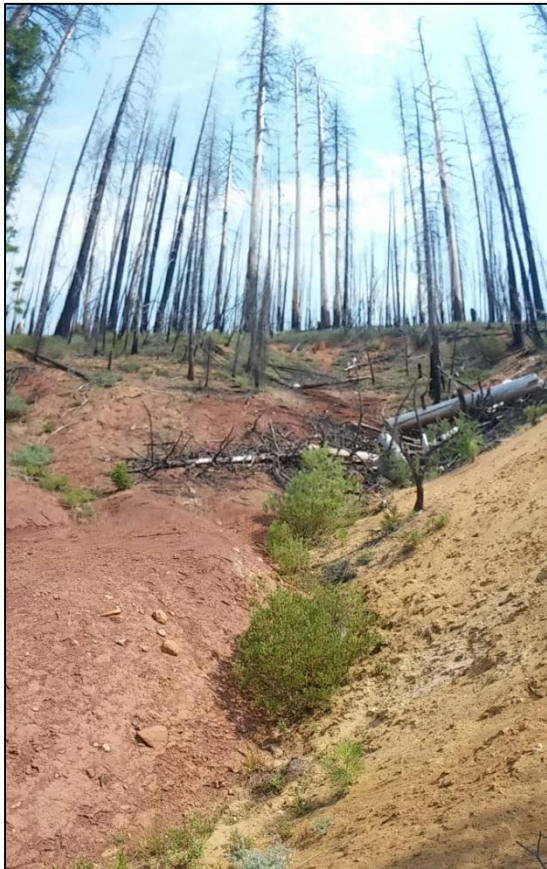
Figure 3. Close up of same area in Figure 2. Note gullying is active in these bare areas.

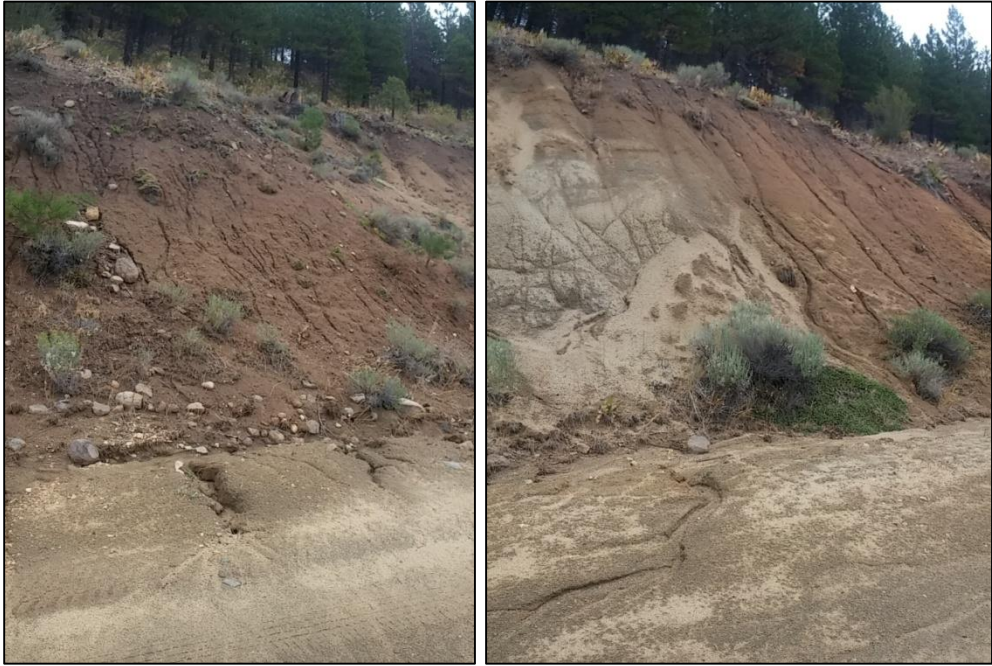
Figure 8. Cutslope rills and road surface gullies that increased and expanded during summer thunderstorms.

Road-stream hydrologic connectivity represents the maximum extent that roads are integrated with streams, and is controlled by the pattern and distribution of runoff, slope length, slope distance from discharge point to stream, vegetation, and delivery paths, among other factors (Bracken and Crocke 2007). Maximum connectivity in the Lights Creek and Indian Creek watersheds observed during the duration of study was during summer convective storm events. In July and August 2014 (240% and 700% of normal rainfall for each month respectively), rapid and widespread expansion of rills and small gullies in road surfaces and cutslopes, and expansion of flow paths below roads were observed (Figure 8). Some of this water was intercepted by or originated on roads.

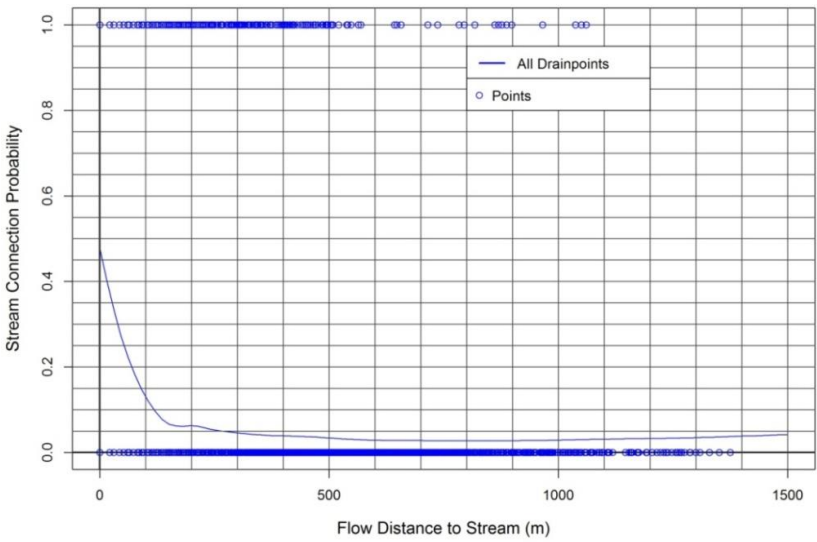
Figure 11. Probability of stream connection decreased with increasing drain point distance to a TauDEM modeled stream.

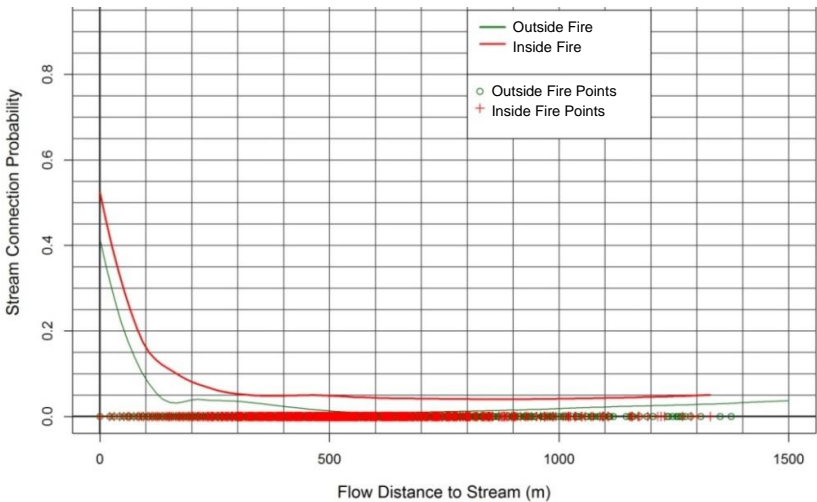
Figure 10. There is a higher probability of stream connection at the same drain point distance to stream within the Moonlight fire perimeter compared to drain points for the entire study area. Stream connection probability with distance to TauDEM modeled stream for drain points outside the perimeter is similar to that of all points.

This relationship is stronger for drain points within the Moonlight fire perimeter (Figure 11). There were 4,316 drain points outside the fire perimeter, and 5,182 within. There is a higher probability of stream connection with drain point distance to modeled stream within the Moonlight fire perimeter. Stream connection probability with distance to modeled stream for drain points outside the perimeter is similar to that of all points. Outside of the fire, for drain points that discharge within a 30 m grid cells that contains a modeled stream, there is a 40% chance that the drain point will be stream connected (Figure 11). For drain points within the fire perimeter that probability is 50%. Outside the fire perimeter, and similar to all drain points, over a distance of 200 m (655 ft), probability of connection decreases sharply from 10% at 100 m (330 ft) to about 5% at 300 m (980 ft). At those same distances, probability that a drain point within the fire perimeter would be stream connected is much greater with a 15% chance at 100 m (330 ft), and 10% at 300 m (980 ft).

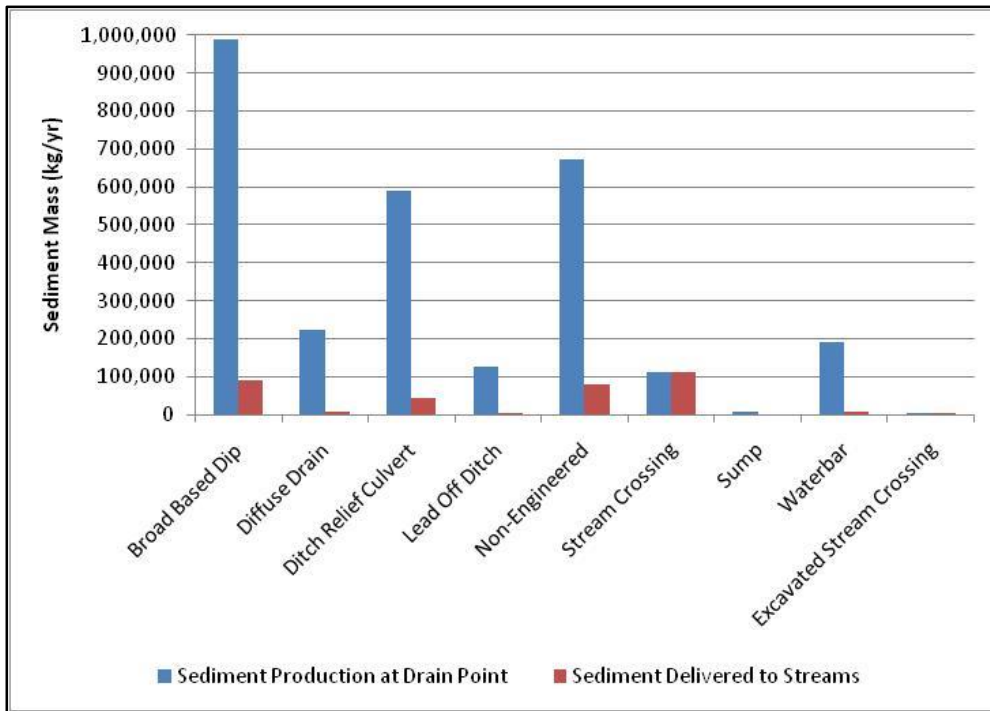
Figure 12. Sediment production and delivery by drain point.

Delivery of fine sediment occurs through a mix of road drainage features, including broad based dips, diffuse road segments, ditch relief culverts, lead-off ditches, non-engineered drains, waterbars, and others (Appendix A, Figure 12). In Table 2, sediment delivery is broken out by drain type to assess their effectiveness in preventing sediment from entering the channel. There were 9,536 drain points observed, of which 1,154 were observed to deliver sediment to stream channels. Model prediction estimated 347 Mg/yr of road surface sediment was routed through the observed stream connected drain points, or 12% of the 2,920 Mg/yr generated on the road surfaces and ditches (Appendix B, Maps 2a-3b). Diffuse drains, ditch lead-offs, and waterbars were equally effective. Collectively they received 19% of sediment produced, but routed only 6% of sediment to streams. Stream crossings, broad based dips (likely many were near stream crossings), and non-engineered drain points (likely many were near stream crossings) routed the most sediment to streams (91% collectively, 111 Mg/yr, 90 Mg/yr, and 78 Mg/yr, respectively; Figure 12). Though stream crossings received a small percentage of all sediment produced (4%), they routed the majority of delivered sediment (32%). This is a strong indicator that drainage features on road approaches to streams would help to reduce sediment routed directly to stream crossings. Sediment delivery in the study area is generated by a very

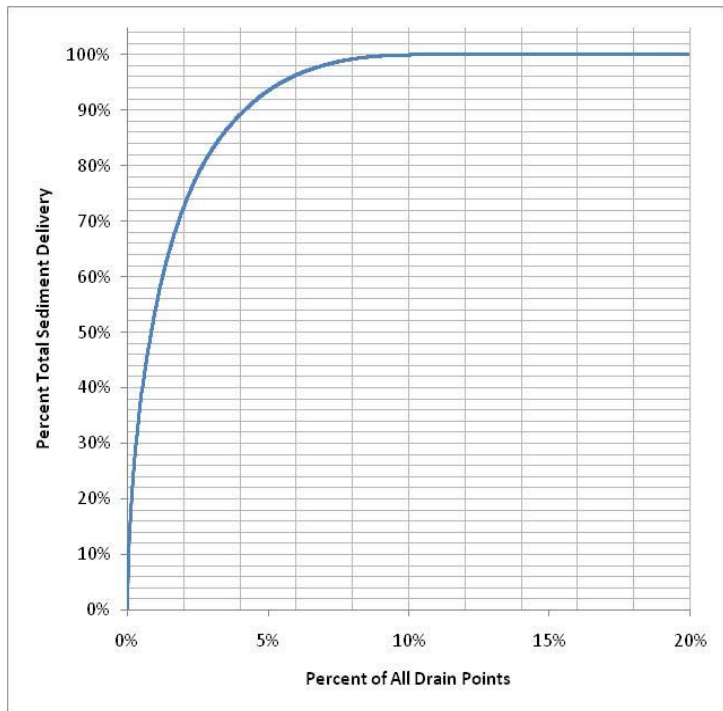
Figure 14. Percent total sediment delivered to streams by percent of drain points. 4.5% of all drain points deliver 90% of the delivered sediment.

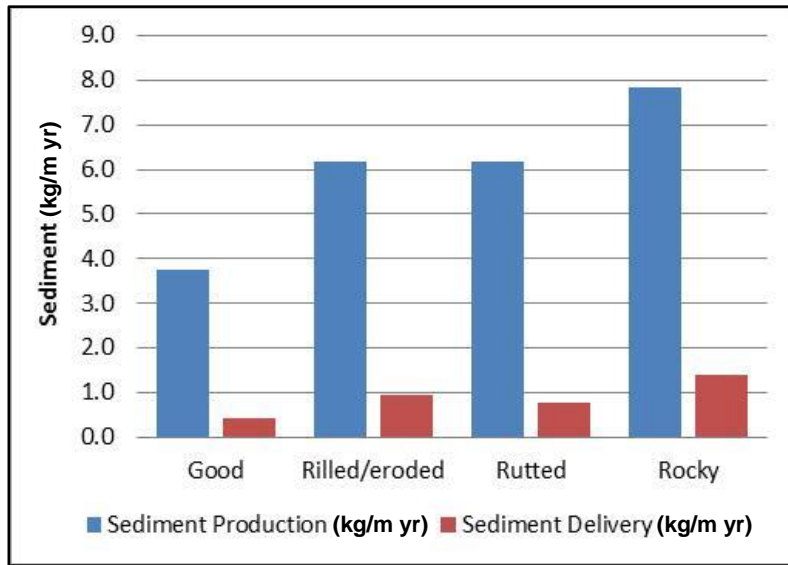
Figure 15. Normalized sediment production and delivery by road surface condition. The values are normalized by road length for each surface condition category.

Road tread surface condition played a role in sediment delivery. Where erosional force was adequate to erode road surfaces, rills, ruts, and rocky surfaces were formed. The same force which caused increased erosion on the surfaces may be a factor in increasing delivery from surfaces that were more eroded. Surface condition information was collected in the field for each road segment. A road segment was classified as being in good condition if there was little erosion present. Where road surfaces were more eroded, the road segments were classified from least to most eroded as being rilled and/or eroded, rutted, or rocky (Cissel et al. 2012A). There were 551 km (342 mi, 81%) classified as being in good condition, while the remaining 19% of road length had some surface problem. In Table 3, sediment produced and delivered from each of these surface condition types was normalized by the total road length for each erosion category. Figure 15 and Table 3 show that sediment production was lowest on road surfaces in good condition (16% of normalized total), followed equally by surfaces that had been eroded to rutted, or rilled/eroded (26%). Surfaces that had eroded to rocky condition had the highest sediment production with 33% of the normalized total. Sediment delivery was highest on surfaces eroded to rocky condition (40% of normalized total), followed nearly equally by surfaces that had eroded to rilled/eroded, and rutted (26% and 23%, respectively). Good surfaces had the lowest delivery rate (11%).

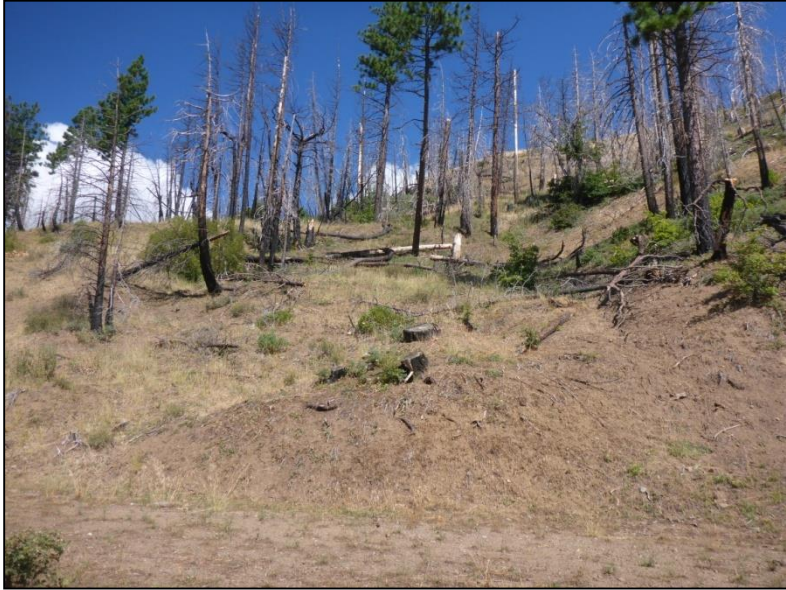
Figure 18. Cutslope failure type landslide in earthflow terrain.

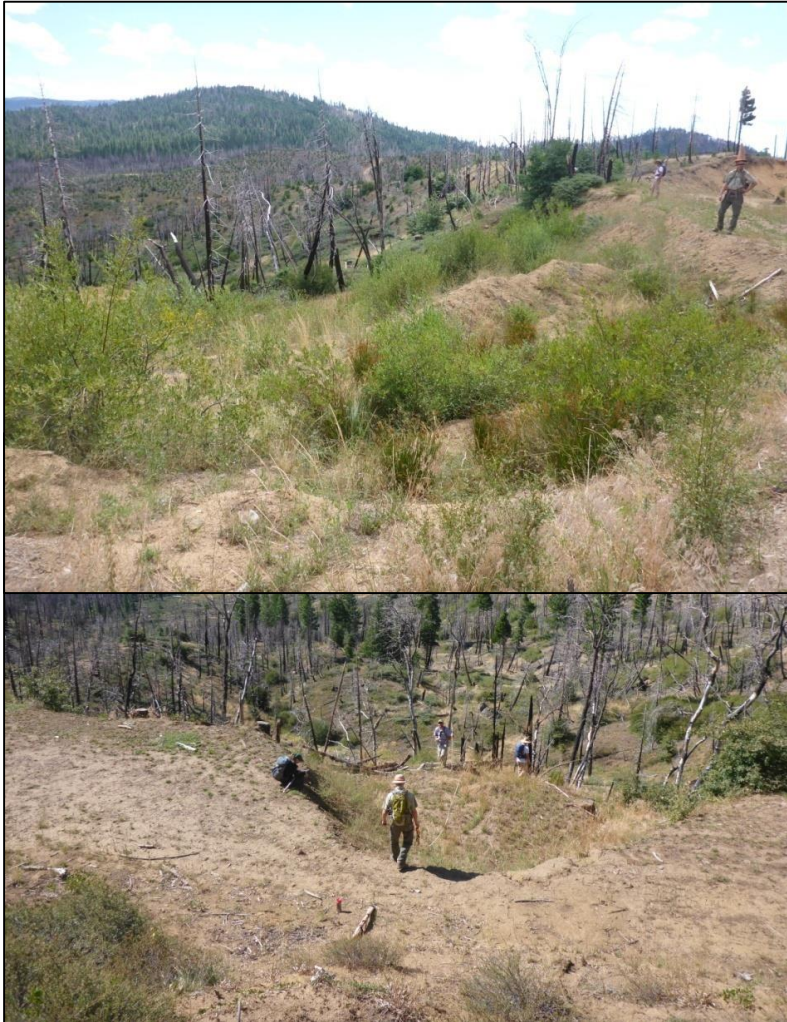
Figure 19. Fillslope failure type landslides in earthflow terrain.

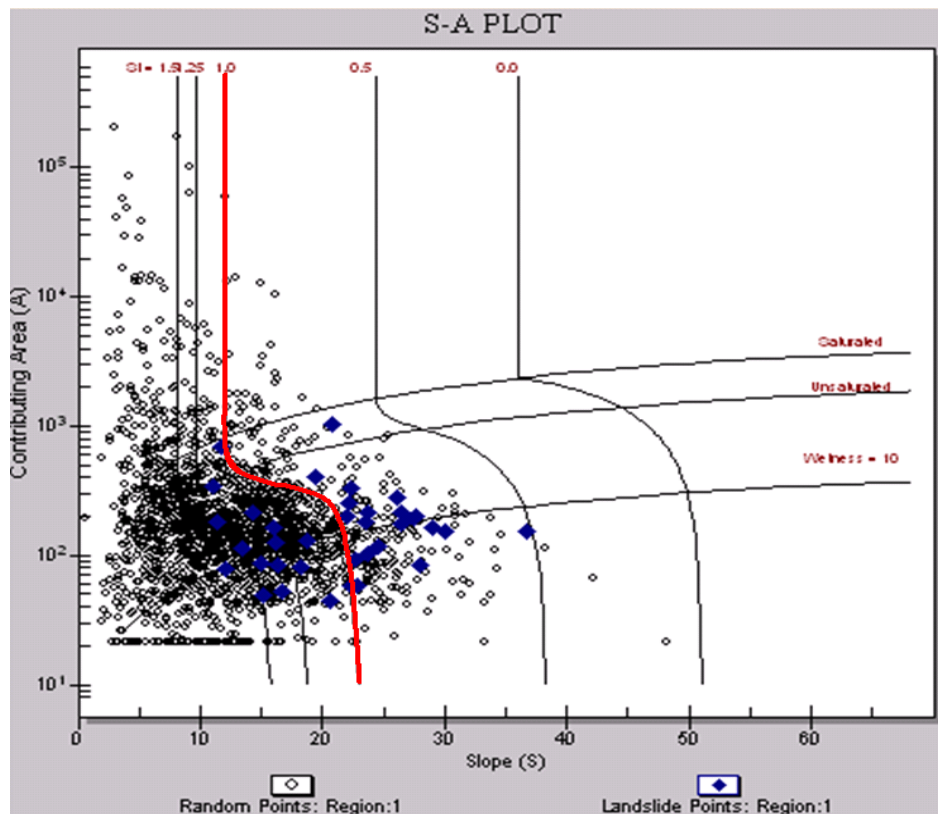
Figure 22. SINMAP generated calibration graph. Points that lie to the right of the red line are considered to be unstable.

Figure 22 shows the calibration plot for all areas within the watersheds from SINMAP (see documentation on the SINMAP website, above). Two types of points are plotted on the contributing area-slope graph. The first type is a random selection of points throughout the watershed that represent the slope-area distribution throughout the watershed, and the second type is the landslide calibration points. Points that fall to the right of the red line are considered to be at high risk.

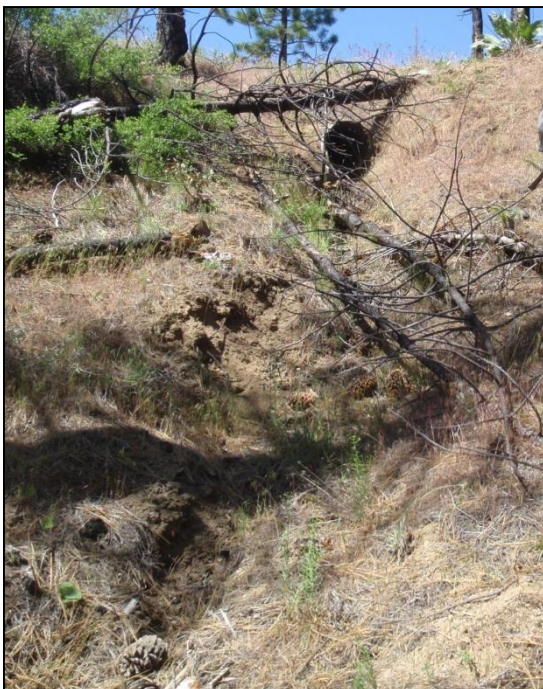
Figure 27. Gully below the outlet of a ditch relief culvert.

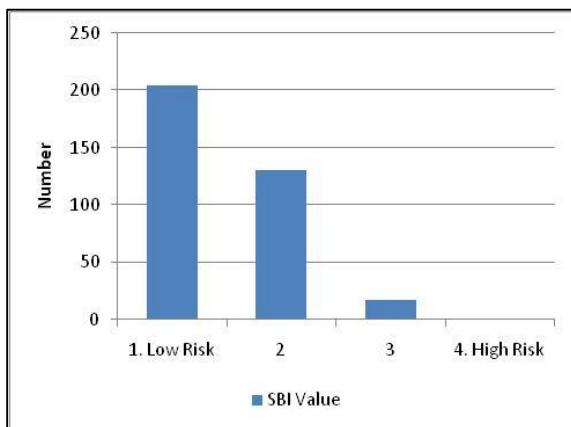
Figure 32. Distribution of SBI values for the Lights Creek and Indian Creek watersheds.

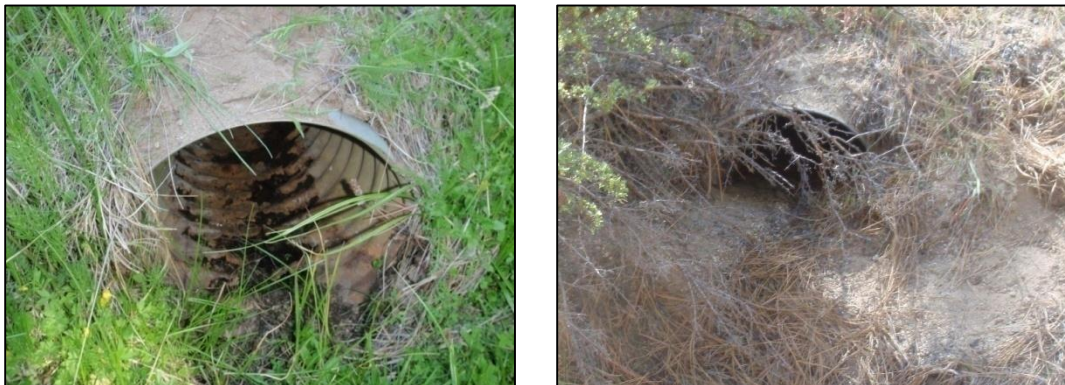
Figure 36. Problems with ditch relief culverts. The left culvert is rusted through. The right culvert has an occluded inlet.
