Bear Valley Road Inventory (GRAIP) Report

In Support of the Bear Valley Category 4b Demonstration USDA Forest Service, Boise National Forest

February 24, 2010

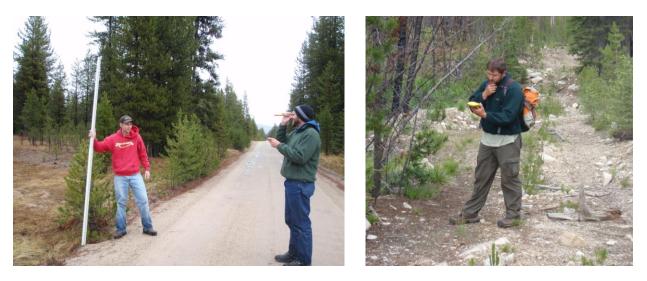
Photo 1. Field crew members collecting data on a stream crossing (left) and collecting GPS points for a drainage feature (right).

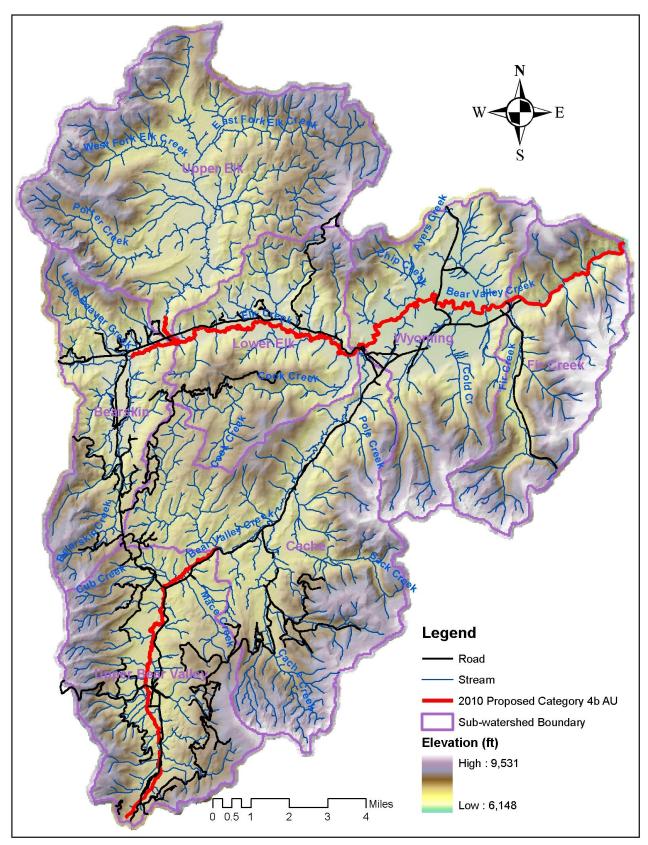
Figure 1. Bear Valley area map including roads surveyed.

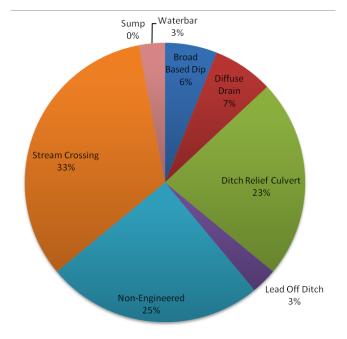
Figure 2. Distribution of total sediment delivered by drain type.

Delivery of fine sediment occurs through a mix of road drainage features including ditch relief culverts, non-engineered drain points, stream crossings and others. In Table 4, sediment delivery is broken out by drain type to assess their effectiveness in preventing sediment from entering the channel. A total of 3,826 drain points were documented, 414 of which (11%) were hydrologically connected to stream channels. However, only 282 of these stream-connected drain points (7% of all drain points) were observed to be actively delivering sediment to a channel (see Table 5). These points deliver 845 tons/year (767 tonnes/yr) of sediment⁴, or 10% of the 8,091 tons/year (7,340 tonnes/yr) of sediment produced by the road surfaces and ditches. Existing drain points are always recorded when spotted in the field, but field crews may determine that a drain point is not actively receiving any water flow from the road based on observed evidence. In this case, the drain point is noted to be an "orphan" drain point and no flow or sediment is routed to it.

Reasons behind the large difference between the three highest producers and the other five may be that many stream crossings, non-engineered drains, and ditch reliefs exist on lower-slope roads that are close to a stream channel. Many of the lower maintenance level, unauthorized, less-travelled, decommissioned, or closed roads are located far from streams, thickly covered by vegetation, or have been closed to traffic for a number of years. Such roads are often mid- to upper-slope and are drained by closely spaced water bars or broad based dips, or they drain diffusely. Consequently,

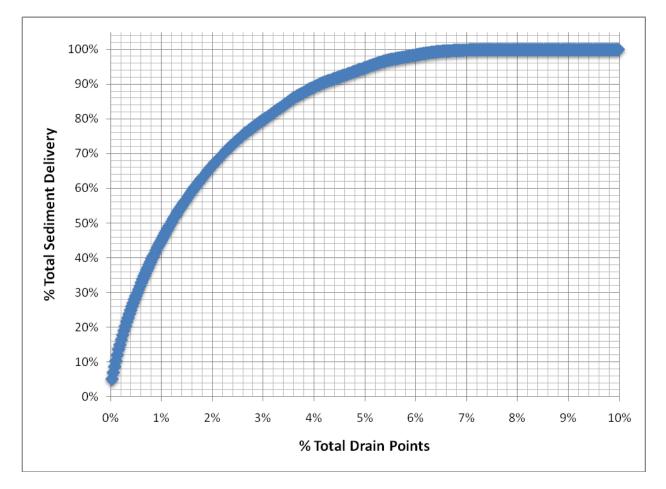
Figure 3. Percentage of the total amount of fine sediment delivered to a stream channel explained by the percentage of the total quantity of drain points.

The precise percentage of all drain points contributing 100% of the sediment to the stream system in Bear Valley is 7.37%. Figure 3 displays the distribution of these drain points contributing sediment on a cumulative scale. The data confirm that 1.2% of all drain points contribute 50% of all the sediment. This is equal to a total of 46 drain points causing half of the problem. Furthermore, 116 drain points (3%) account for 80%

of the sediment, 157 (4.1%) for 90% of the sediment, and so on. These figures suggest a feasible amount of maintenance and road improvement could drastically diminish the impact of roads on Bear Valley Creek and its tributaries.

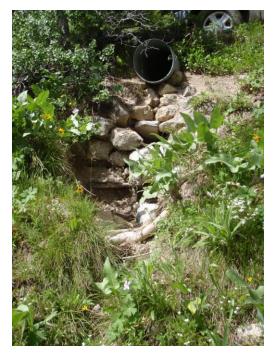
Photo 2. Photos of high delivery drain points. a) Gully at outlet of highest delivering drain point in the entire basin, located on NFSR 569. b) Sack Creek stream crossing on FR 582, one of top 24 highest delivering drain points in basin. c) Eroded and dilapidated stream crossing of Bearskin Creek on NFSR 563C1.

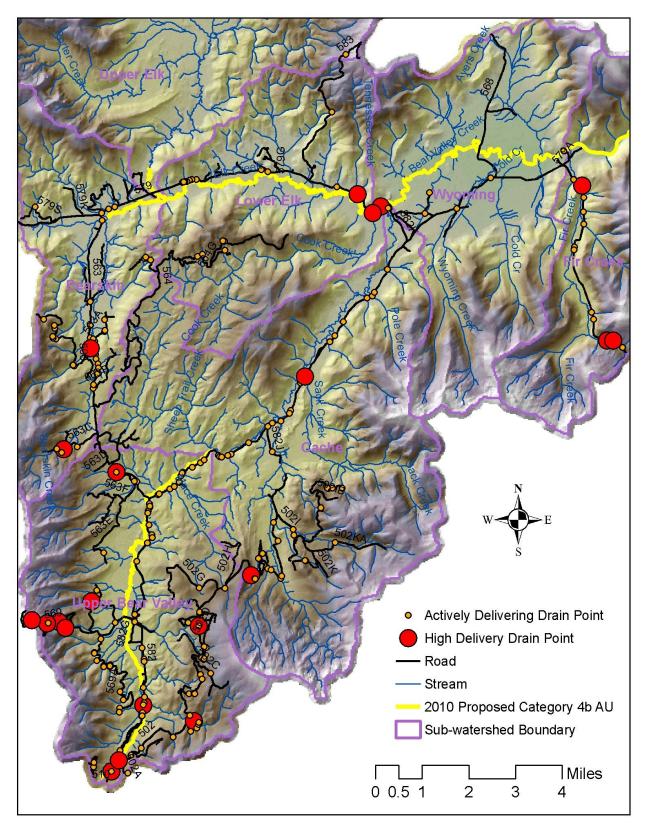
Figure 4. Map of all drain points which are actively delivering sediment to a channel. The top 24 drain points in terms of highest annual sediment delivery are emphasized.

Drain points draining extended lengths of road, if connected to the stream, are likely to deliver a large quantity of sediment. Figure 4 shows a map of the top 24 sediment-delivering drain points throughout the entire Bear Valley watershed. These 24 drain points deliver a total of 285.5 tons/year (259 tonnes/yr) of sediment to streams, which equals 34% of the total amount of road sediment reaching streams. The average length of road draining to the top 24 sediment-delivering drain points was 184 meters compared to an overall average of 61 meters per drain point. All but one of these features were within 200 meters of a stream crossing or a stream running parallel to the road and 14 were within 53 meters. Shortening the length between drain points may reduce the amount of sediment produced within these 24 drain points.

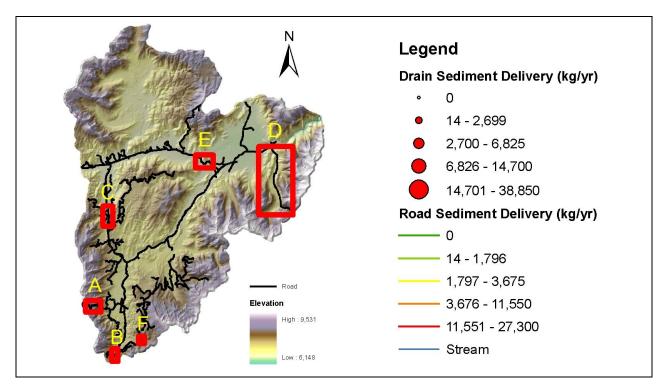
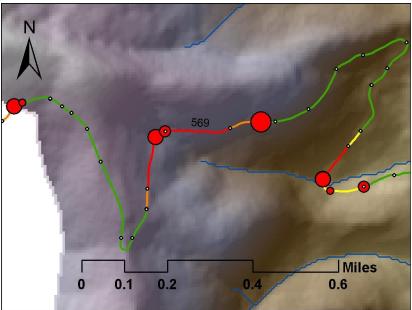
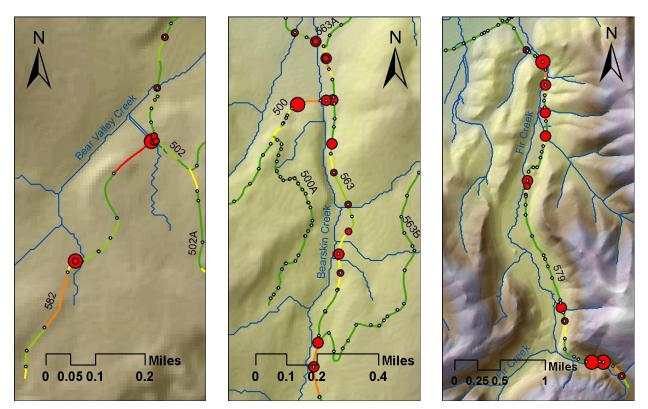
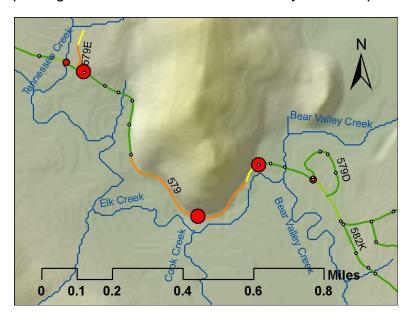
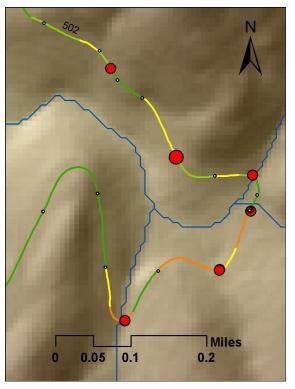
Figure 5. Maps of fine sediment delivery to channels by road segment and drain point. As indicated in the legend below, the road line is colored to indicate the predicted mass of fine sediment that is produced on the road and delivered to the channel. The size and color of the circle indicate the accumulated mass of sediment delivered through each drain point. All red circles indicate a drain point that is actively delivering sediment to streams while small white points represent a drain point not connected to the stream (see Legend below). See Table 6 for length of sediment-contributing road segments and amount of sediment delivery for each displayed road.

A) NFSR 569 leading to Whitehawk Lookout has a steeper grade (9% average for displayed segment) compared to most Bear Valley roads and has the highest sediment delivery rate out of any stretch of road in the entire watershed (see Table 6).

Bear Valley Road, FR 582 (B), at the headwaters of Bear Valley Creek drains large quantities of sediment to streams. This segment of the Bearskin Road, FR 563 (C), has frequent drain points that are connected to a stream. Along Fir Creek from Cape Horn Summit to the cutoff for the Fir Creek Campground, NFSR 579 (D) passes through a burn area and exhibits concentrated flow and frequent sediment delivery. The NFSR 579 culvert crossing of Fir Creek was upgraded to a bridge to allow aquatic organism passage in 2009 after the GRAIP survey was completed. The project included a new

ditch lined with rock. The project was designed to significantly reduce the sediment delivery at this stream crossing.

E) FR 579 near the confluence of Elk Creek and Bear Valley Creek runs very close to the banks of Elk Creek. The two delivering drain points nearest Elk Creek, and their adjacent road segments, represent diffuse drainage and not

concentrated flow. Although well-defined flow paths and drain points did not occur on this road segment, evidence of fine sediment reaching the channel was observed by the field crew. It is unlikely that any improvements, short of road realignment) could mitigate sediment delivery along this road segment because of the close proximity between the road and the stream and the road is already draining diffusely.

F) NFSR 502 has multiple stream crossings, many of which are directly receiving sediment. This portion of NFSR 502 has three stream crossings. The streams in this image are unnamed streams in the headwaters of Bear Valley Creek.

A map of the road surface sediment delivery and the accumulated sediment delivered through drain points is shown for portions of NFSR 569, FR 563, NFSR 579, FR 579, FR 582, and NFSR 502 (Figure 5). These road segments have relatively high levels of stream connectivity and sediment delivery.

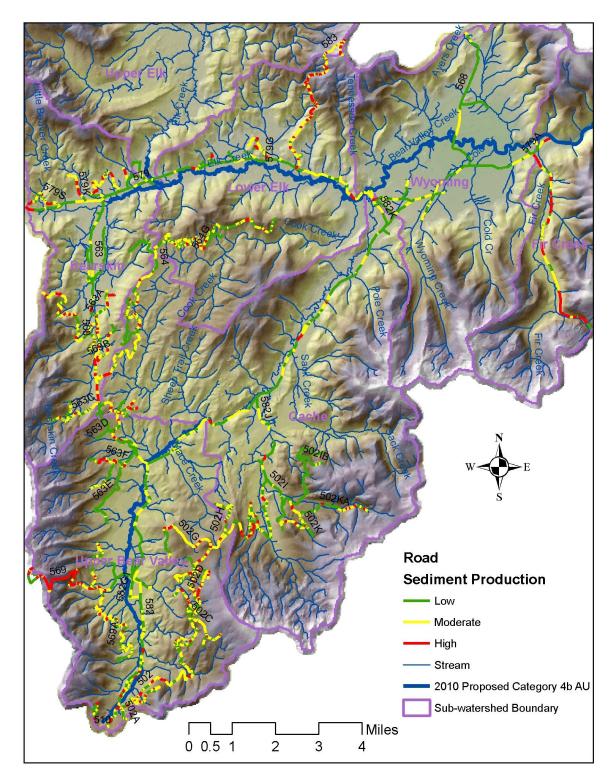
Figure 6. Bear Valley area map of relative sediment production rates by road segment.

Sediment Production on roads in the Bear Valley area occurs at various rates. As previously mentioned, the total amount of fine sediment production from roads is 8,091 tons/year (7,340.4 tonnes/yr). Figure 6 displays the relative sediment production rates on roads throughout the Bear Valley and Elk Creek watersheds. As would be expected, roads with steeper gradients produce the most sediment. For example, NFSR 569 and NFSR 583 appear to be high sediment producers. Given the high level of fine sediment delivery from NFSR 569, it would be assumed that the production rate is also high, which is estimated to be 537.5 tons/year (487.6 tonnes/yr) or 7% of the total. NFSR 583 (Photo 3) delivers very little sediment to streams, yet its production rate is among

the highest in the basin at 736.1 tons/year (667.8 tonnes/yr) or 9% of total. Sediment production is also relatively high where NFSR 579 runs alongside Fir Creek and on much of NFSR 502.

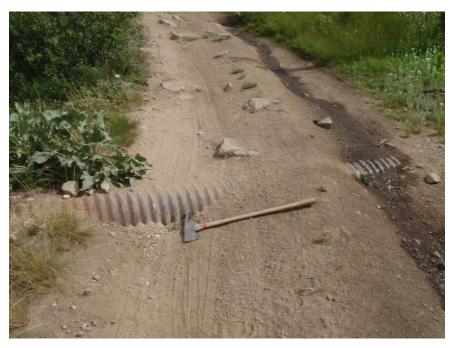
Photo 3. Photo of a road segment of NFSR 583 leading to Bear Valley Mountain Lookout. Although, this road delivers very little sediment, much of the road is badly eroded and yields high sediment production rates.

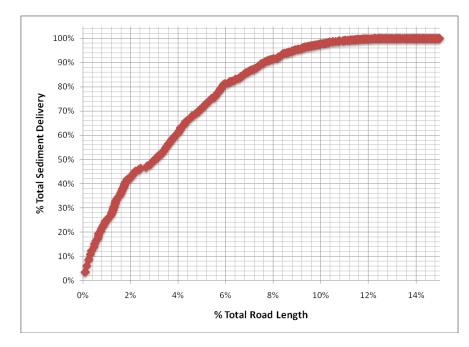
Figure 7. Percentage of the total amount of fine sediment delivered to a stream channel explained by the percentage of the total road length.

The fraction of sediment delivered can be quantified in terms of percentiles of road length. Figure 7 displays the distribution of individual road segments contributing fine sediment to a channel by road length. Of the 146 miles (235 km) of total road length, 4.5 miles (7.2 km) are generating 50% of the sediment delivered to streams. That means approximately 3% of the road length surveyed is generating half of the road sediment load found in Bear Valley streams. This includes many of the road segments displayed in Figure 5. Less than 6% (8.6 mi or 13.8 km) of road length generates 80% of sediment delivered, 7.6% (11.1 mi or 17.9 km) generates 90%, and 12.5% (18.3 mi or 29.4 km) generate 100% of sediment delivered.

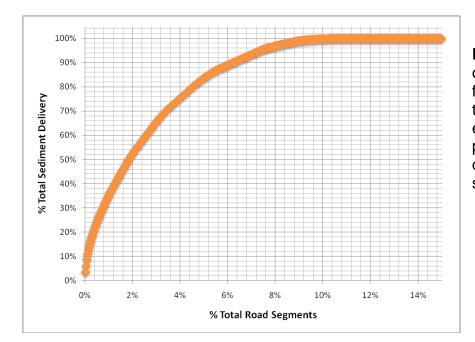
Figure 8. Percentage of the total amount of fine sediment delivered to a stream channel explained by the percentage of the total quantity of road segments.

The total number of road segments is not meaningful for many analytical puposes because each road segment varies in length and other characteristics. However, it is useful to note the number of recorded road segments that would require attention or repair for management purposes. Not all problematic road segments are adjacent to each other, which may necessitate detailed logistical planning for the implementation of project work. Figure 8 demonstrates the relationship between the percentage of total sediment delivery to streams and the percentage of all road segments contributing sediment. Out of a total of 3,175 individual road segments, 338 (11%) are delivering sediment to streams. Of these segments, 59 (1.9%) are contributing 50% of the sediment, 145 (4.6%) account for 80% of the sediment, and 198 (6.2%) generate 90% of delivered sediment.

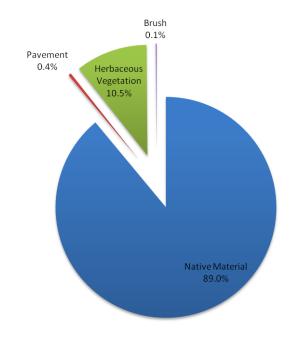
Figure 9. Distribution of road surface types found in Bear Valley by road length.

The dominant surface type found on Bear Valley roads was native material (see Figure 9). Many decommissioned, closed, or otherwise lightly-used roads were found to have grasses and herbaceous vegetation growing abundantly on the road surface. Small lengths of closed or decommissioned roads had significant amounts of brush growing on the surface. A short segment of NFSR 568 to Dagger Falls was previously paved to reduce sediment delivery in this important Chinook spawning reach adjacent to the Bear Valley Creek crossing. Native surfaced roads produce considerably more sediment than other surface types, with paved roads producing the least amount of sediment. The GRAIP model calculates that native surfaced roads produce 25 times the sediment of paved roads, and 5 times that of any other surface type.

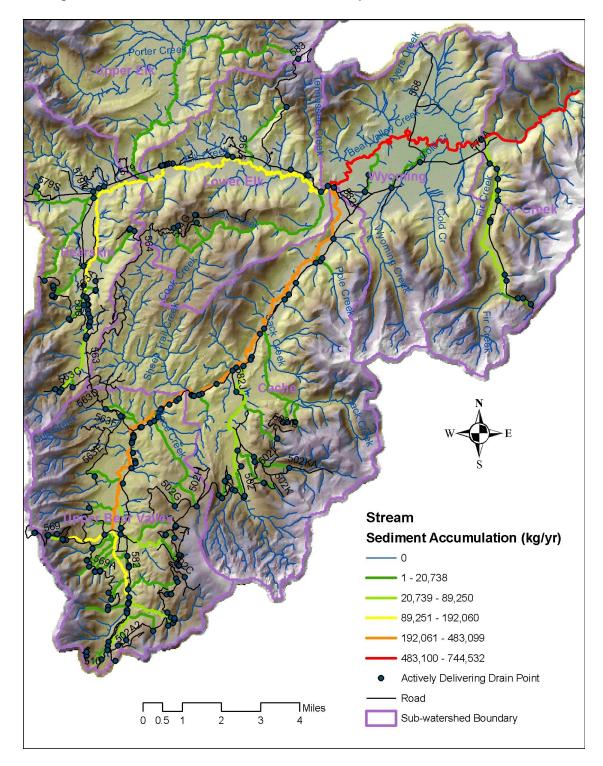
total accumulated sediment from upstream stream segments (Figure 10). The total predicted amount of accumulated road sediment found in the stream segment nearest to the mouth of Bear Valley Creek was 820.7 tons/year (744.5 tonnes/yr). The sediment load was greatest after the confluence of Bear Valley and Elk Creeks.

The majority of stream sediment accumulation (74%) is produced by roads which drain to Bear Valley Creek and its tributaries, a total of 609.0 tons/year (552.5 tonnes/yr). From this amount 532.5 tons/year (483.1 tonnes/yr) or 65% of total sediment accumulation originates from above the confluence with Elk Creek. Cache Creek contains 52.0 tons/year (47.2 tonnes/yr) at its mouth. Elk Creek and its tributaries carry 211.7 tons/year (192.1 tonnes/yr) of road sediment (26% of total) prior to converging with Bear Valley Creek.

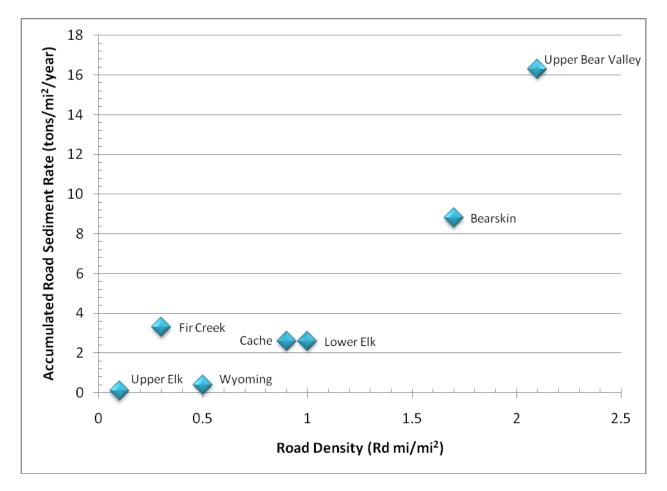
In comparing road density to the accumulated road sediment rate (Figure 11), where higher road densities exist, higher accumulated road sediment rates generally occur as well. However, this is not true for all sub-watersheds in the basin. The Fir Creek and Upper Bear Valley sub-watersheds have higher accumulated road sediment rates in comparison to their road densities than do most other sub-watersheds, whereas the Wyoming and Upper Elk sub-watersheds have lower ratios. Upper Elk measures extremely low in both categories, which would be expected as it has a large area and very little road length. Although the sample size of sub-watersheds for this basin is too low to draw out any real statistical correlation, the two sub-watersheds with the highest road density, Bearskin and Upper Bear Valley, also have the highest accumulated road sediment rates. Many other variables, such as terrain and geology, may also be related to this phenomenon.

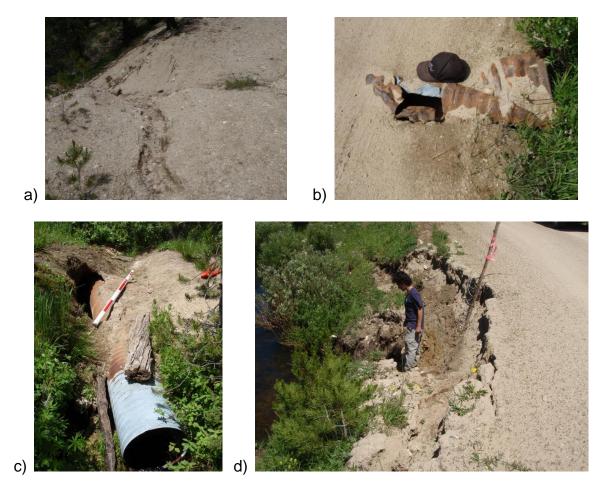
Photo 4. Examples of drain point condition problems including: a) erosion at a broad based dip, b) a rusted and damaged ditch relief culvert, c) a stream crossing with flow around and possibly over the pipe, and d) a non-engineered feature where the stream is cutting into the road fill material.

The GRAIP inventory involves an assessment of the condition of each drain point and a determination of how well it is performing its intended function. Problems with drain point condition are pre-defined for each drain type. Broad based dips are considered to be in poor condition if they are insufficiently outsloped and pond water on the road. Culverts are defined to be in poor condition if they have more than 20% occlusion of the inlet by sediment, substantial inlet crushing, significant rust, or flow around the pipe. Lead off ditches are considered problematic if they have excess deposition or are gullied. Non-engineered features are almost always a problem due to a blocked ditch, a gully, a broken outside berm, or a diverted wheel track. Stream crossings are considered a problem if they are blocked by sediment or wood, crushed or rusted significantly, incising, scouring or loosing much water from flow around the pipe. Sumps are a problem if they pond water on the road surface or cause fill saturation. Water bars that are damaged, under sized, or do not drain properly are defined as problematic. Diffuse drains (outsloped roads) are rarely observed to have drain point problems.

In Bear Valley, non-engineered features were observed to have the highest rate of problems (58%), while lead off ditches or berms and diffusely drained roads were least likely to have problems (Table 8). Any drain point that causes erosion of fill material at its outlet is considered problematic. Drain point features that most often eroded fill material at the outlet or away from the fillslope were non-engineered features and water bars (both at 4%).

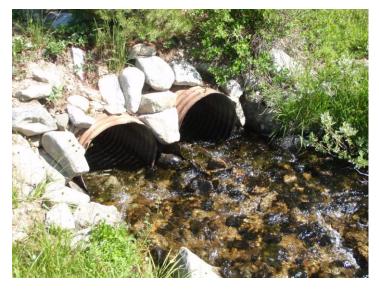
Photo 5. Many stream crossings such as this one have more than one pipe to prevent blockage or flow diversion. SBI figures do not account for the presence of multiple pipes which means some SBIs may predict higher risk than what actually exists.

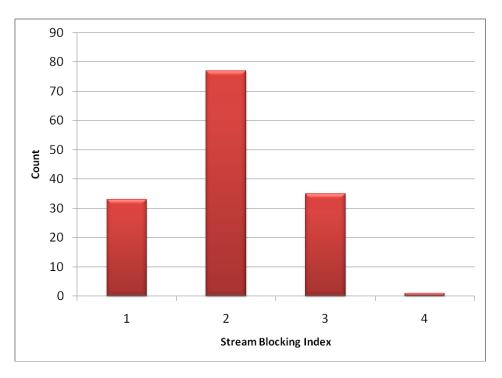
Figure 12. Distribution of Stream Blocking Index values.

The SBI values for Bear Valley stream crossings were relatively high with an average value of 2 for the 146 assessed stream crossings (Figure 12). This is out of a range of 1 to 4, where 1 suggests minimal to no risk of blockage. The 36 stream crossings with values of 3 and 4 all had pipe to channel width ratios equal to or less than 0.75. Approximately one third of these crossings had a channel angle (angle at which the channel enters the pipe) greater than 25 degrees. Some stream crossings predicted to be at risk in Bear Valley may not be as prone to failure as predicted. Therefore, a more thorough field survey of stream crossings with high SBIs would indicate where failures would likely occur and where repair is needed.

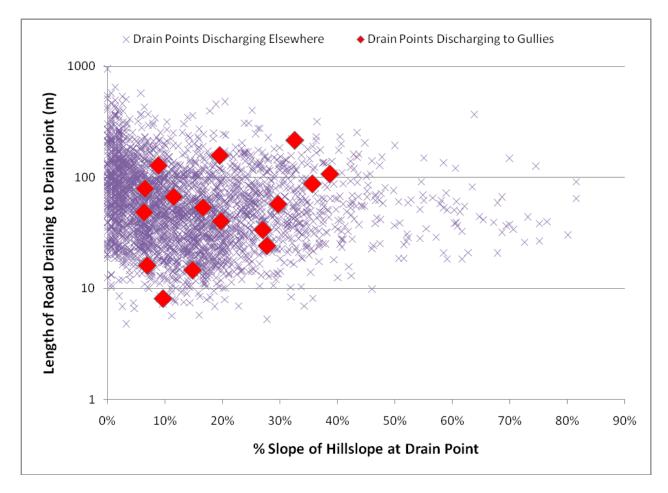
Figure 13. Distribution of where drain points discharge flow from the road by ELength and slope of the hillslope at the drain point.

is no ESI at which the risk of gullying increases significantly, because the drain points with gullies are distributed relatively evenly throughout the road length-discharging hillslope range (Figure 13).

The average ESI for all drain points was 1.9, with an average contributing road length of 61 m. The average slope of the hillslope at the drain point was 14%. Of all drain points discharging to a gully, 10 (59%) had an ESI less than the average of 1.9. This affirms the conclusion that the sample of observed gullies in Bear Valley is insufficient to determine ESI_{crit}, which suggests that the gullies found in Bear Valley are not strongly tied to road length draining to them or the slope of the hillslope on which they are located. Other factors such as localized geology, past wildfires, or isolated large storm events may be causes of the gullies that do exist. Given the active wildfire history of the basin, it might be predicted that gullying would be a greater risk than observed, especially taking into account concentrated flow from roads. Nearly 30% of the area of Bear Valley burned during the Red Mountain wildfire in 2006 and the Sheep Trail wildfire in 2007, and a total of 59% of the basin has burned within the last 25 years. This emphasizes the prediction that the risk of gullying throughout areas of the watershed with roads is uniformly low.

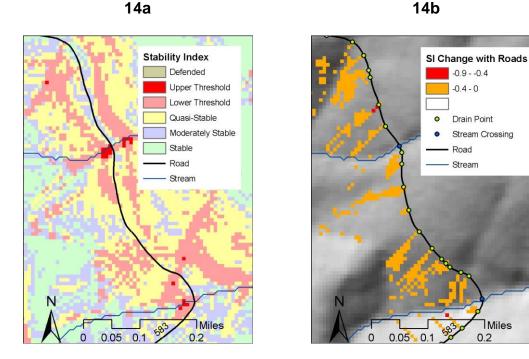
a) SI values for hillslopes in an un-roaded condition.
 b) Negative changes in SI due to the addition of road drainage.

The risk of shallow landslide initiation is predicted using SINMAP 2.0 (Pack et al., 2005, http://hydrology.neng.usu.edu/sinmap2/), then modified to account for contributions of road runoff. An example from NFSR 583 is shown in Figure 14 to illustrate the change in risk in an area where the inherent landslide risk is high. This risk is assessed by referring to an index referred to as the Stability Index (SI). SINMAP was run initially to determine the intrinsic stability (SI) of the slopes over which the road traverses and to identify locations that are at high risk of failure without a road(Figure 14a).

The grid cells surrounding portions of NFSR 583 with increased risk of landsliding due to road drainage are shown in Figure 14b. This stretch of NFSR 583 runs through a previously burned area where flow of water on the road is highly concentrated, resulting in high amounts of energy when water discharges from the road prism. The road surface is highly eroded. The drain points depicted in the figure below are mostly water bars with a few non-engineered drains and one ditch relief culvert. The addition of drain points to the roads primarily increased previously existing high landslide risk. Instances where previously stable hillslopes were classified as unstable due to road drainage were few.

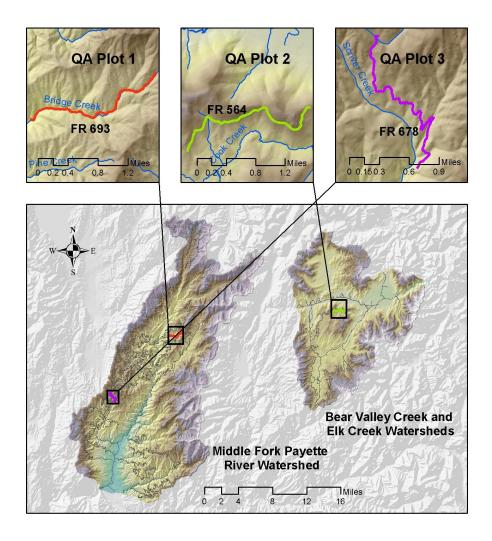
Figure 15. Map of QA plot locations in the Middle Fork Payette River and Bear Valley and Elk Creek watersheds.
