National Register of Historic Places Registration Form

Historic name: Shenango Work Station

Other names/site number: Squaw Creek Ranger Station, 24GA0788, Squaw Creek Work Center

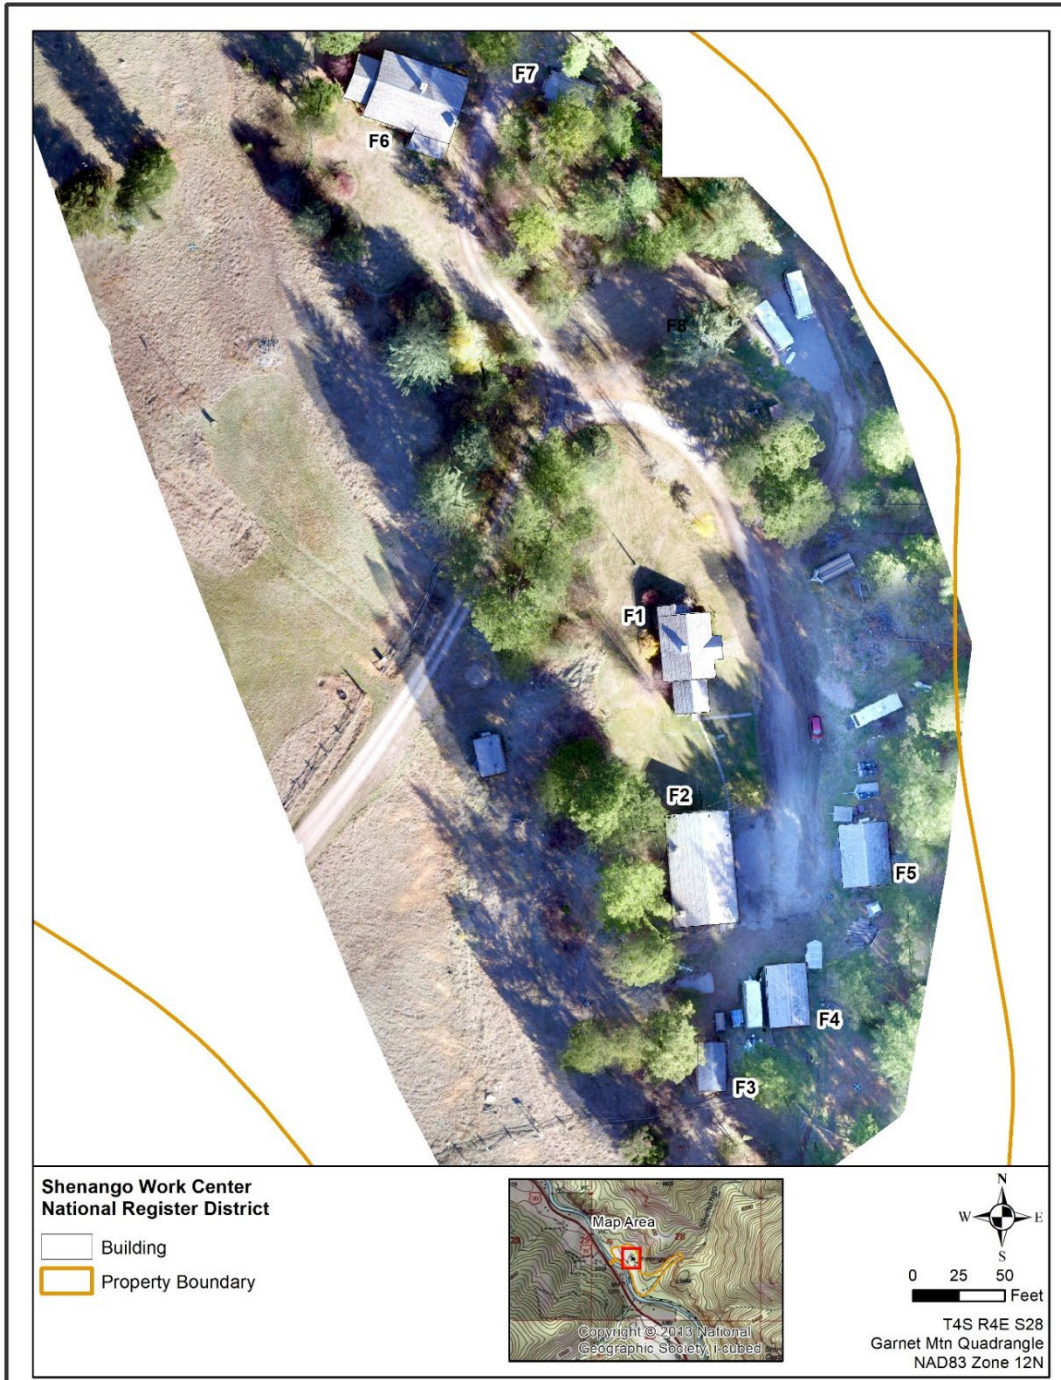
Sketch map with UAV derived orthoimage showing detailed layout of concentration of CCC era buildings on property

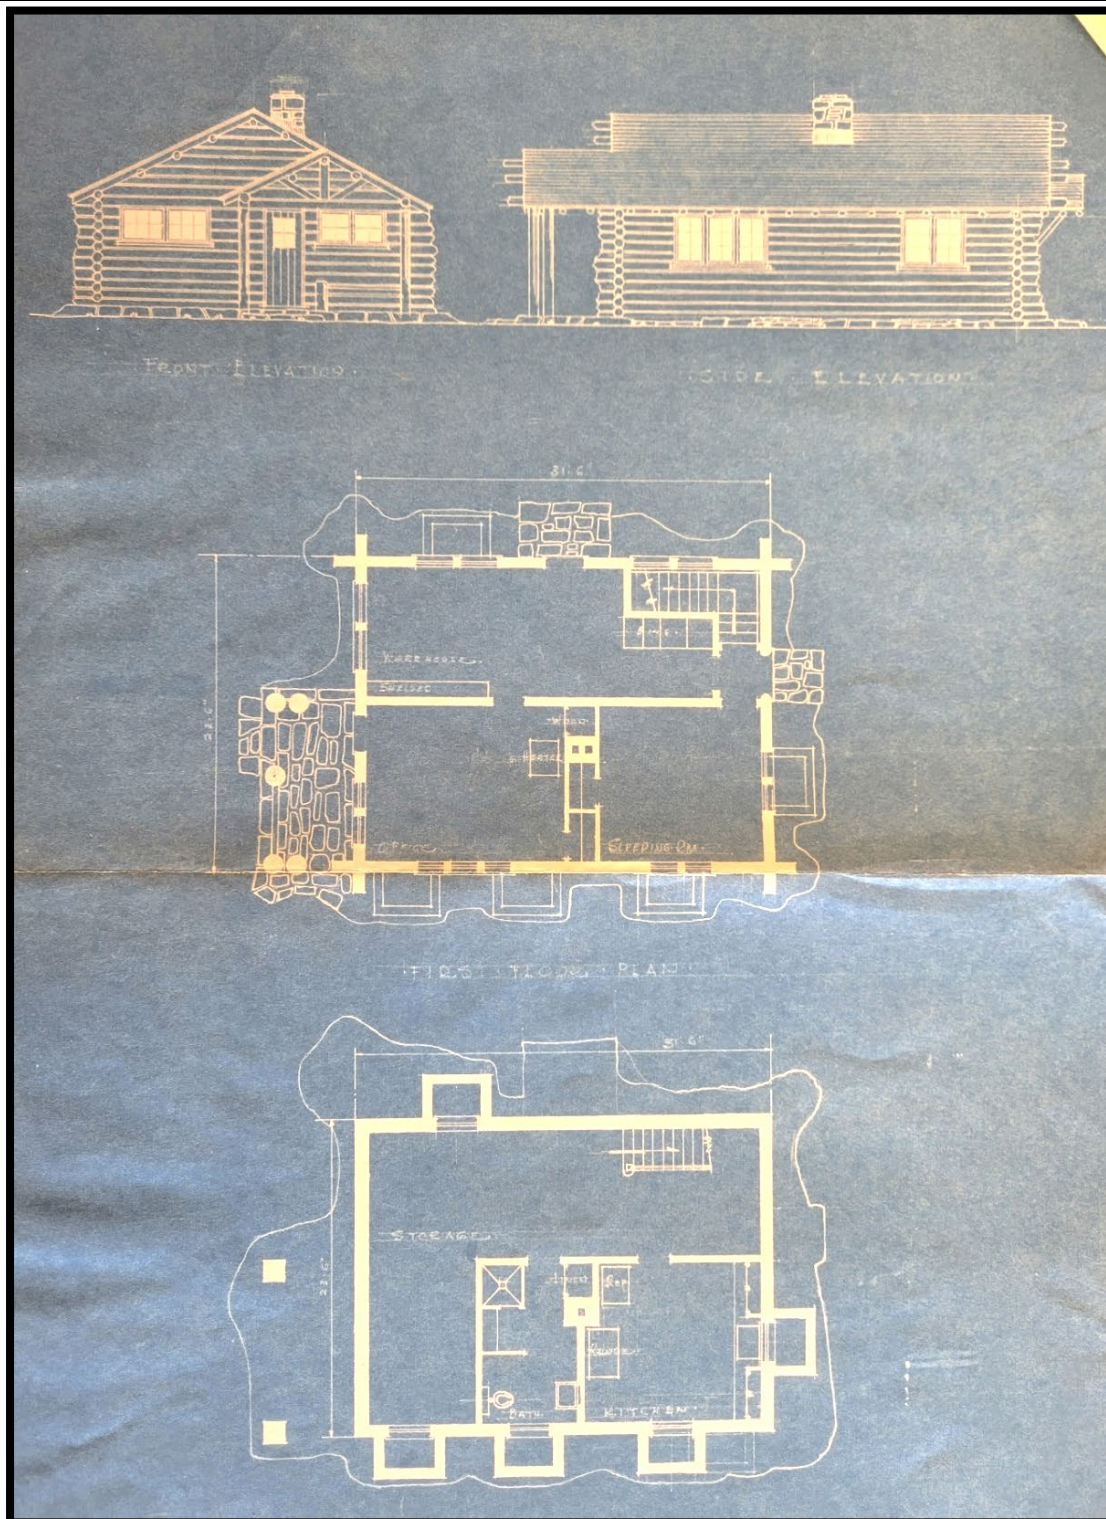
Administration building floor plan for basement, first floor and front and side elevations 1937

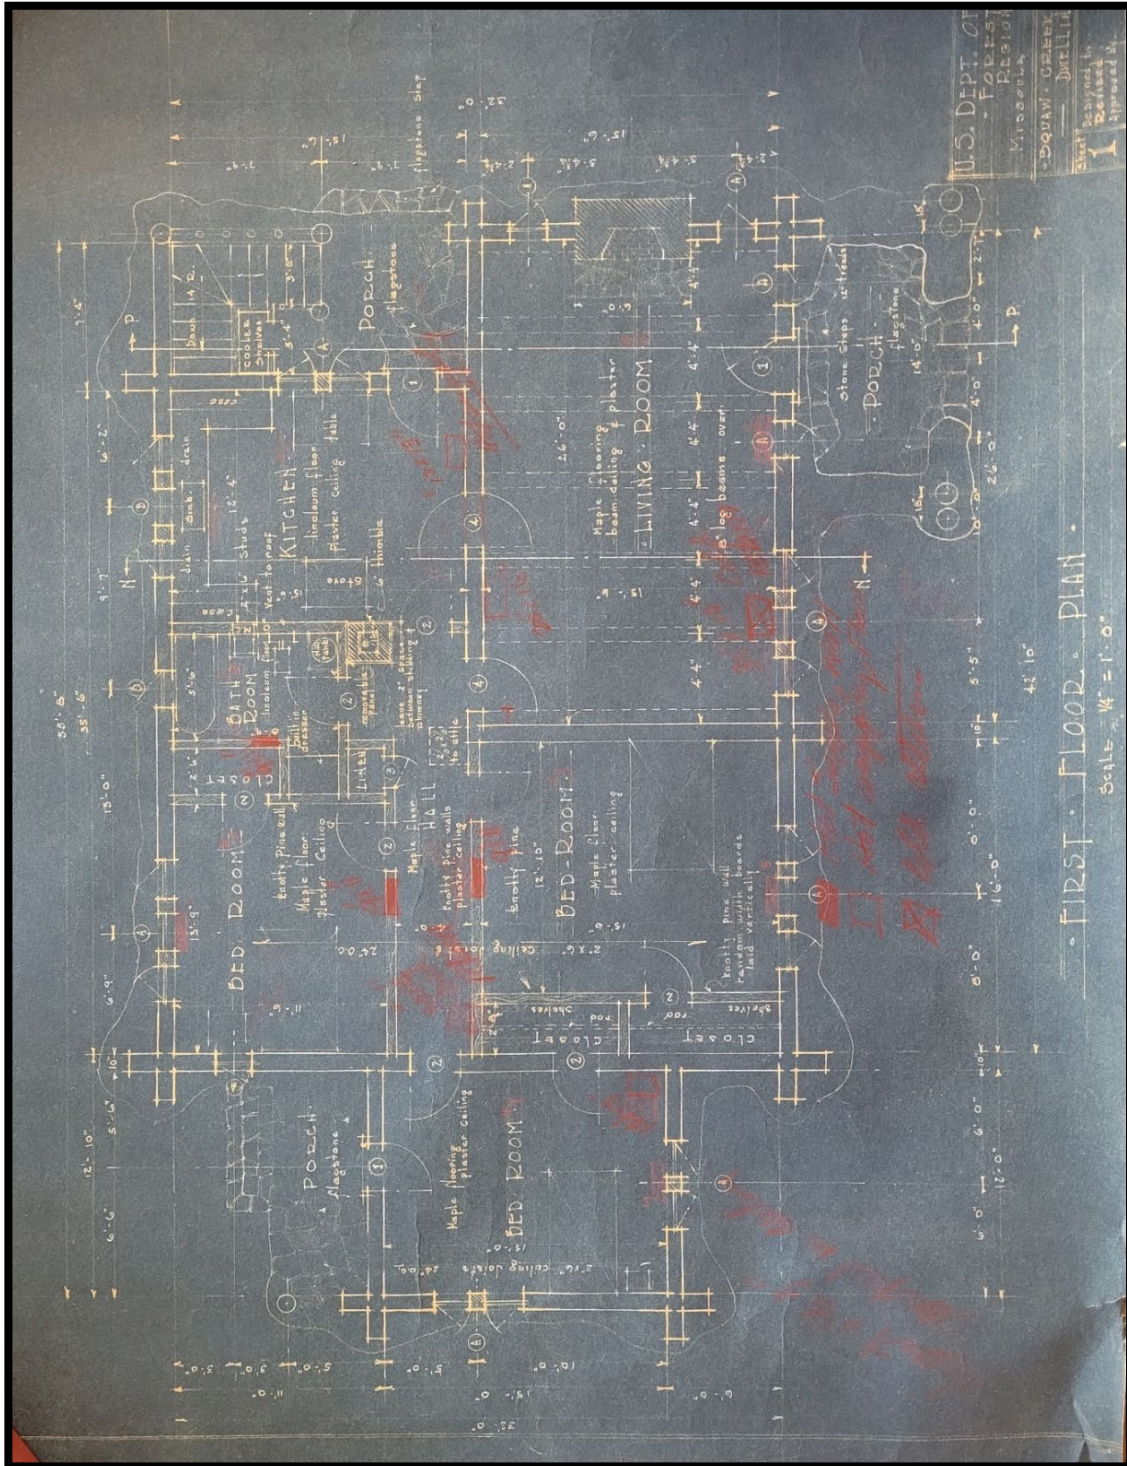
Ranger residence first floor plan revised August 1935 and approved by Fickes

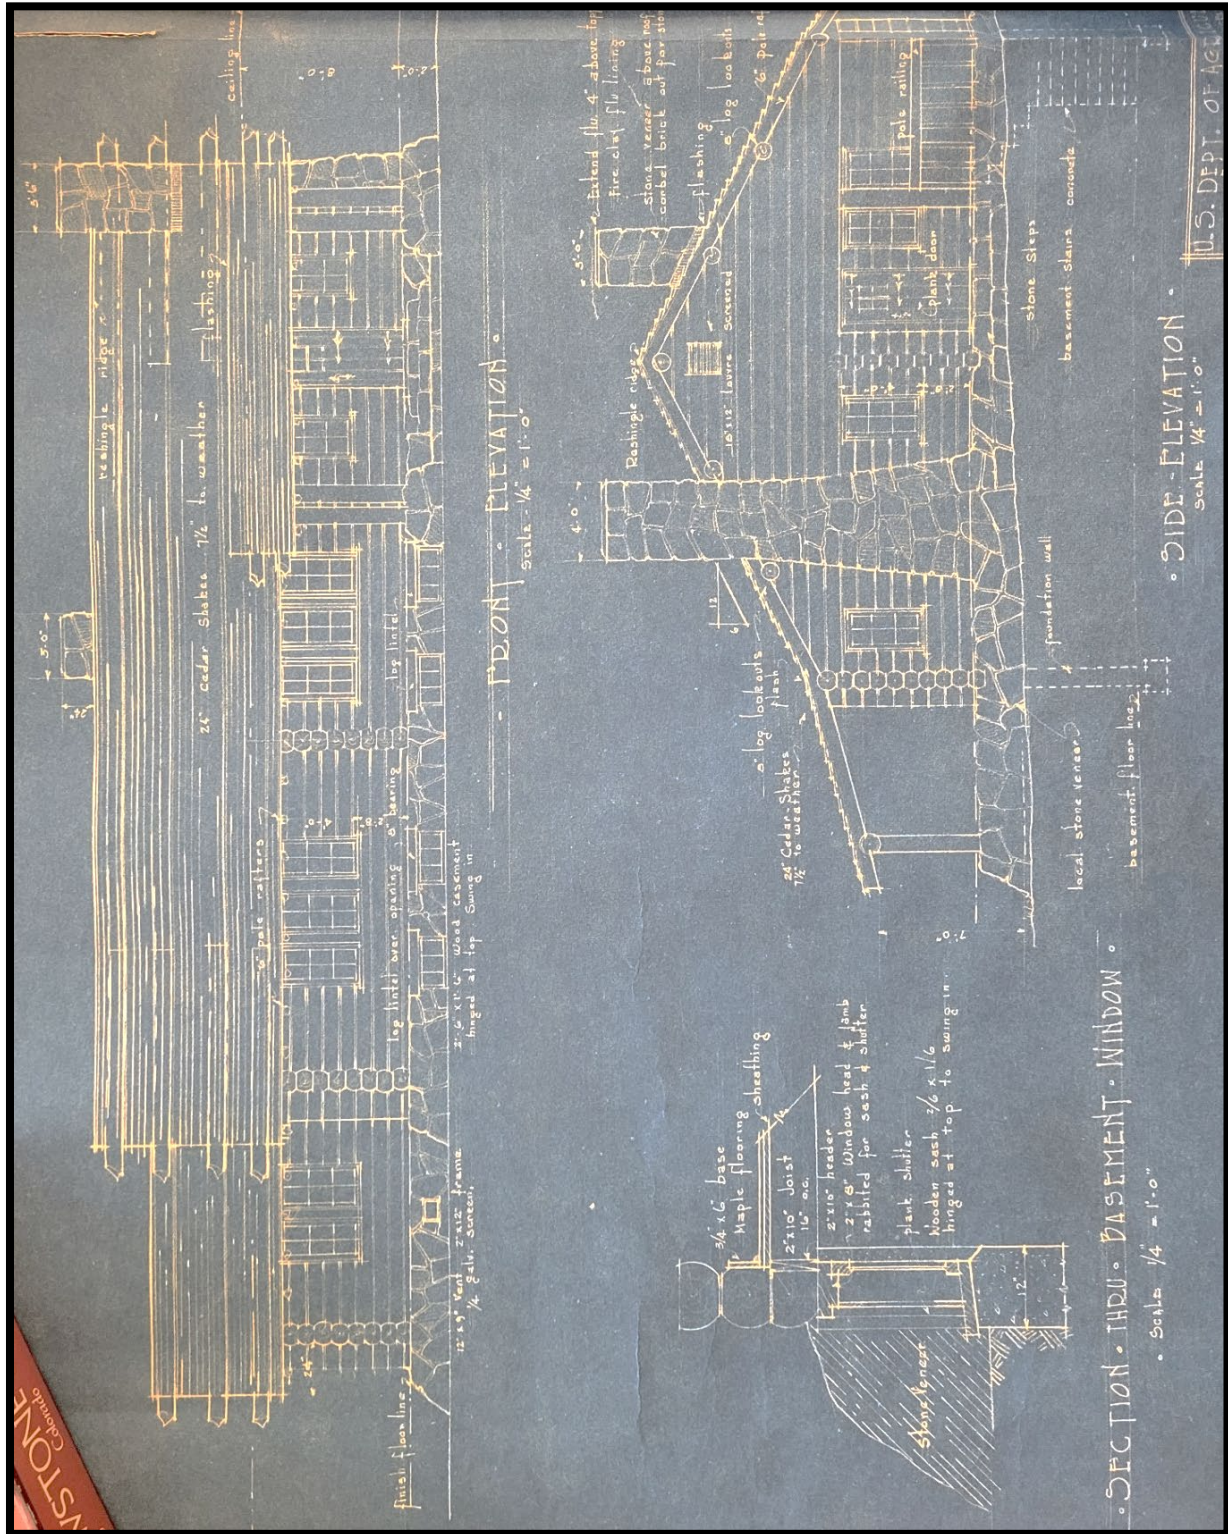
Front and side elevations of Ranger Residence blueprints August 1935 approved by Fickes

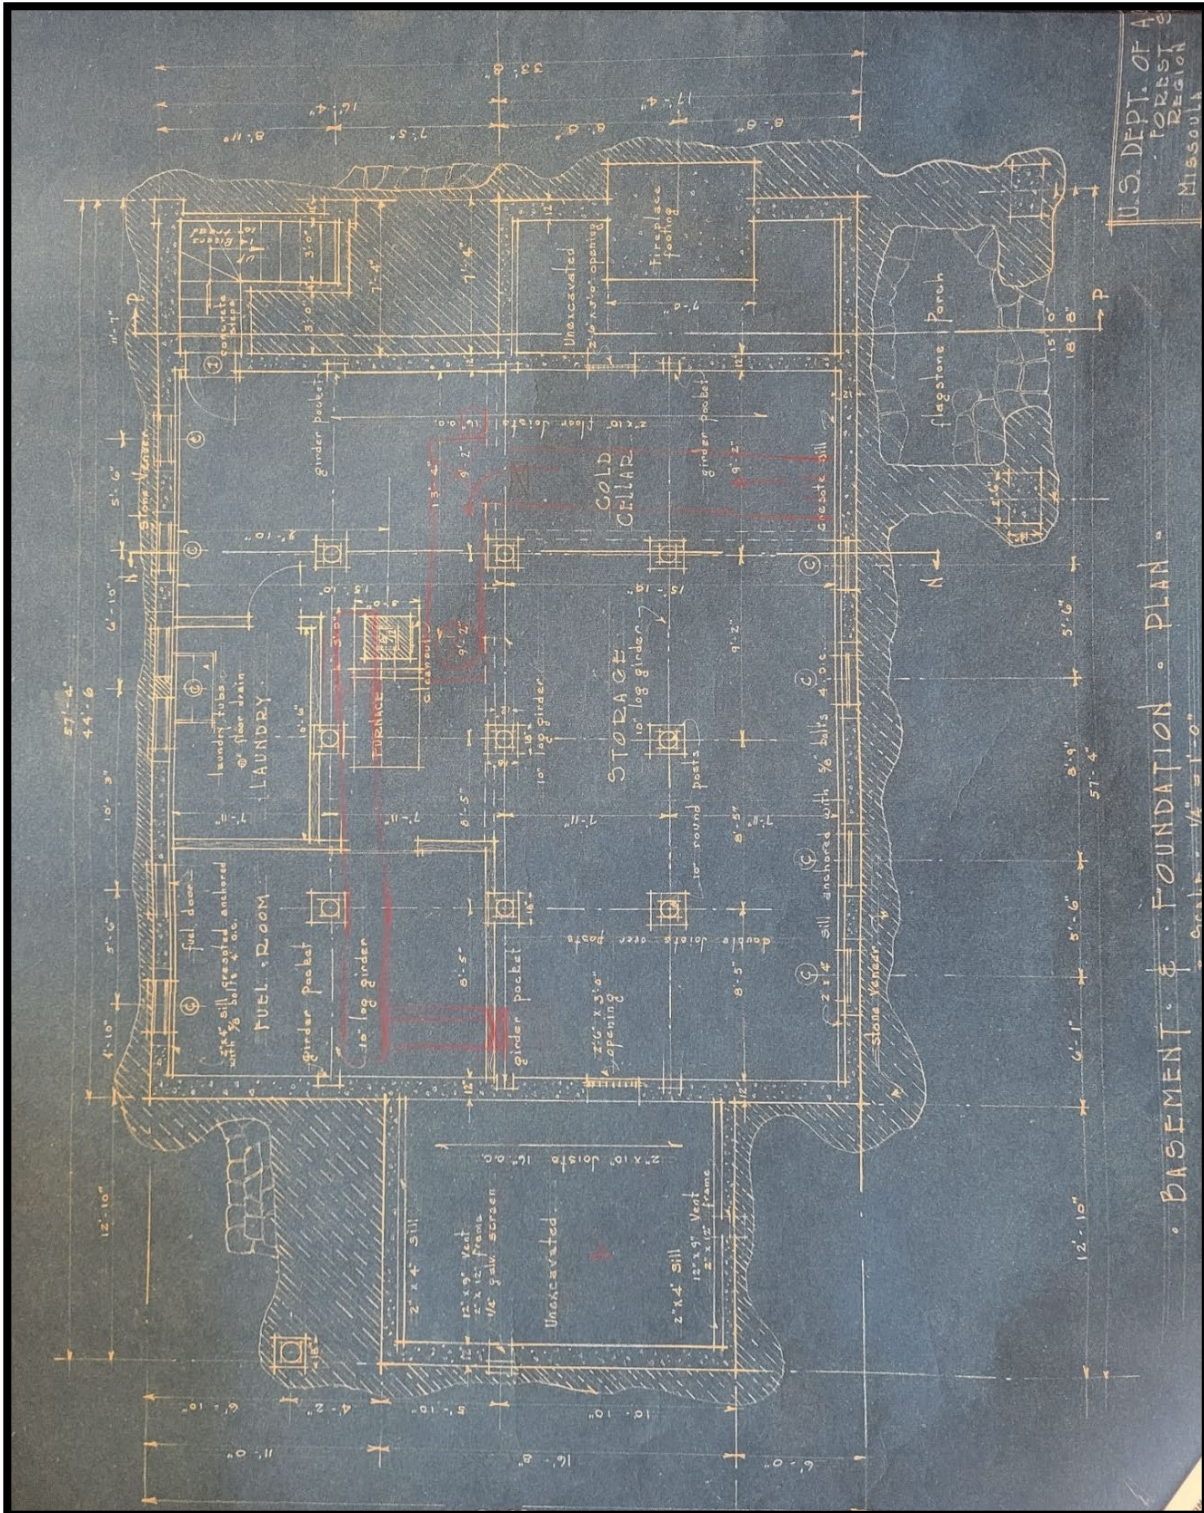
Basement floor plan blueprint for Ranger Residence August 1935 approved by Fickes

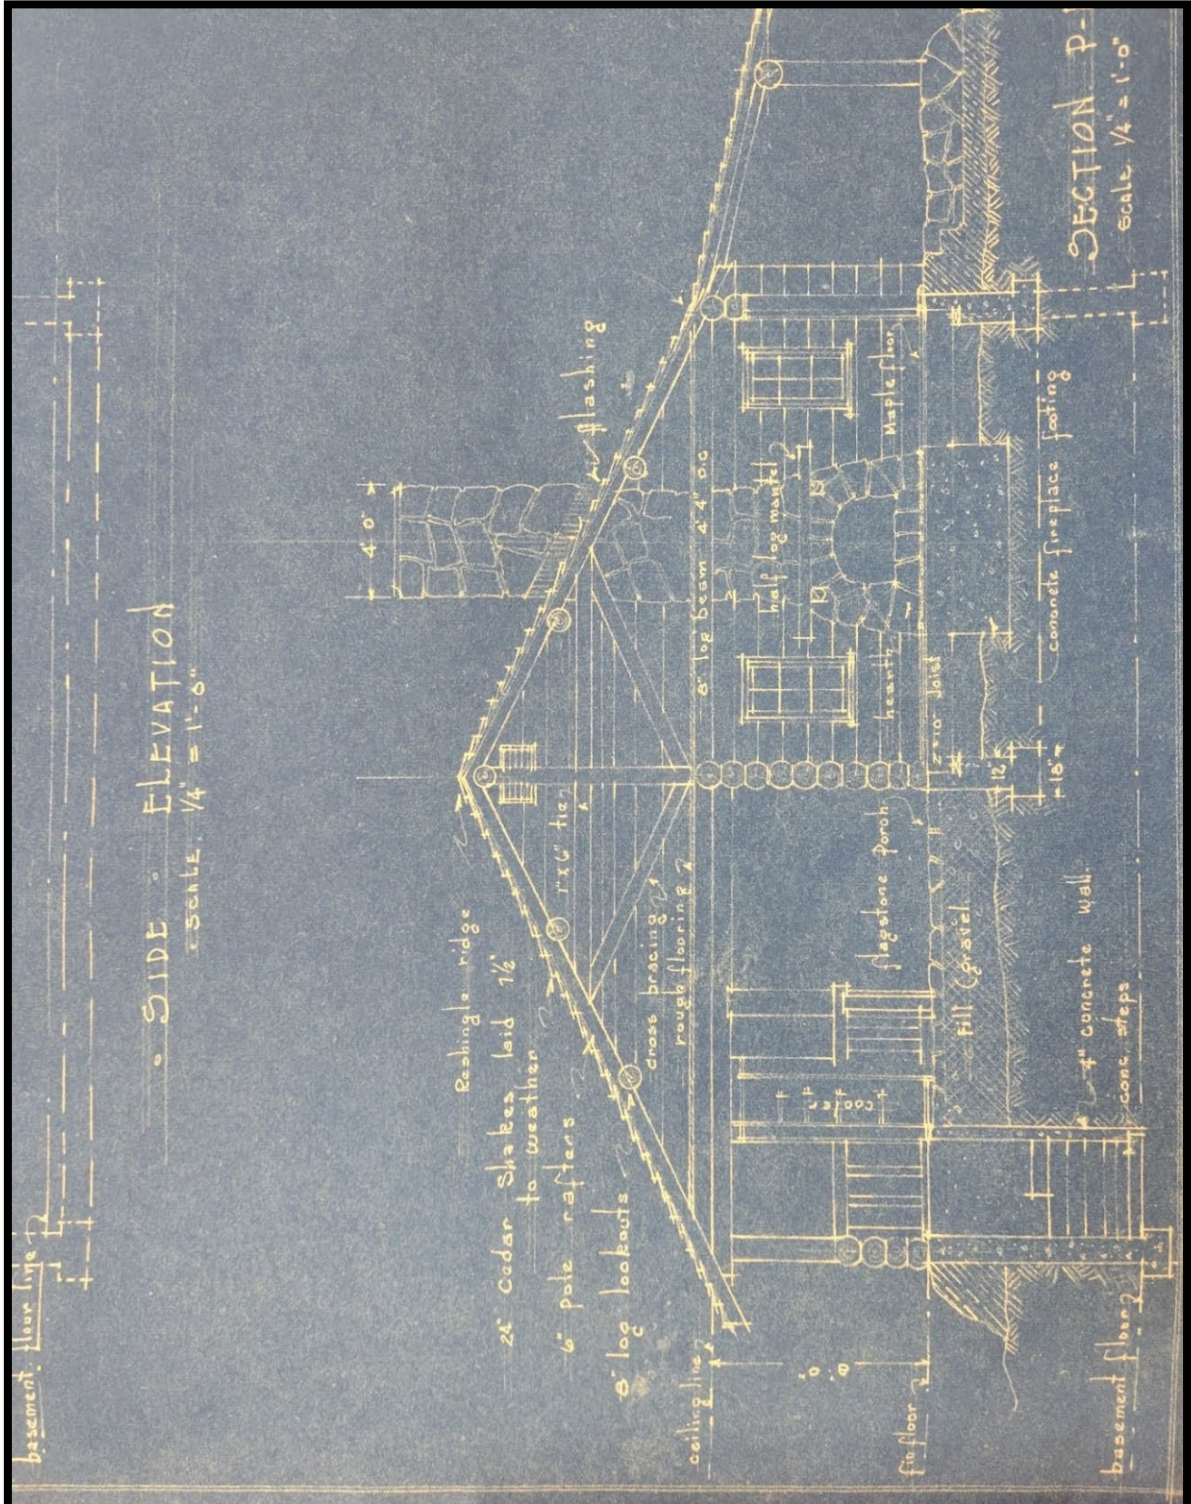
Side elevation of Ranger Residence, blueprint from August 1935

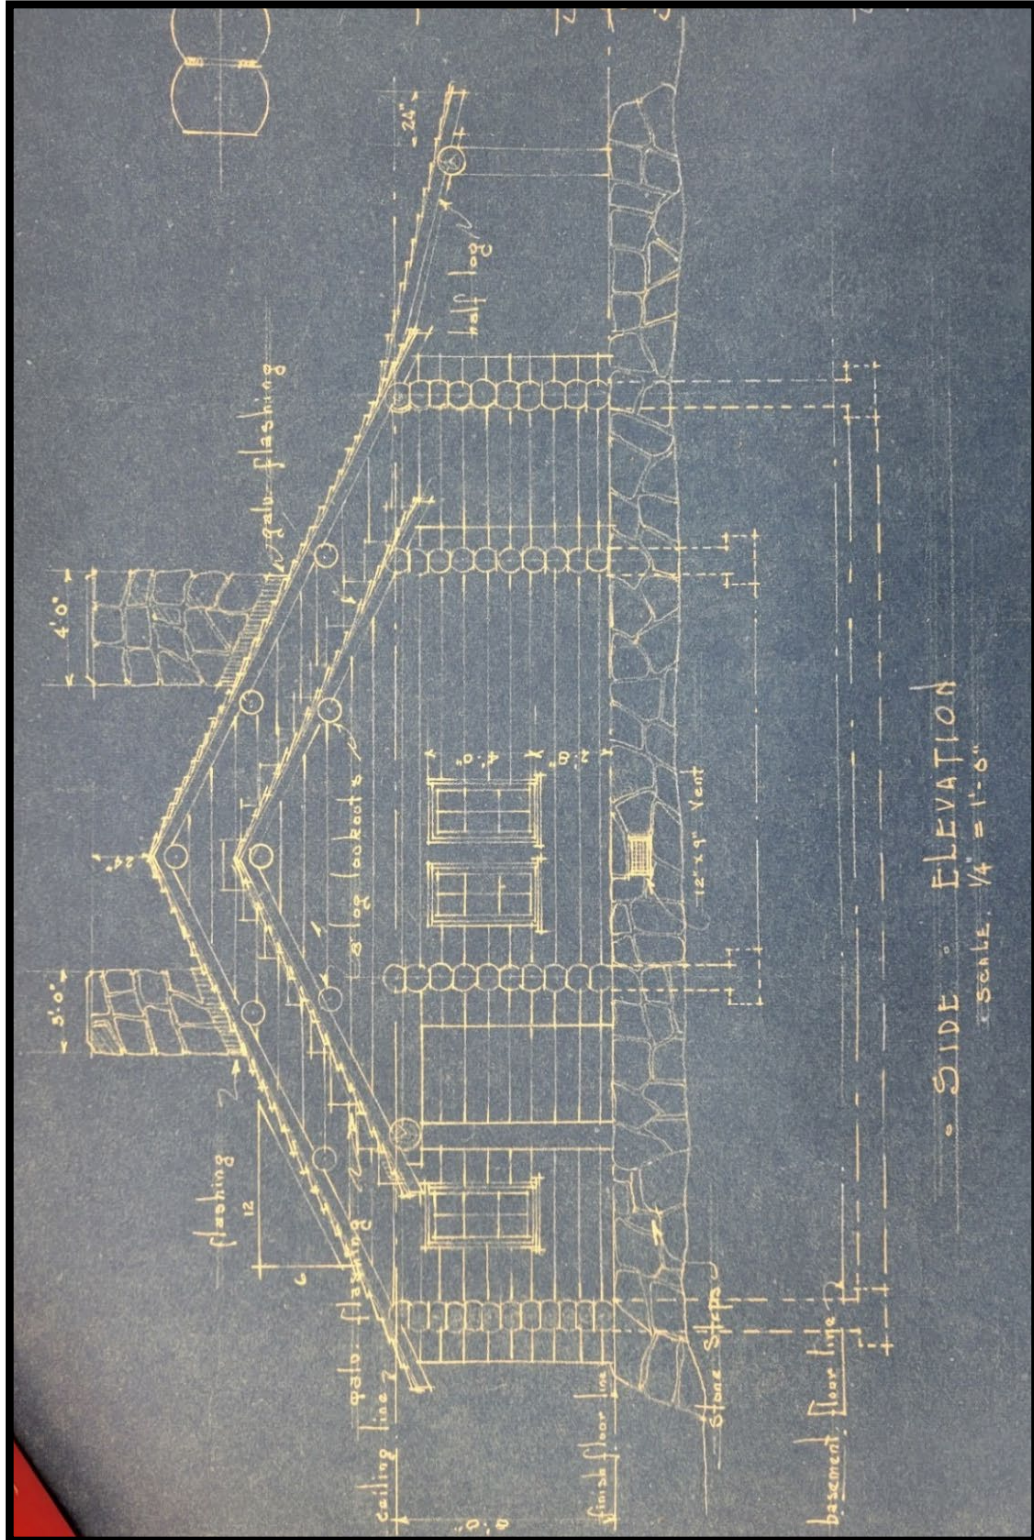
Side elevation of Ranger Residence, blueprint from August 1935

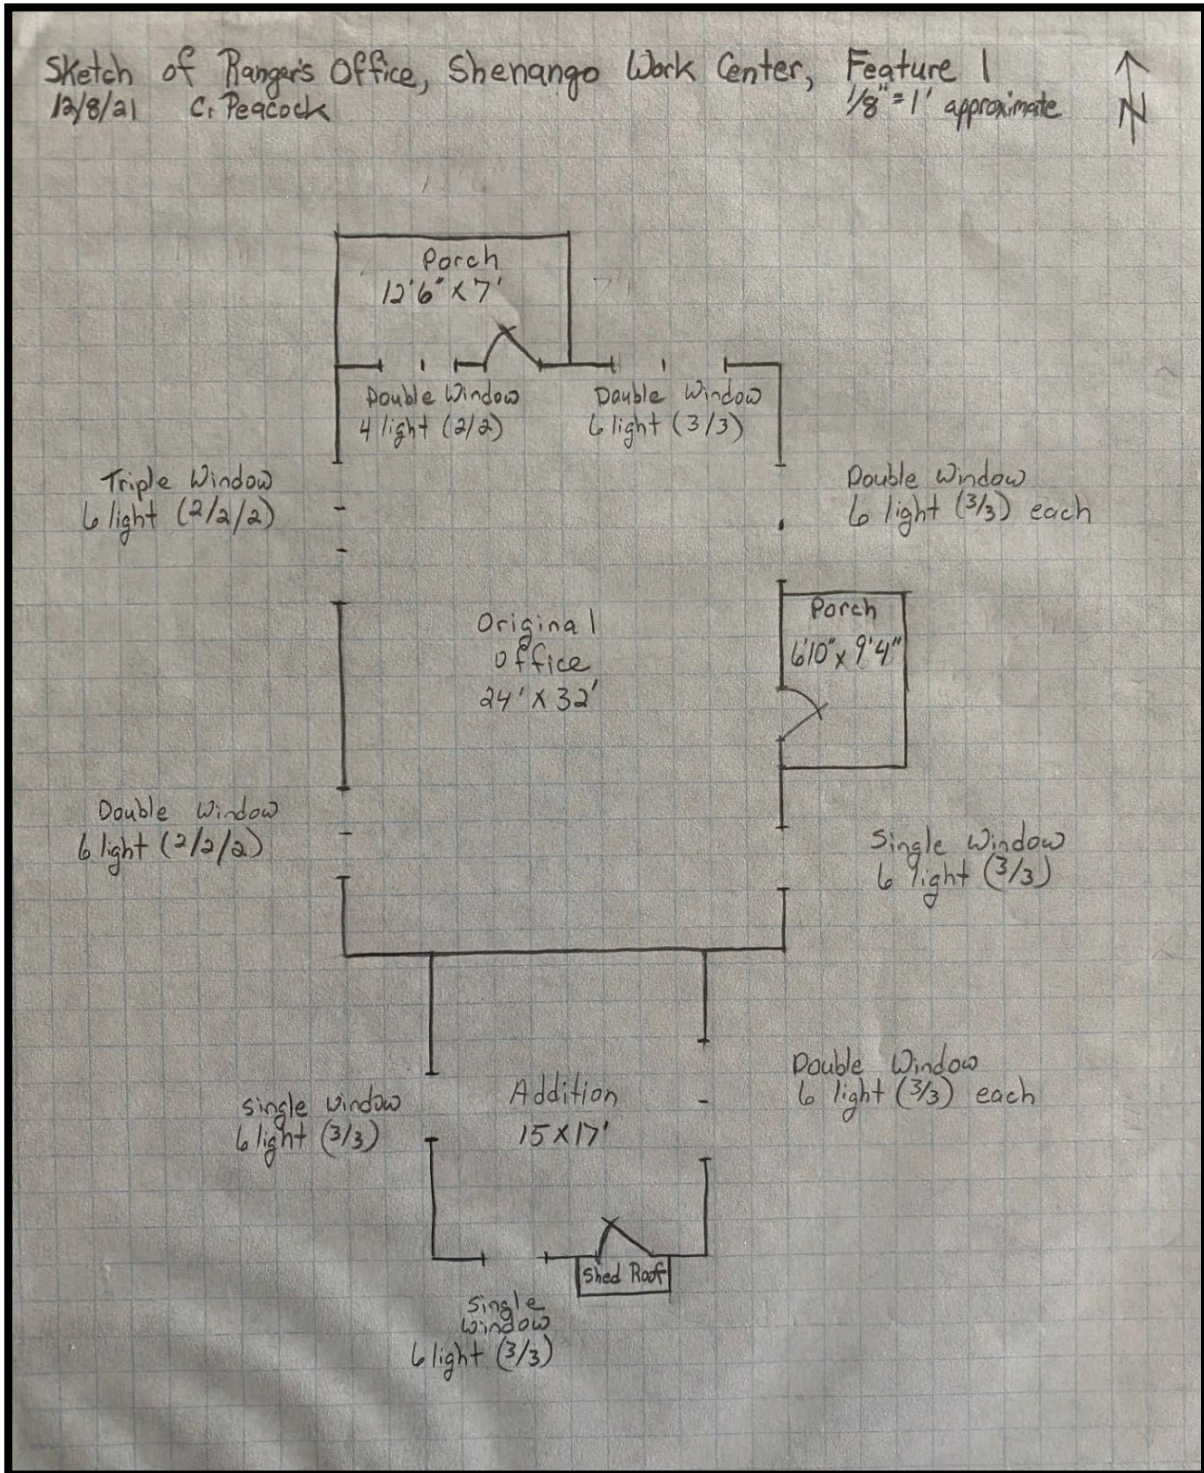
Architectural sketch of Feature 1 Rangers Office

The north elevation has an offset, open-gable porch roof supported by large, peeled round log columns and a king post truss. The porch features a stoop of flagstone set in concrete. The offset wood plank door matches the main entrance door and holds a single, fixed window, decorative wrought iron hinges, and a screen door. There are a pair of 4-lite (2/2) wood frame windows west of the door and under the porch roof, and a bank of two 6-lite (3/3) windows to the east, not under the porch roof. The construction and condition of the north porch, as well as evidence from historic plans, indicates that this porch is original to the structure.

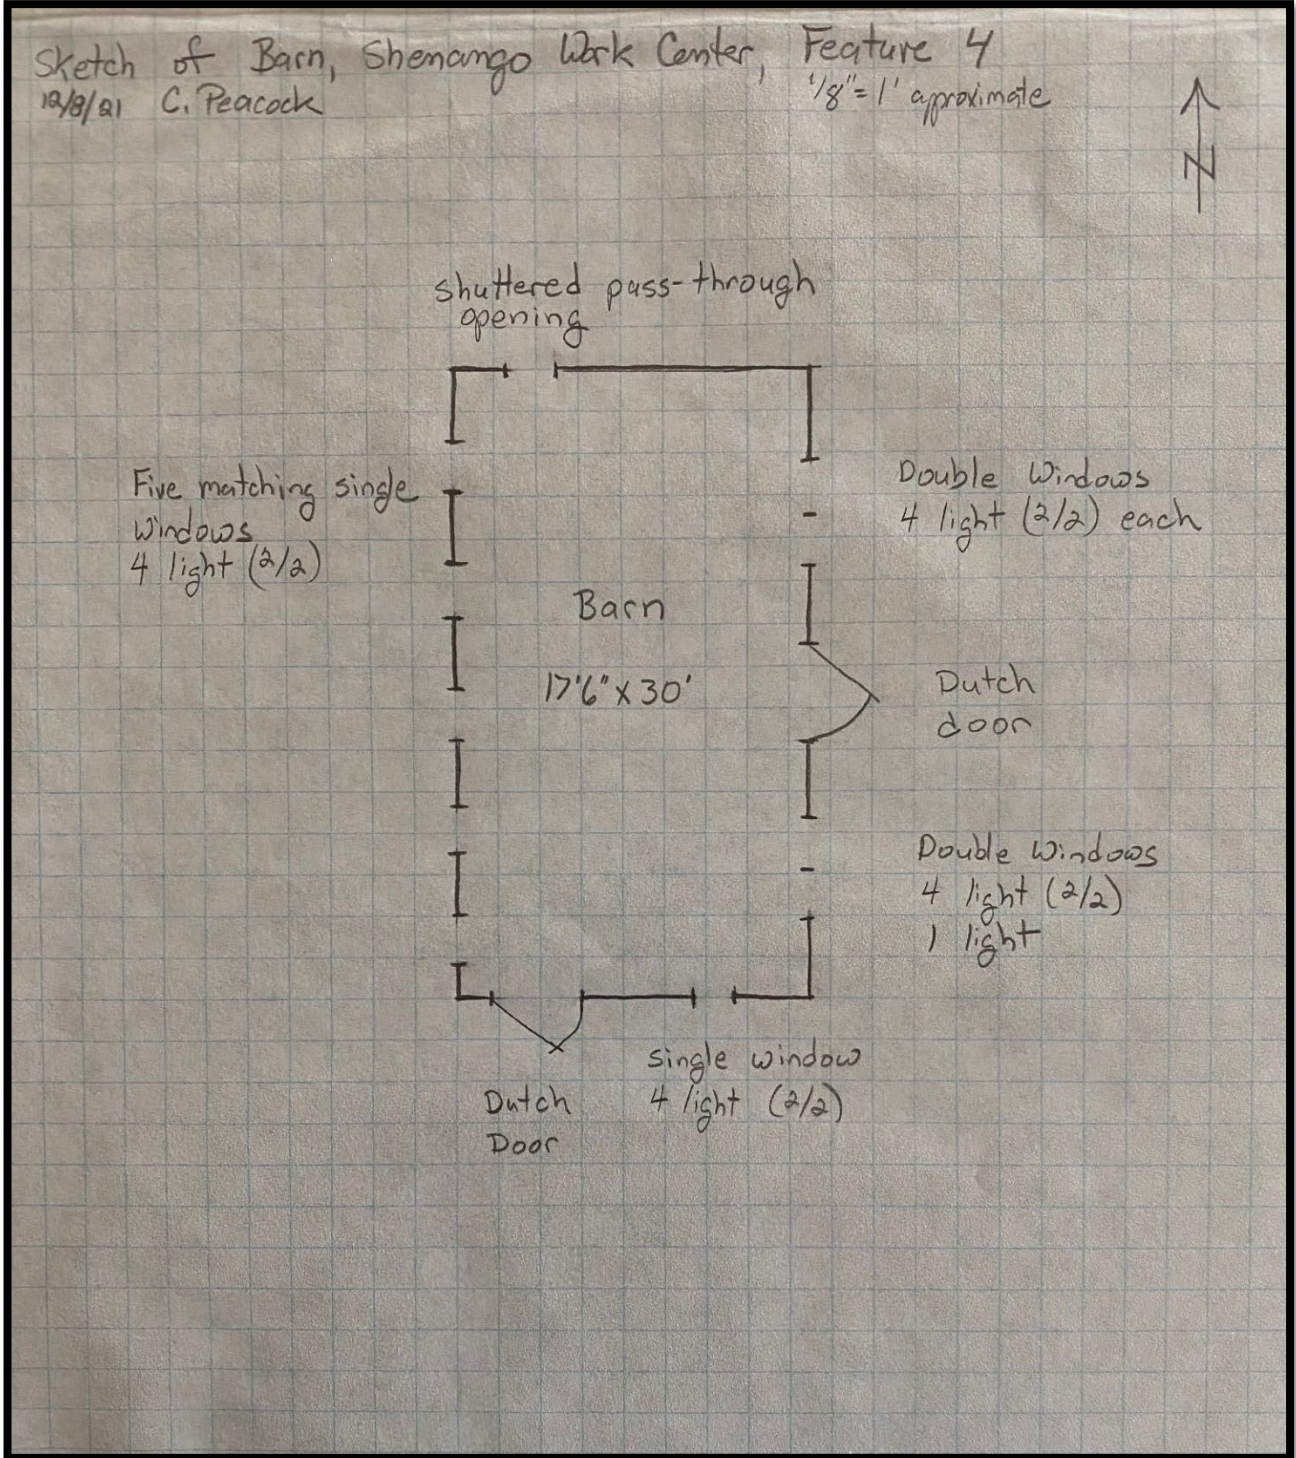
Architectural sketch of Feature 4 barn

Feature 4 – Barn (one contributing building, constructed 1936): The barn, constructed in 1936, is a one and a half story, rectangular, log building of peeled, round logs with saddle-notch joinery and chopper-cut crowns. The foundation is a poured-in-place concrete slab. The side-gabled roof is clad in wood shingles and displays a galvanized metal ridge roll with globe ends. Log rafters and purlins are visible. There are Dutch doors in the north and east elevations and a hayloft door in the north gable end. The south gable end holds a fixed, divided lite window (4 lite, 2/2). The north elevation has a 4 lite (2/2) window to the west of the door. The east and west elevations have four divided lite (4 lite, 2/2) windows each. All windows are a mix of 4-lite fixed and hopper

except for one window on the east elevation that has been replaced with a fixed, single lite. A small, shuttered opening on the south side provides a pass through from the interior of the barn to the attached post and pole corral located to the southeast that compliments the historic qualities of the barn and setting of the property. Some rot is noticeable in the foundation logs of the barn.

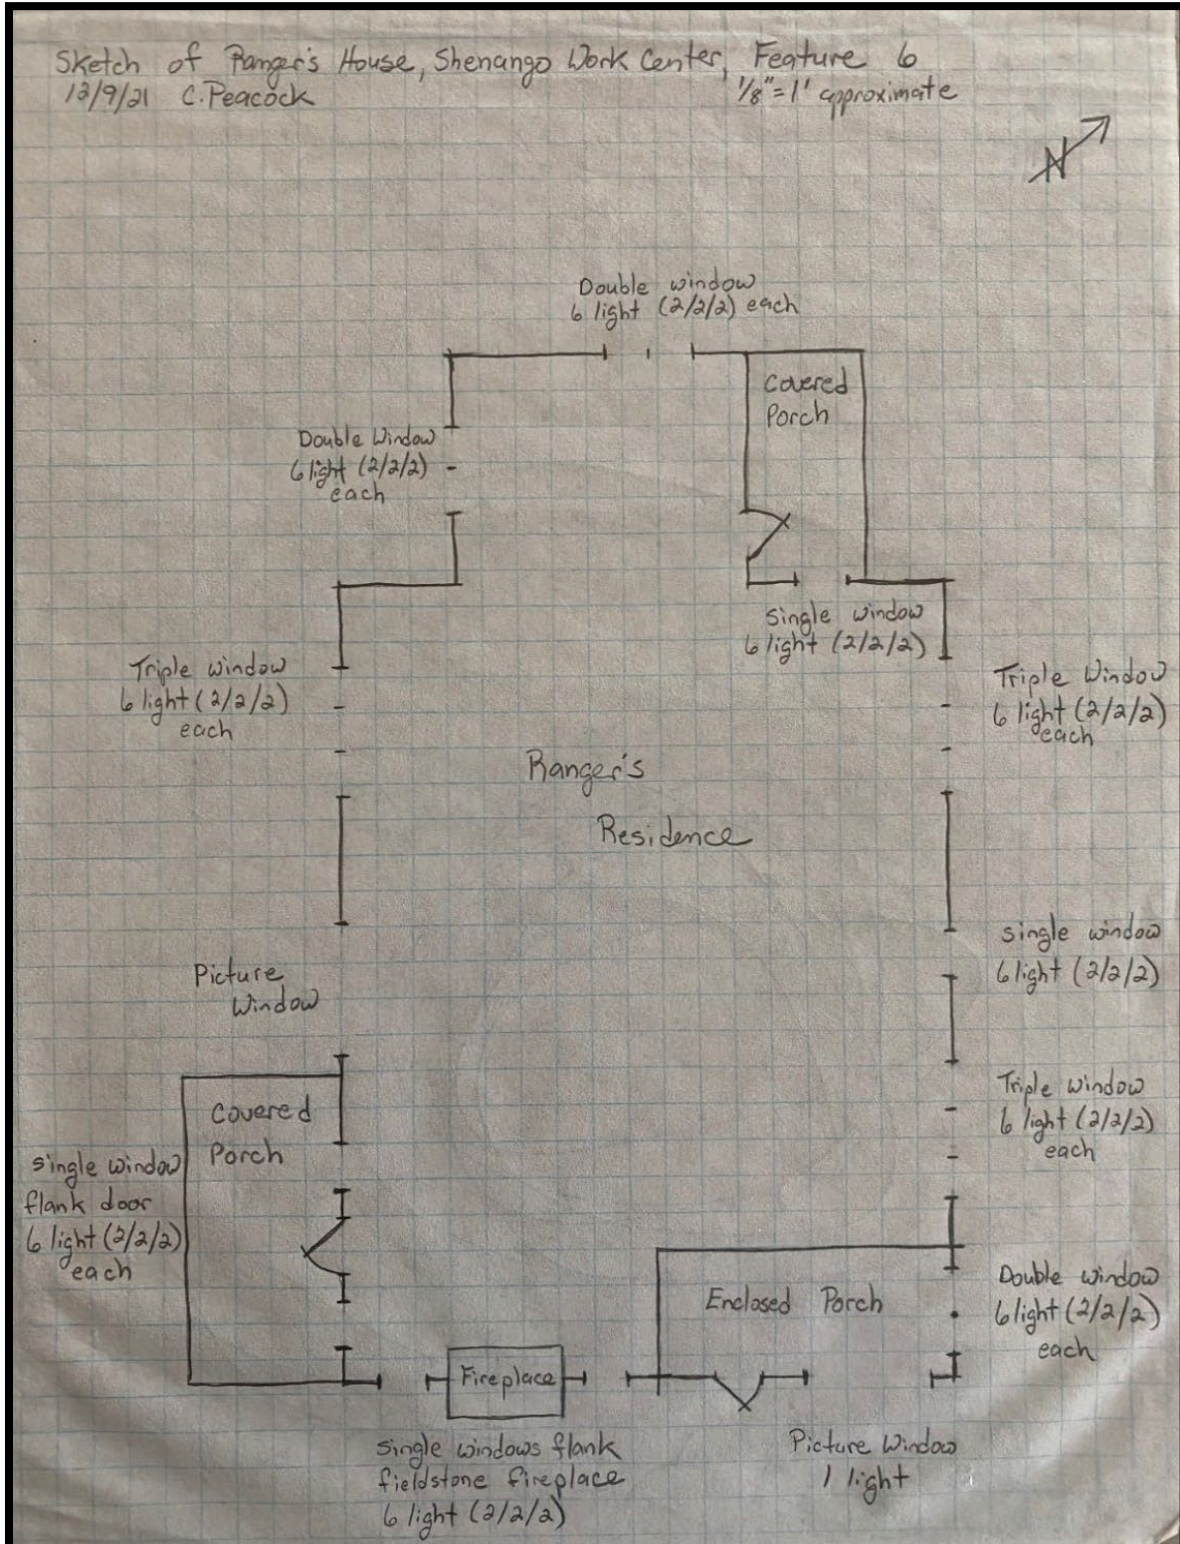
Architectural sketch of Feature 6 ranger residence

Feature 6 – Ranger's Residence (one contributing building, constructed in 1936): Finished in 1936, the ranger's residence was the first building constructed on the property by the CCC. It is a one story, side-gabled, rectangular structure of peeled, round logs with saddle-notch joinery and chopper-cut crowns. It features an original wing off the west wall, a shed-roofed porch on the south side, and a covered patio in the northwest corner. The residence has a full, poured-in-place concrete basement with the exposed foundation faced with fieldstone. Some of the fieldstone is cracked and spalling. The roof is clad in wood shingles with galvanized metal ridge roll with globe ends. Rafter ends and purlins are visible. An interior fieldstone fireplace appears on the east end of the building and is associated with the exterior gable end field stone clad chimney with concrete cap. Original wood plank doors, each with a single, fixed lite and decorative cast iron strap hinges, appear in the south, east, and north elevations.

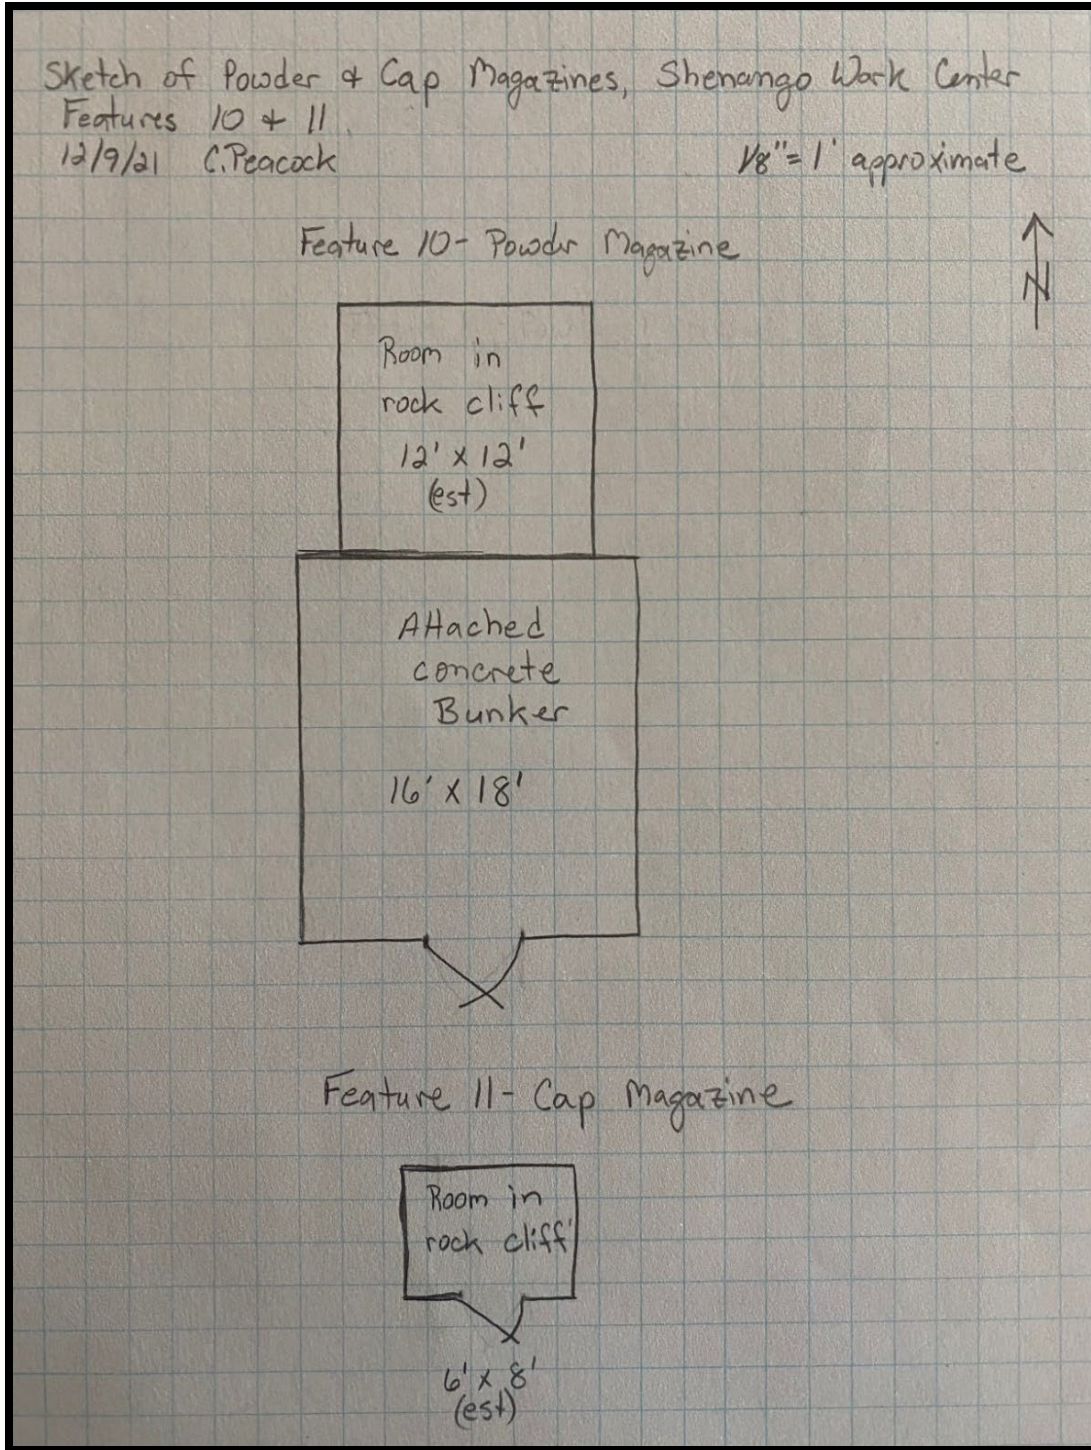
Architectural sketch of Features 10 - 11 powder and cap magazines

bunker was added in front of the chamber. The bunker features a concrete foundation, walls, and roof. The southeast elevation of the bunker has a large steel door that measures approximately 4' by 7'.

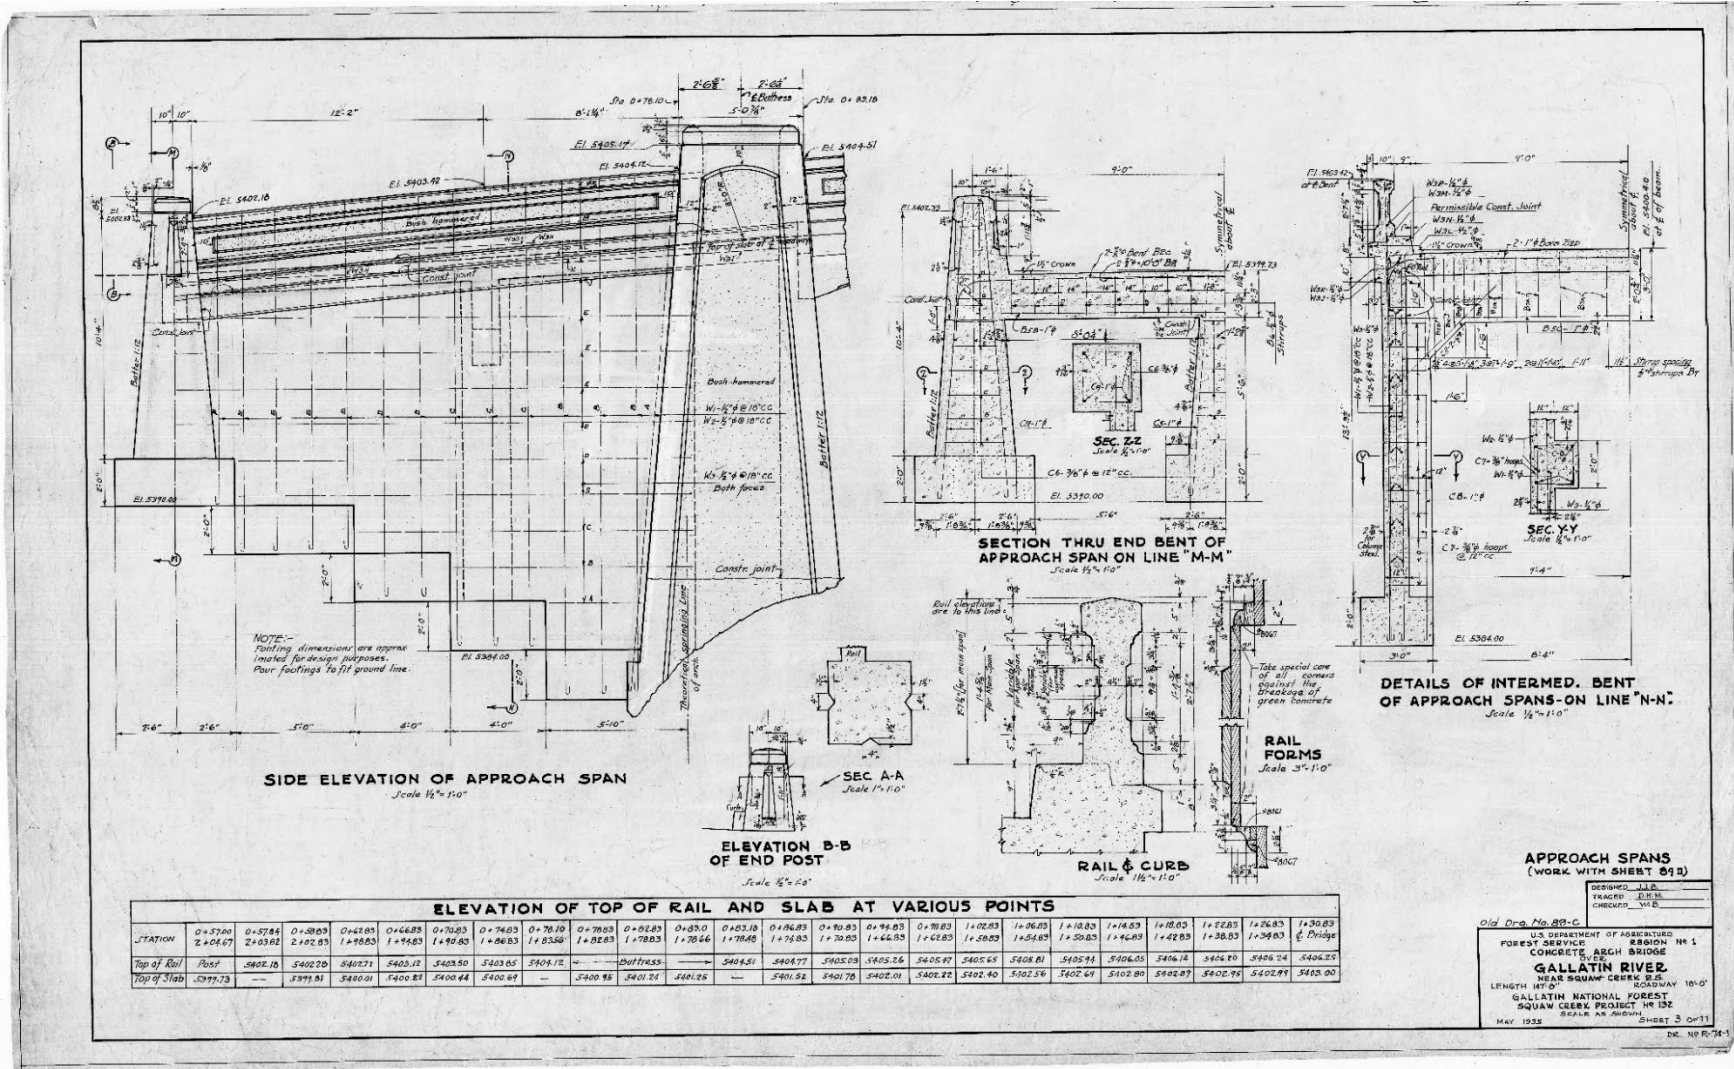
Original engineering drawings for Squaw Creek Bridge from May 1935 Missoula Regional Office Engineering records p. 3 of 10

April saw the beginning of Camp F-57's most ambitious project – a concrete arch bridge spanning the Gallatin River near the new ranger station.³⁸ Designed by Forest Service engineer Jim Byrne, the bridge was the largest undertaken by Region 1's Engineering Division up to that time, and possibly the largest of any CCC project in Region 1. Work began with drilling into bedrock for the bridge footings. When drills failed, explosives were used (figures 11 and 12). Crews on both sides of the river crushed and stockpiled rock, along with cement, gravel, and other supplies. A rock crusher and six dump trucks worked double shifts. Local carpentry contractors supervised the building of the bridge's forms. Work suffered a setback in mid-June, as the Gallatin's spring highwater took out the suspension footbridge at the job site (Figure 13), forcing men and material to access the site from Squaw Creek, by way of the old bridge and CCC road. Nonetheless, by late June the Fort Missoula CCC newsletter reported that the bridge was well underway, with the east abutment and approach finished, and the west abutment half completed. Bridge forms were erected in preparation for a concrete pour in early July (Figure 14). Engineer Henry Teitjen estimated that the completed bridge would require 430 cubic yards of crushed rock, 230 cubic yards of sand, 3,120 sacks of cement, and 34 tons of steel reinforcement. When finished in mid-September 1935, the new bridge consisted of two 26-foot approach spans, a center span of 95' 8 inches, and an 18-foot roadway width (Figure 15). Designed to withstand the Gallatin's bridge-killing spring torrents, it arched 16' above the river's estimated highest water.³⁹
