National Register of Historic Places Registration Form

Historic name: Shenango Work Station

Other names/site number: Squaw Creek Ranger Station, 24GA0788, Squaw Creek Work Center

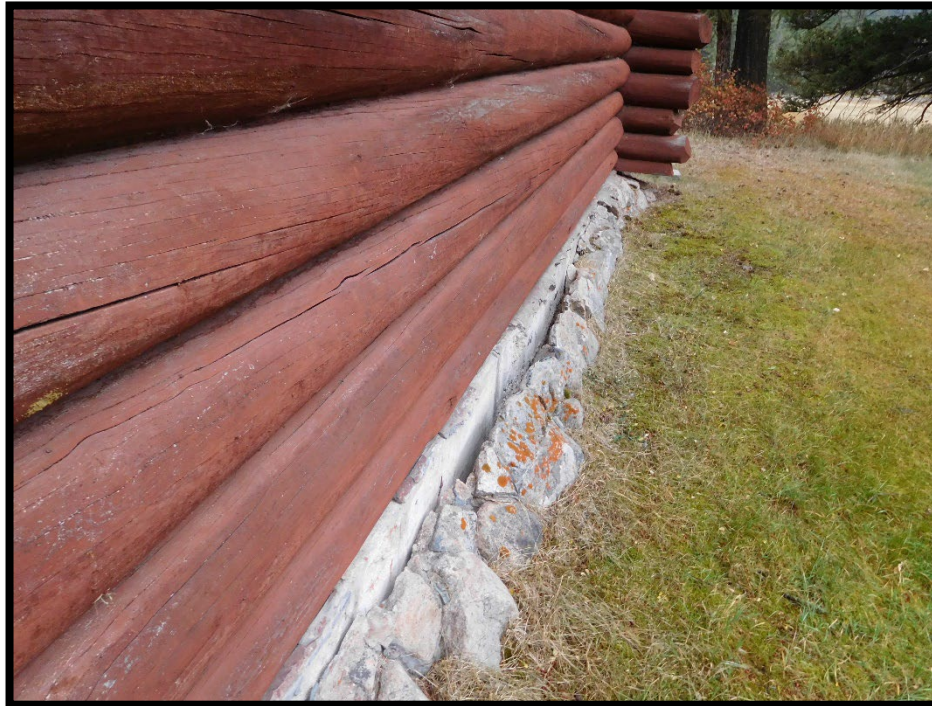
Shenango Work Center	Gallatin County, MT	Photo 49	MT_GallatinCounty_ShenangoWorkCenter_0049	F2 example of cast in place concrete foundation faced with native
Shenango Work Center	Gallatin County, MT	Photo 50	MT_GallatinCounty_ShenangoWorkCenter_0050	F6 example of native rock work on Ranger Residence porch and chimney
Shenango Work Center	Gallatin County, MT	Photo 51	MT_GallatinCounty_ShenangoWorkCenter_0051	Flagpole near Feature 1 original to construction
Shenango Work Center	Gallatin County, MT	Photo 52	MT_GallatinCounty_ShenangoWorkCenter_0052	Modern well house, built to mimic historic buildings on site
Shenango Work Center	Gallatin County, MT	Photo 53	MT_GallatinCounty_ShenangoWorkCenter_0053	Modern rock storage is white structure to viewers right in photo
Shenango Work Center	Gallatin County, MT	Photo 54	MT_GallatinCounty_ShenangoWorkCenter_0054	Modern helibase office southwest and southeast elevations facing northeast

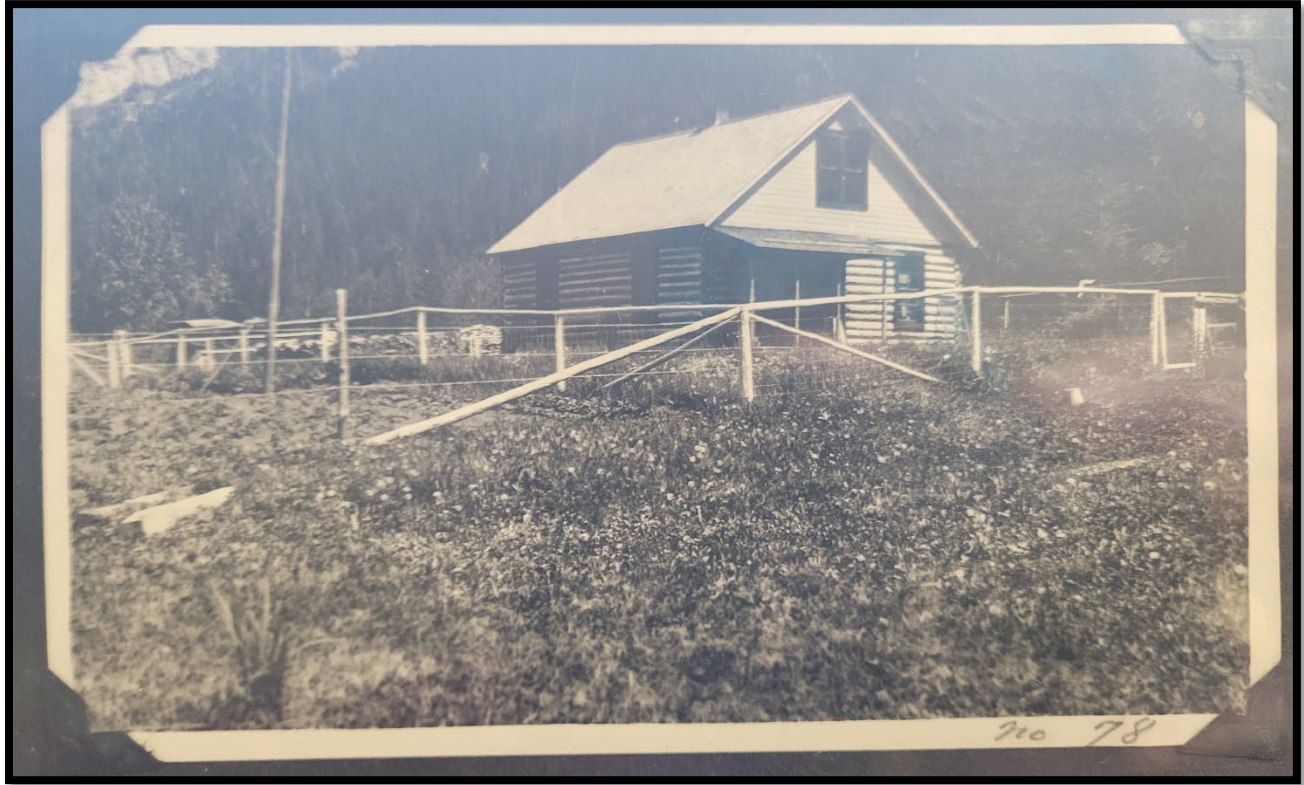
Figure 1. Second generation ranger station circa 1920s (pre-CCC era)

It's unknown whether the original one-room Squaw Creek cabin was replaced as part of the 1908 improvements. However, in 1916 the Squaw Creek Ranger Station included a larger log cabin with framed gable ends and a log barn, situated on the south side of Squaw Creek (figures 1 and 2). One Forest Service document credits Harold Knopp, Squaw Creek district ranger from 1916 to 1918, with building the cabin. It served as district headquarters for the Lower Gallatin (Squaw Creek) Ranger District until 1931, then as district headquarters for the Gallatin Ranger District, a consolidation of the Upper (Cinnamon) and Lower Gallatin districts, until 1934.²¹

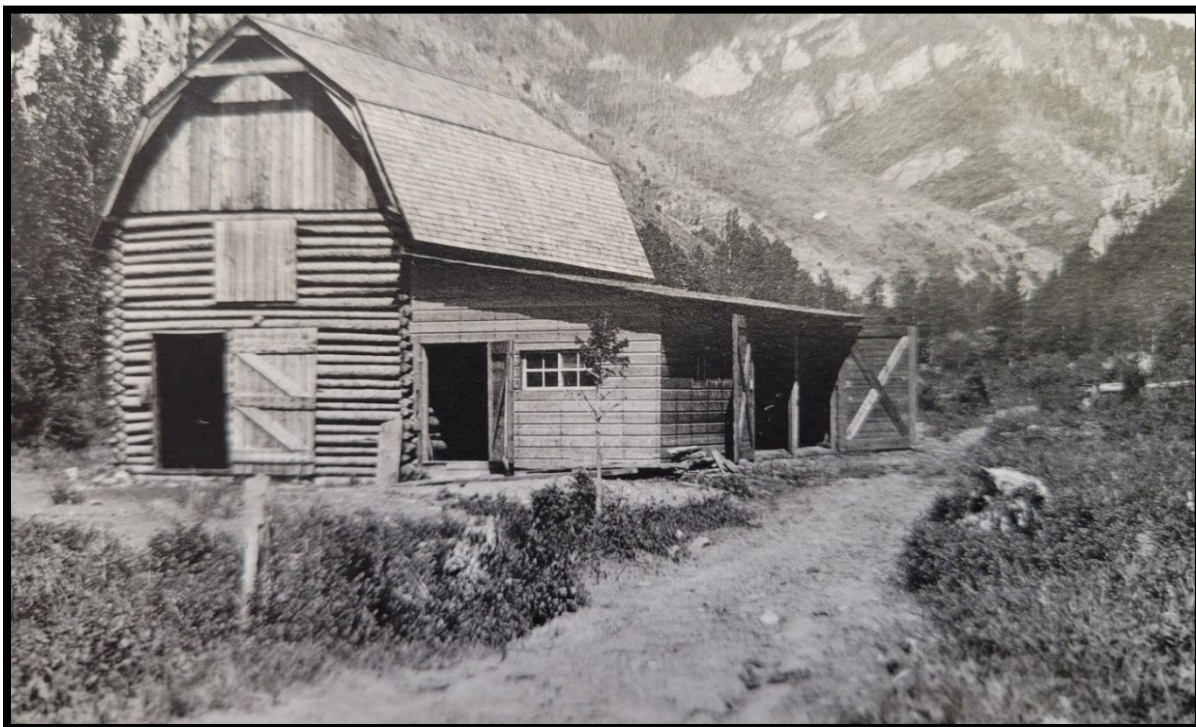
Figure 2. Second generation barn circa 1920, removed when ranger station moved to current CCC era location

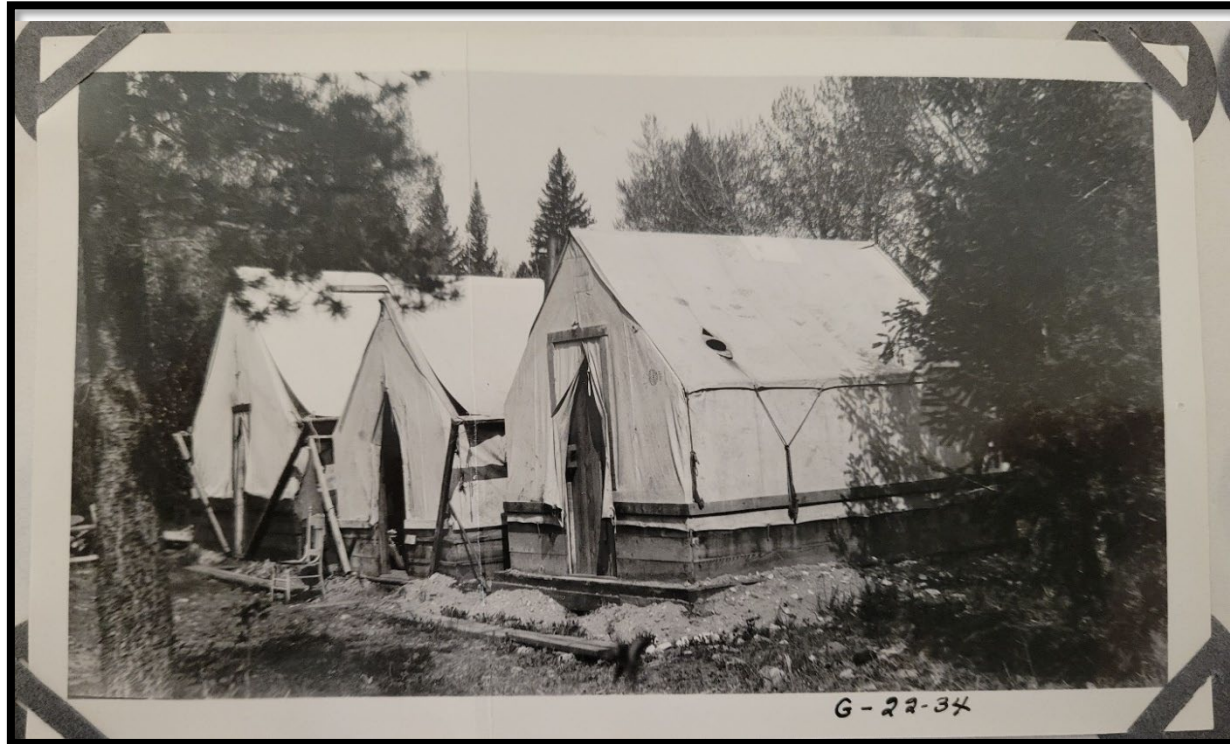
Figure 3. Example of temporary tent camps at Squaw Creek CCC camp in 1934

In 1934, permanent CCC facilities began to replace seasonal camps (Figure 3), enabling crews to work through the winter months. Designed to accommodate 200 men, permanent camps contained four 50-man barracks, a mess hall, recreation and education buildings, office, and a supply and storage warehouse. With closure of the Basin camp and departure of Company 1249 the previous fall, the Gallatin Forest needed a permanent camp to fulfill its work plans. In the spring of 1934, the Basin camp reopened with Montana CCC crews who worked to complete the previous years’ projects. In July, newly organized Company 1963 moved to Basin (now designated Camp DF-73) to continue roadbuilding, fencing, and other Forest Service work. A month later, the CCC authorized eight winter (permanent) CCC camps in Montana, including one for the Gallatin Forest. Army and Forest officials initially selected the mouth of Squaw Creek as the site for the Gallatin’s new camp. However, by September, it was decided to build the permanent camp two miles north of Squaw Creek, on a grassy flat north of Shenango Creek. Despite the new location, the camp retained its original designation as Squaw Creek Camp F-57.²⁷

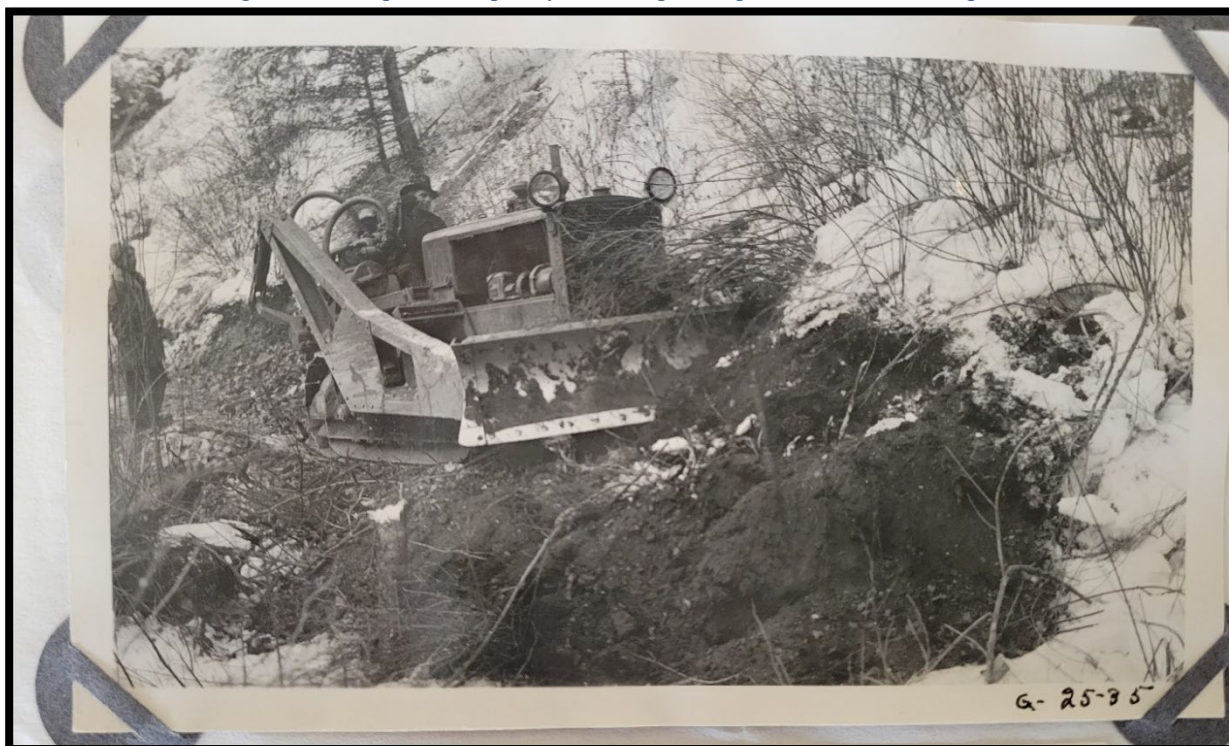
Figure 4. Road building activities from January 9, 1935

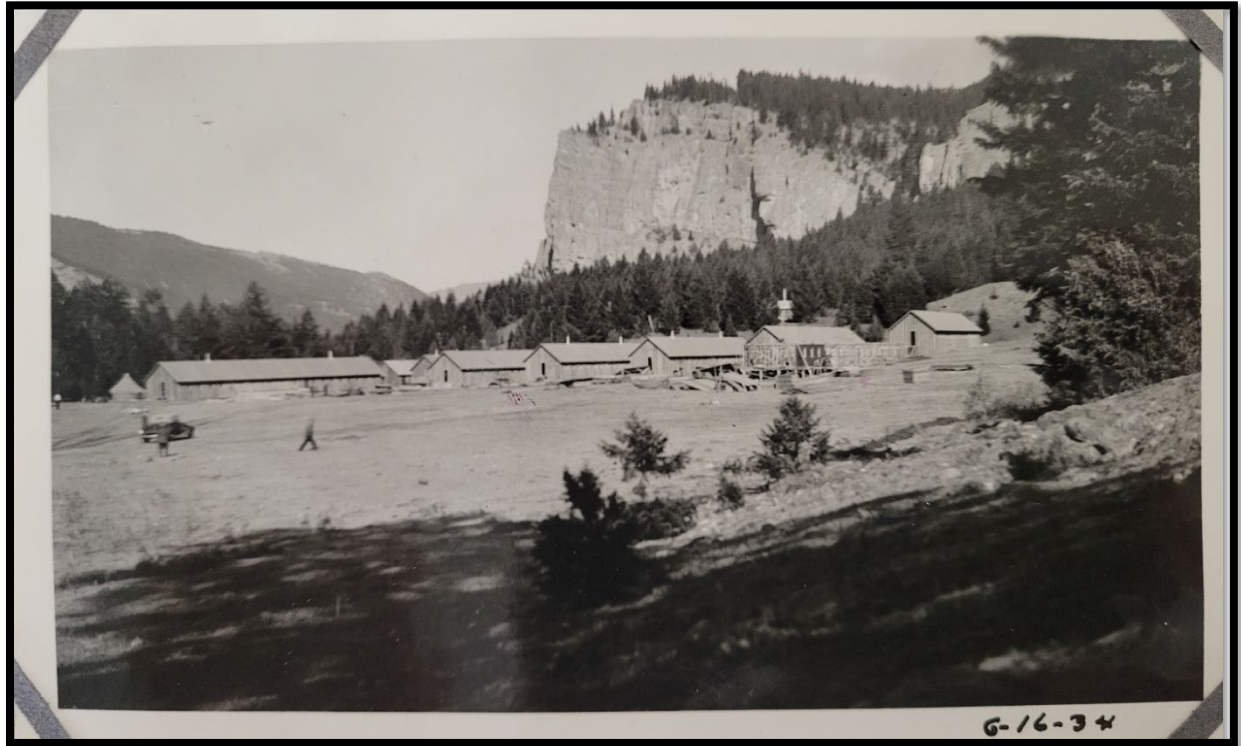
Figure 5. Permanent quarters for CCC enrollees at Squaw Creek January 9, 1935

With the help of several Bozeman carpenters employed as LEMs, the CCC spike crew completed the camp barracks, mess hall, recreation hall, and other buildings by October 31, 1934 (Figure 5). The remaining 173 members of Company 1963 moved into Camp F-57 the next day, in the midst of a snowstorm. Progress at the new camp was rapid. By mid-December, the camp’s water line, office, seven-stall garage, and 20’ x 40’ workshop were nearly finished (Figure 6). The water system, designed as a permanent feature of the new ranger station, drew water from Shenango Creek, utilizing a 12,000-gallon underground reservoir, 350’ of 6-inch wooden pipe, 2,900’ of 3-inch pipe, and 350’ of 2-inch pipe.³⁴ Over the rest of the winter, the CCC enrollees constructed a creosote plant to treat post and poles for fencing (Figure 7). By April 1, 1935, the camp’s 15-man logging crew cut 400 house logs for the ranger station buildings, as well as 350 cords of firewood and 2,000 telephone poles (Figures 7 - 10). Gallatin District Rangers Eric White and Region 1 engineer C.B. Swim personally selected the ranger station logs and timbers.³⁵ Timbers were sourced locally from the nearby Rat Lake drainage (T5S, R4E, Section 1) with the help of Gallatin District Ranger Vern J. Edwards³⁶

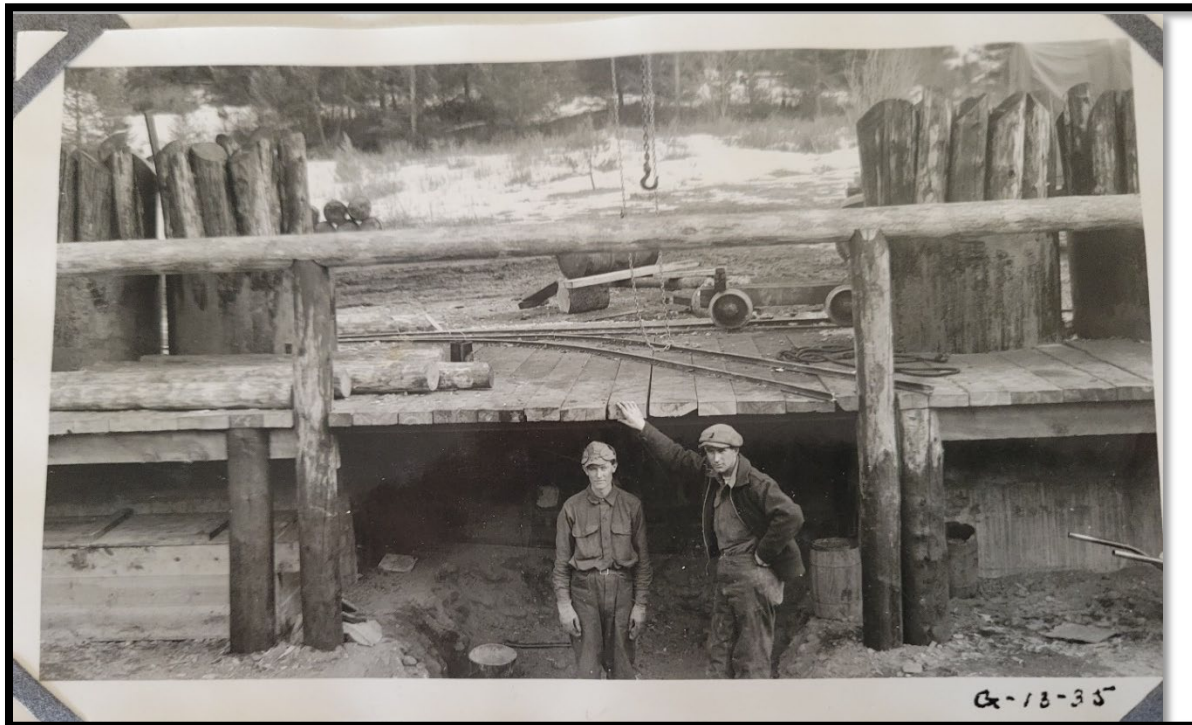
Figure 7. Creosote plant from March 1, 1935

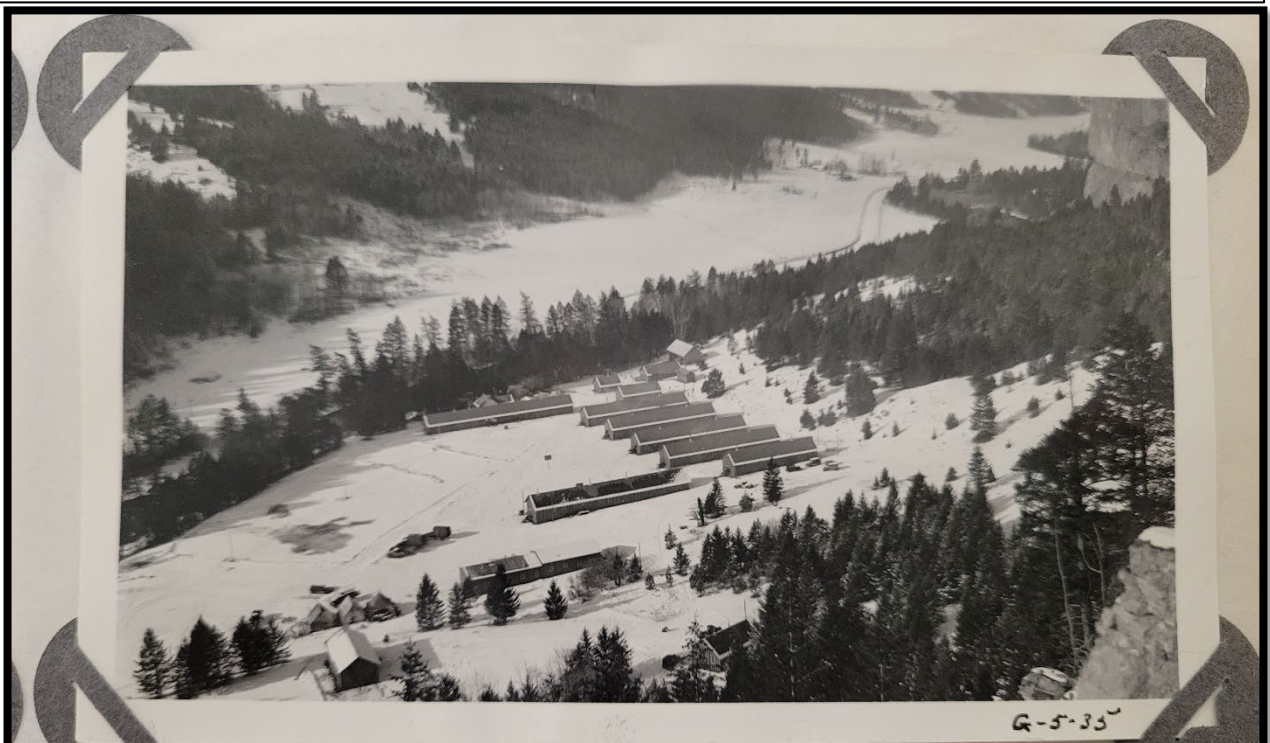
Figure 10. Completed CCC camp D-F-57 overview as of January 9, 1935

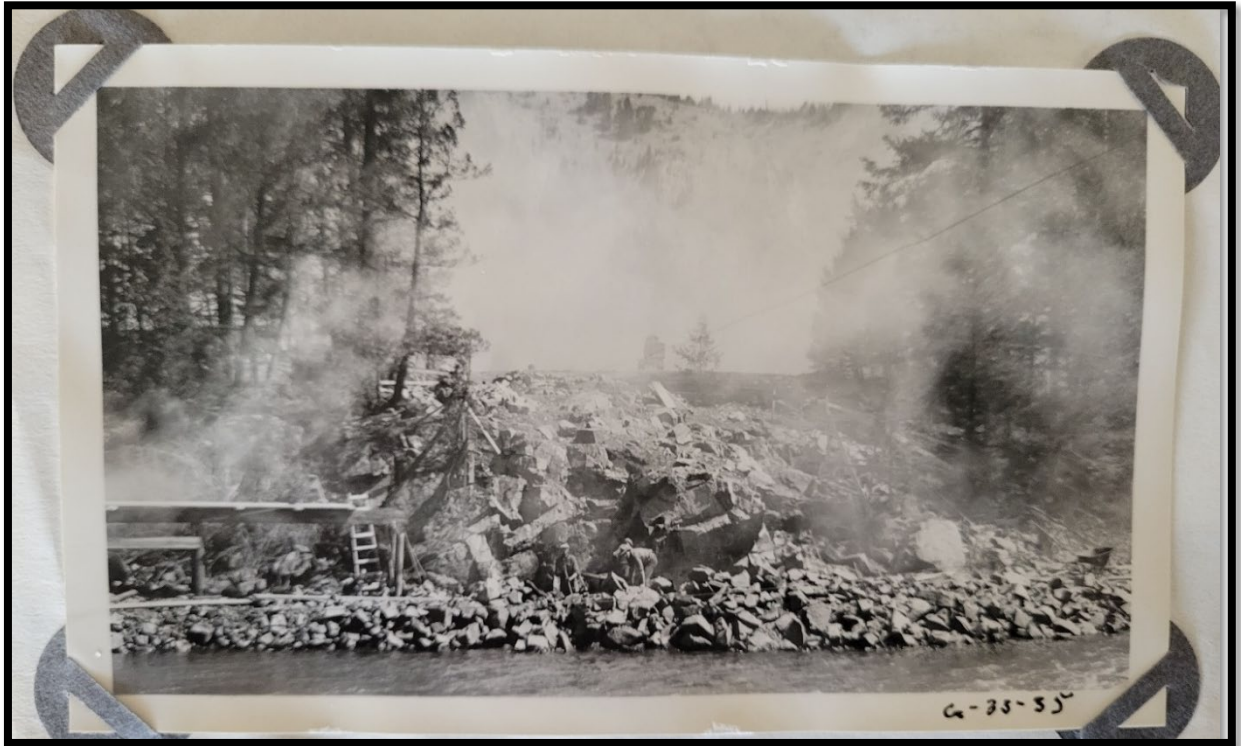
Figure 11. View of excavation for concrete footings with dynamite looking at east side of river April 26, 1935

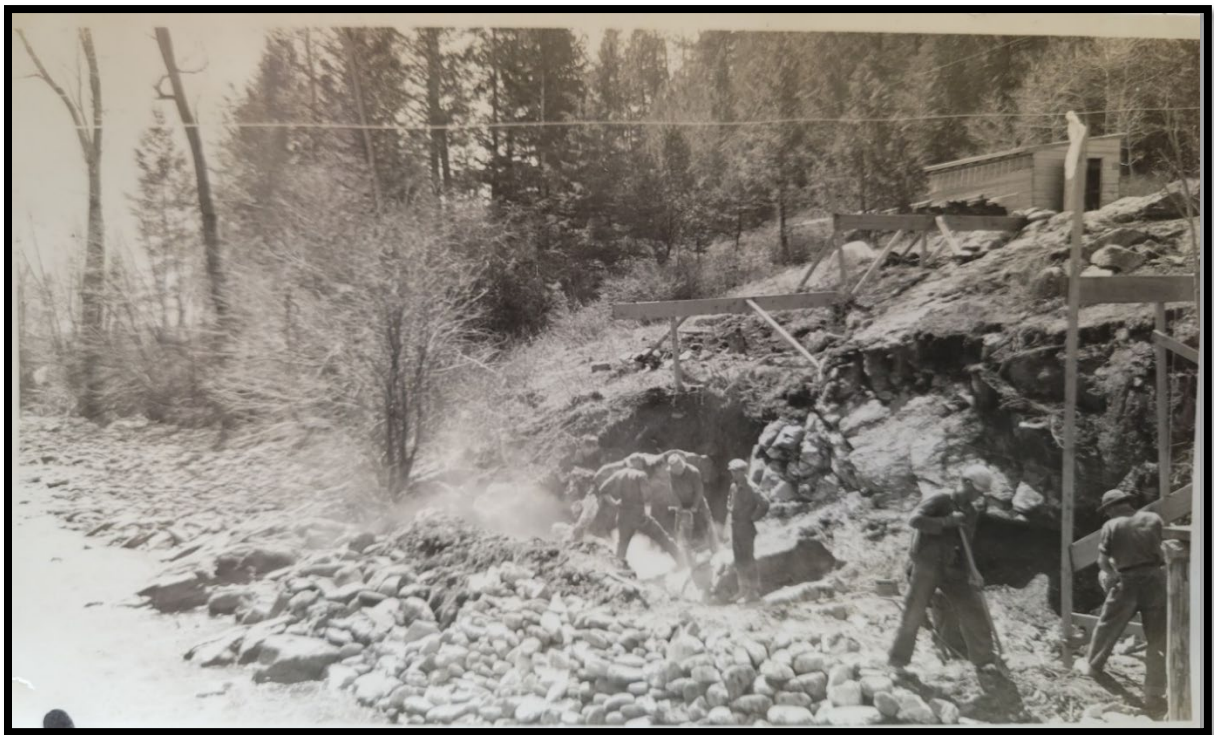
Figure 12. View of excavation for concrete footings with hand tools looking at west side of river April 26, 1935

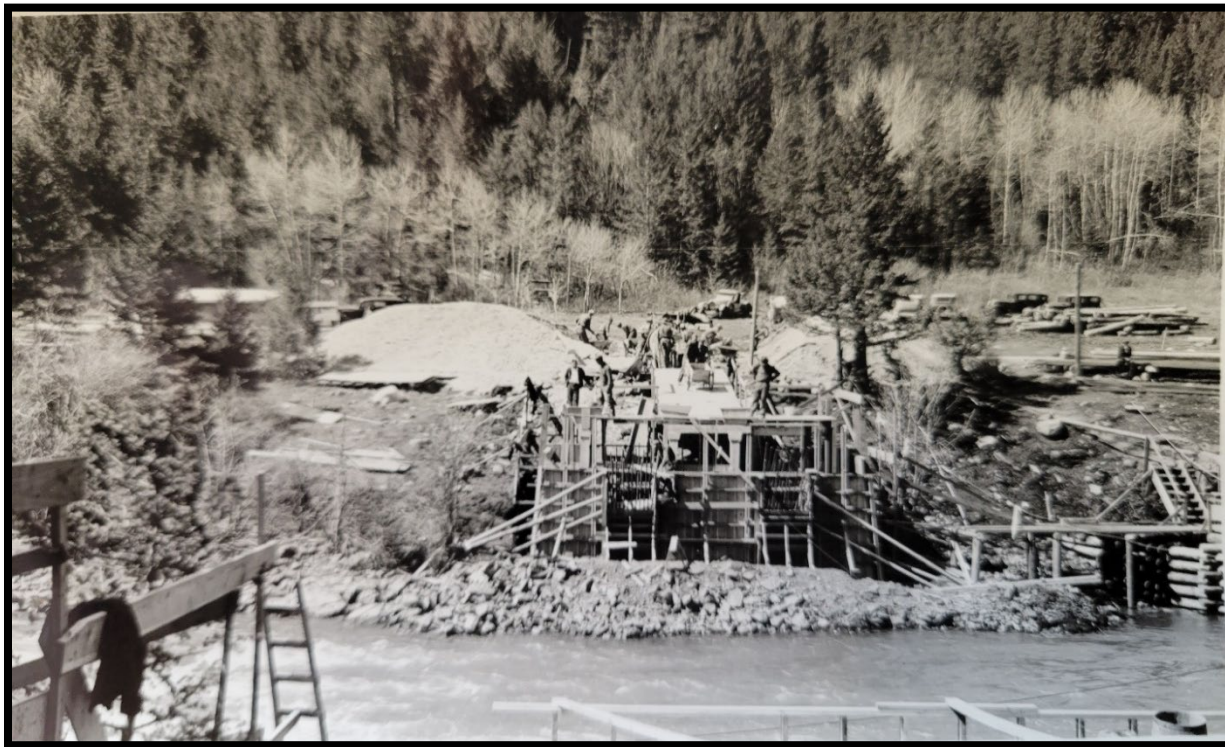
Figure 14. Bridge forms beginning to be put in place 1935

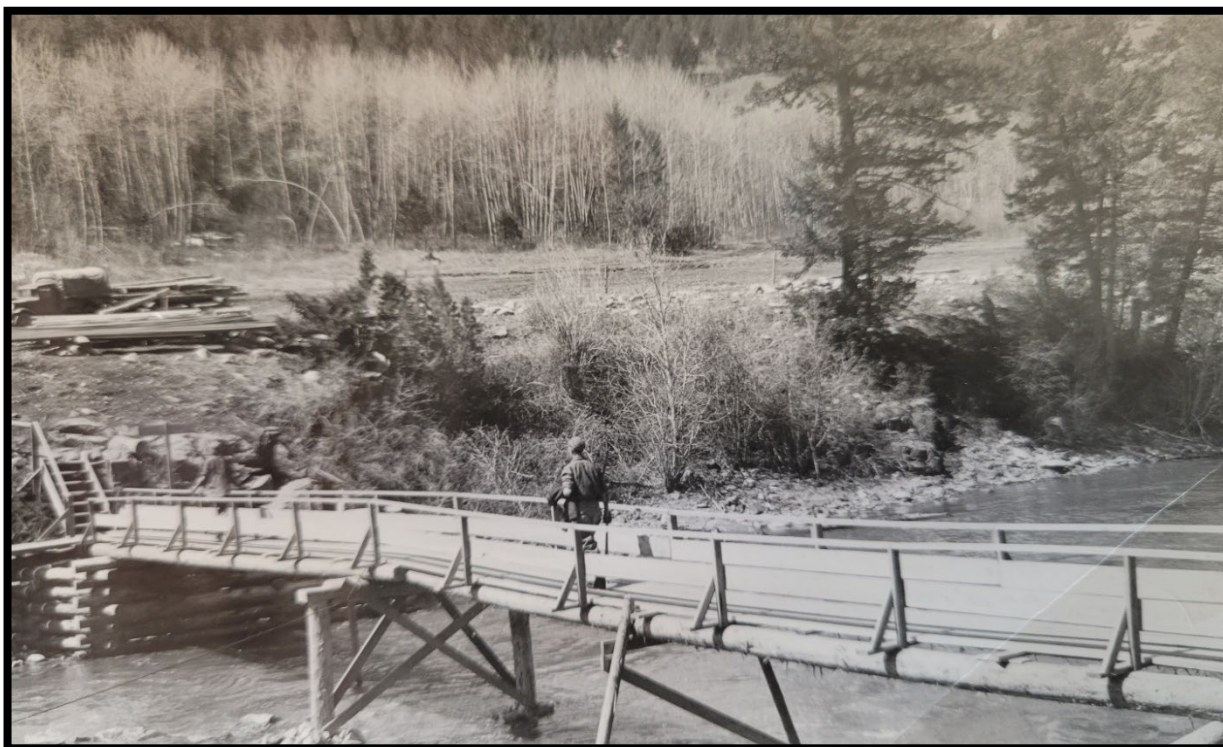
Figure 13. Temporary footbridge over Gallatin River for bridge construction April 26, 1935

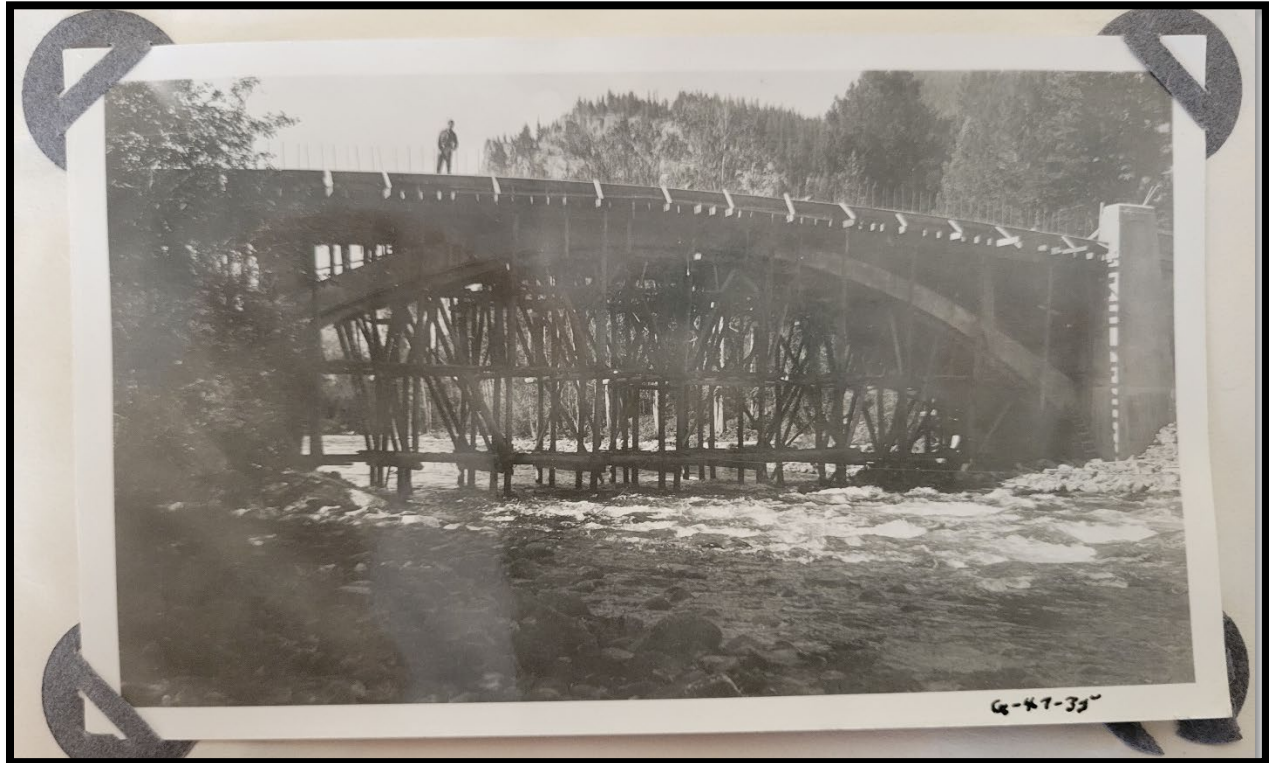
Figure 15. Completed bridge as of September 11, 1935 facing downriver (northwest)

April saw the beginning of Camp F-57's most ambitious project – a concrete arch bridge spanning the Gallatin River near the new ranger station.³⁸ Designed by Forest Service engineer Jim Byrne, the bridge was the largest undertaken by Region 1's Engineering Division up to that time, and possibly the largest of any CCC project in Region 1. Work began with drilling into bedrock for the bridge footings. When drills failed, explosives were used (figures 11 and 12). Crews on both sides of the river crushed and stockpiled rock, along with cement, gravel, and other supplies. A rock crusher and six dump trucks worked double shifts. Local carpentry contractors supervised the building of the bridge's forms. Work suffered a setback in mid-June, as the Gallatin's spring highwater took out the suspension footbridge at the job site (Figure 13), forcing men and material to access the site from Squaw Creek, by way of the old bridge and CCC road. Nonetheless, by late June the Fort Missoula CCC newsletter reported that the bridge was well underway, with the east abutment and approach finished, and the west abutment half completed. Bridge forms were erected in preparation for a concrete pour in early July (Figure 14). Engineer Henry Teitjen estimated that the completed bridge would require 430 cubic yards of crushed rock, 230 cubic yards of sand, 3,120 sacks of cement, and 34 tons of steel reinforcement. When finished in mid-September 1935, the new bridge consisted of two 26-foot approach spans, a center span of 95' 8 inches, and an 18-foot roadway width (Figure 15). Designed to withstand the Gallatin's bridge-killing spring torrents, it arched 16' above the river's estimated highest water.³⁹

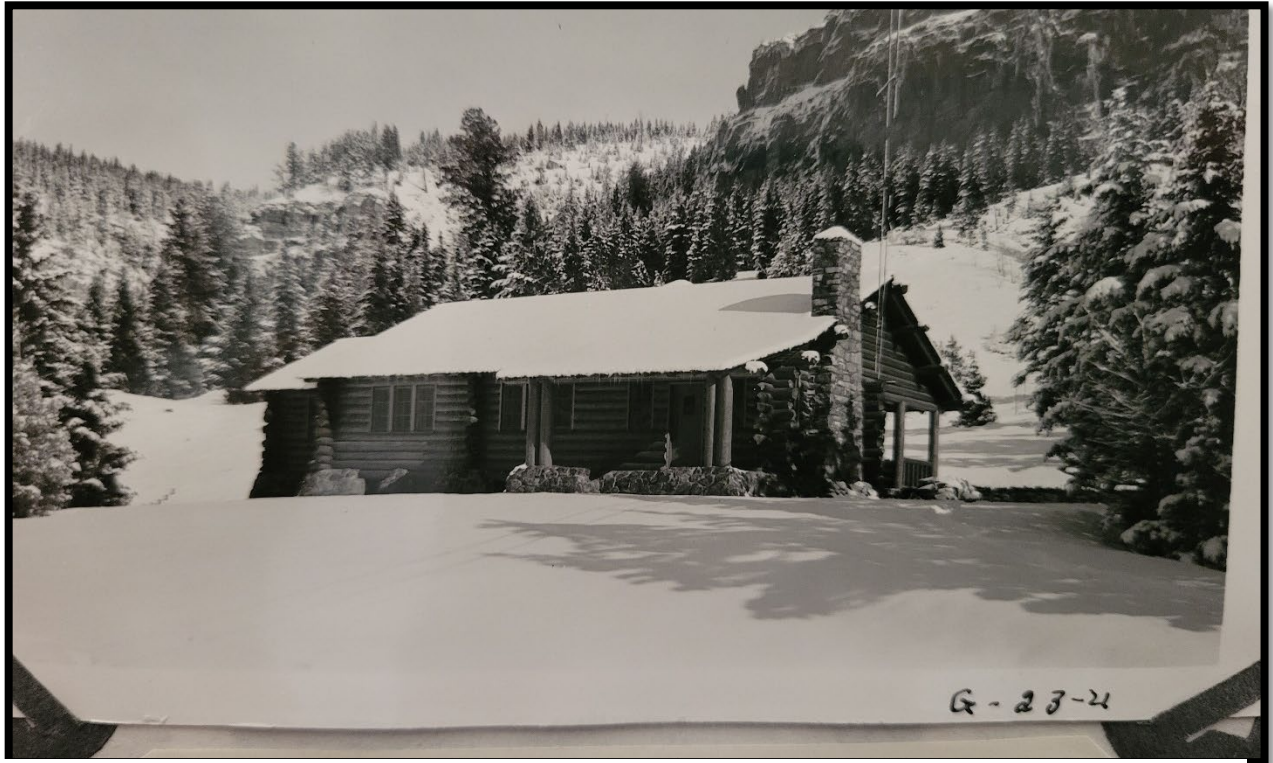
Figure 17. Ranger's residence newly completed circa 1936

Log work continued on the ranger station buildings through fall and early winter 1935 (Figure 17). Heavy snow and sub-zero temperatures slowed the work but by February 1936 wall logs and rafters were in place at the ranger residence, with sheathing and shake roofing underway. According to *The Gallatin Forester*, the house was "beginning to show its massiveness and beauty" (Figure 18). The log walls of the 30' x 56' garage/shop building (Plan B-12) and barn were being raised. The barn was a point of contention between Region 1
