CUB CREEK 2 FIRE

Cub Creek 2 Burned Area Summary

2500-8 Burned Area Report

WILDFIRE-ASSOCIATED LANDSLIDE EMERGENCY RESPONSE TEAM REPORT

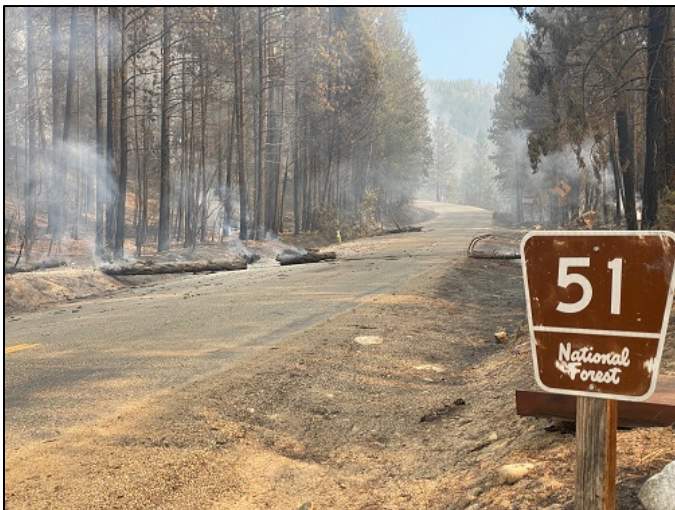
Figure 2 Hazard trees pose a recurring threat during and after a fire.

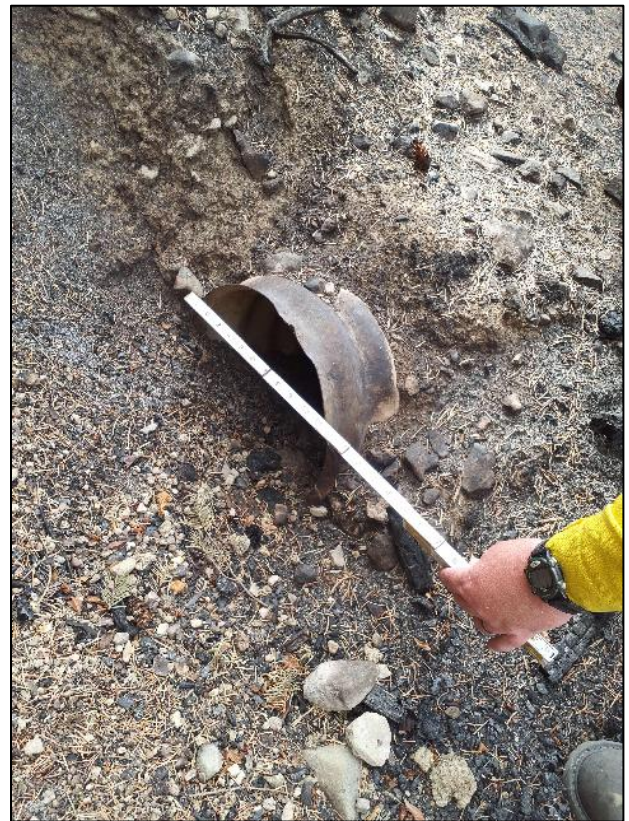
Figure 3 Plugged culverts can lead to a road being overtopped by flood waters.

The proposed treatments include signs warning travelers of the increased danger, temporary closures of roads where safety is at particularly high risk, post-storm inspection, drainage dips, clean ditches and inlets to handle increased flows, and fixing burned holes in the road prism.

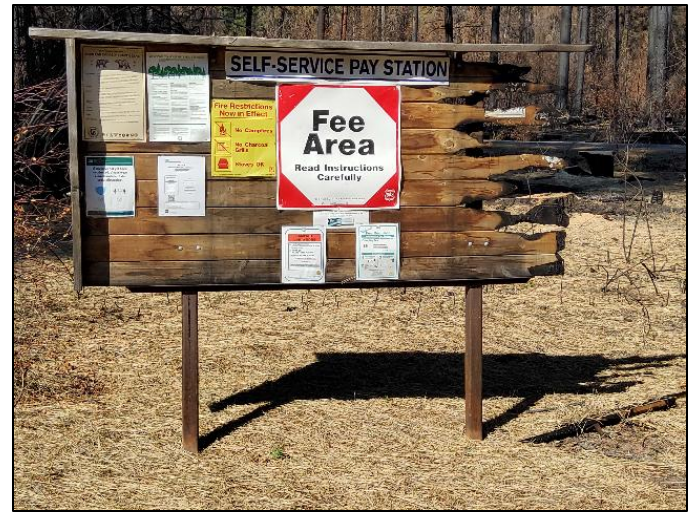
Camping: Both campers and infrastructure at Falls Creek, Chewuch, Camp 4, Buck Lake, and Nice campgrounds are at high risk due to the threat of increased flooding and debris flow. These campgrounds are located on alluvial fans from previous debris flow events. Geologists found evidence of debris flows in the not-too-distant past. Based on the combined evidence of the USGS debris flow analysis, site assessments, and preliminary post-fire flow modeling by the BAER team, these sites were judged to be at varying degrees of risk of inundation. This risk is compounded at campgrounds, where people stay overnight and may not be able to respond to rapid events such as flash floods or debris flows.

Figure 4 Burned sign at the Nice Campground

The recommended treatment includes temporary campground closure, physical closure with gates, and warning signs. To prevent damage to campground water supply wells at Falls Creek and Chewuch campgrounds, pump jacks should be removed and well heads capped. Portable site infrastructure, such as picnic tables, could be removed and stored outside of the flood plain at each campground recommended for closure.

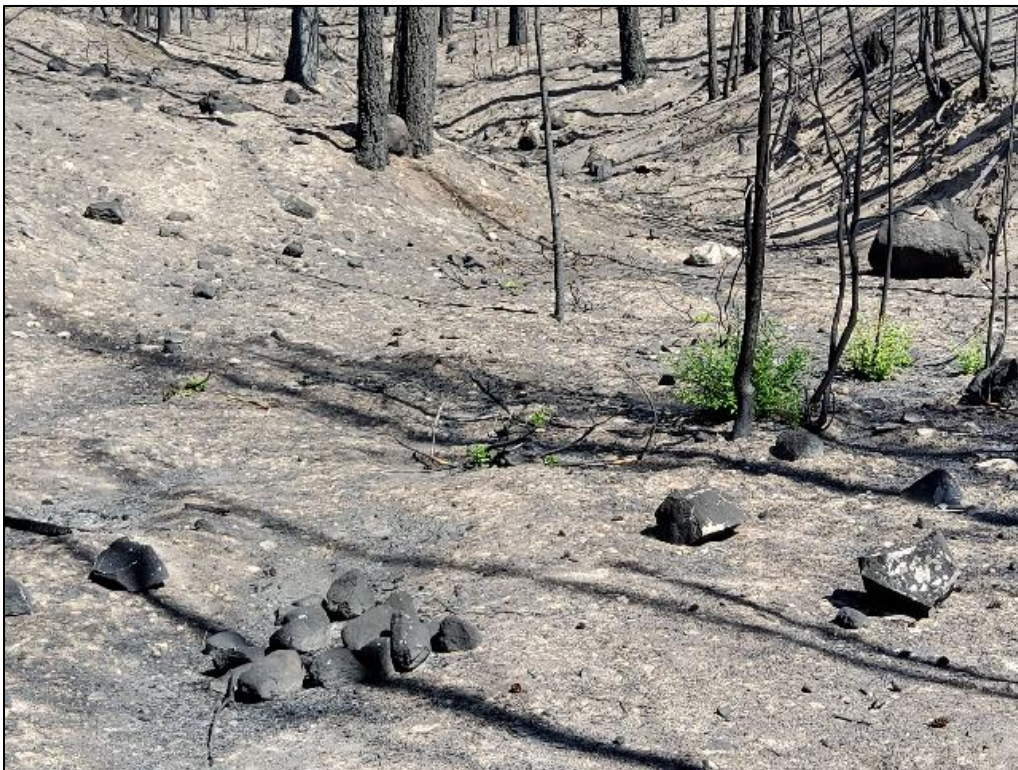
Dispersed camping is a popular activity in this area as well. While no infrastructure is at risk in these areas, human life and safety is still a major concern at many of these sites, due to falling trees and flooding. The forest recommends temporarily closing either the dispersed camping or the road corridor between specific points. These roads are discussed in the engineering analysis performed by the BAER team.

Figure 6 This dispersed campsite was heavily burned and poses substantial risks to potential overnight visitors.

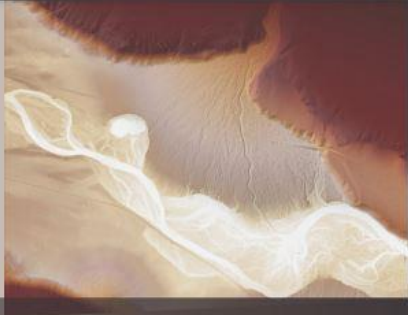
WHAT YOU SHOULD KNOW ABOUT ALLUVIAL FANS AND WILDFIRES

If you live or work on an **alluvial fan** you could be at risk from potentially dangerous debris flows and floods, especially if you are near a recent wildfire burn area.

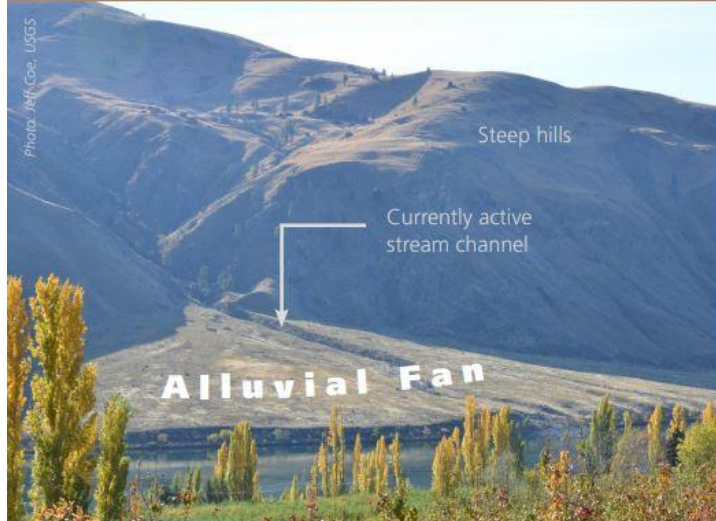
Alluvial fans are always changing and often have several active and inactive stream channels. The streambed that is currently filled with water may not be the active channel after a flood. A previously safe structure could quickly become inundated following a major storm. A home far from a stream channel could suddenly be right in the path of a surging wall of mud and debris.

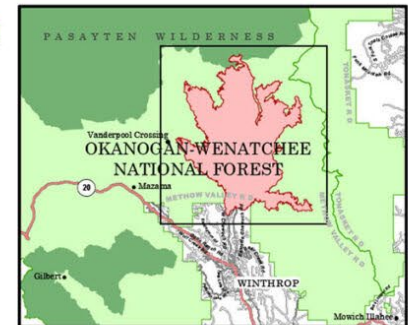
USGS Debris Flow Combined Hazard - 15 minute Intensity of 32 mm/h

The USGS-derived models estimate a moderate to high level of debris-flow hazard for most of the area burned by the Cub Creek 2 fire. Many stream reaches and drainages have a greater than 40% likelihood of debris flow occurrence at the modeled rainfall intensity. Many of the basins and stream reaches near the center of the burn area have a high (60-80%) to very high (>80%) likelihood of debris-

flow occurrence. These high hazard areas mostly occur in drainages above Doe Creek, Falls Creek, Eight Mile Creek, and the Chewuch River (see map on page 7).
