## TWENTYFIVE MILE FIRE

#### Wildfire-Associated Landslide Emergency Response Team Report

# Twentyfive Mile Fire Burned Area Summary

## 2500-8 Burned Area Report

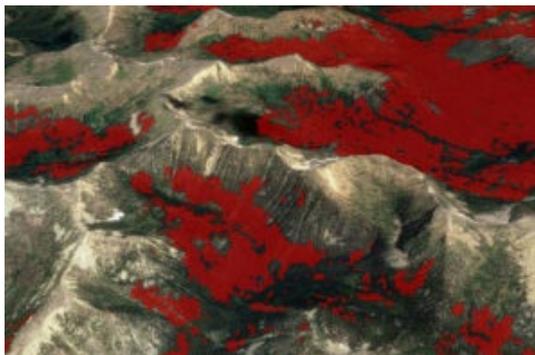
Open the Google Earth program. [ If you don't already have Google Earth, you can download and install it for free **HERE**. ] Drag the KMZ file onto the Google Earth program icon or main screen (or in Google Earth, click File, Import and select the KMZ file). After the KMZ file loads, you can zoom way in for more detail, change the angle of view, show or hide each burn severity level, and adjust transparency of levels. Click image below for an example screenshot from Google Earth, showing just high severity level.

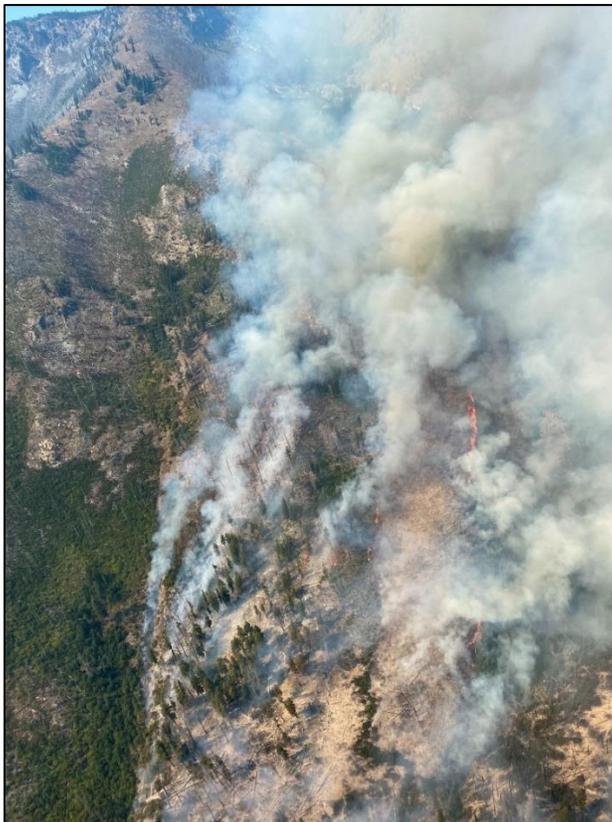
Figure 1 Fire activity within the Twentyfive Mile Fire.

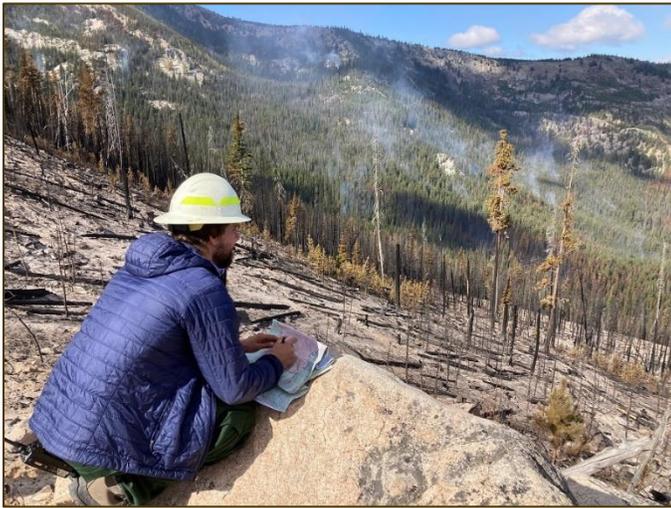
Figure 2 Scientists spent multiple days making ground observations about burn conditions.

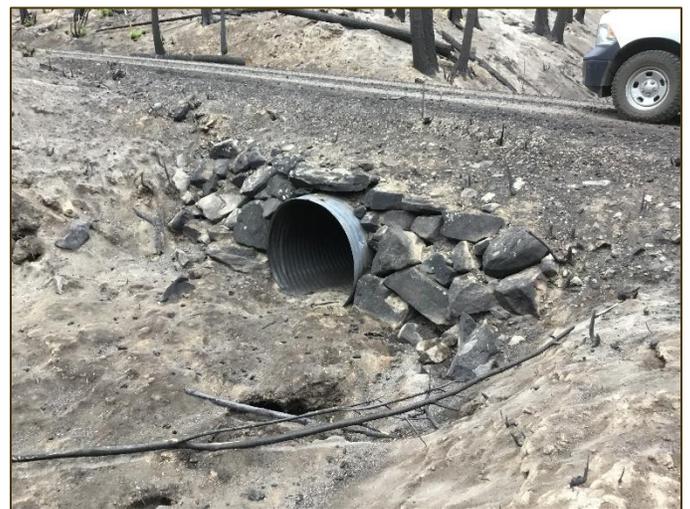
Figure 3 Engineers and hydrologists evaluate culverts like this one to evaluate its capacity to handle the predicted increased flows.

There are two bridges identified that have an increased risk of damage from predicted flooding or debris flows: Ramona Bridge and the North Fork Twentyfive Mile Creek Culvert. The team recommends post-storm inspection and response using heavy equipment, if necessary.

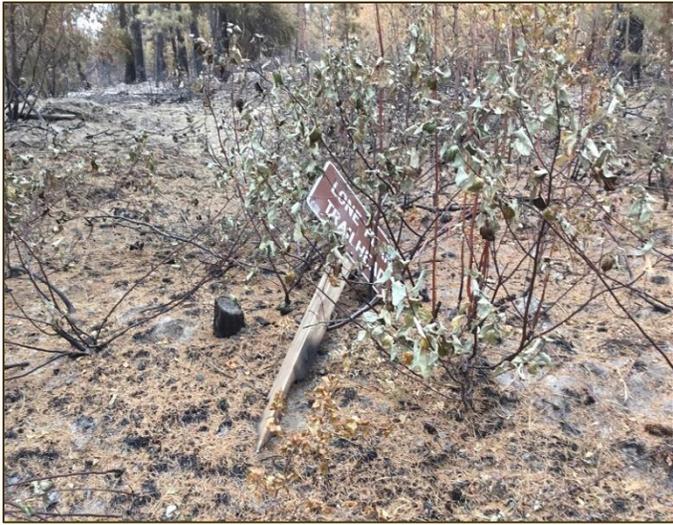
Figure 4 This burned trailhead sign is indicative of the passing fire.

In addition to trail-specific treatments, the BAER team recommends the removal of “danger trees” (fire-killed trees) in areas where crews will be working to implement identified treatments. The team also recommends the placement of warning signs at 13 trailheads or logical ingress points to the burned area (figure 4). Finally, the team also identified one burned-over vault toilet that will be pumped, sanitized, wrapped, and sandbagged to reduce the possibility of contamination and discharge into Twenty-Five Mile Creek.

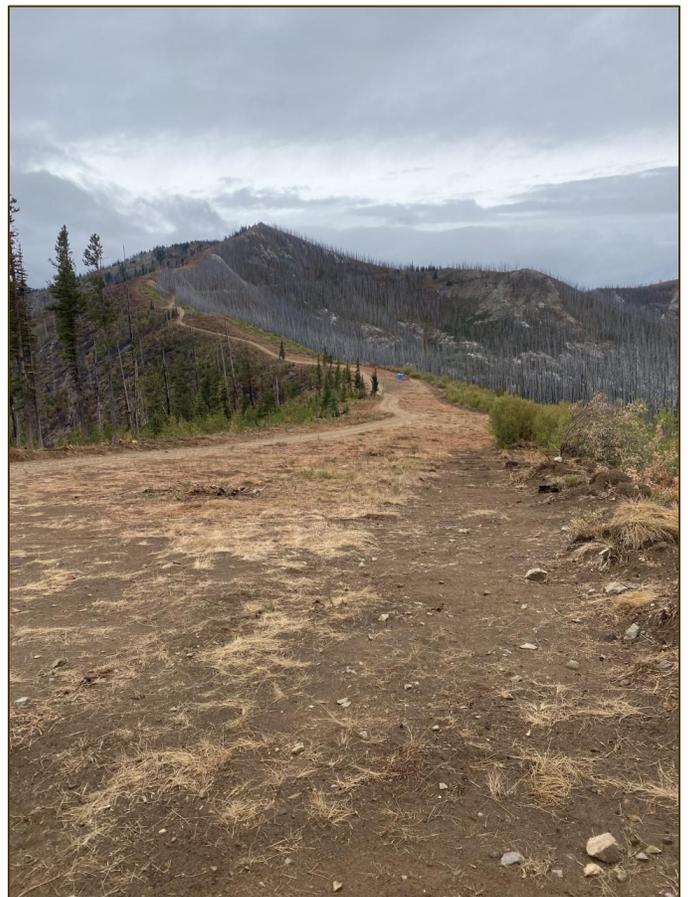
Approximately 15 miles of dozer line (figure 5) and 7 miles of handline were constructed outside and within the burn perimeter. In addition to causing an increase in weed invasion, the disturbances caused by dozer lines are expected to create accelerated erosion and soil compaction that may also inhibit the recovery of native plant populations.

Figure 5 Dozer suppression lines are hot spots for invasive weeds.

The Forest recommends a treatment of Early Detection, Rapid Response (EDRR) to monitor for noxious weed infestation and expansion. In areas disturbed due to mechanical suppression activity (approximately 88 acres) and burned areas prone to new noxious weed infestations (230 acres), weed technicians will perform regular surveys and treat new infestations.

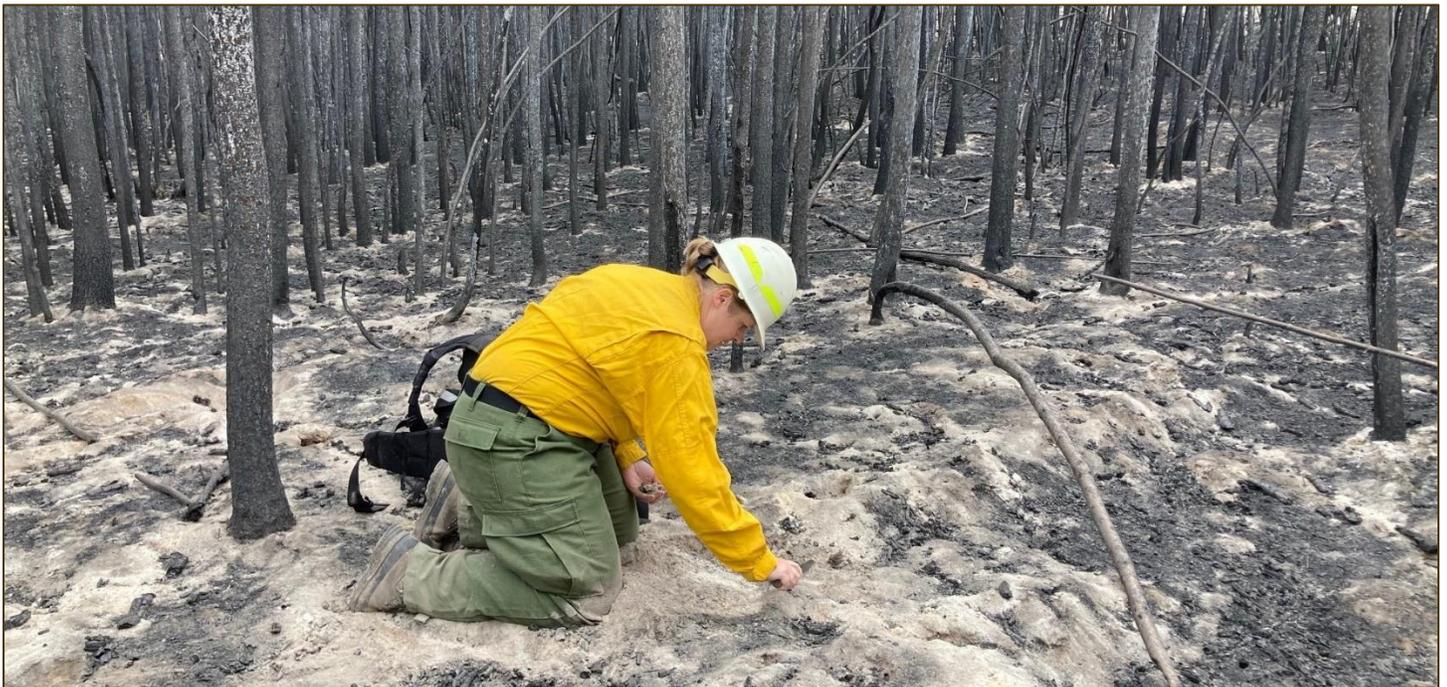
Figure 6 Soil scientist evaluating water repellency on the Twentyfive Mile Fire.

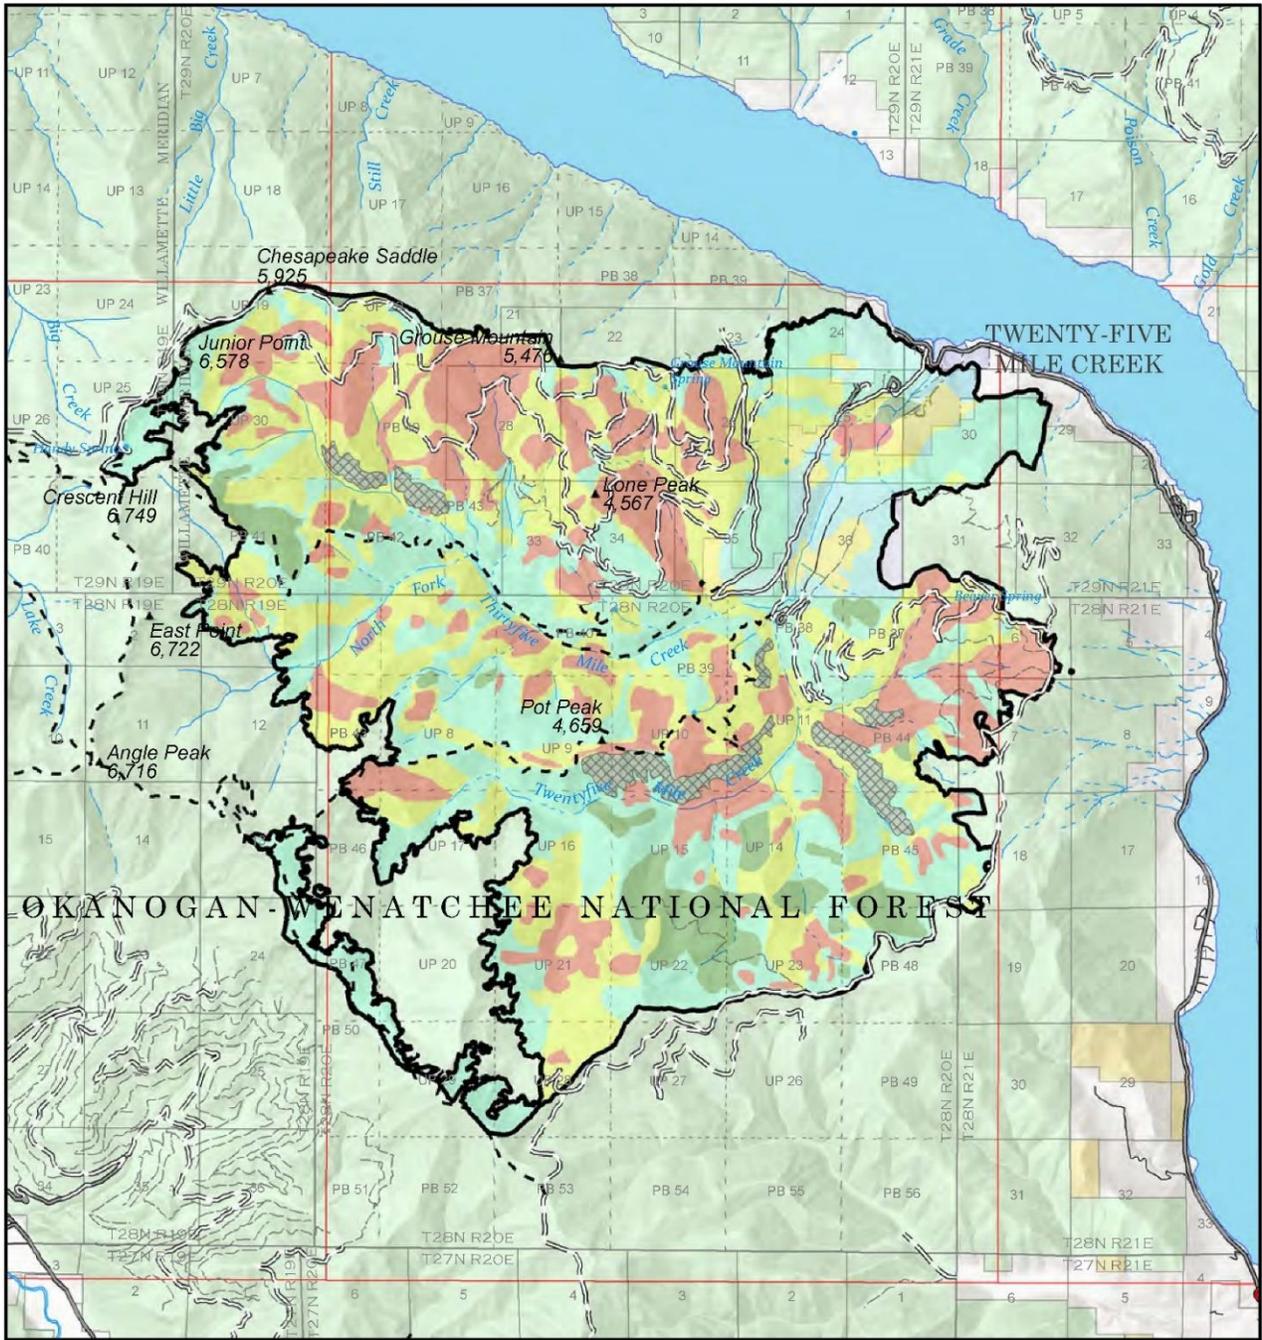
Figure 7 Burn severity map of the Twentyfive Mile Fire.

Mapped and validated SBS acres for the fire are High (21%), Moderate (32%), Low (39%), and Unburned (6%) (see map on page 6). Modeled average erosion rate for the entire burned area is 11 tons/acre producing approximately 883 yd<sup>3</sup>/mi<sup>2</sup>. When the individual catchments were modeled the erosion rate ranged from 9 tons/acre to 19 tons/acre

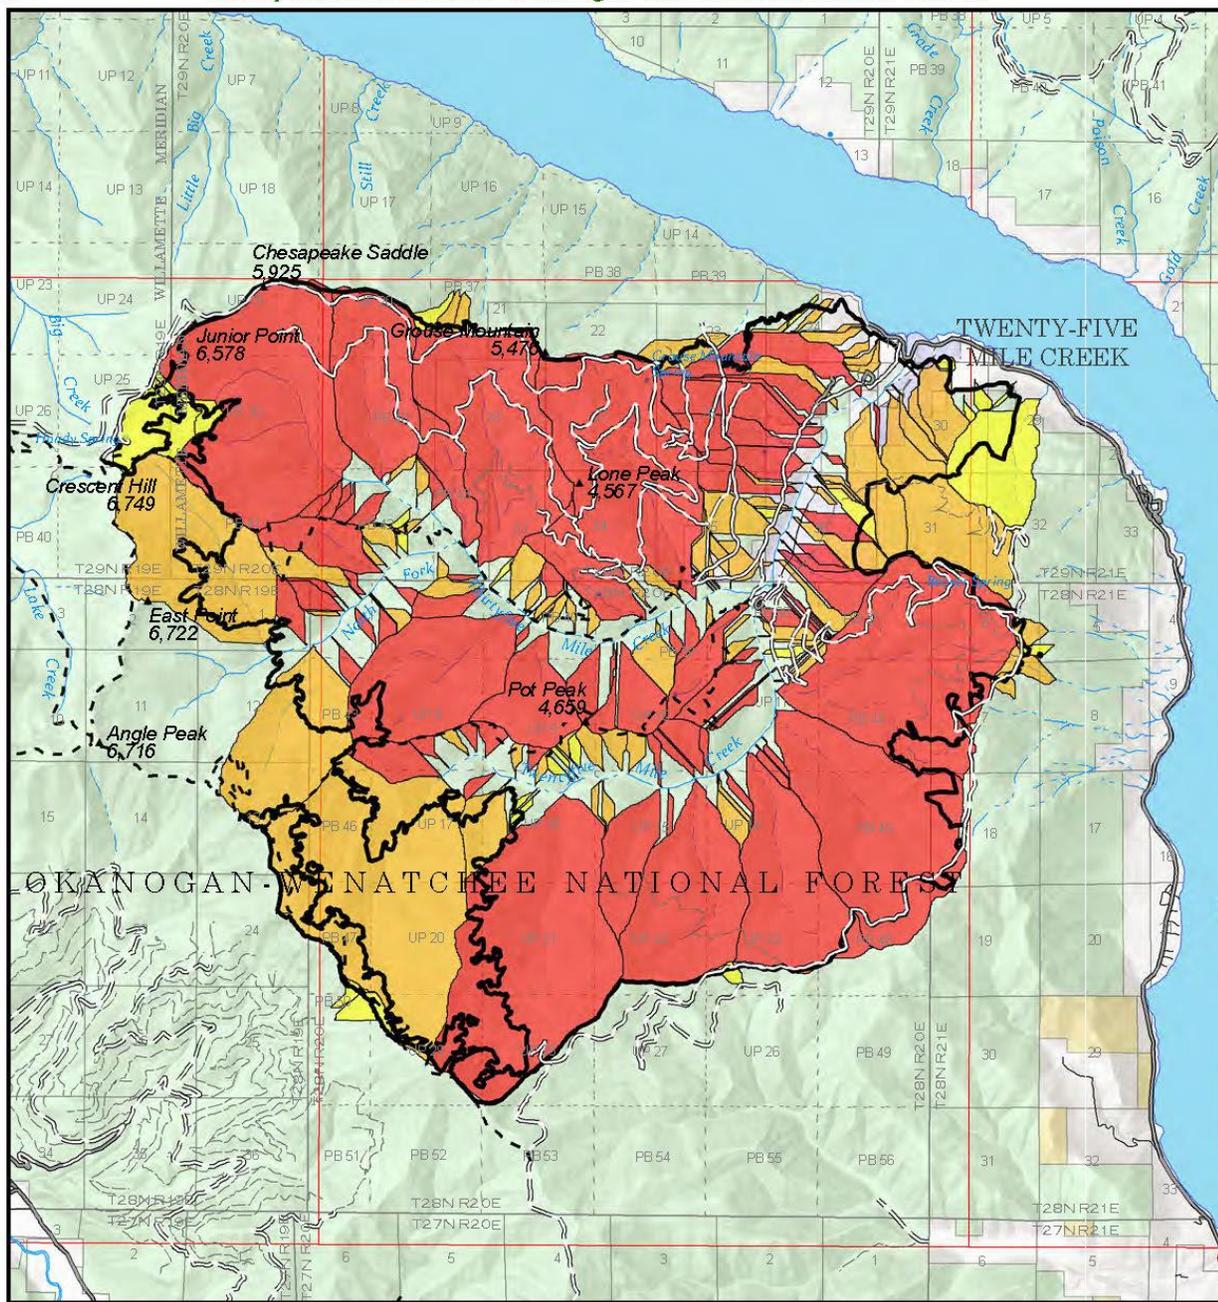
Figure 8 Debris flow hazards for the Twentyfive Mile Fire

The USGS-derived models estimate a moderate to high level of debris-flow hazard for most of the area burned by the Twentyfive Mile fire. When modeled against a 15 min / 40mm/hour storm (approximately 0.4" rain in 15 minutes), most large basins within the burned area have a high debris flow hazard rating. Both North Fork and the main Twenty-Five Mile Creek should expect to experience debris flows (see map on page 7).

**Combined relative debris-flow hazard in response to a rainstorm with a peak 15-min rainfall intensity of 40mm/hr. Data generated by the USGS**
