# THE MCKINLEY LAKE MINE

GOLD FEVER FIZZLE

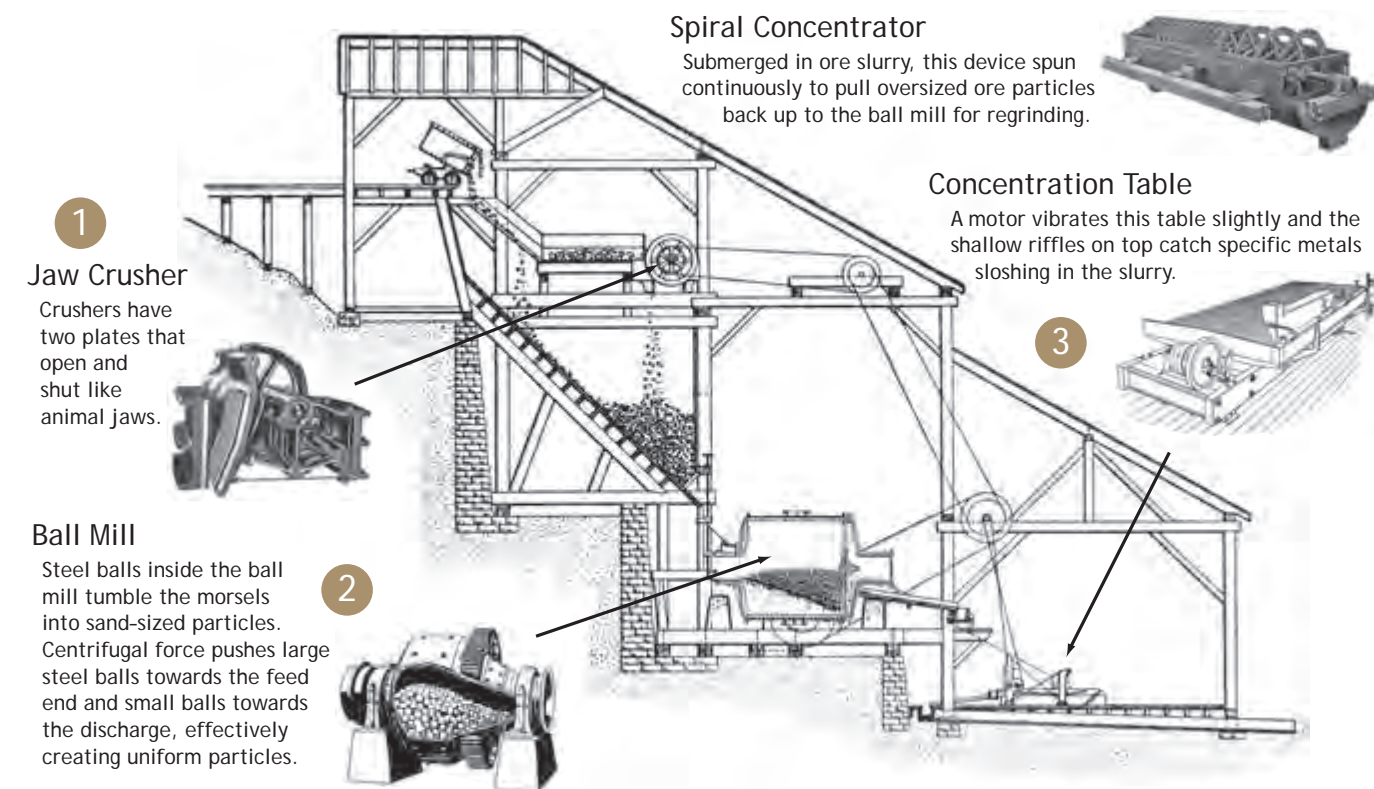
McKinley Lake Mine's mill may have worked like this typical amalgamation-concentration mill.

The milling process starts at the top. Rough ore is delivered in carts along a tram line and dumped over a screen. Large chunks go to a **coarse jaw crusher** 1 and are crushed into morsels. These morsels tumble down to the next stage, fine grinding.

The morsels are ground into sand-sized particles in the **ball mill**. 2 The particles are screened to assure a uniform size, then washed down to the recovery process.

Ground ore slurry is processed over and over with different methods until every bit of valuable ore is recovered. One method is **flotation recovery**; ground ore slurry is agitated to create bubbles. Adding specific chemicals to the bubbles causes some minerals to float where they are skimmed off. Another method pulses water through a **jig**, a box-like device over a screen which separates minerals according to size and weight. Finally, at the end of the recovery process, **concentration tables** 3 collect any remaining valuable ore.

1 Jaw Crusher  
Crushers have two plates that open and shut like animal jaws.

2 Ball Mill  
Steel balls inside the ball mill tumble the morsels into sand-sized particles. Centrifugal force pushes large steel balls towards the feed end and small balls towards the discharge, effectively creating uniform particles.

3 Concentration Table  
A motor vibrates this table slightly and the shallow riffles on top catch specific metals sloshing in the slurry.

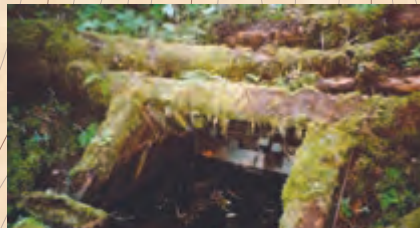
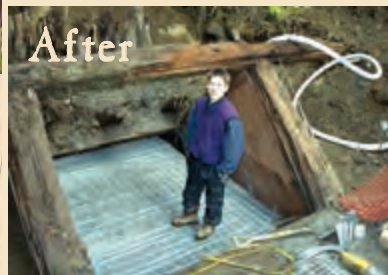
# The Inclined Shaft

Excavation of the Inclined Shaft began in 1938, one of the first areas mined at the Mill Creek site. Its full depth is unknown, however, in 1939 it reportedly was 20 feet deep at a 50-degree angle. Narrow gauge rails extended out of the opening and connected to a tram line between the log platform and the Trench Shaft. By 2000, rot had weakened the sidewalls of the shaft and deep water posed a drowning hazard. To eliminate these hazards, water was first pumped out of the shaft so it could be excavated by hand and an aluminum grate was placed over the opening to prevent persons from falling in.

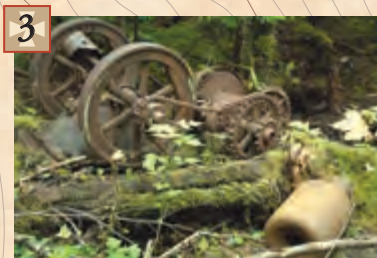
This winch powered a tram descending into the Inclined Shaft. CHUGACH NATL. FOREST PHOTO

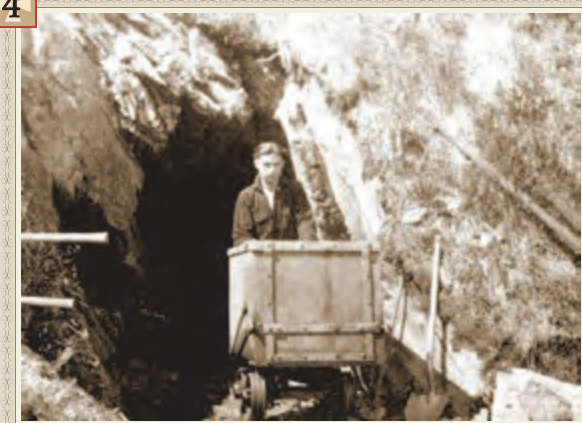
A miner pushes an ore cart on the McKinley Lake Mines, Limited, Inc. property, date and person unknown. A similar ore cart lies near the McKinley Lake Trail. UNIVERSITY OF ALASKA ANCHORAGE ARCHIVES PHOTO, DR. W.H. CHASE COLLECTION

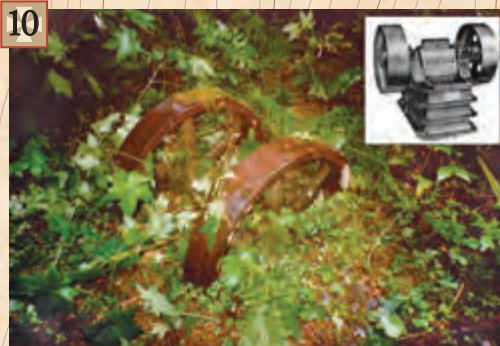
An ore crusher part, similar to the "Denver Jaw Crusher" (inset photo) lies near the McKinley Lake Trail. STATE OF ALASKA DNR PHOTO

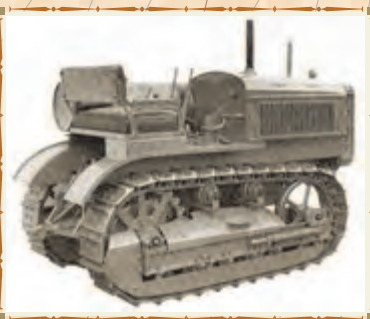
The remains of a Model Thirty Caterpillar tractor, like the model shown above and at right, can be seen at the McKinley Lake Mine site. Manufactured between 1925 and 1932, it was probably very useful for building the jeep trail to the mine, for skidding logs, and many other uses. CATERPILLAR INC. CORPORATE ARCHIVES PHOTOS

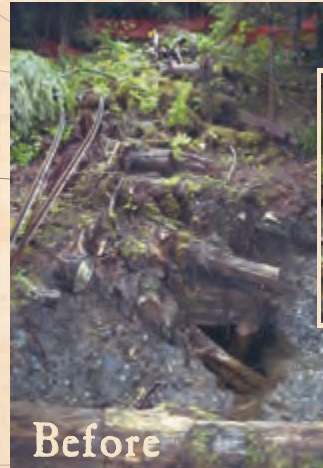
# The Trench Shaft

The Trench and Mill Creek Shafts were dug in the late 1930s to access the Little Fissure Vein. The Trench shaft, a small vertical shaft reportedly 20 feet deep, exposed the center area of the vein. The Mill Creek shaft, described by Dr. Chase as an "inclined shaft" 20 feet deep, exposed the east end of the vein. Inside the shaft, notched timbers suggest a pulley or winch system may have hoisted rocks to the surface. Over time, the steep sidewalls of both shafts rotted and filled with water and in 2000, the shafts were filled in to prevent their collapse.

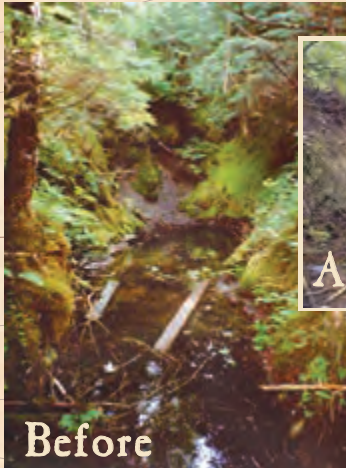
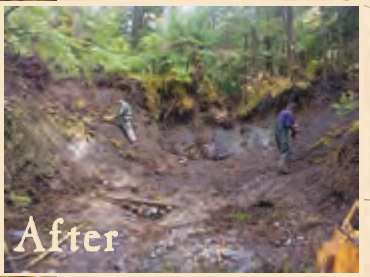
# The Mill Creek Shaft

The Trench and Mill Creek Shafts were dug in the late 1930s to access the Little Fissure Vein. The Trench shaft, a small vertical shaft reportedly 20 feet deep, exposed the center area of the vein. The Mill Creek shaft, described by Dr. Chase as an "inclined shaft" 20 feet deep, exposed the east end of the vein. Inside the shaft, notched timbers suggest a pulley or winch system may have hoisted rocks to the surface. Over time, the steep sidewalls of both shafts rotted and filled with water and in 2000, the shafts were filled in to prevent their collapse.

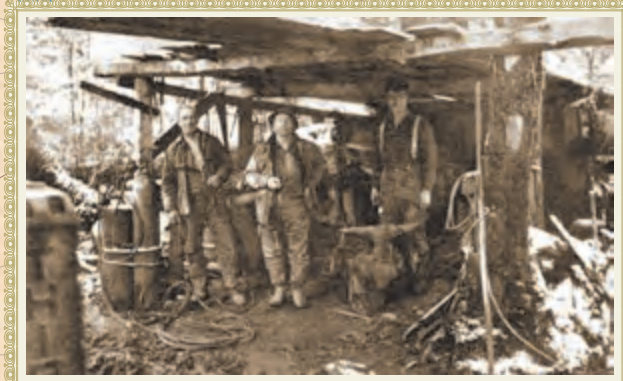
The McKinley Lake Mine mill building was under construction in the early 1940s. Today, much of the abandoned equipment at the mill site can tell the story of what happened there. UNIVERSITY OF ALASKA, ANCHORAGE ARCHIVES PHOTO, DR. WILL H. CHASE COLLECTION

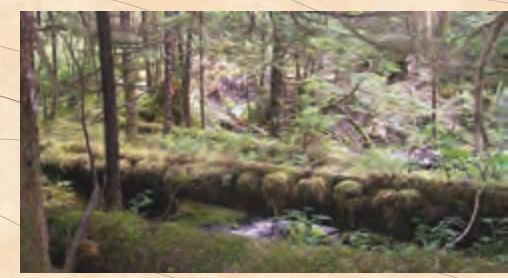
This log bridge, circa 1930, connected to the corduroy road branching off the McKinley Lake Trail and extending north toward Bear Creek. CHUGACH NATIONAL FOREST PHOTO
