FY16 Restoration and Resource Protection Projects on the Coconino National Forest

In fiscal year 2016, the Coconino National Forest physically blocked, signed, and or revegetated a number of areas with system or non-system roads to decrease impacts to forest resources and forest users. While there are many areas across the Forest that could benefit from road rehabilitation or additional steps to manage motor vehicle use, the Forest has limited resources and must prioritize these efforts to focus on the protection of watersheds, wildlife habitat, and to address unauthorized use adjacent to communities.

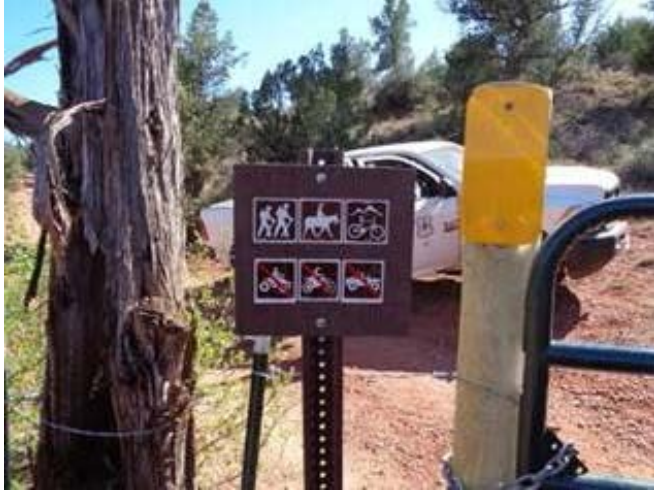
Figure 2. Gate and pass through installation with signage informing appropriate uses of the 9845N route

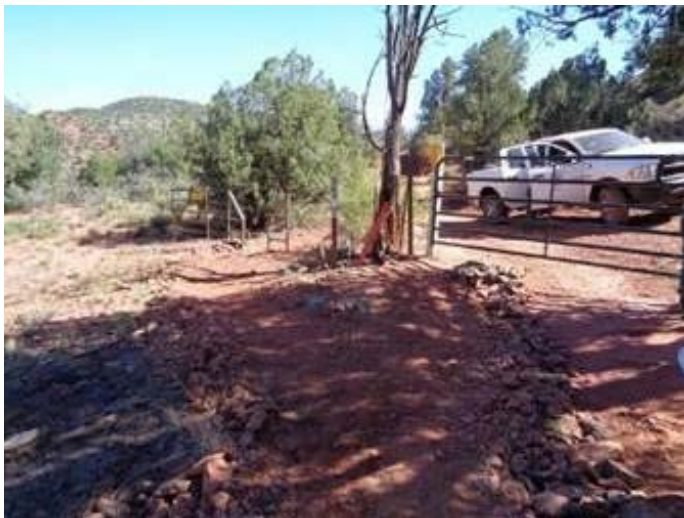
Figure 3. Gate installation included installation of a foot-travel and equestrian pass through, as well as erosion control features to restore gullies in the road.

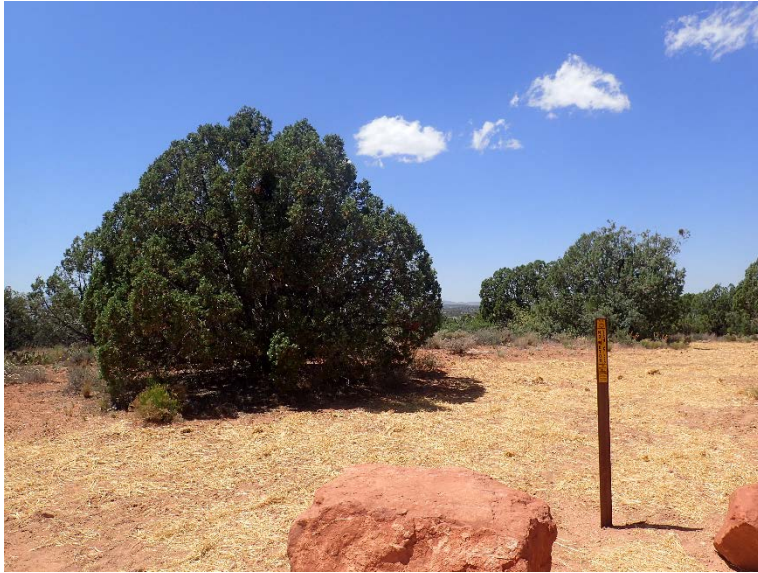
Figure 4. Areas along 9845N were seeded and mulched to restore vegetation in areas that had been damaged from motor vehicle use

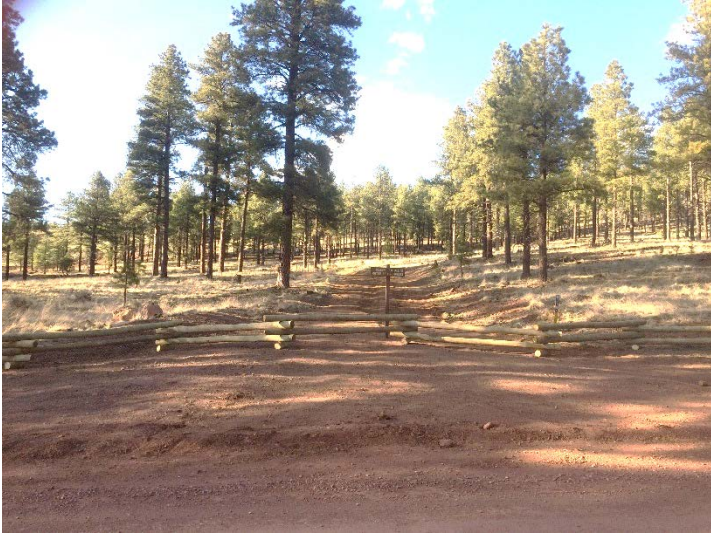
Figure 6. Log pole fence and signage blocking unauthorized motor vehicle use on the 9018K and adjacent area.

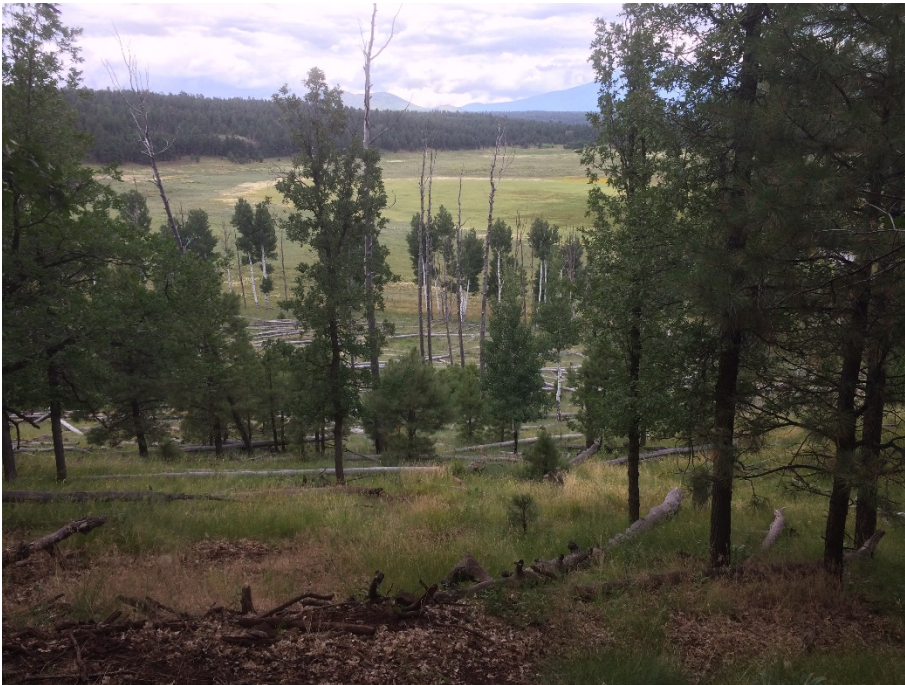
Figure 7. View from the rim of the caldera showing desirable elk habitat and aspen

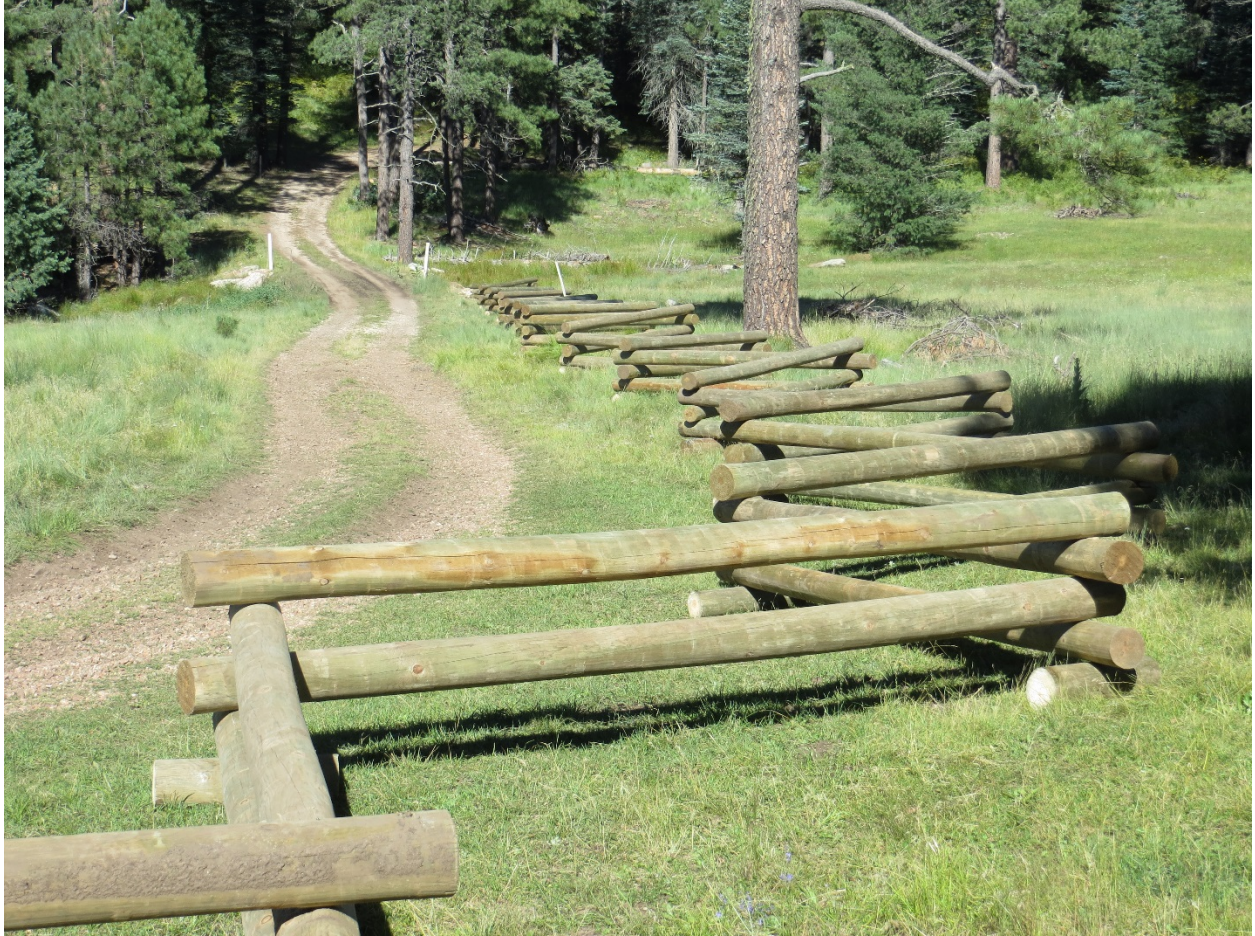
Figure 9. Installed log pole fence to reduce unauthorized motor vehicle use in sensitive meadow habitat at Holder Cabin

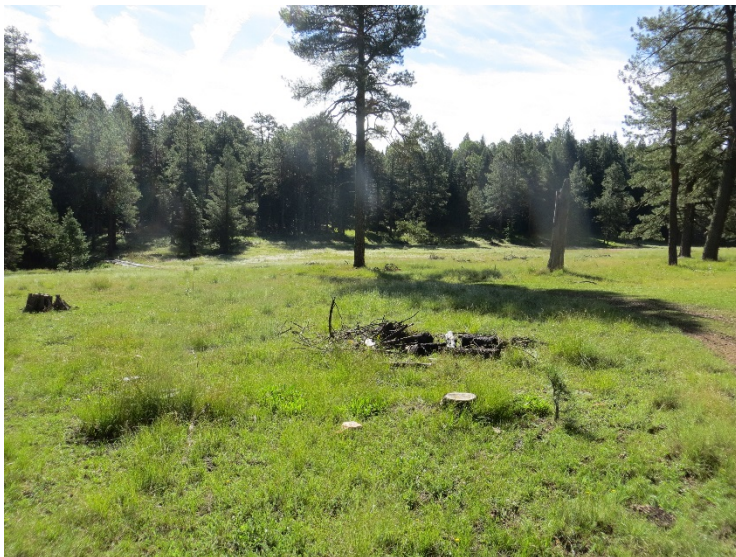
Figure 10. Restored meadow at Holder Cabin

Explanation/reason for closure: The Mogollon Rim Ranger District constructed a log pole fence along designated Forest road 9714G to reduce unauthorized motor vehicle use in a meadow surrounding Holder Cabin. This is an effort to contribute to restoration based activities that have been implemented at this location for the past seven years to restore the meadow habitat at this location. According to Arizona Game and Fish Department Wildlife Manager, Garrett Fabian, "Hard to believe that meadow had an illegal quad race track through it and was a barren dirt patch a decade ago. Looks awesome."

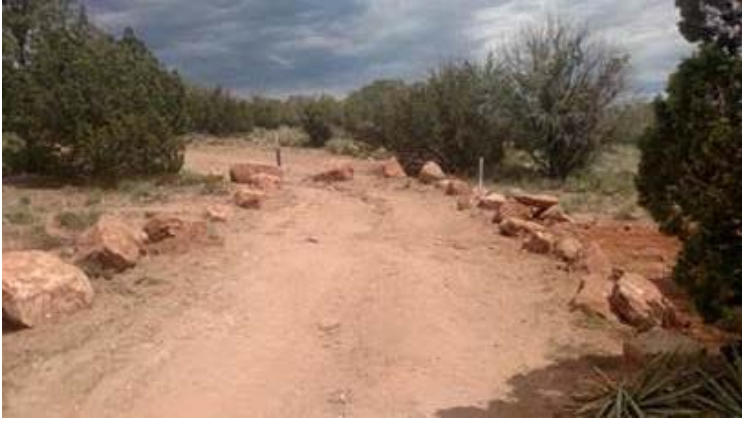
Figure 12. Boulders and carsonite signage placed along FR 9845C to reduce unauthorized motor vehicle use and new route establishment along Dry Creek.

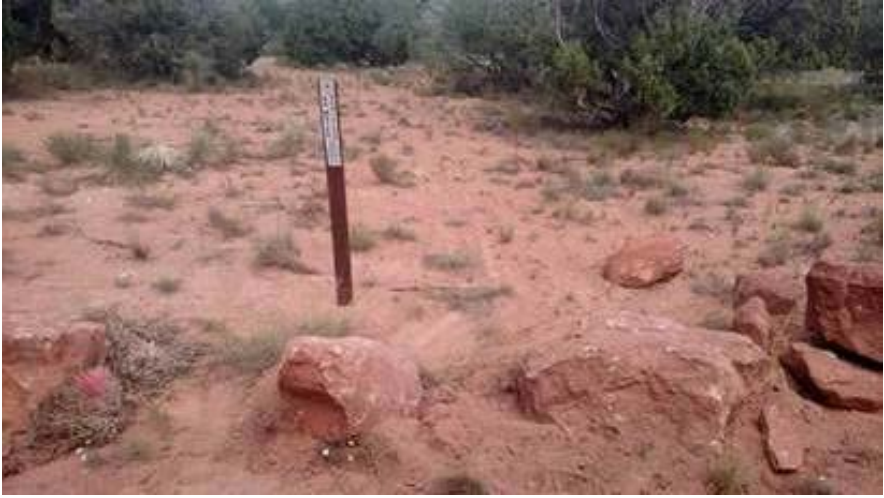
Figure 13. Boulders and carsonite signage placed along FR 9845 to reduce unauthorized motor vehicle use and new route establishment along Dry Creek.

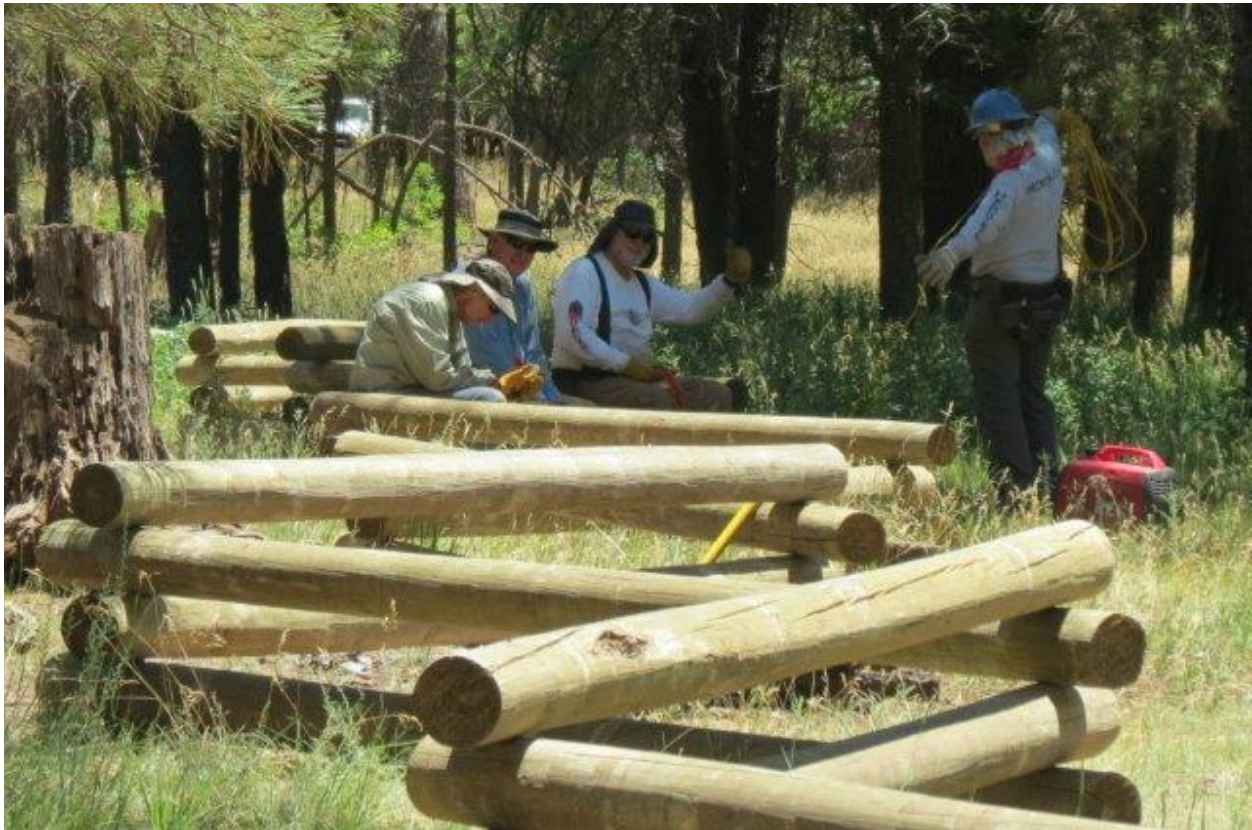
Figure 14. Friends of Northern Arizona Forests volunteers take a quick breather during the reconstruction of the log pole fence surrounding Sheep Springs.

Explanation/reason for closure: The Friends of Northern Arizona Forests (FONAF) joined with the Flagstaff Ranger District to re-build a failing fence that had been installed to keep motor vehicles and car camping out of Sheep Springs, which is a small spring that supports a wet meadow ecosystem with riparian vegetation and lush aspen trees. In addition to reconstructing the fence, approximately nine separate non-system motorized trails that have become established since the old log worm fence

became non-functional were blocked and closed using either treated logs, slash, or boulders. Volunteers also posted signs noting that motorized access to this area is not permissible. These efforts are expected to facilitate recovery of riparian habitat near Sheep Springs and Bootlegger Spring, and reduce the disturbance and wildlife habitat impacts associated with unauthorized motor vehicle use. For example several of the routes blocked are within 1.4 mile of the Milos Butte Mexican spotted owl Protected Activity Center (PAC) and the Sheep Springs Northern goshawk Post-Fledgling Area.

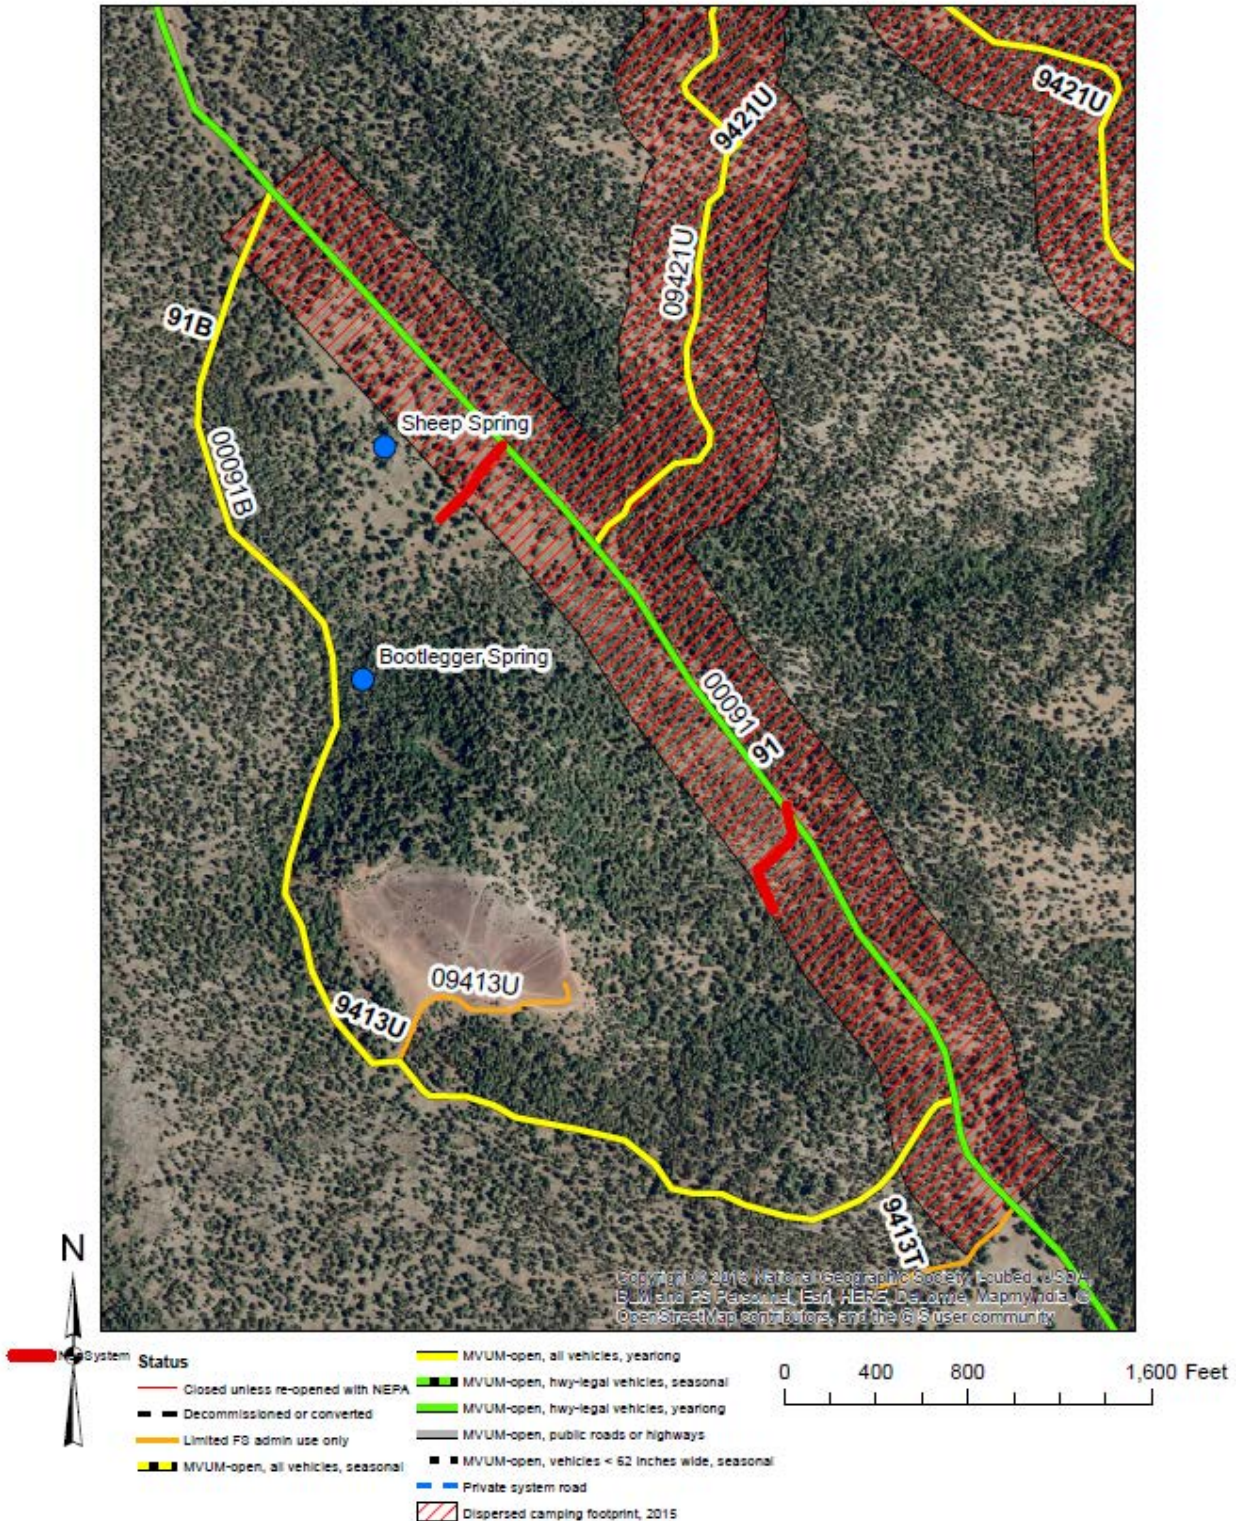
Figure 15. Map of general location of road rehabilitation and restoration activities

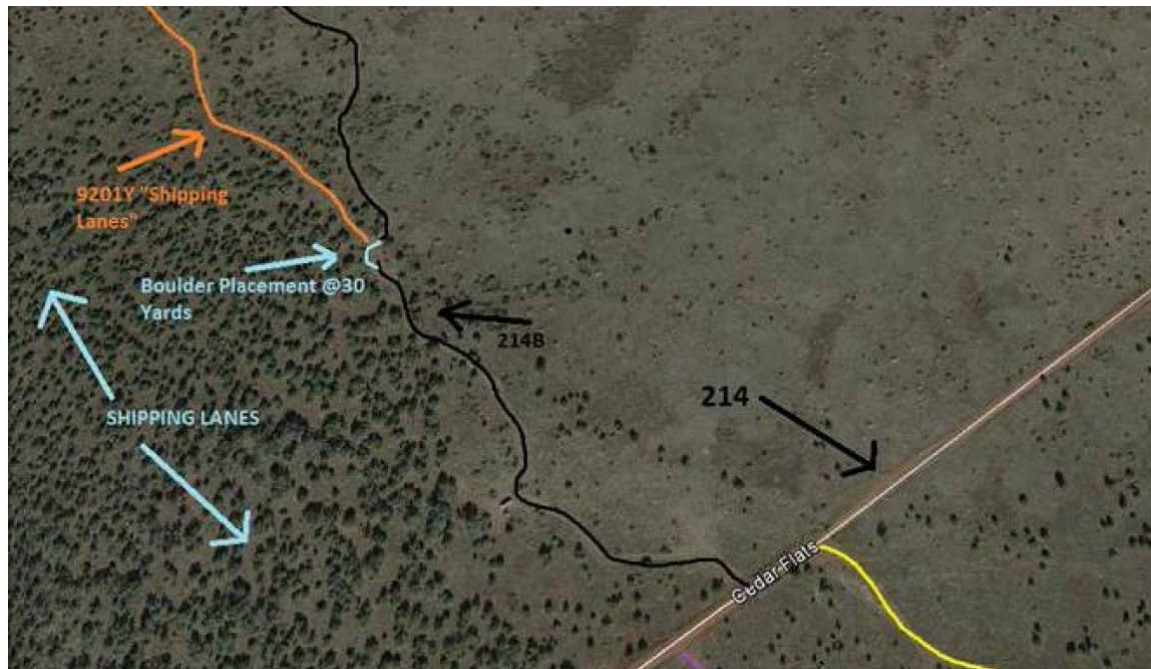
Figure 16. Aerial photo of 9201Y closure area

Explanation/reason for closure: Blocking the non-designated 9201Y road reduces unauthorized motor vehicle use to stop the establishment of non-system roads and build on watershed restoration-based vegetation treatments that have occurred in the same general area.

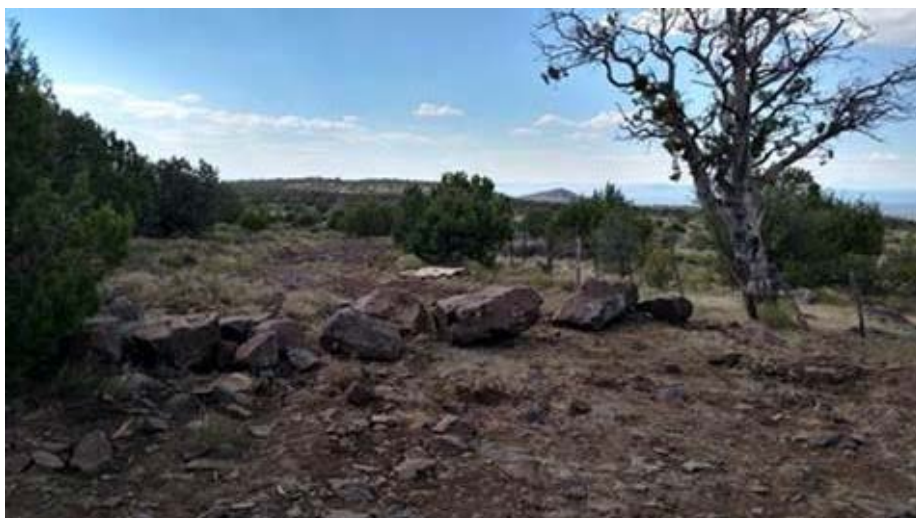
Figure 17. Area used to access 9201Y and surrounding non-designated routes blocked with boulders to discourage unauthorized motor vehicle use

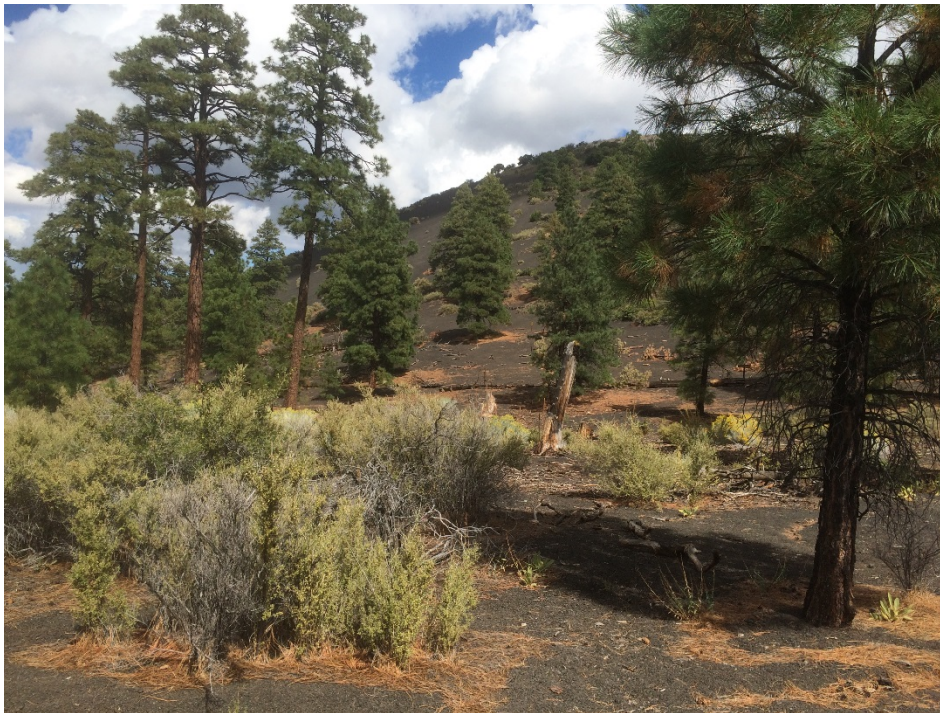
Figure 18. View of Haywire Crater from a dispersed campsite adjacent to Forest Road 244, which is the primary access point for unauthorized motor vehicle use in this area

Explanation/reason for closure: Unauthorized motor vehicle use has resulted in the establishment of a number of non-system roads from an existing, large campsite along Forest Road 244 to the nearby Haywire Crater. It appears that regular OHV use from the campsite has created a number of routes on the top and south-facing slope of the crater as to be visible from approximately a mile away. In addition, several of the routes appear to be extending north toward a wildlife drinker constructed and maintained by the AZGFD. Continued unauthorized motor vehicle use in this area would likely increase impacts to scenery and result in wildlife harassment and habitat degradation. Large logs and signage were installed surrounding the existing dispersed campsite to discourage unauthorized motor vehicle use and facilitate more effective enforcement efforts at this location.

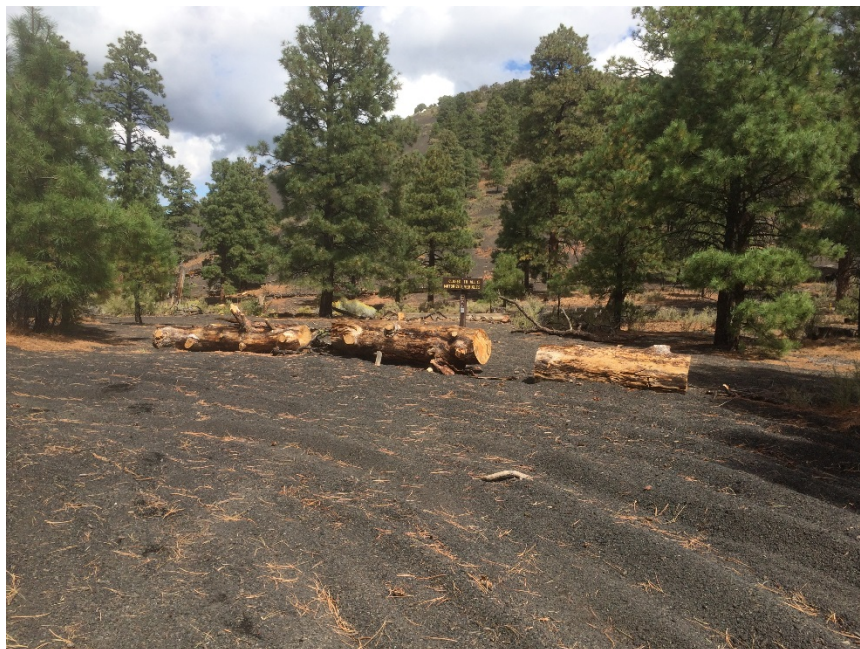
Figure 20. Barriers and signage were placed to discourage unauthorized motor vehicle use

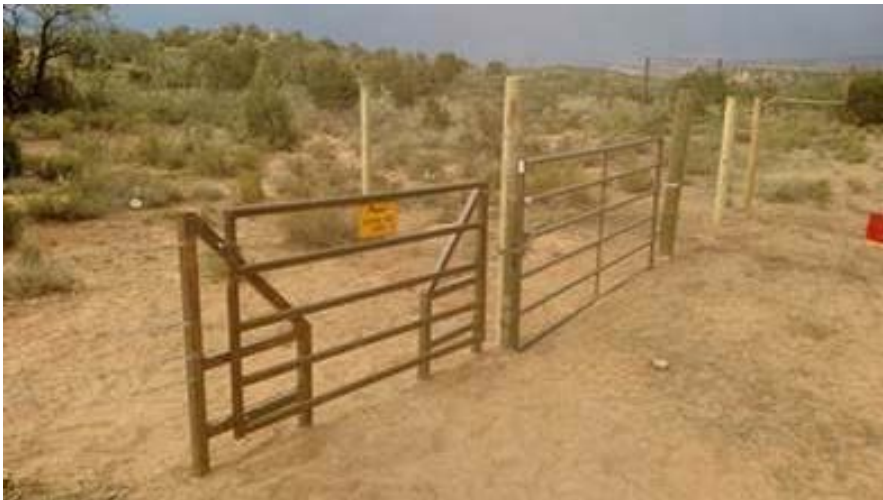
Figure 21. Gate and pass through installed at 9202Y

Explanation/reason for closure: Both 9205K and 9202Y are Forest System roads adjacent to private communities where there is ongoing unauthorized motor vehicle use and route establishment. Conditions in both of these areas continue to deteriorate, which affects soils, vegetation, and downstream water quality. Several efforts have been made to limit unauthorized motor vehicle use using signage, targeted enforcement, and education; but they have met with limited success. In February 2016, a decision was signed approving the re-alignment and delineation of the 9205K and 9202Y roads, establishing delineated trailhead/ parking areas, authorizing the installation of signage and at least one informational kiosk, and allowing for rehabilitation of surrounding non-system roads. In 2016, the Red Rock District began implementation of this decision by installing wet weather gates with pass throughs and repairing and rehabilitating the adjacent areas by filling and armoring several deep gullies that were contributing to ongoing erosion in the area. Unauthorized roads near the green gate (9205K) area were blocked, scarified, and re-seeded with the help of volunteers during National Public Lands Day on September 24, 2016.

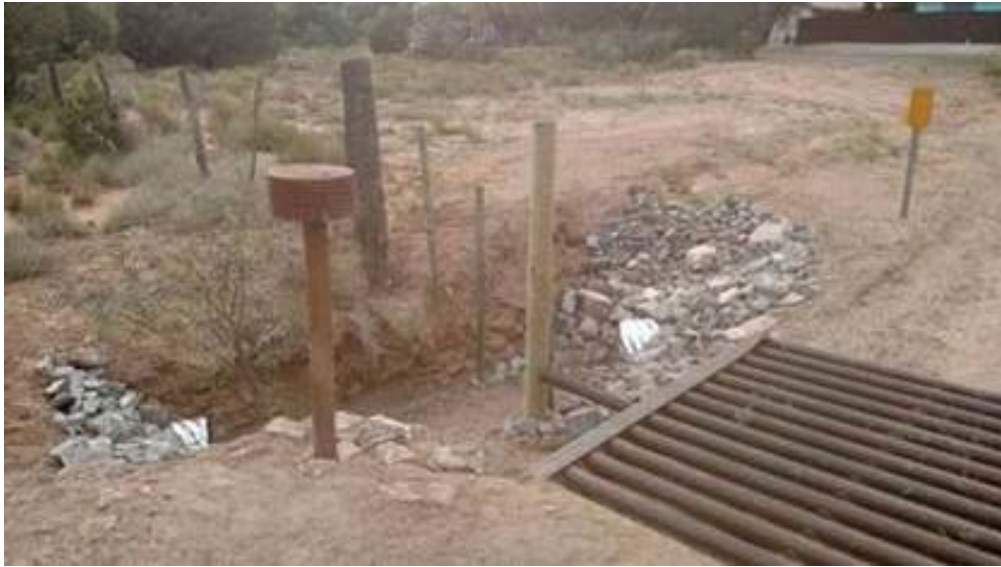
Figure 22. Large gully that was repaired and armored at the 9202Y gate

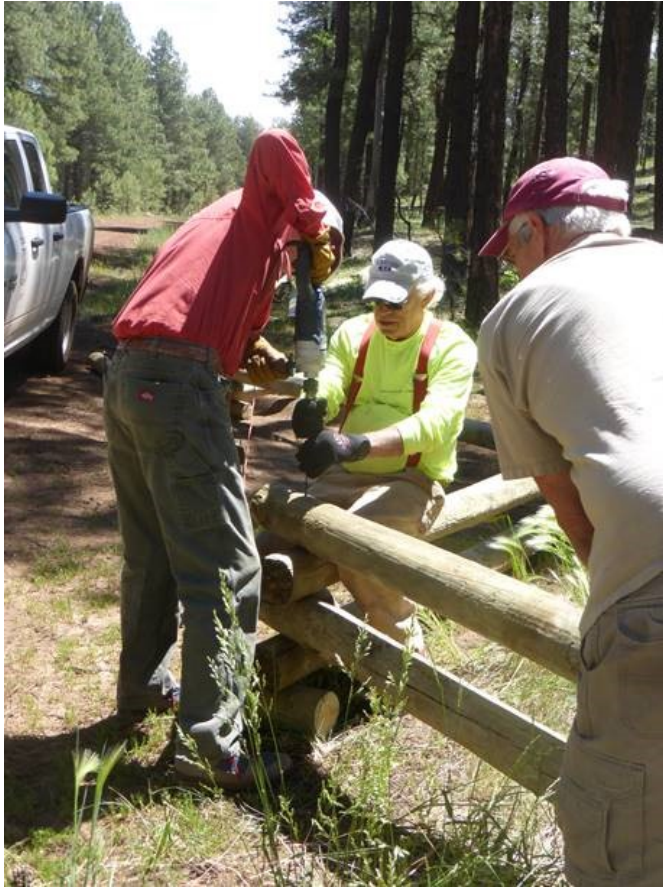
Figure 23. Members of FONAF installing a log pole fence to prevent motor vehicle use in leafy spurge infested areas.

road was blocked with the construction of a log-pole fence, and the leafy spurge was treated. Signage was installed on the fence to explain to Forest visitors the purpose of the log pole fence.

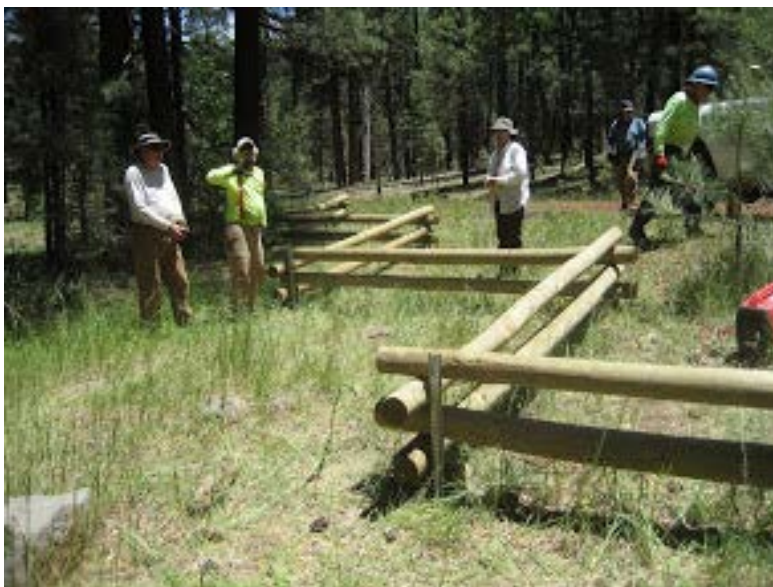
Figure 24. Log pole fence at 9473J

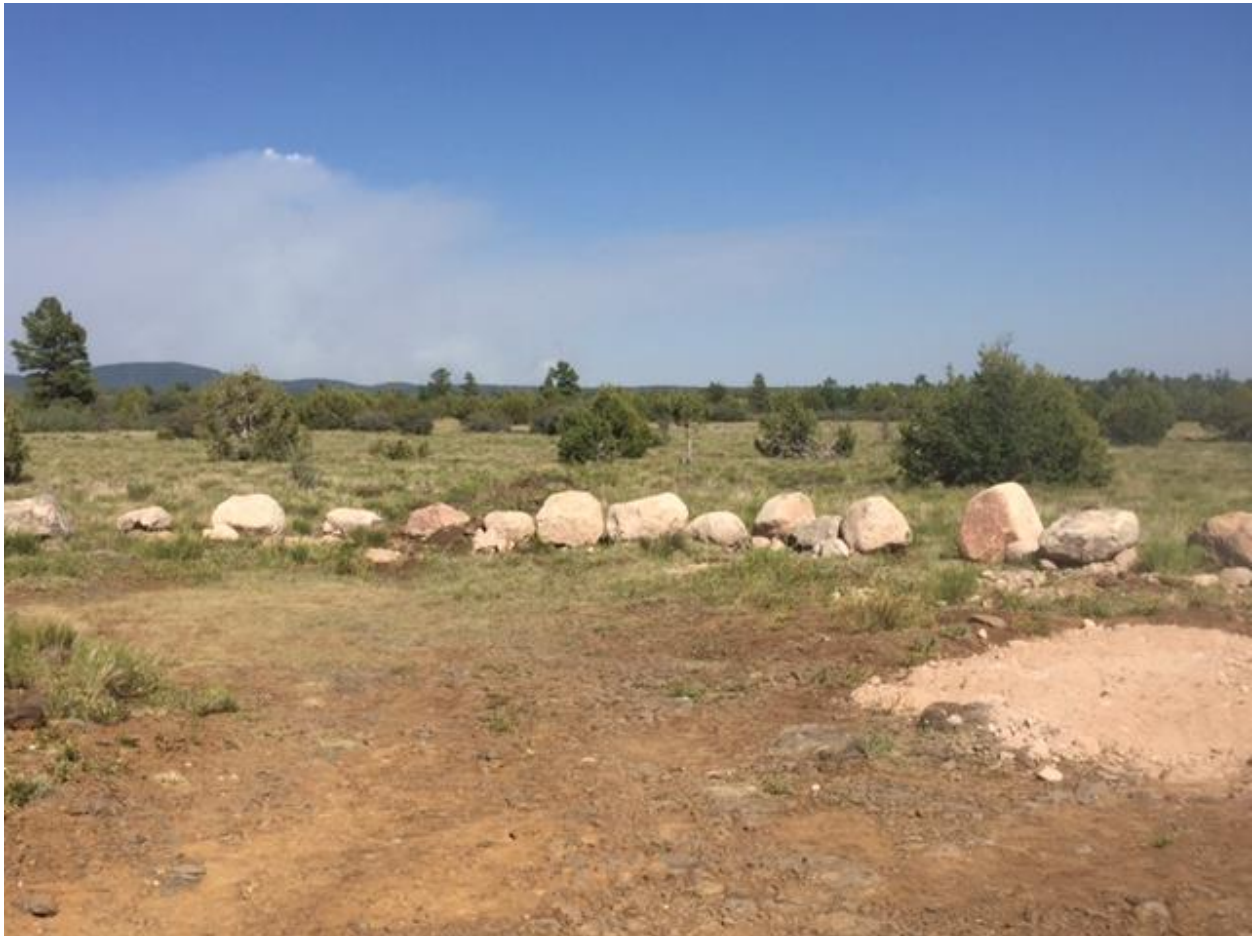
Figure 25. Boulders places near 9241E to prevent motor vehicle use outside of existing campsites.

Explanation/reason for closure: The 9241E road is a road accessible from the south side of Stoneman Lake road, which includes a number of well-established campsites as it is easily accessible off a paved road, and provides very quick access for hunters to the Rattlesnake Quiet Area. The first 300 feet of this route was originally designated for motor vehicle use, but there were concerns that without some sort of physical blockade, the route would enable ongoing motor vehicle use in nearby Rarick Canyon. To address the issue of potential watershed impacts while still allowing for motor vehicle dispersed camping at the several existing campsites in this area, the Red Rock Ranger District delineated the camping area with boulders and installed a gate on the 9241E road to prevent motor vehicle use beyond the existing motorized campsites. The Forest has only received positive feedback from this effort, such as one Forest visitor who e-mailed to say. "Your group went in there and strategically placed large rocks around the perimeter of the campsite effectively blocking access to the interior. Thank you for a great job!"
