# Anan Wildlife Observatory

Viewing Deck Replacement Project

Anan Deck Replacement  
Preliminary Conceptual Designs  
January 2018

Conceptual Design  
March 2018

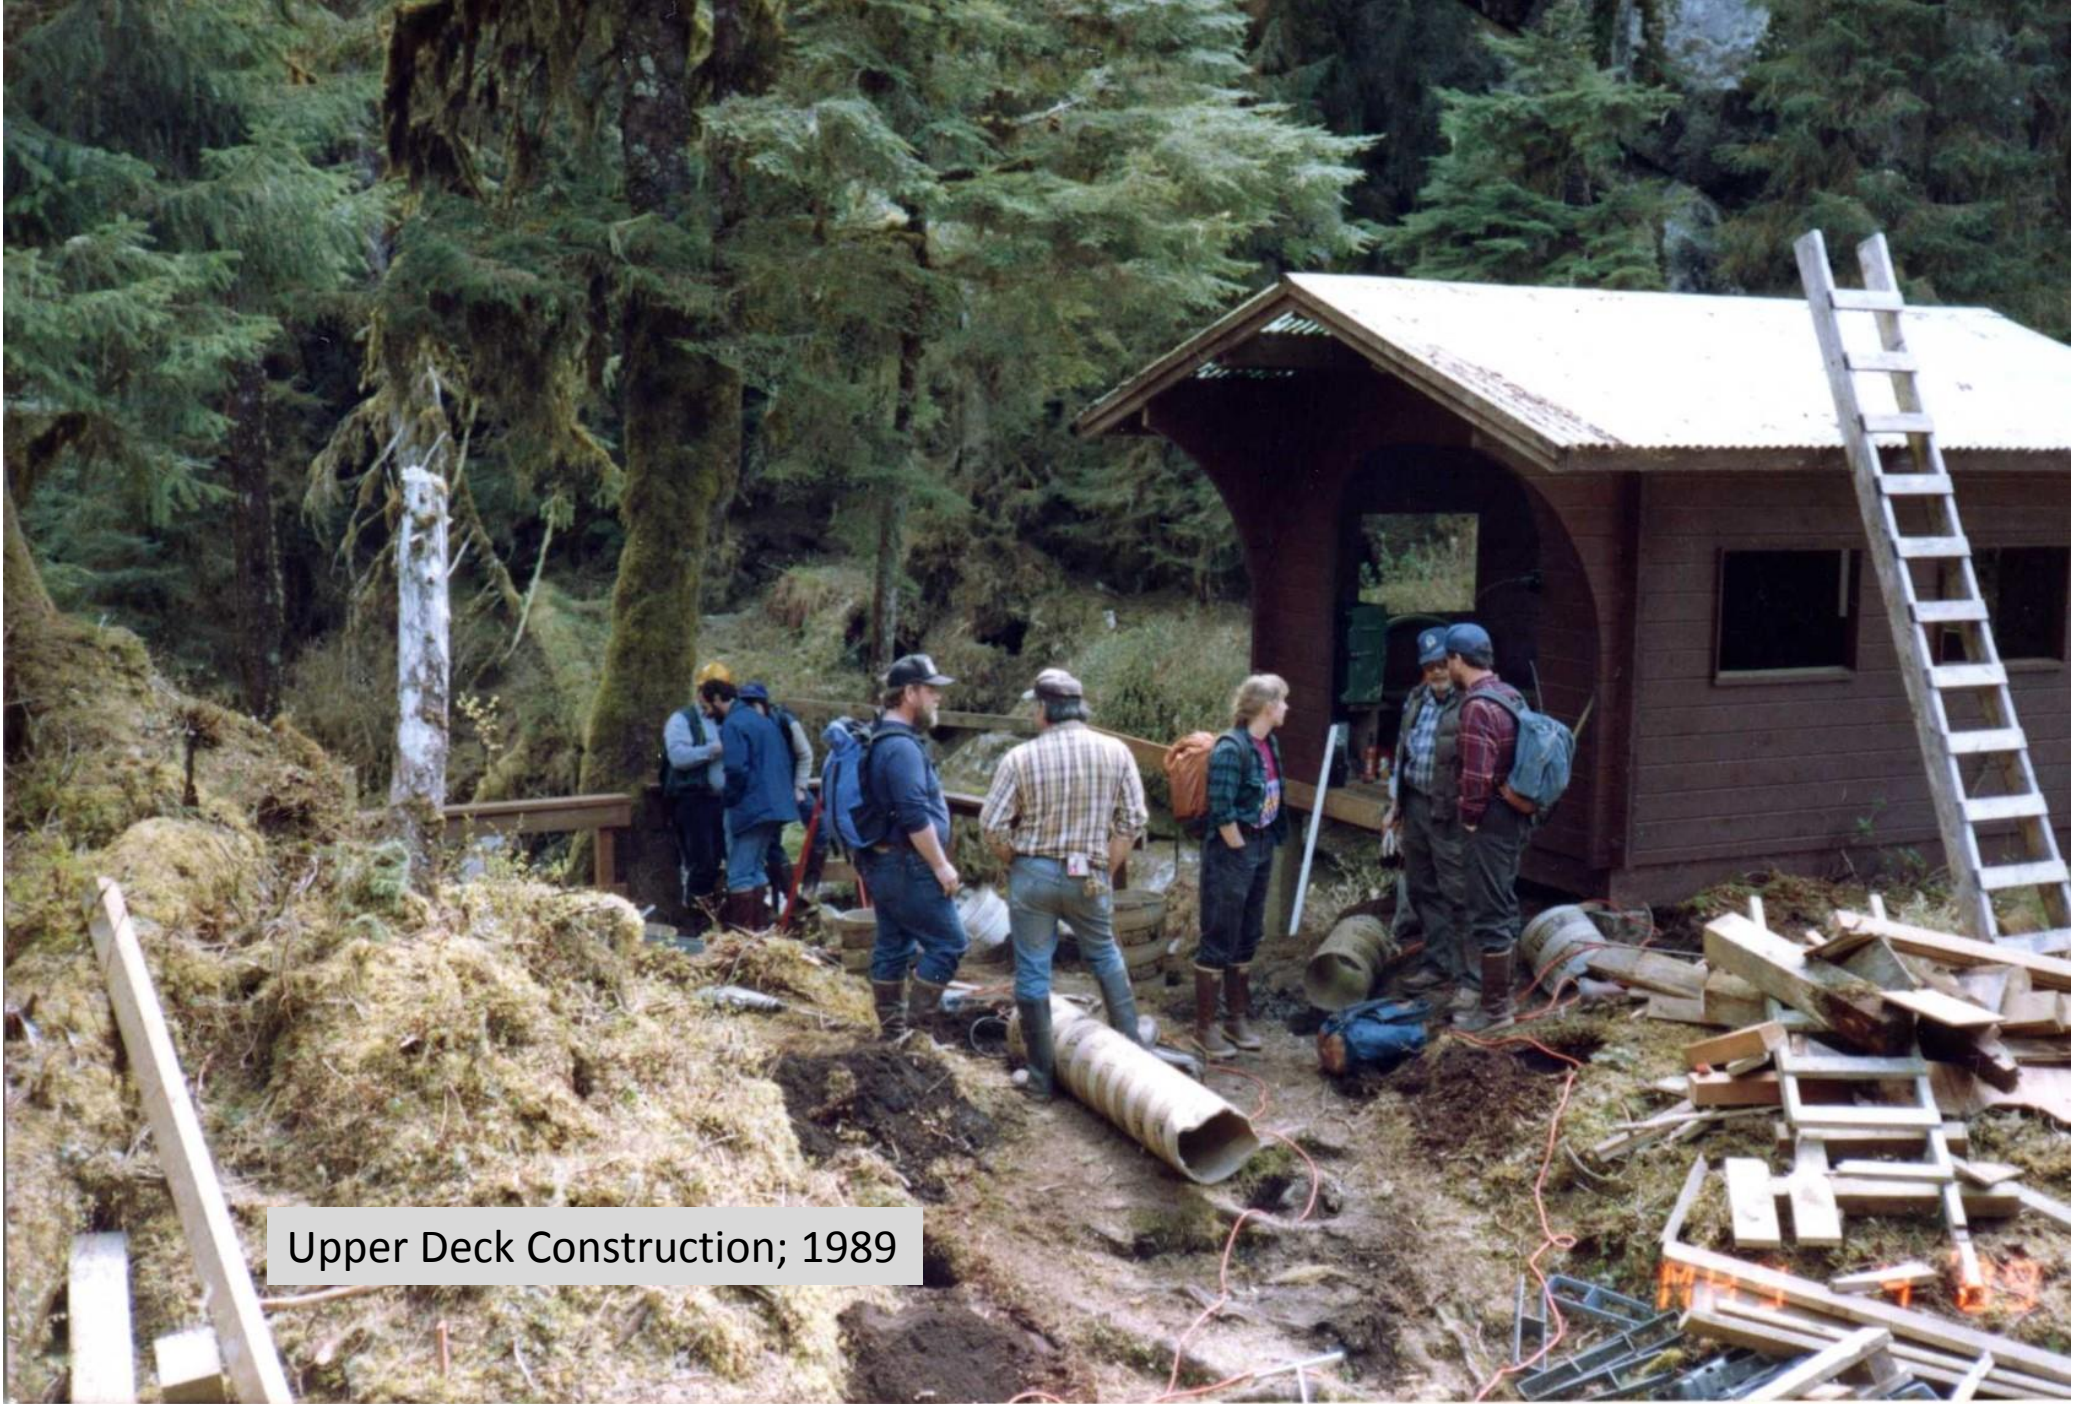
Upper Deck Construction; 1989

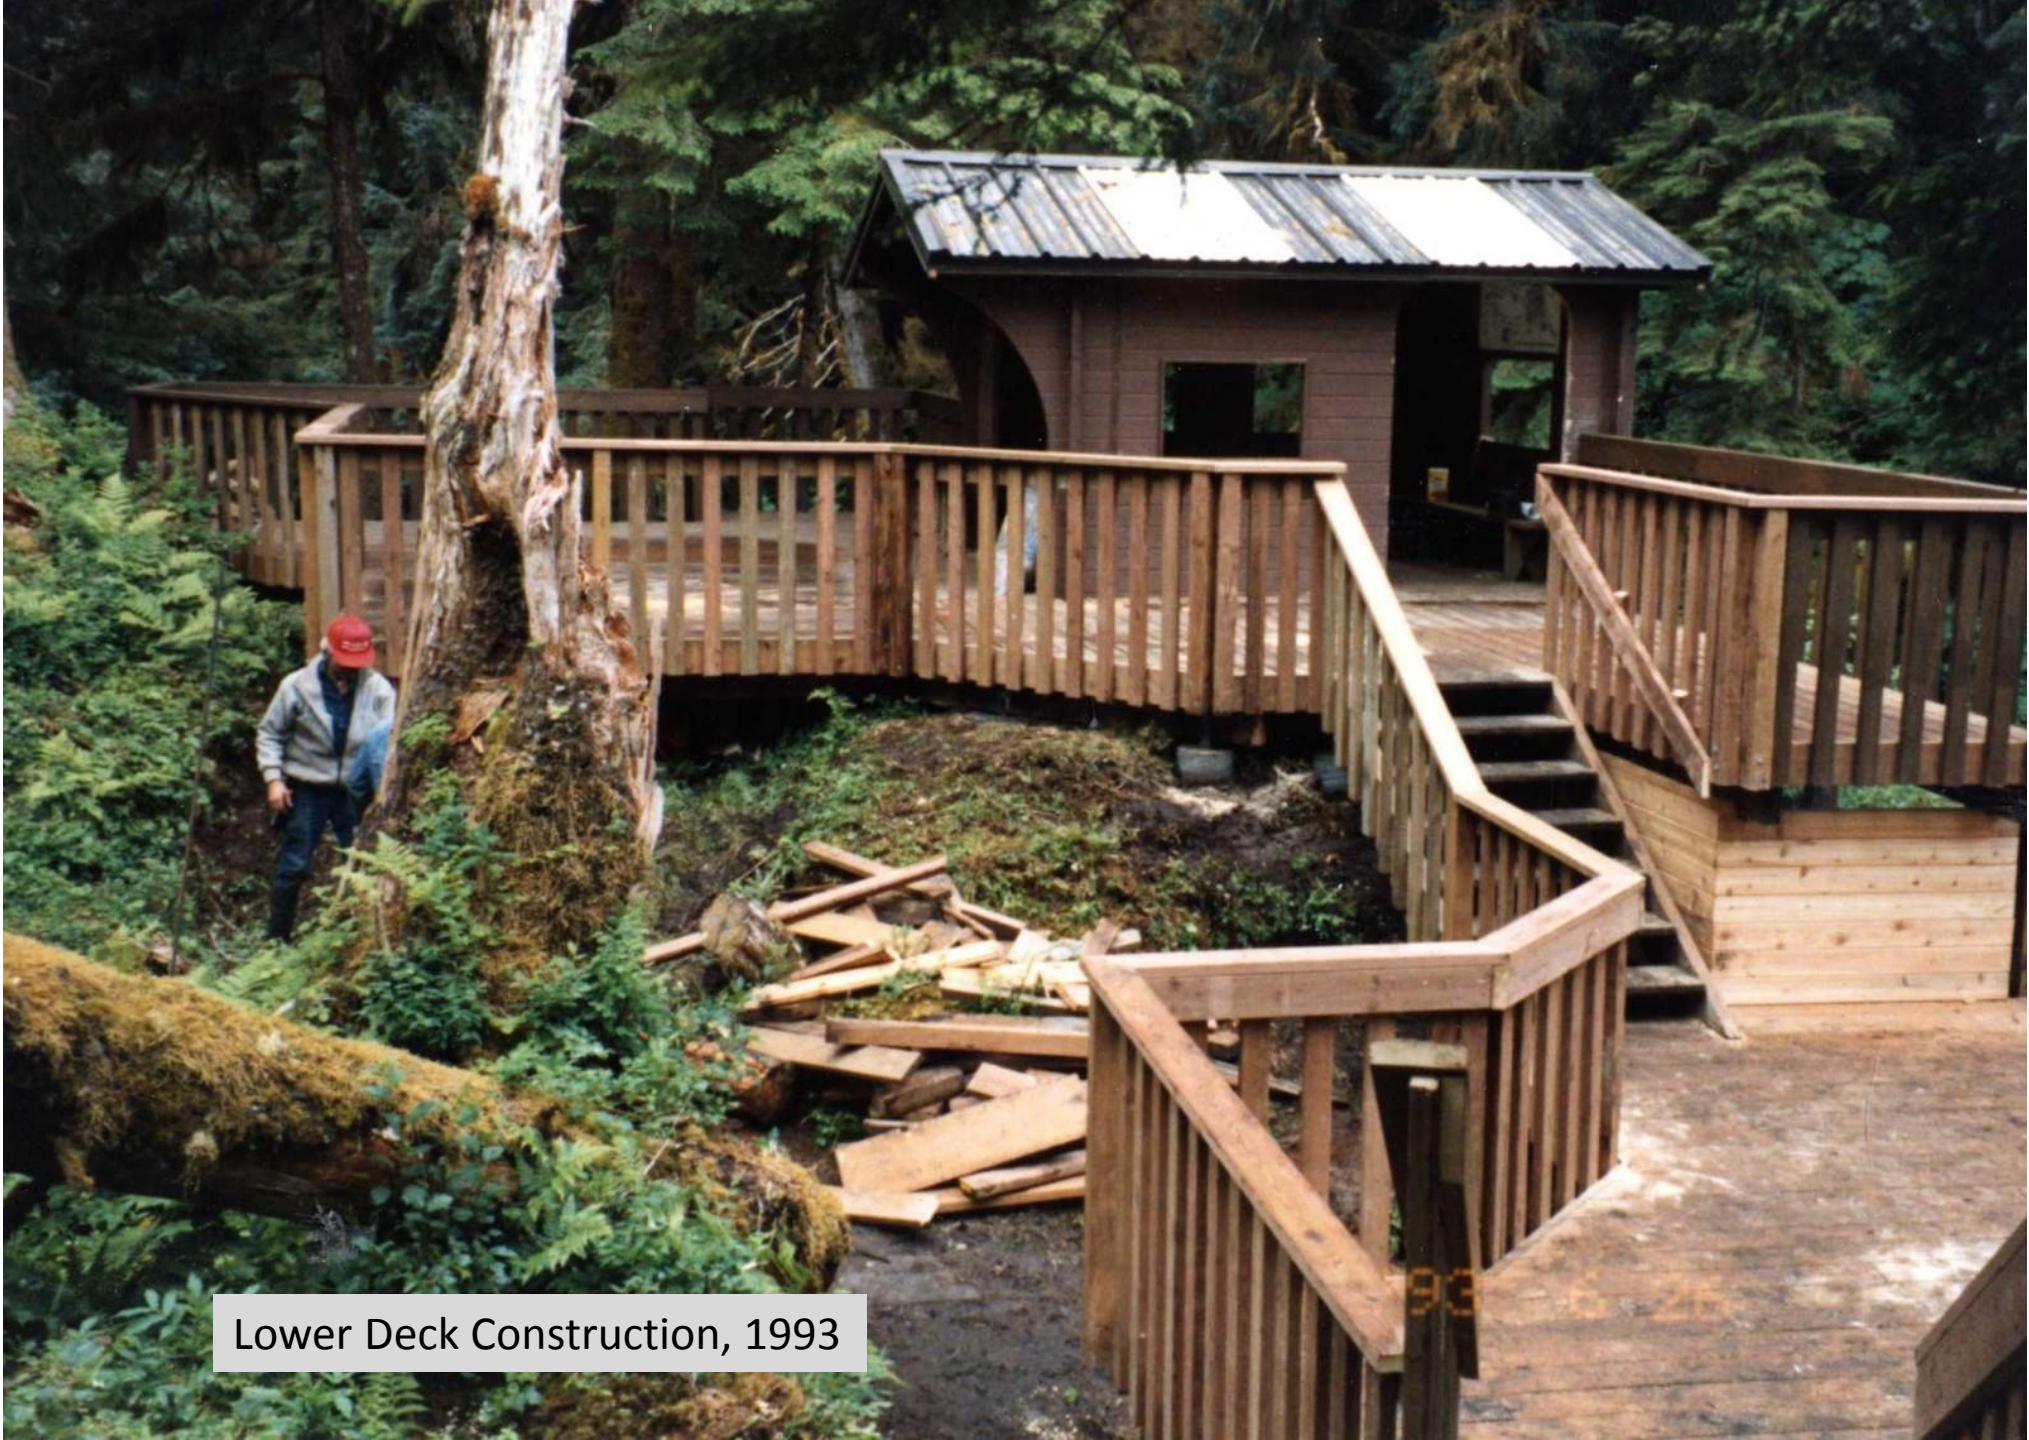
Lower Deck Construction, 1993

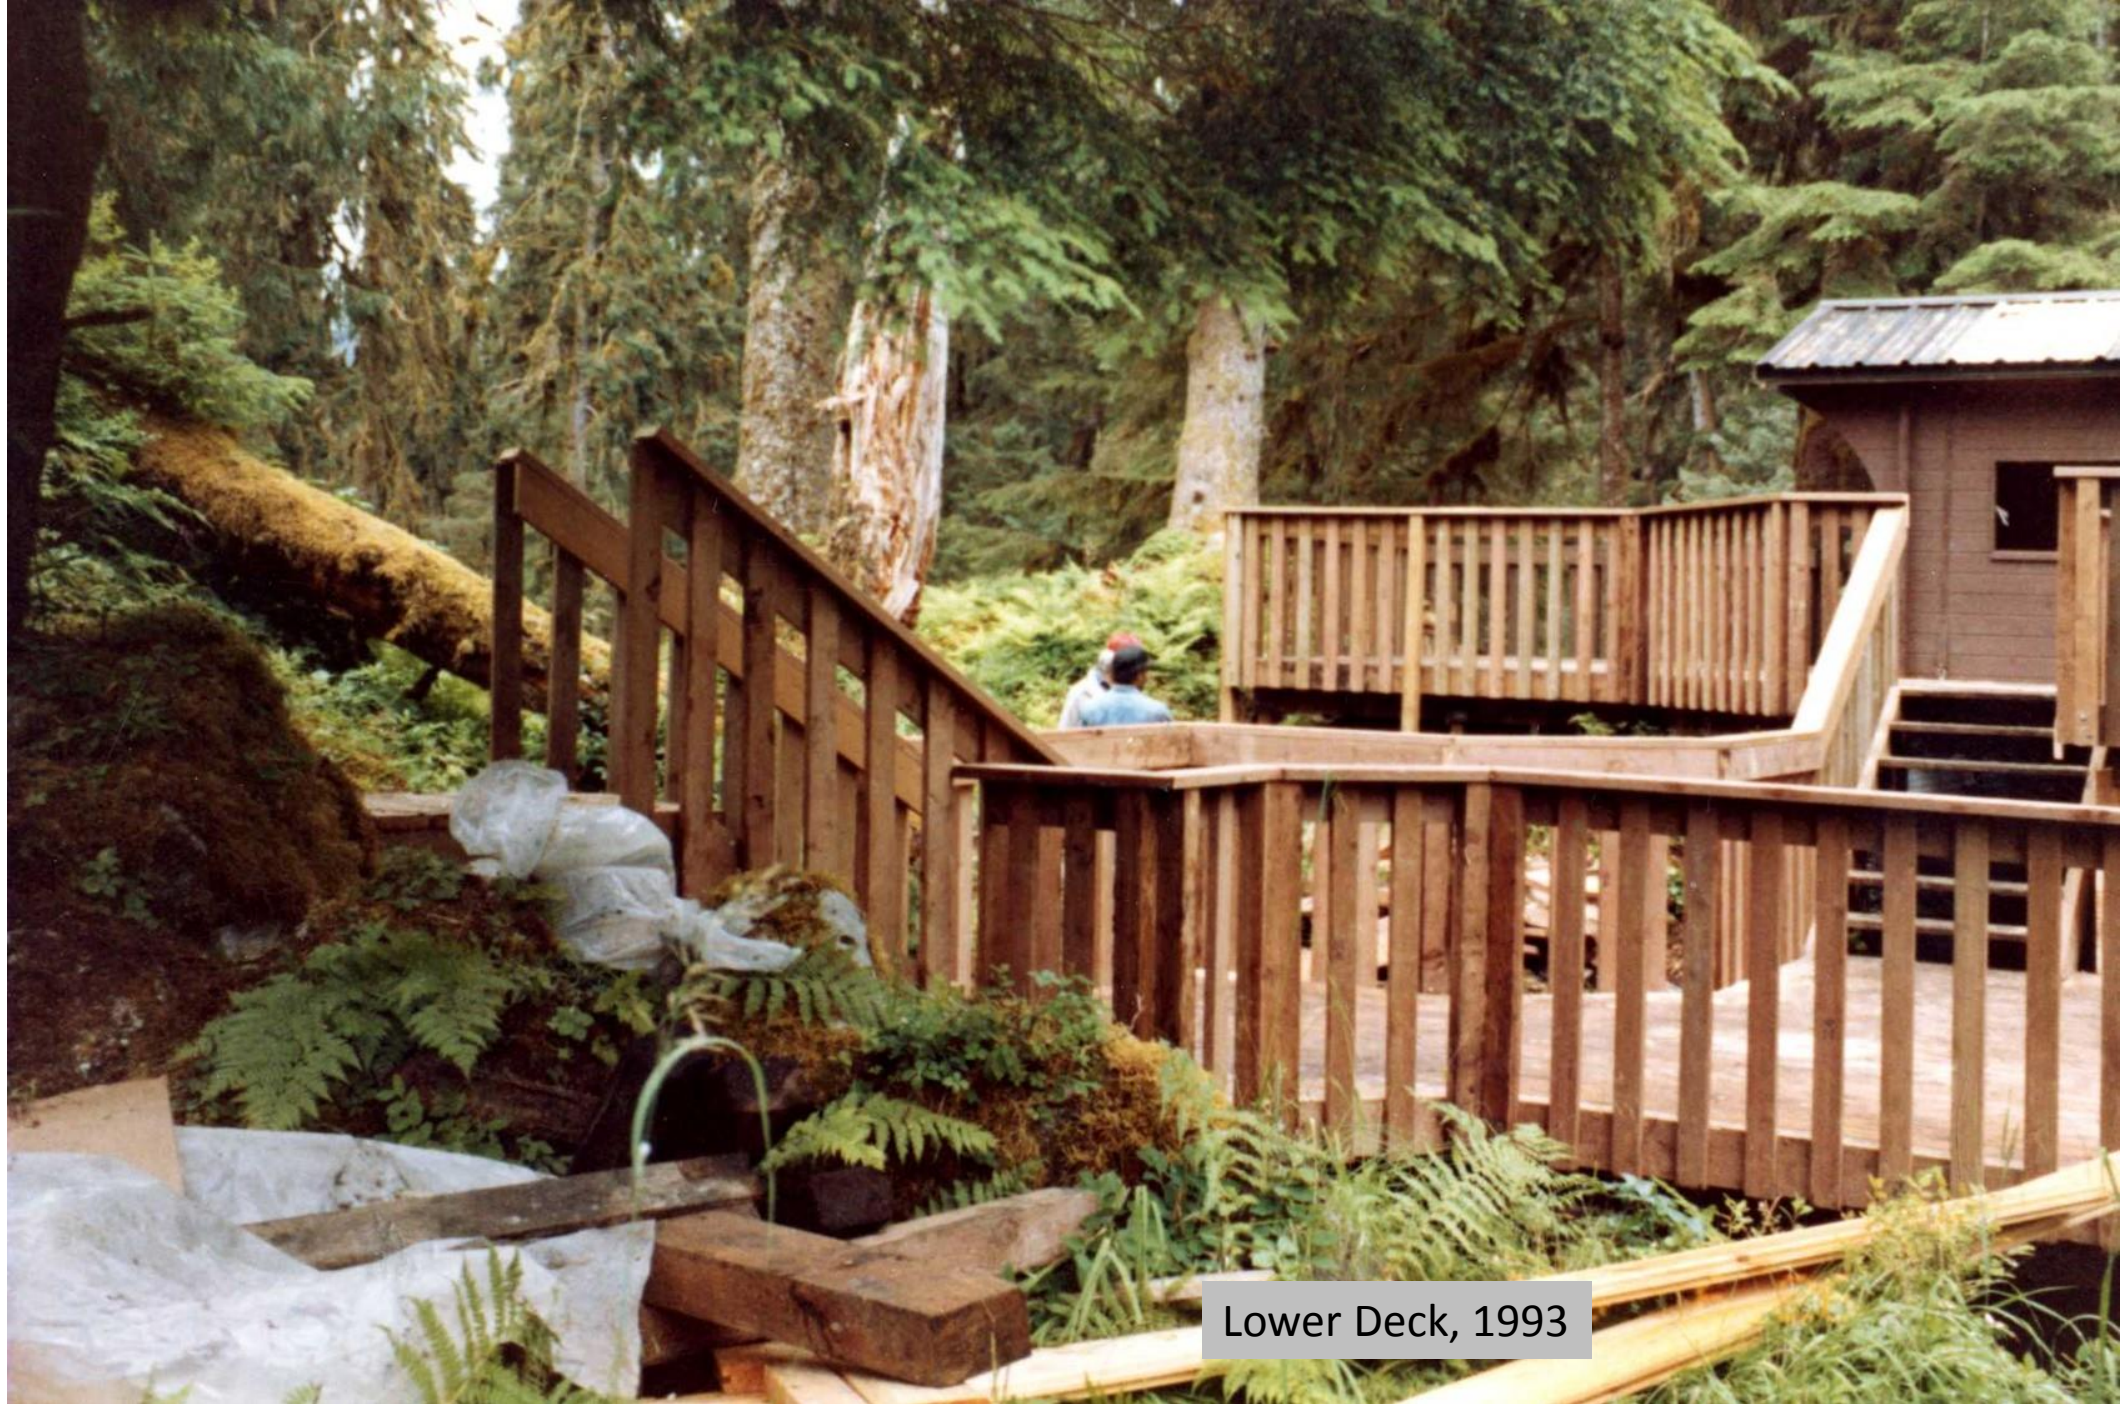
Lower Deck, 1993

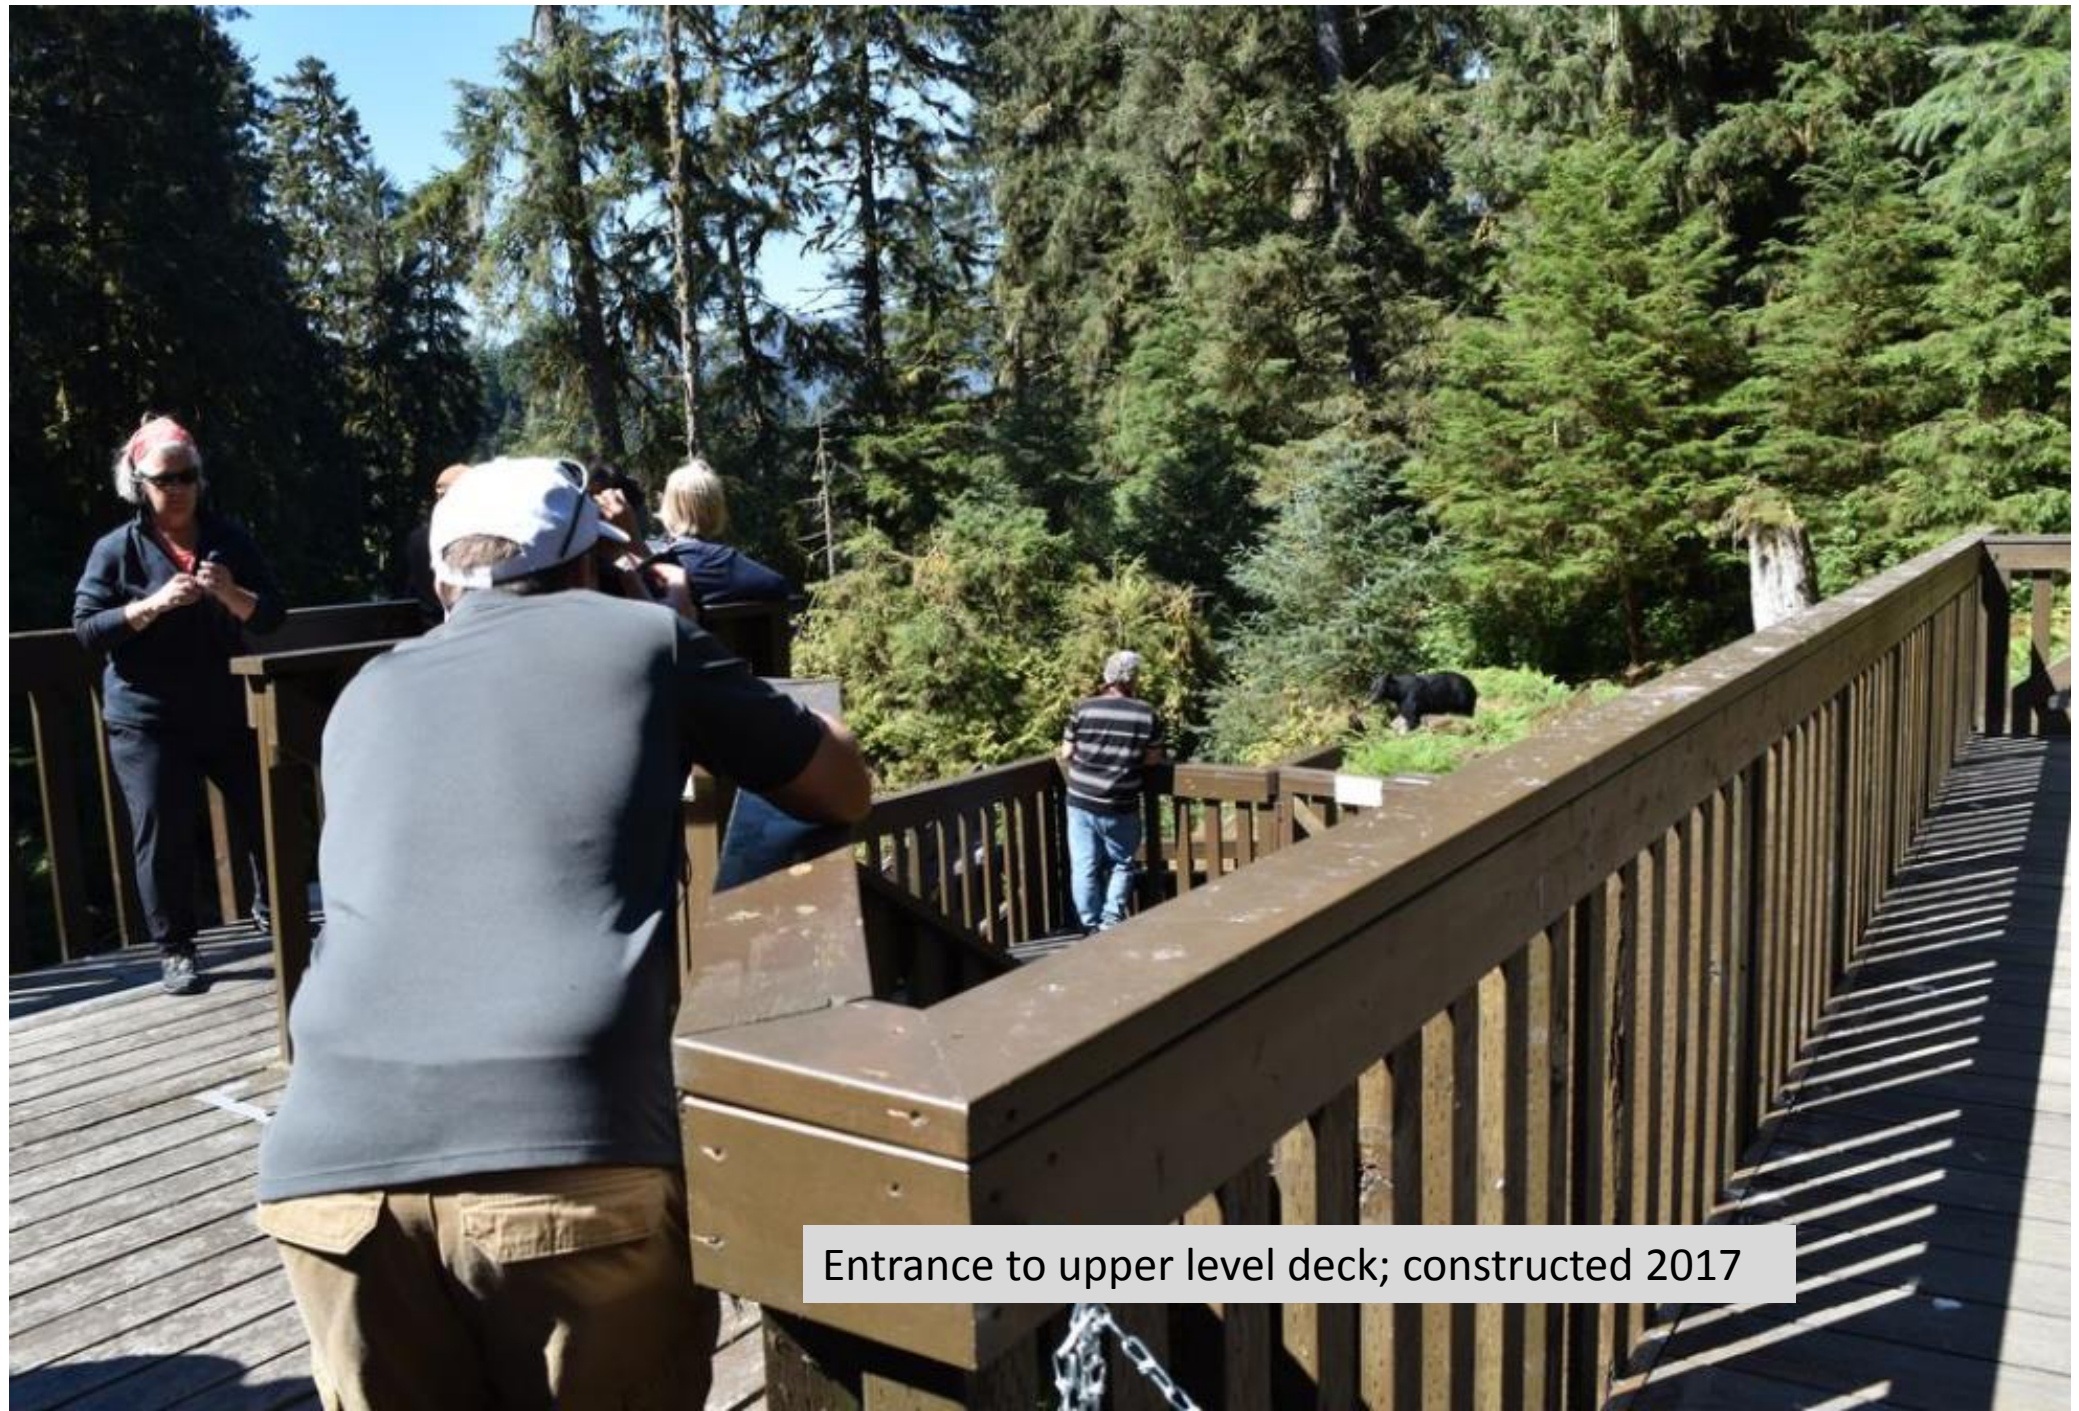
Entrance to upper level deck; constructed 2017

Toilet attached to deck  
(within railing)

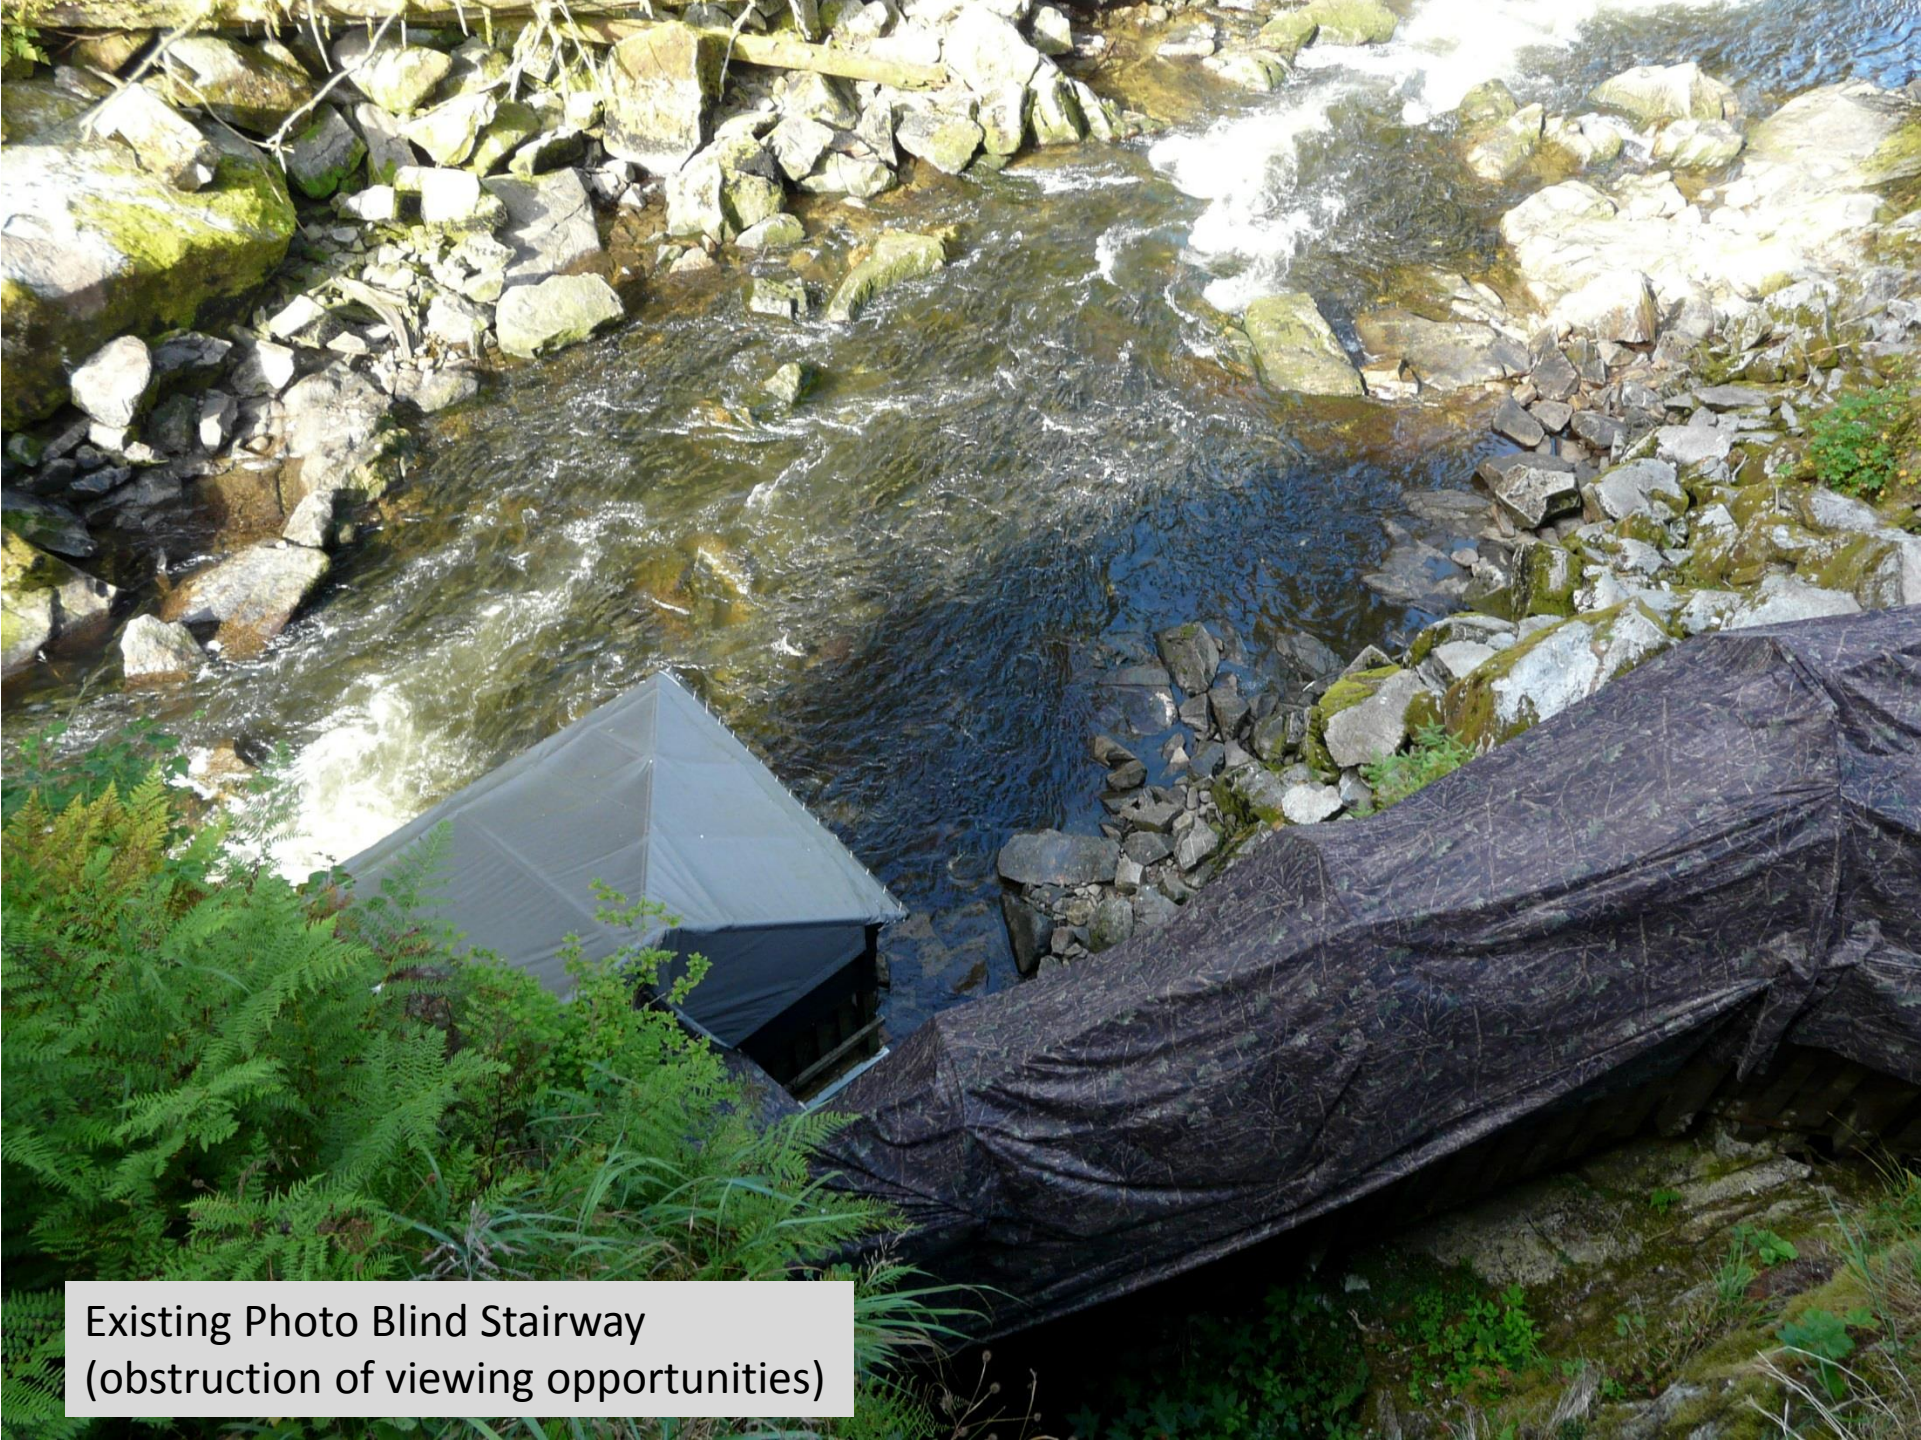
Existing Photo Blind Stairway  
(obstruction of viewing opportunities)

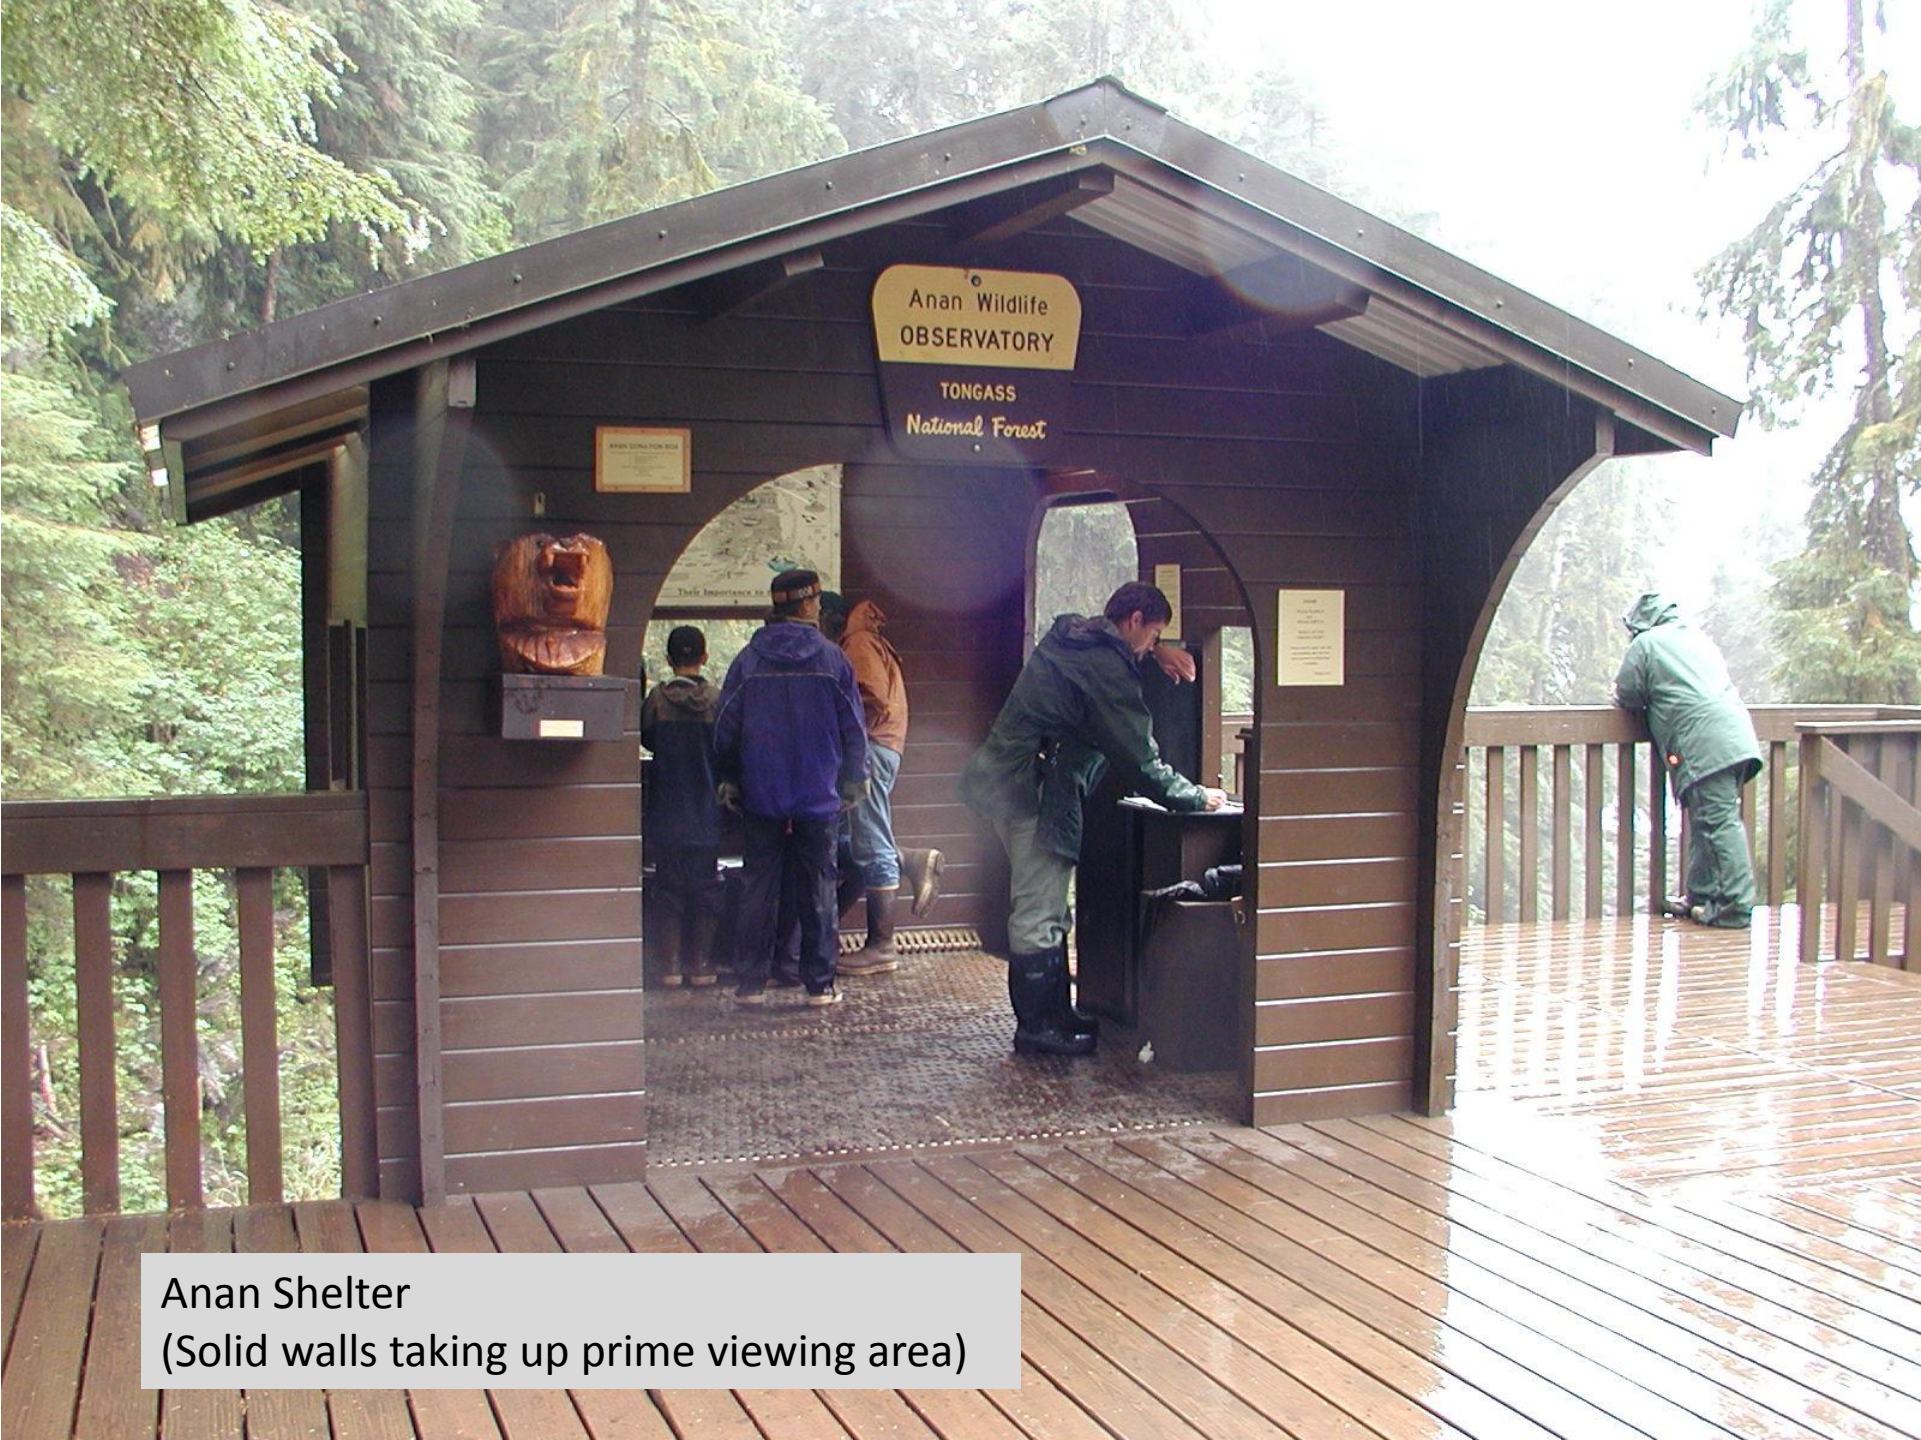
Anan Shelter  
(Solid walls taking up prime viewing area)

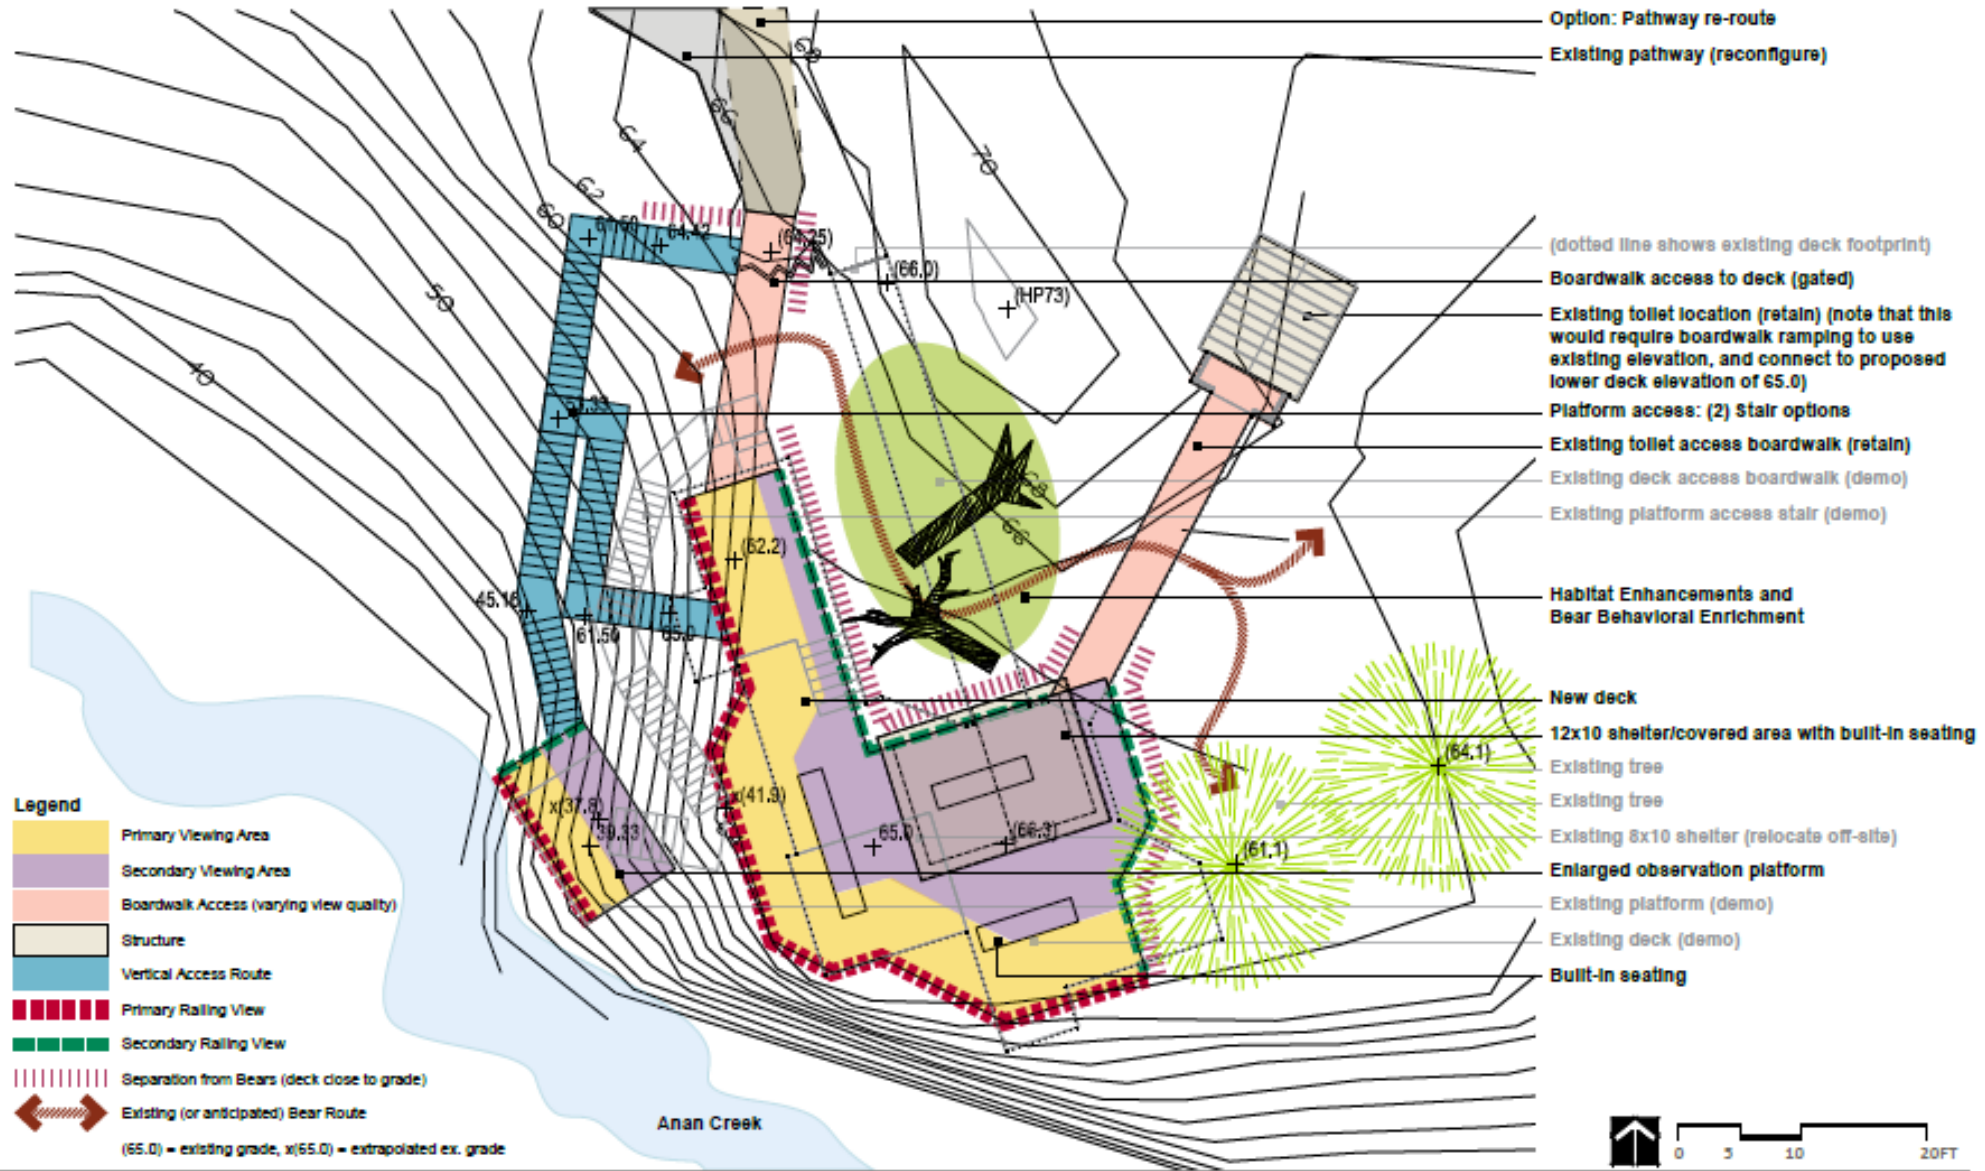
Anan Wildlife Observatory Conceptual Design  
 Site Plan - Option 3: Minor Expansion of Existing Footprint
