PUBLIC INFORMATION MEETING

Mammoth Mill Site Cabin Area CERCLA Investigation Status Update

**Inyo National Forest
Summit Ranger District
Mammoth Lakes, CA**

Mammoth Mill CERCLA Site Cabins Area Fact Sheet

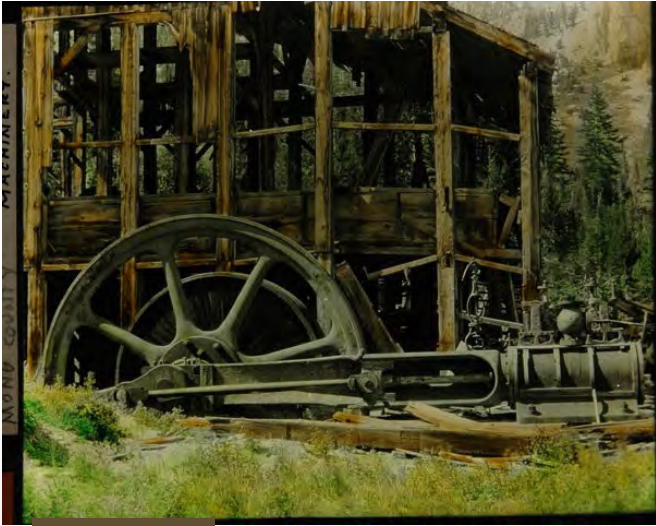
Historical Photo of Stamp Mill & Flywheel
Photo provided by Mammoth Museum

- Mercury used to separate gold from ore that had been crushed.
- Ore particles were suspended in water and mercury was added and passed over a corrugated surface.
- Gold and mercury would amalgamate to form a paste and upon heating would evaporate to recovery mercury and leave gold behind.
- Tailings remained following this process and were allowed to dry and deposited near mill site.
- Mercury not recovered or reused during processing is present in high concentrations in tailing materials.

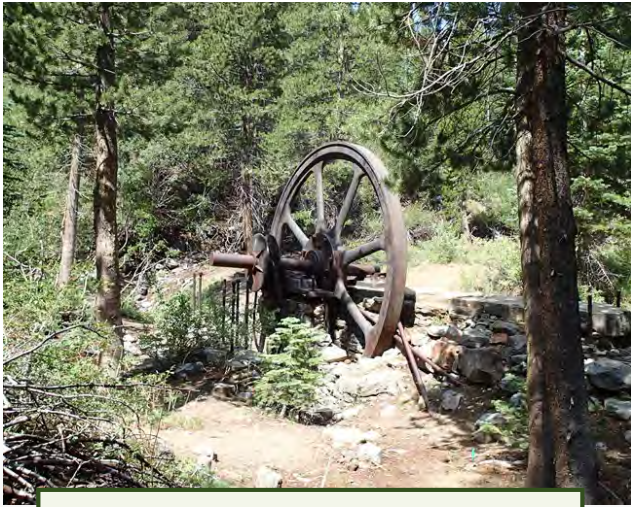
**Recent photo of Stamp Mill
Flywheel facing west**

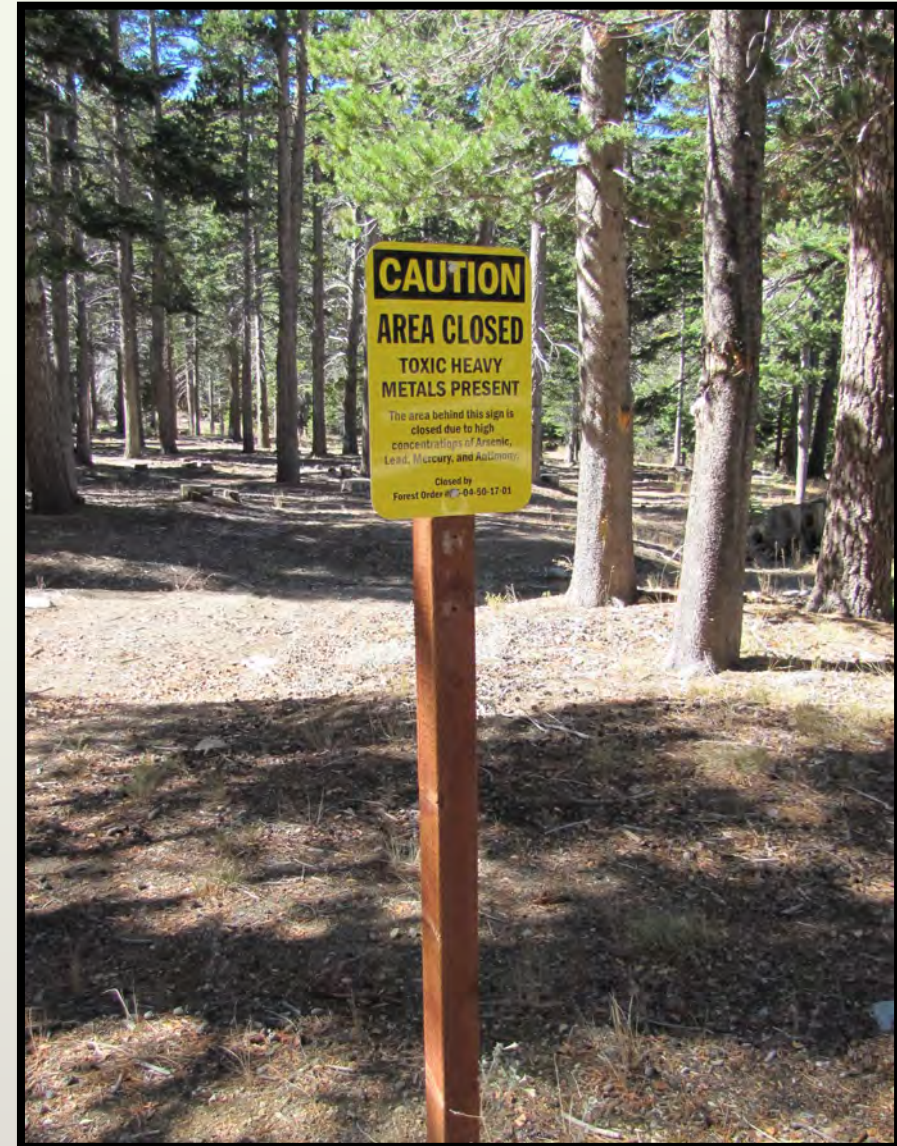
Human Health Risk Assessment

- Contamination at the Site poses a human health risk to recreational visitors and cabin occupants.
- Health risks posed by site contamination are driven by arsenic and mercury in surface and subsurface soils and mill waste
- Exposure Pathways – incidental ingestion, dermal, inhalation
- Risk analysis is based on a cabin occupancy of 100 days/year for 40 years

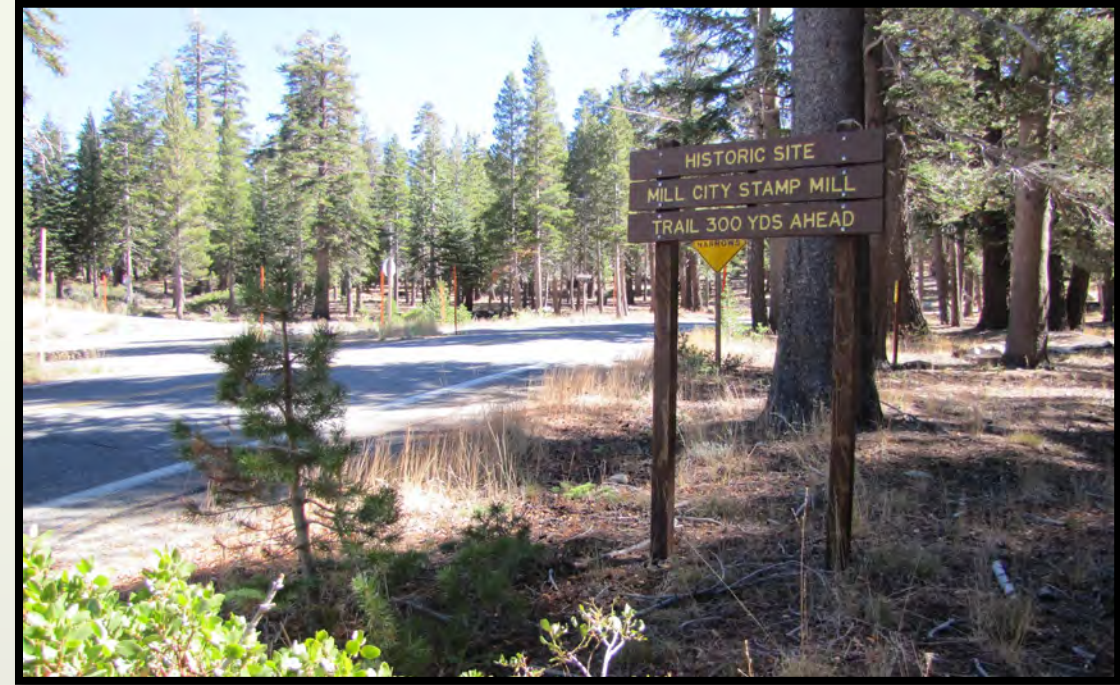
Updated/Focused Human Health Risk Analysis

- Analysis focused on contamination present in the expanded Cabin Area, with current and future cabin occupants as the primary receptors
- Analysis excluded Mill Area, diversion ditch and area east of the unnamed tributary to Mammoth Creek
- If no cleanup was performed in the Cabin Area, the updated risk analysis found cabin occupants could only be allowed on site for no more than 5 days per year in order to mitigate health risks posed by site contamination

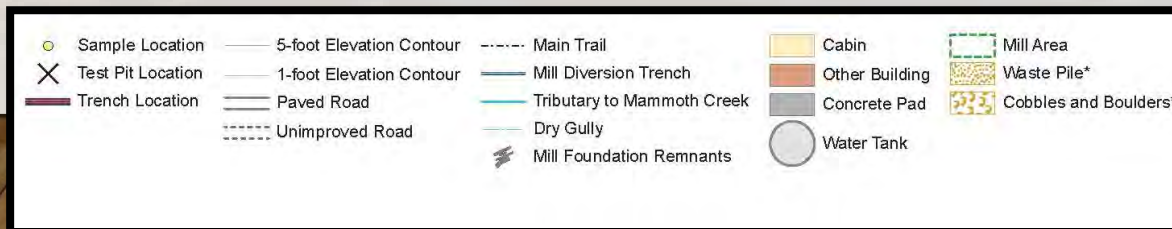
Sampling East of Unnamed Tributary to Mammoth Creek (Cabin 29 Area)

- Site investigation found great variability in chemical makeup and appearance in the soils and materials around Cabin 29 (chemically and physically different from other contaminated material at the site).
- Based on this variability, USFS Contractor believes the contaminated material surrounding Cabin 29 may have come from a separate source.
- Additional investigation efforts are planned for this area.

A Preliminary Assessment/Site Inspection will be conducted in the area east of the creek to determine lateral extent of contamination and associated risk to Cabin 29 occupants and recreational users and if the source is connected to Mammoth Mill CERCLA Site.

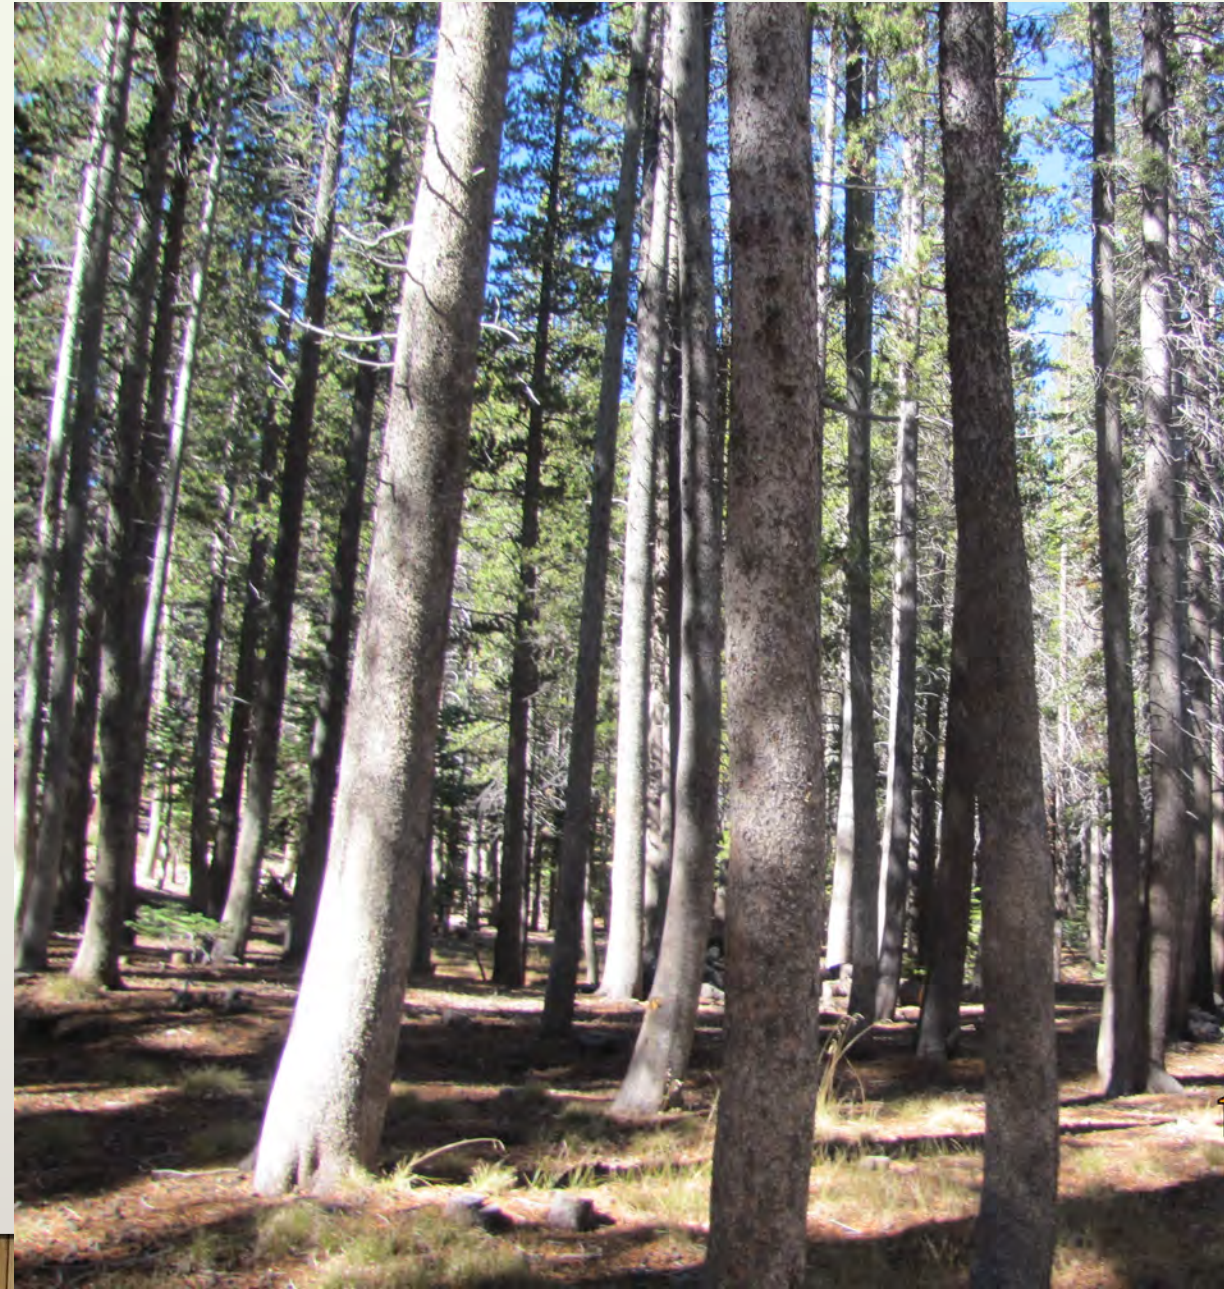
Tree removal and protection

- Initial alternatives analysis include excavation and offsite disposal, onsite encapsulation or combinations of the two options.
- To perform any excavation activities, tree removal will be necessary.
- In one alternative, the protection of trees with larger trunks is included.
- Tree protection can include:
 - Dry well around base
 - Brick or stone barrier wall at 18' radius
 - 2 inch rock

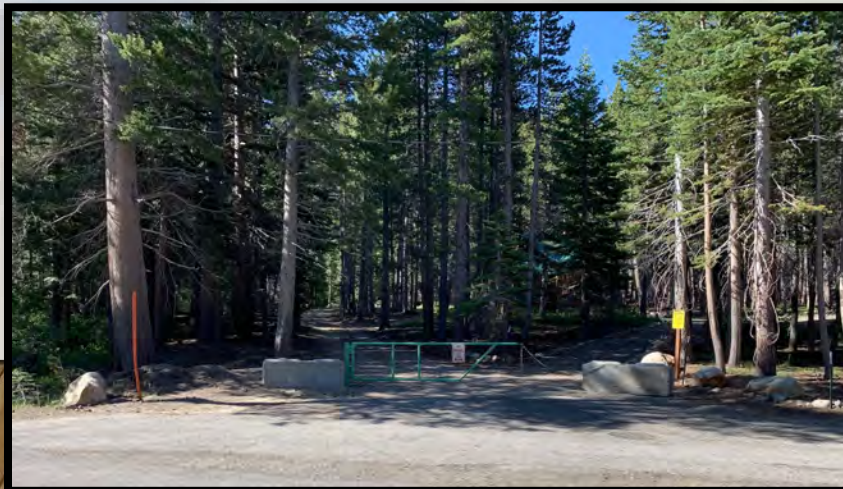
Alternative I – No Action

- Site contamination not addressed
- Land Use Controls (LUCs) implemented to prohibit access
- Cabin occupants would be restricted to 5 days/year occupancy
- Alternative includes fencing, gate, signage, O&M and administrative costs
- Not protective of human health or the environment
- Estimated 30 YR Cost - \$609,491
