# Removal Preliminary Assessment

# Big Blue Mill Site

Kernville Ranger District  
Sequoia National Forest

February 10, 2020

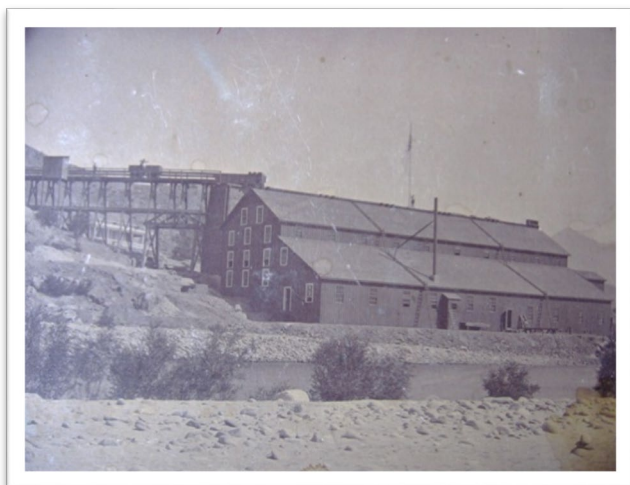
**Figure 2: Big Blue Mill Site on the west bank of the Kern River (date is unknown but thought to be from the 1870s era)**

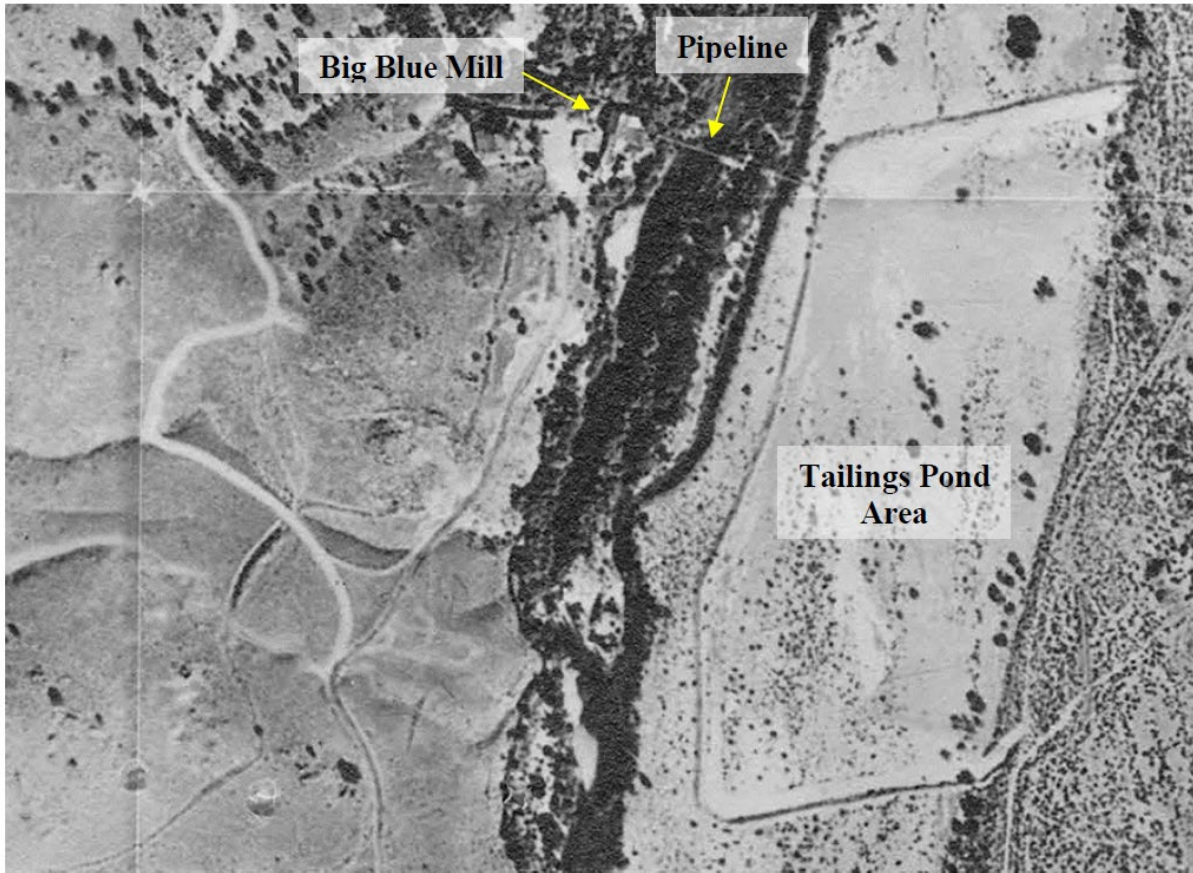
Figure 4: October 20, 1938 Aerial photo showing Big Blue Mill, pipeline, and tailings pond area

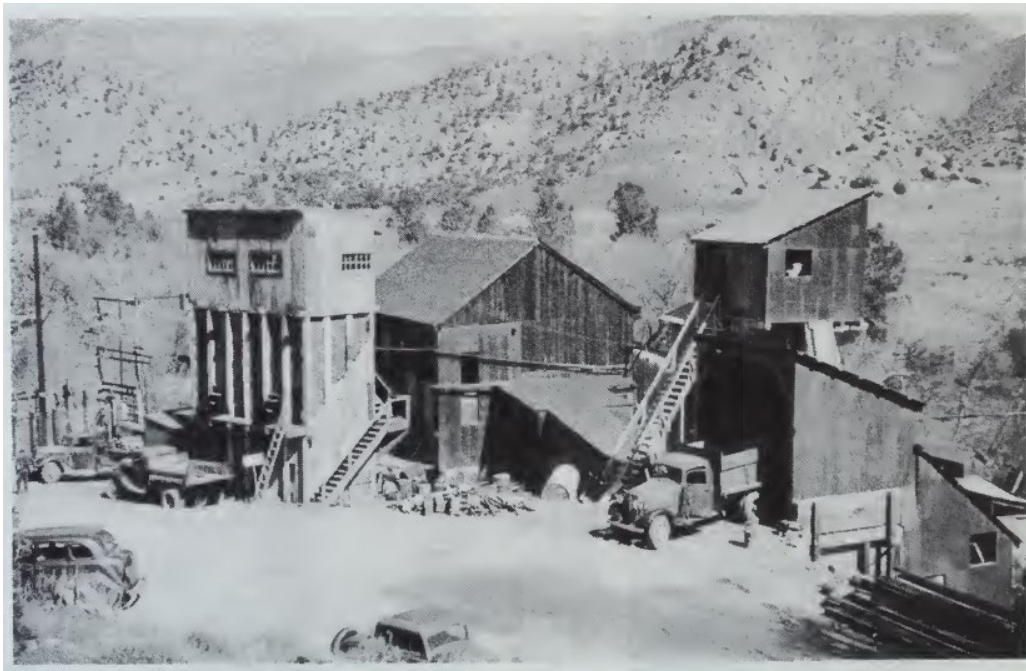
Figure 5: Big Blue Mill Circa pre-1940 (source January 1940, Vol 36 California Journal of Mines and Geology)

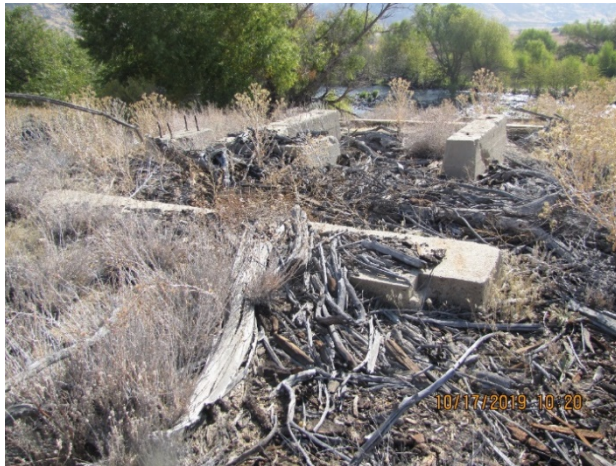
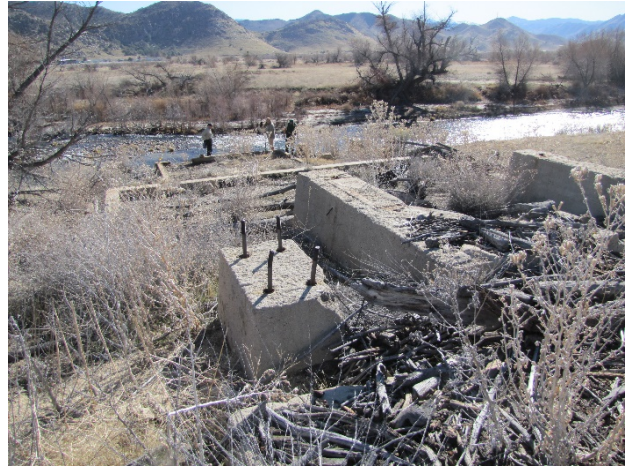
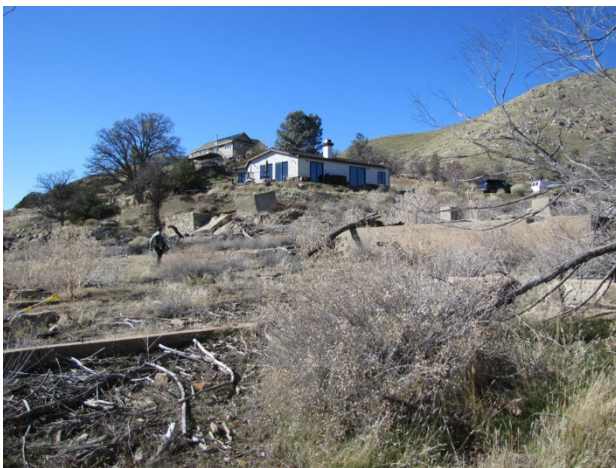
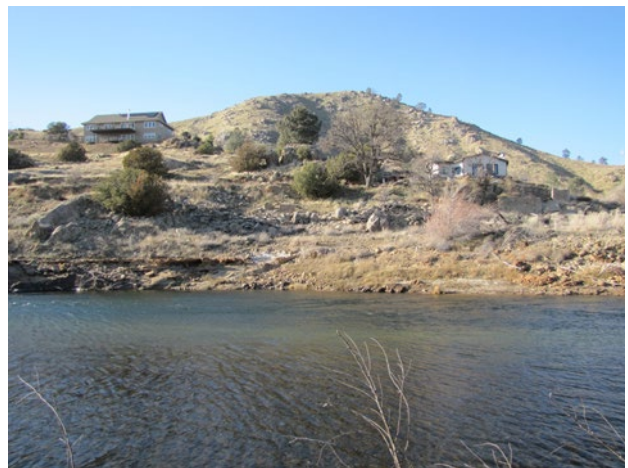
The only physical evidence remaining at the site of the former mill structures are concrete foundations and dilapidated retaining walls. The area is strewn with driftwood and other river debris and indicates that the site has been subject to periodic flooding.

**Figure 9: Concrete foundations that once supported structures and processing equipment at the Big Blue Mill. Photo taken from across the Kern River shows the proximity of nearby residences to the foundations that once supported site structures and processing equipment.**

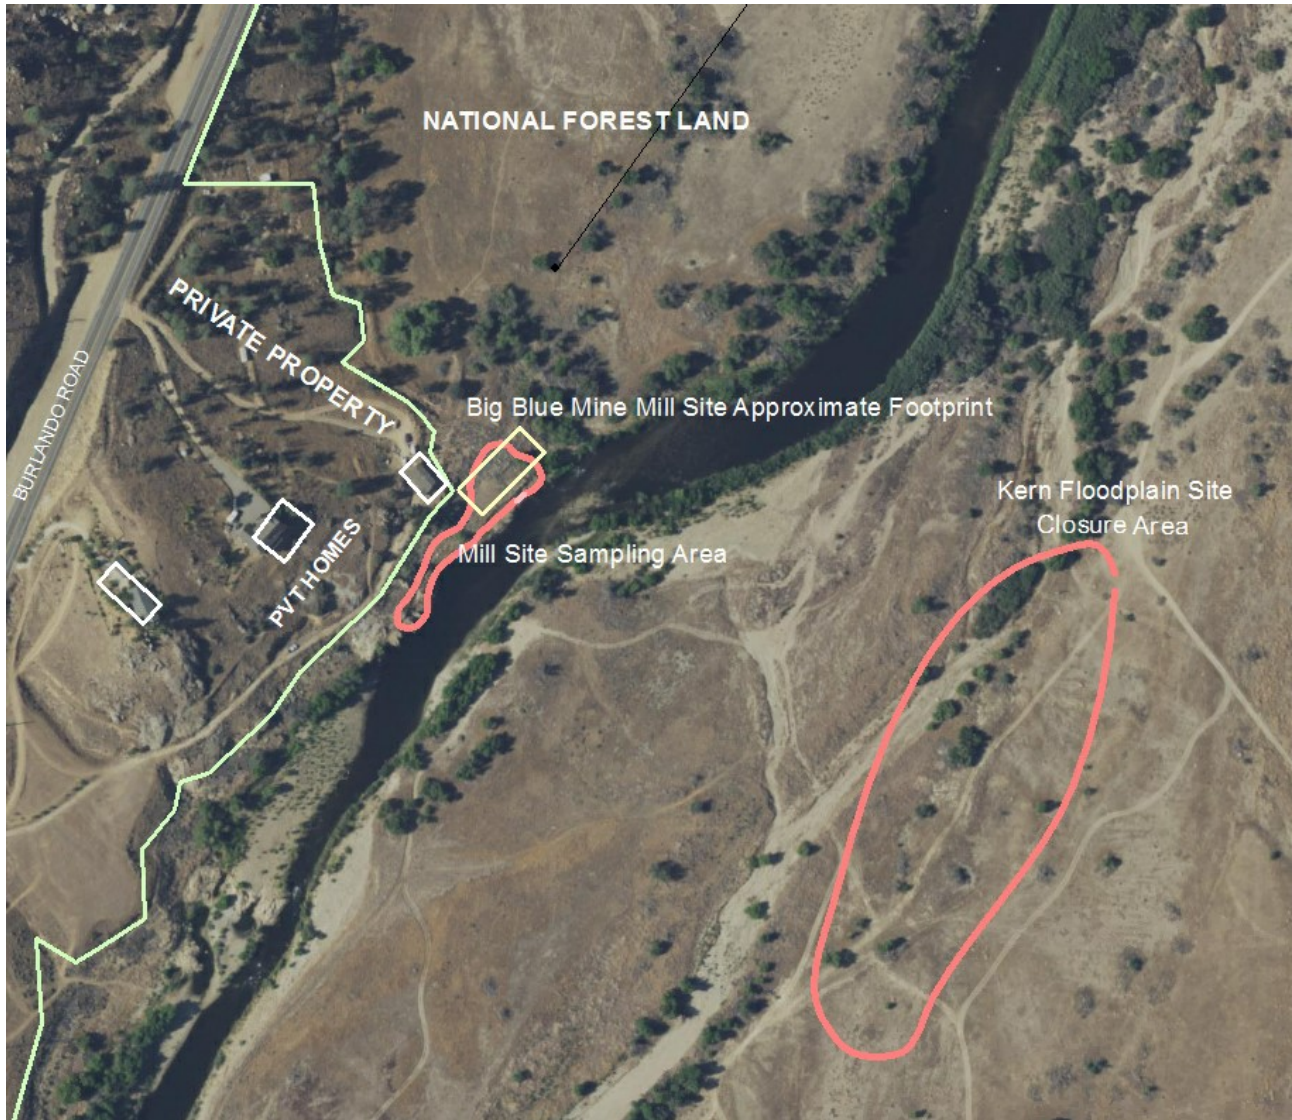
The mill foundation and tailings materials are located within 100 feet of the northern parcel single-story residence that was constructed up to the public/private property boundary in the early 2000s (Figures 9 and 10). Given the large footprint of the former Mill structures, there is the potential that the home foundation is immediately adjacent, if not on top of the footprint of the former mill structures. Two other residential dwellings are located within 500 and 1,000 feet of the site. Trash and other evidence of human visitation to the Site is present throughout the area.

**Figure 10: Approximate location of the former mill relative to nearby residences and the Kern Floodplain Site**

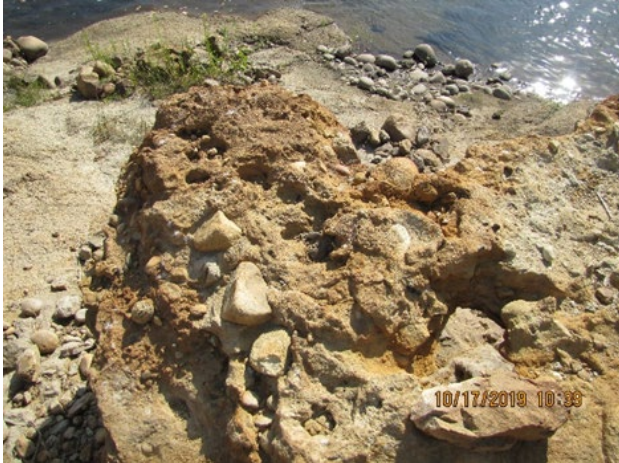
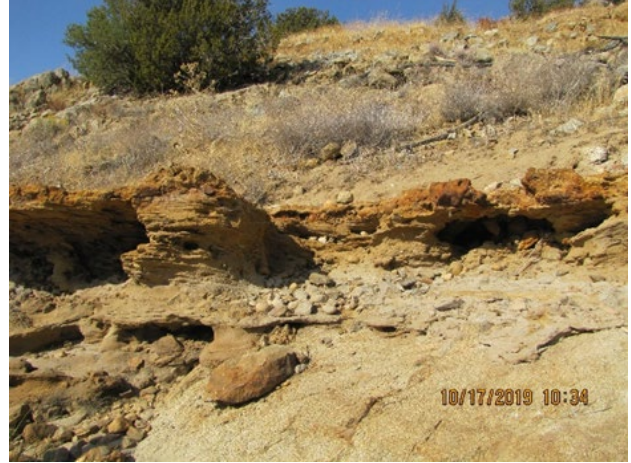
Fishing is very popular along the Kern River from the shoreline. A well-used 'Fishermen's Trail' exists through the Site and a fishing platform was observed on the heavy metal impacted tailing materials at the shoreline. The west bank of the Kern River near the former site is heavily eroded although pockets of tailing deposits remain. The east side of the river is lined with cottonwoods, locust and willow trees. Along the shoreline there is clear evidence of tailings depicted by very fine brown materials, rust colored formations, white powdery and chunked deposits, likely to be mineral processing wastes from the former mill operations. (Figures 11, 12).

**Figure 11: Rust colored tailings and mineral processing deposits along the Kern riverbank below the former mill.**

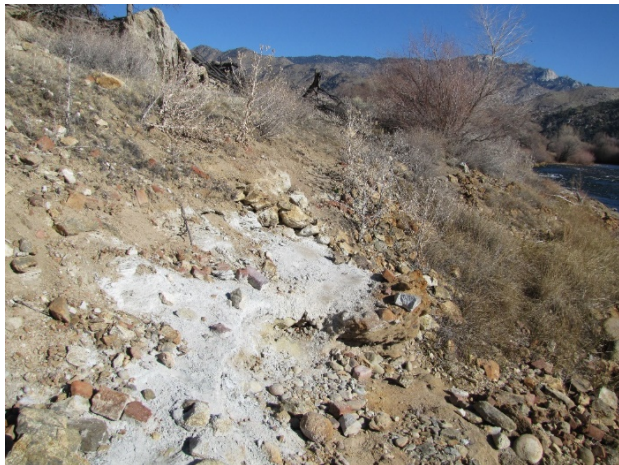
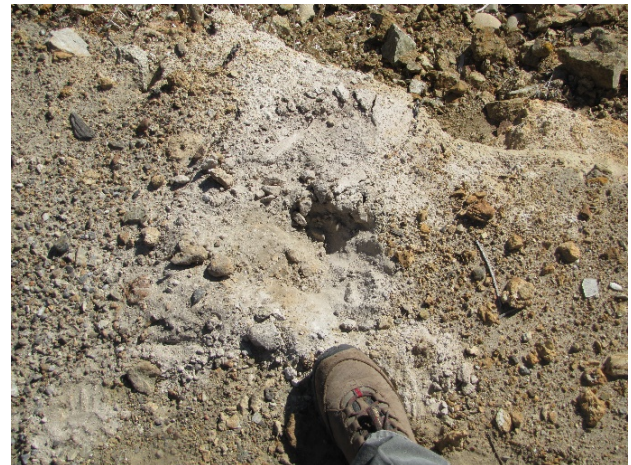
**Figure 12: Deposits of very fine white powdery material along the riverbank (left) and brown silty materials below the former mill foundation (right) where elevated arsenic, lead and mercury were found.**

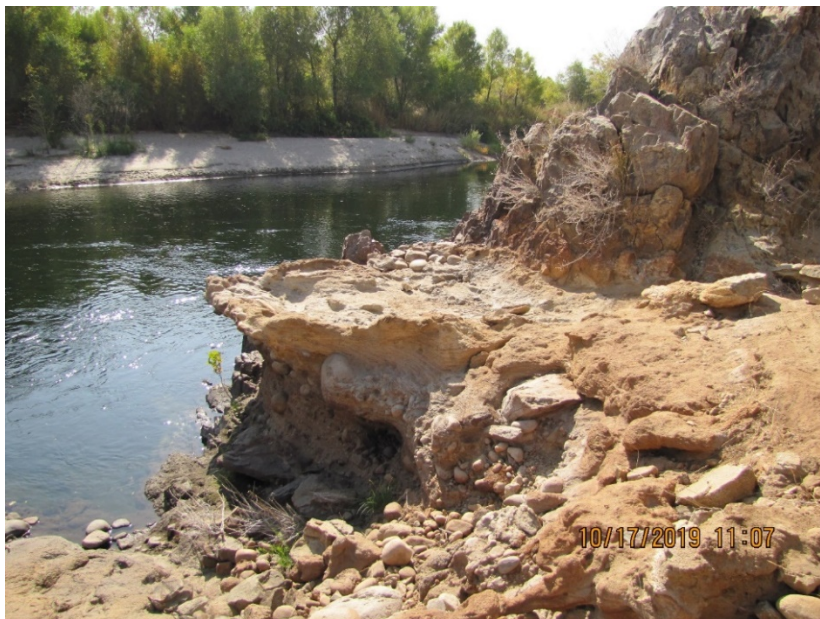
**Figure 13: Fishing platform on river bank comprised of mill tailing deposits below the former mill site.**

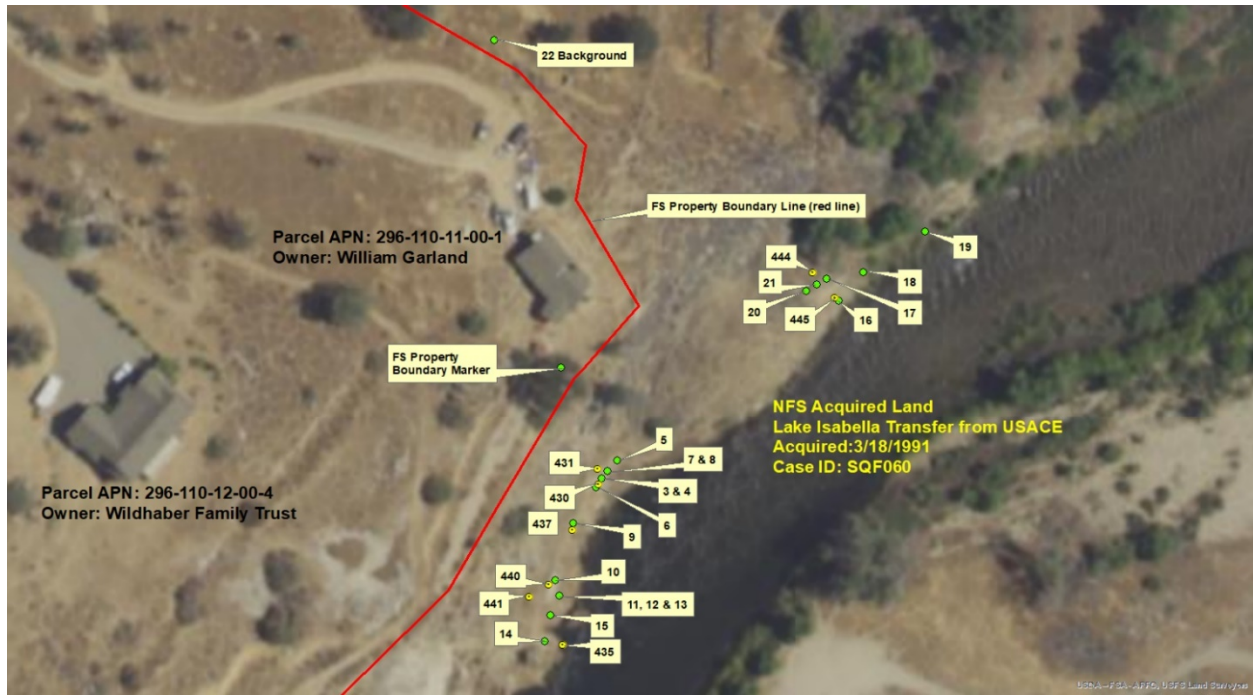
Field screening was conducted using a Thermo Scientific Niton Model XL3t-600 and an Olympus Delta Model DS-4000 handheld X-Ray Fluorescence analyzer. XRF sampling was performed by Forest Service OSCs along the areas with visible evidence of tailings along the streambank and near foundation of the former mill. A total of 31 locations throughout the former mill site were sampled, including one (1) up gradient location for site background (Figure 14).

**Figure 14: January 14, 2020, XRF (sample Locations 429-445 taken by the Thermo Scientific Niton Model XL3t-600 and sample numbers 3-22 by the Olympus Delta XRF Model DS-4000).**

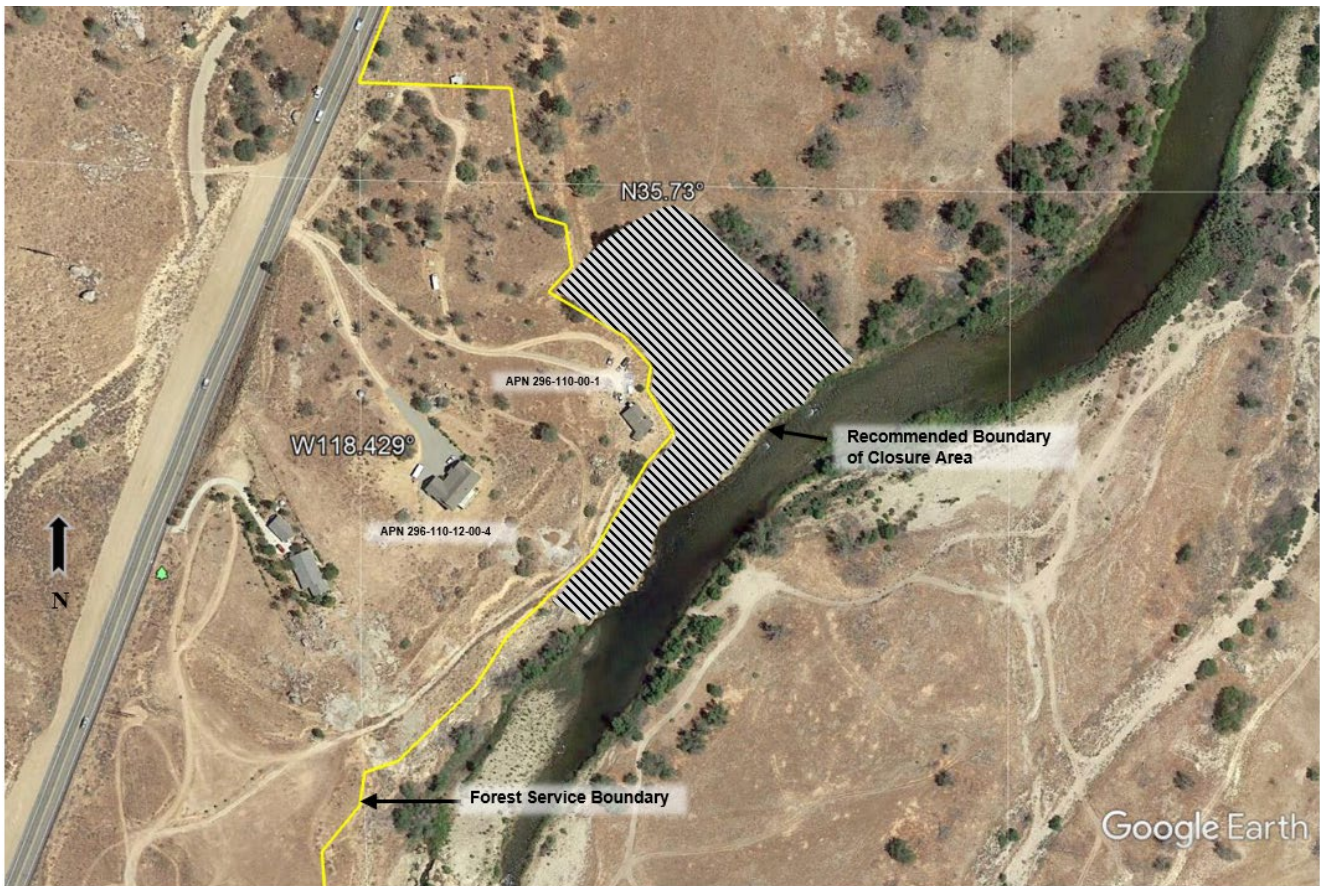
Figure 15: Recommended Closure Area

Conditions represent a threat of release of CERCLA hazardous substances, threatening to public health, or welfare, or the environment based on the factors set forth in the NCP, 40 CFR § 300.415(b)(2). A Time-Critical Removal Action (TCRA) is recommended to implement institutional controls to restrict all public access to the Site and the area of contamination. It is recommended that these controls include a prohibition on all public entry to the Site. Based on available data, the recommended initial closure area includes former mill area east and northeast of the adjacent private Parcel APN 296-110-11-00-1 and the area between the Kern River and private Parcels APN 296-110-11-00-1 and 296-110-12-00-4 (see Figure 15 below).
