TECHNICAL MEMORANDUM • AUGUST 2019

Aquatic Species Assessment for the Sespe Creek Watershed

California Trout
21 South California St. Suite 305
Ventura, CA 93001

Stillwater Sciences
895 Napa Ave., Suite B-4
Morro Bay, CA 93442

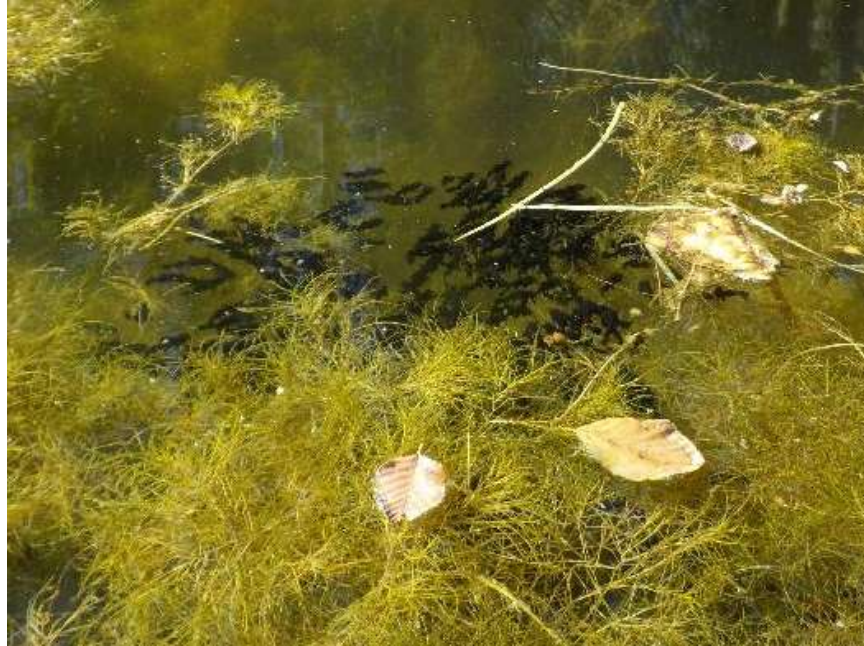
Figure 2. School of juvenile bullhead catfish observed in Reach 7.

during a 2019 reconnaissance effort (NOAA 2019). Bullhead catfish were the most abundant AIS observed during this survey and were often found in large schools (>50 fish) containing young-of-the-year fish (<100 mm long) (Figure 2). Large schools of age-1+ juvenile bullhead catfish (100–150 mm long) were also common, while only a few bullhead catfish observed exceeded 150 mm in length with the largest bullhead catfish observed estimated to be in 250–300 mm size range. Green sunfish were slightly less abundant than bullhead catfish but were still observed in large numbers, primarily due to high abundance of juvenile fish (<100 mm) while fish over 150 mm were uncommon. The largest green sunfish were estimated to be in the 200–250 mm size range (Table A-2). In total, only 12 bullhead catfish over 200 mm were observed; however, bullhead catfish over 200 mm were often observed in deep cover and deep pools with low visibility, so this number may not be representative of the actual abundance of larger fish. Only five green sunfish over 200 mm were observed and appeared easy to detect while snorkeling, since green sunfish over 200 mm would typically swim very close to snorkelers in what was interpreted to be an aggressive behavior.

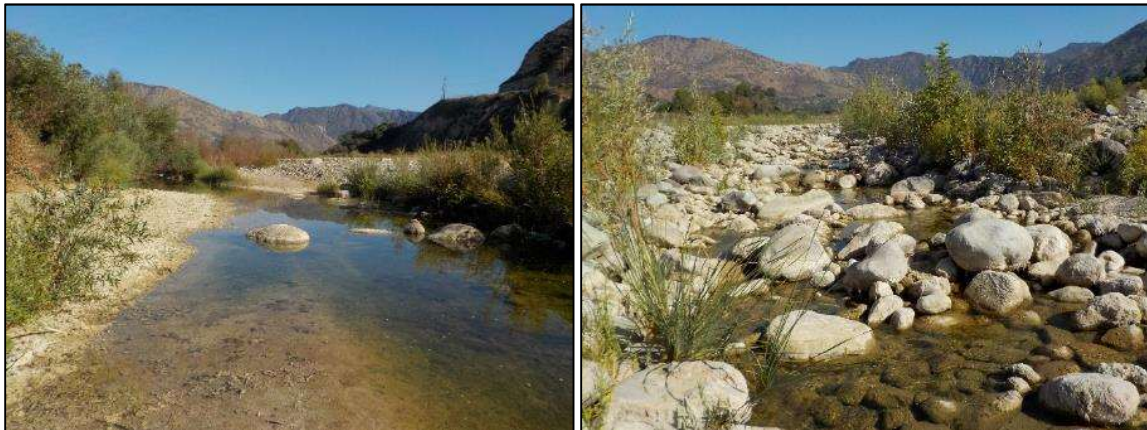
Figure 3. Reach 1 representative pool habitat (left) and riffle habitat (right).

Reach 1 is located in lower Sespe Creek downstream of recent wildfire burn areas. Sespe Creek within this reach has a low-gradient channel, a wide floodplain, long low-gradient riffles, and long shallow pools (Figure 3). Substrate in Reach 1 is primarily comprised of sand with lesser amounts of cobble substrate particularly along the edges of the channel and within low-gradient riffles between pools. The large volume of sand observed, and shallow pools are likely a result of recent wildfire activity upstream resulting in increased sediment input. During the survey significant flow was observed entering Reach 1 (approximately mid-reach) from a large cement canal that appeared to convey agricultural runoff. Water temperatures in Reach 1 were around 20°C during the survey. General habitat conditions in Reach 1 are shown in Figure 3. Sespe Creek had flowing water throughout most of Reach 1 but was dry at the downstream end.

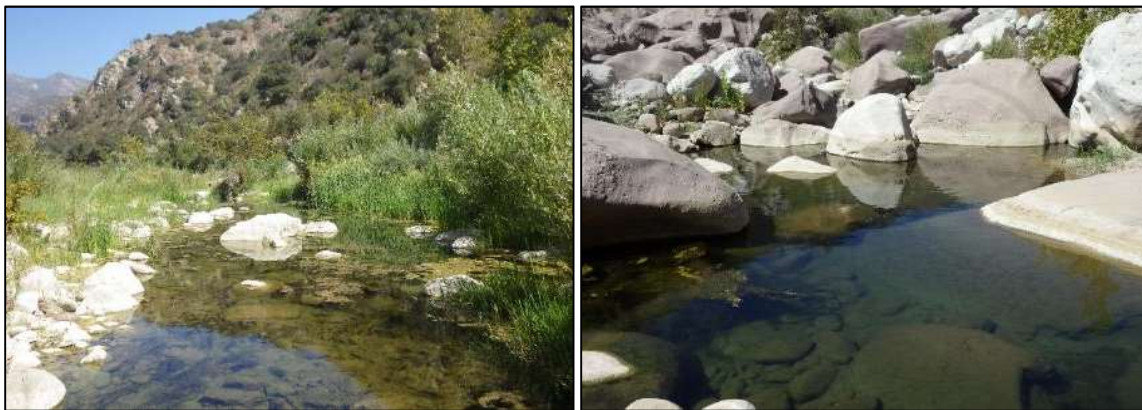
Figure 5. Reach 2 representative pool habitat.

Reach 2 is located within a highly confined canyon and is characterized by having a high gradient channel with deep pool habitat formed around large boulders (Figure 5) which are separated by high gradient riffles. This section of the watershed was burned during the Piru Fire in 2003 and by the Thomas Fire in 2017. The substrate in Reach 2 is primarily comprised of boulders with small patches of sand. Although the recent wildfires likely increased sediment input, the high transport capacity of the channel in Reach 2 appears to mobilize excess sediment downstream and pool filling is not apparent. Fish cover is abundant throughout the reach in the form of large boulders. Water temperatures in Reach 2 were fairly consistent and ranged from 21°C to 22°C during the survey. Sespe Creek had flowing water throughout the reach during the survey. Pine Creek enters Sespe Creek at the downstream end of Reach 2. Perennial flows were observed in Pine Creek during the survey (Figure 6), and water temperatures were 23°C. Substrate in Pine Creek was predominantly gravel with lesser amounts of cobble.

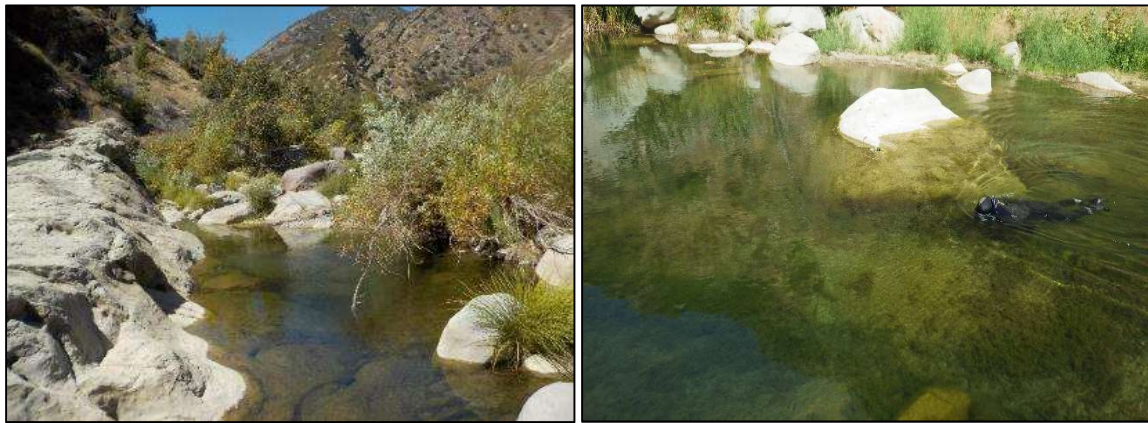
Figure 8. Reach 3 representative pool habitat with no fine sediment infilling (left) and pool with fine sediment around boulders (right).

Reach 3 is located near the middle of the Sespe Creek watershed and includes the confluence with West Fork Sespe Creek near the upstream end of the reach. This section of the watershed was burned by the Piru Fire in 2003 and the Day Fire in 2006. Likely owing to sediment input from the recent fires, sand is the dominant substrate in Reach 3 and boulders are the subdominant substrate (although bedrock formed pools were also common). Habitat in Reach 3 is characterized by bedrock and boulder pools separated by high gradient riffles. Apparent infilling of pool habitat with fine sediment was variable in Reach 3 with some locations showing not apparent infilling and others with large deposits of fine sediment (Figure 8). Fish cover in the form of large boulders is abundant throughout the reach. Sespe Creek during the survey had flowing water throughout the reach, and water temperatures ranged from 19°C downstream of West Fork Sespe Creek to 21°C upstream of West Fork Sespe Creek. The water temperature in West Fork Sespe Creek was 16°C during the survey. Deep boulder pools were common in West Fork Sespe Creek (Figure 9) where boulders are the dominant substrate and gravel is the subdominant substrate.

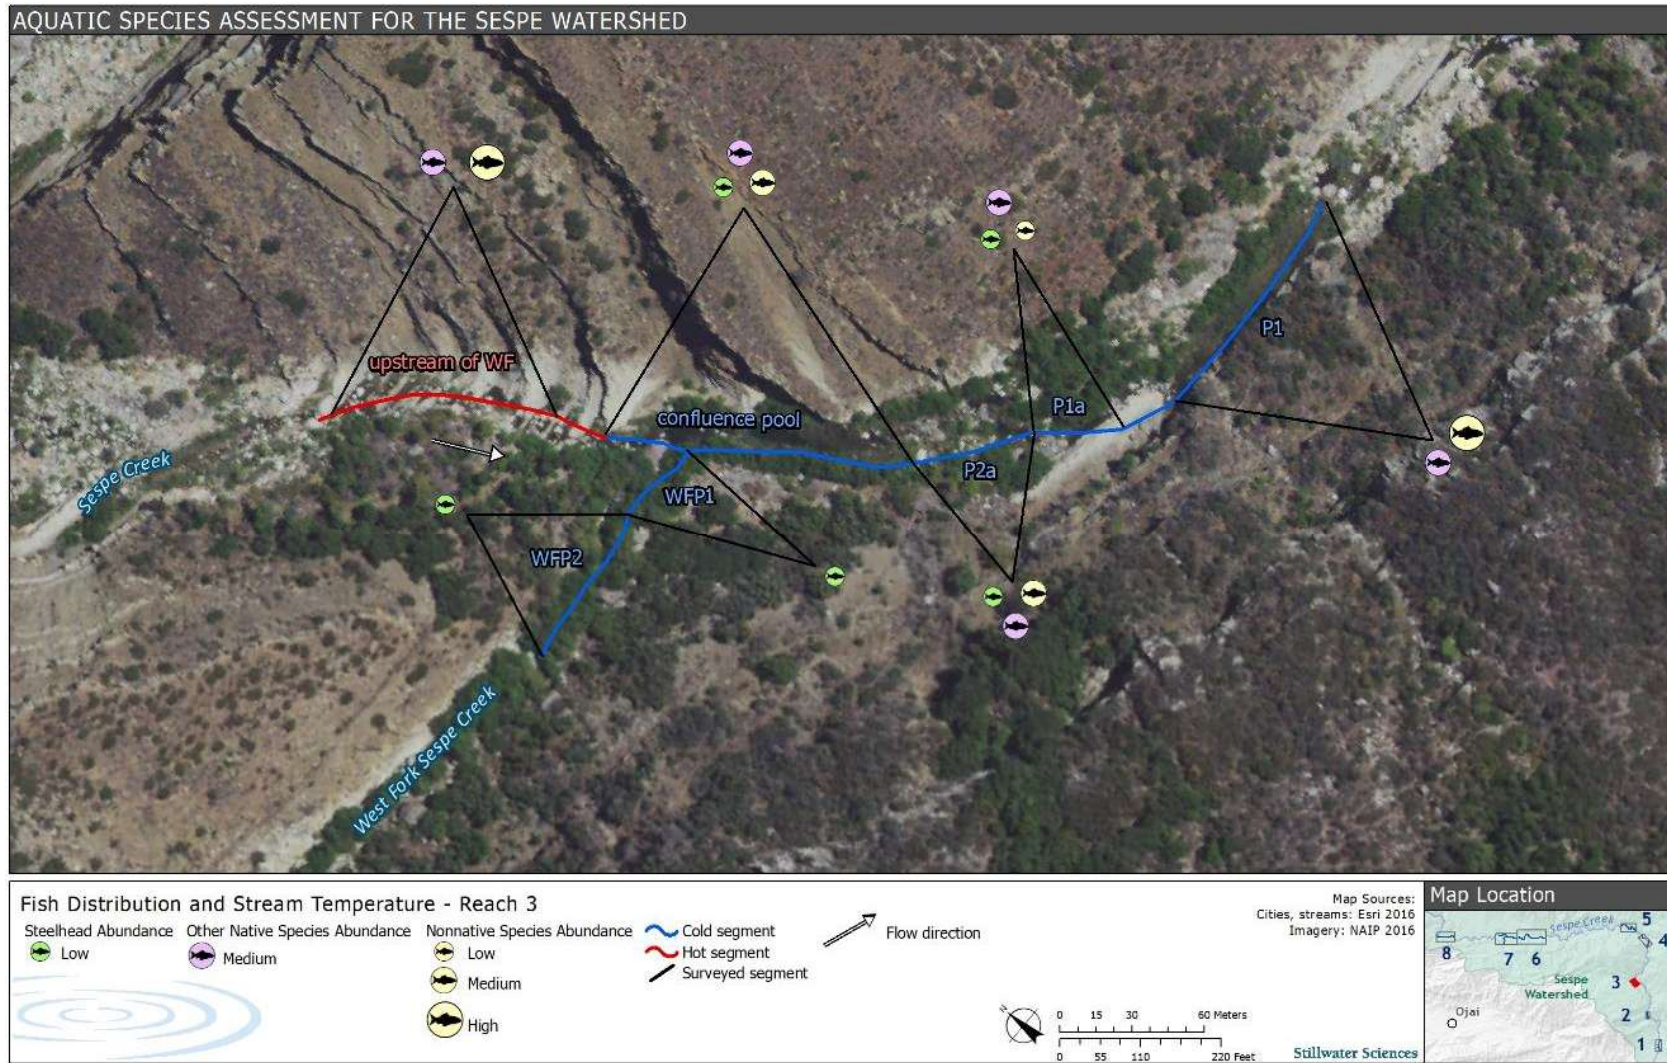
Figure 10. Fish distribution and water temperatures in Reach 3.

In Reach 3 AIS were observed in greater abundance than native fish. Green sunfish were the most abundant fish species observed (Table 3) and were found in nearly every mainstem habitat unit snorkeled with fish up to 250 mm observed in Reach 3. Arroyo chub were the next most common fish species observed and were found in all mainstem habitat units snorkeled. Other species

observed included, bullhead catfish, and steelhead. Steelhead were observed downstream of, and within, West Fork Sespe Creek, but they were not observed upstream of West Fork Sespe Creek (Figure 10). Reach 3 was the downstream most reach where steelhead were observed during this survey.

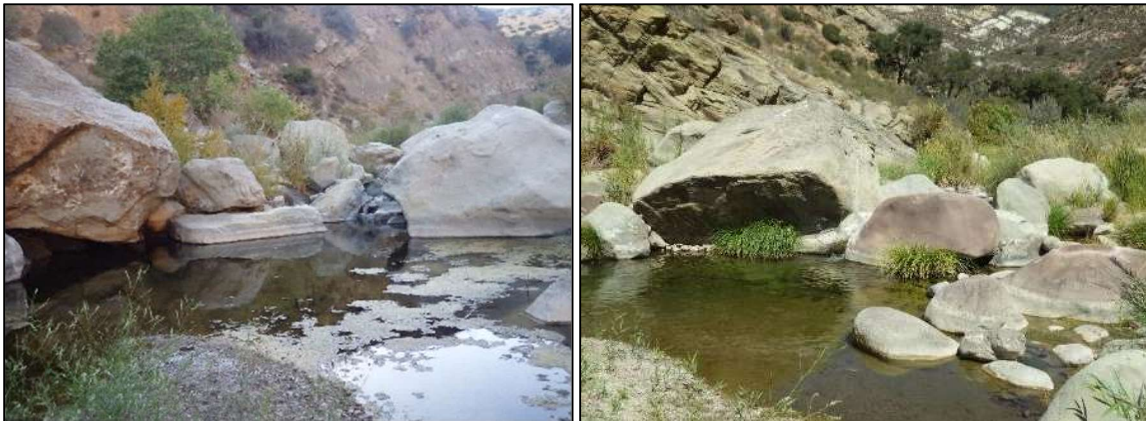
Figure 11. Reach 4 representative pool habitat.

Reach 4 is located near the Middle of the Sespe Creek watershed downstream of Alder Creek. This section of the watershed was burned during the Day Fire in 2006. Within Reach 4, Sespe Creek begins to narrow as it flows into a highly confined canyon section that extends downstream of Reach 2. Sand is the dominant substrate in Reach 4 and boulders are the subdominant substrate but gravel suitable for steelhead spawning was also abundant. Habitat in Reach 4 is characterized by deep boulder formed pools separated by low-gradient riffles. Sand deposits were common along pool margins and between boulder substrate with moderate levels of infilling observed in pools (Figure 11). Fish cover in the form of large boulders is abundant throughout the reach. During the survey Sespe Creek had flowing water throughout the reach, and water temperatures ranged from 17°C to 21°C. No surface flows were observed in Alder Creek during the survey.

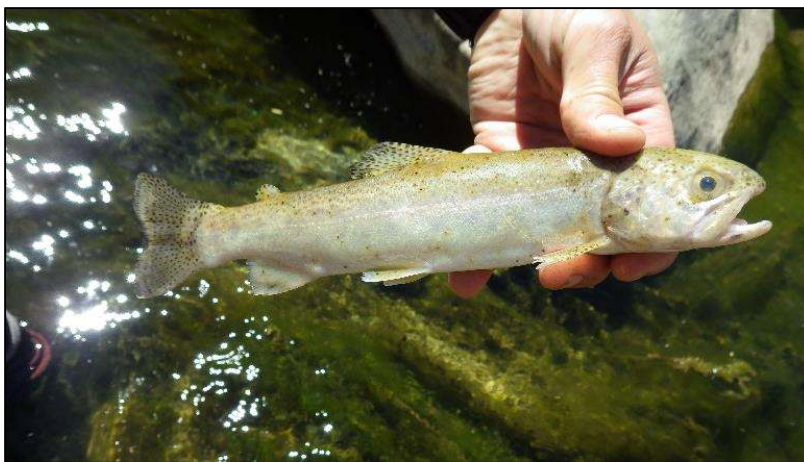
Figure 12. Dead steelhead observed in Reach 4.

Arroyo chub were the most abundant fish species observed in Reach 4 and were found throughout the reach. The only native fish species observed in Reach 4 was a single dead steelhead. Based on fish color and markings, it appeared that the steelhead died within a day or two prior to the survey (Figure 12). AIS observed in Reach 4 included bullhead catfish and green sunfish. Large bullhead catfish up to 300 mm were observed in Reach 4. Fish abundance in Reach 4 was similar for native and AIS (Table 3 and Figure 13).

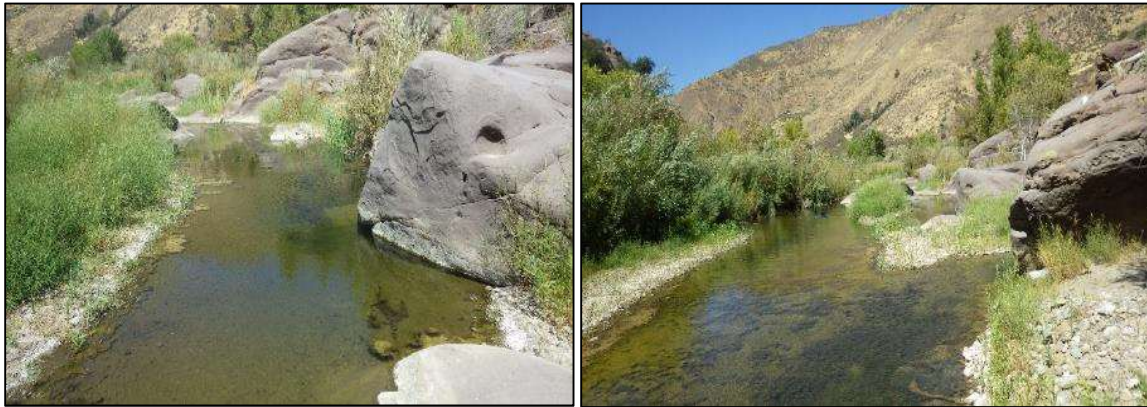
Figure 14. Reach 5 representative pool habitat.

Reach 5 is located near the Middle of the Sespe Creek watershed downstream of Hot Springs Canyon. This section of the watershed was burned during the Day Fire in 2005. Reach 5 is located upstream of the confined canyon section of Sespe Creek and has a low-gradient channel. The dominant substrate in Reach 5 is composed of sand with intermittent large boulders and small patches of gravel suitable for steelhead spawning were also present along the channel margins. Habitat in Reach 5 is characterized by deep boulder formed pools separated by low-gradient riffles. Sand and gravel deposits were found along channel margins throughout Reach 5 with moderate levels of apparent sand infilling of pool habitat (Figure 14). Fine sediment mixed with gravel was also observed within Hot Spring Canyon (Figure 15). Fish cover is abundant throughout the reach in the form of large boulders. Sespe Creek had flowing water throughout the reach during the survey with temperatures ranging from 15°C to 19°C in the lower half of Reach 5 while water temperatures in the upper half ranged from 19°C to 26°C with temperatures increasing in proximity to the confluence with Hot Springs Canyon. Upstream of Hot Springs Canyon, water temperatures dropped back to 19°C. Hot Springs Canyon delivers significant flow into Sespe Creek at the upstream end of Reach 5 (Figure 15) and water temperatures within Hot Spring Canyon were 26°C during the survey.

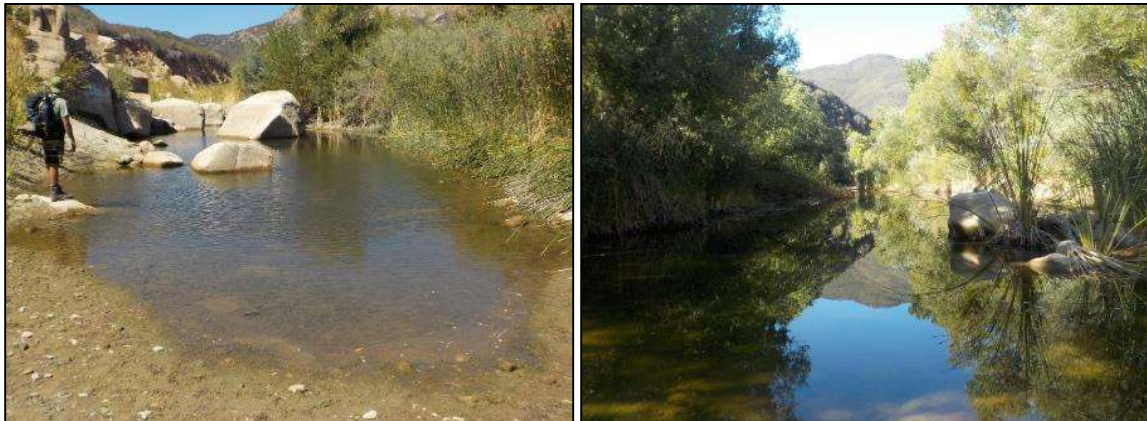
Figure 17. Reach 6, isolated boulder scour pool (left) and pool downstream of Bear Creek where steelhead were observed (right).

Reach 6 is located between Trout Creek and Bear Creek. This section of the watershed was burned during the Day Fire in 2006. Within Reach 6 Sespe Creek flows through a relatively wide floodplain. Flows were intermittent in Reach 6 during the survey and fish habitat was generally found in isolated pools (Figure 17) separated by long dry sections of stream channel. The dominant substrate in Reach 6 is composed of sand with boulder substrate being subdominant but gravel suitable for steelhead spawning was also abundant within the active channel. Pool habitat in Reach 6 appeared to have extensive infilling of fine sediment and many pools were observed to have scouring of sand substrate associated with a few large boulders (Figure 17). Fish cover is limited within pools and is primarily available in the form of boulders and to a lesser extent aquatic vegetation. Water temperatures during the survey ranged from 14°C to 17°C at the downstream end of the reach where Bear Creek enters Sespe Creek and ranged from 20°C to 21°C upstream of Bear Creek. Trout Creek did not have surface flow during the survey, but Bear Creek was flowing, with water temperature measured at 14°C. Within Bear Creek stream habitat was primarily pocket water and riffles. Gravel was the dominant substrate in Bear Creek and was suitable for steelhead spawning while cobble was the subdominant substrate.

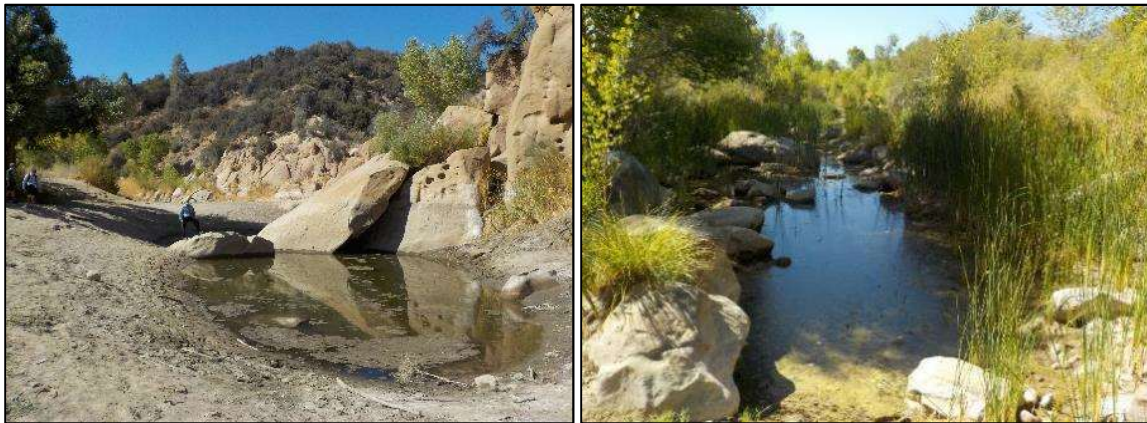
Figure 19. Reach 7 isolated boulder scour pool (left) and dense riparian habitat in the upper reach (right).

Reach 7 is downstream of the confluence with Howard Creek (includes Rose Valley Lakes) and extends from just downstream of Lion Creek to just upstream of Trout Creek. This section of the watershed was burned during the Wolf Fire in 2002 and the Thomas Fire in 2017. Within Reach 7, Sespe Creek flows through a relatively wide low-gradient floodplain. Reach 7 had intermittent flows during the survey with the middle of the reach containing two small isolated pools and the upper and lower sections of the reach containing long wet sections that were adjoined by dry channel on both the upstream and downstream ends. Aquatic vegetation is abundant where water occurs, and dense riparian habitat occurs in the longer wetted sections at the upper and lower ends of the reach (Figure 19). Sand is the dominant substrate and boulders are the subdominant substrate but gravel suitable for steelhead spawning was also abundant within the active channel. Pool habitat in Reach 7 appeared to have extensive infilling of fine sediment and many pools were observed to have scouring of sand substrate associated with a few large boulders (Figure 19). Fish cover is abundant within pools and is primarily available in the form of aquatic vegetation. Water temperatures in Reach 7 ranged from 14°C to 24°C during the survey with the warmer temperatures found within small (<30 m long) isolated pools. Although Lion Creek was only a trickle where it enters Sespe Creek, further upstream there was flowing water. The water temperature in Lion Creek was 20°C during the survey. Habitat in Lion Creek was primarily step-pools separated by low-gradient riffles (Figure 20). Substrate in Lion Creek was primarily boulders with large amounts of cobble.

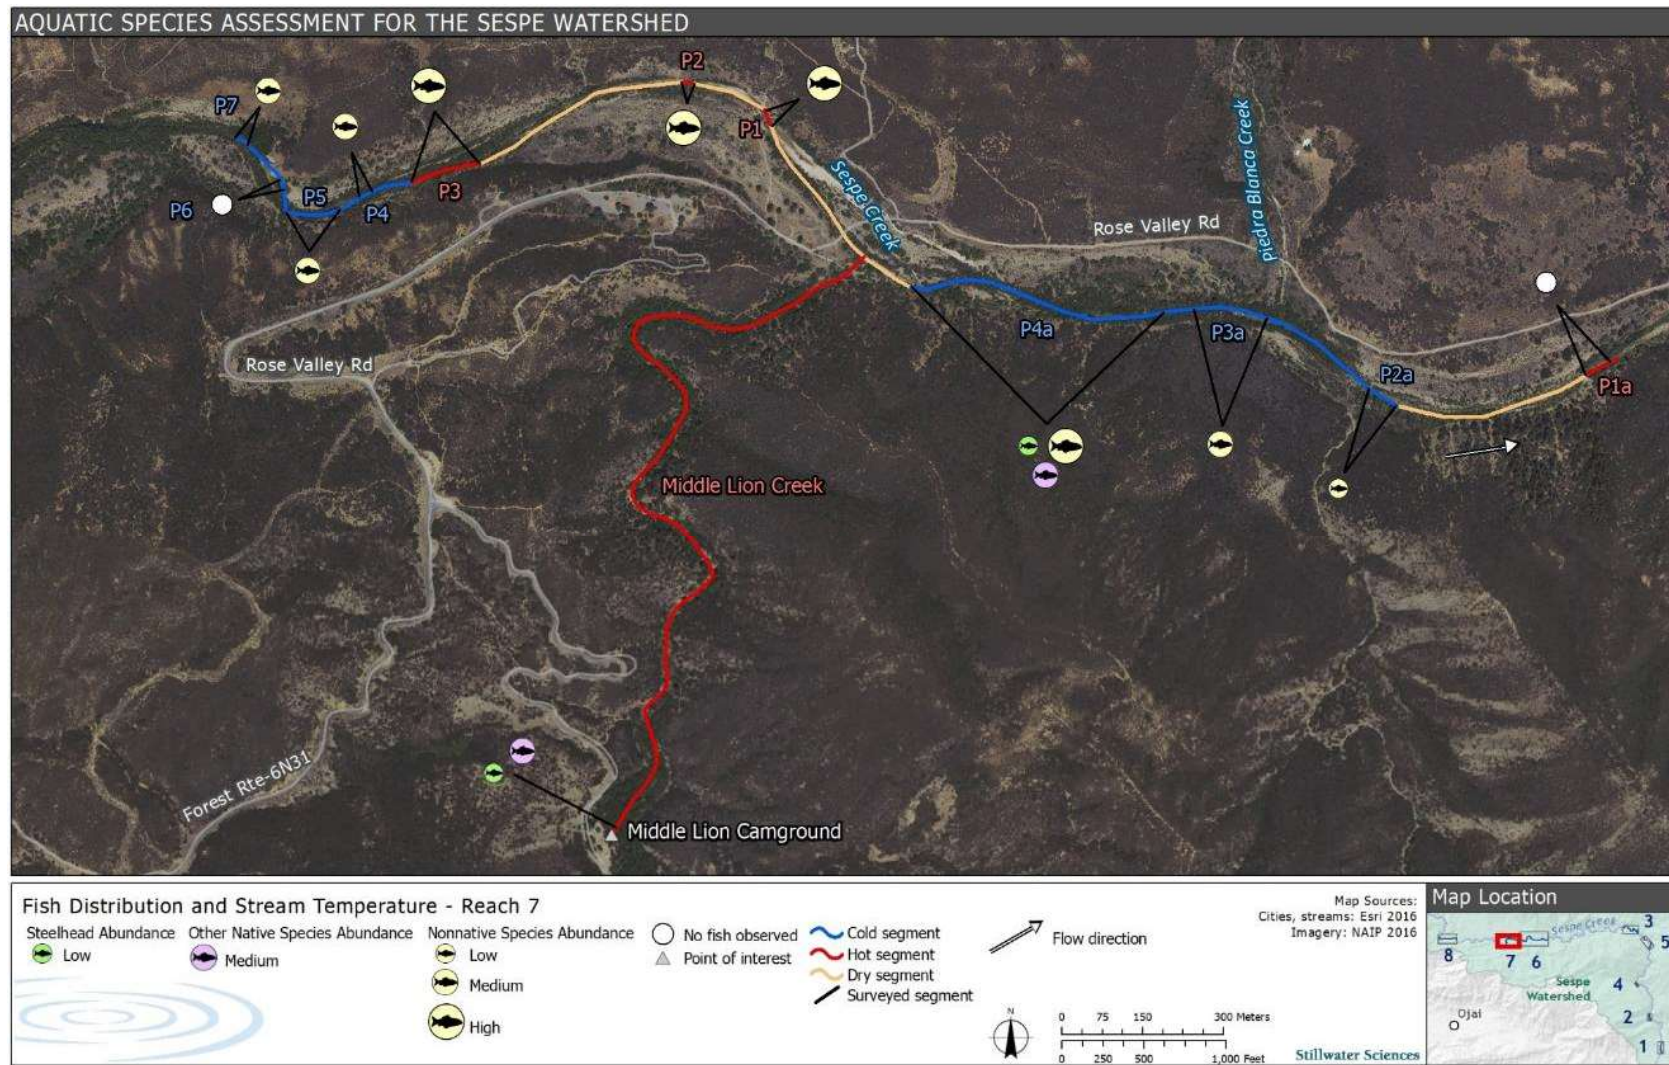
Figure 21. Fish distribution and water temperatures in Reach 7.

Green sunfish and bullhead catfish were abundant in Reach 7 with relatively few observations of Arroyo chub and steelhead. While green sunfish and bullhead catfish were observed throughout Reach 7, Arroyo chub and steelhead were only observed in one segment located downstream of the confluence with Lion Creek (Table 3 and Figure 21). American bullfrog tadpoles were also abundant throughout Reach 7. Within Lion Creek, steelhead and three-spine stickleback were the only fish species observed.

* Species abundance: Low <math>< 50</math> fish, Medium = 50–100 fish, and High >100 fish. Hot segment >20 °C and Cold segment $\leq 20^{\circ}\text{C}$

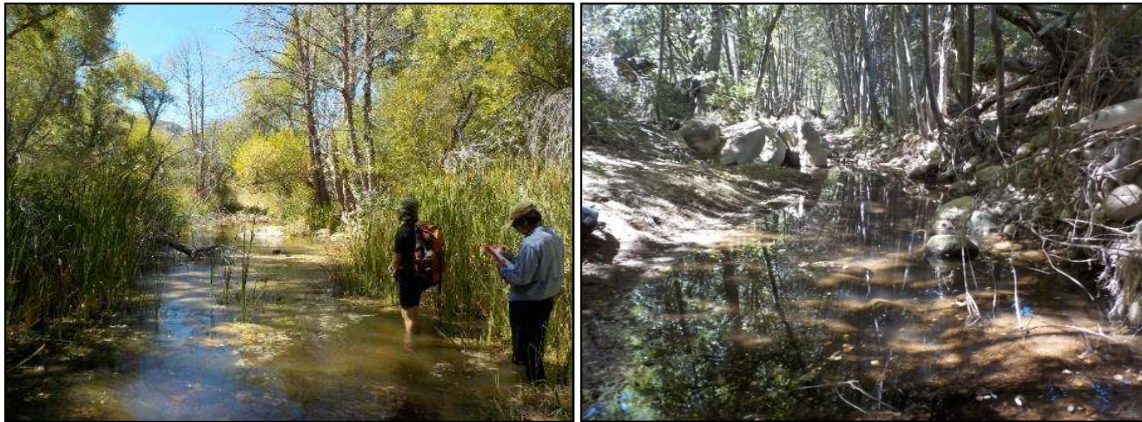
Figure 22. Reach 8 representative pool habitat and dense riparian vegetation.

Reach 8 was the upstream most reach surveyed and is upstream of the Howard Creek confluence. This section of the watershed was burned during the Wolf Fire in 2002 and the Thomas Fire in 2017. Within Reach 8 the channel has intermittent flows and the channel is characterized primarily by pool habitat separated by low-gradient riffles and long segments of channel that were dry during the survey (Figure 22 and Figure 23). Sand is the dominant substrate and primarily found within pool habitat while gravel is subdominant and was observed in higher abundance along with cobble in low gradient riffle sections of Reach 8. Suitable spawning gravel for steelhead is abundant in Reach 8. Aquatic vegetation was abundant in locations where water was found, and locations with water were found within dense riparian habitat. Water temperatures in Reach 8 ranged from 13°C to 17°C except for one small section at the downstream end of the reach that included a few small isolated pools where the water temperature was 25°C during the survey.

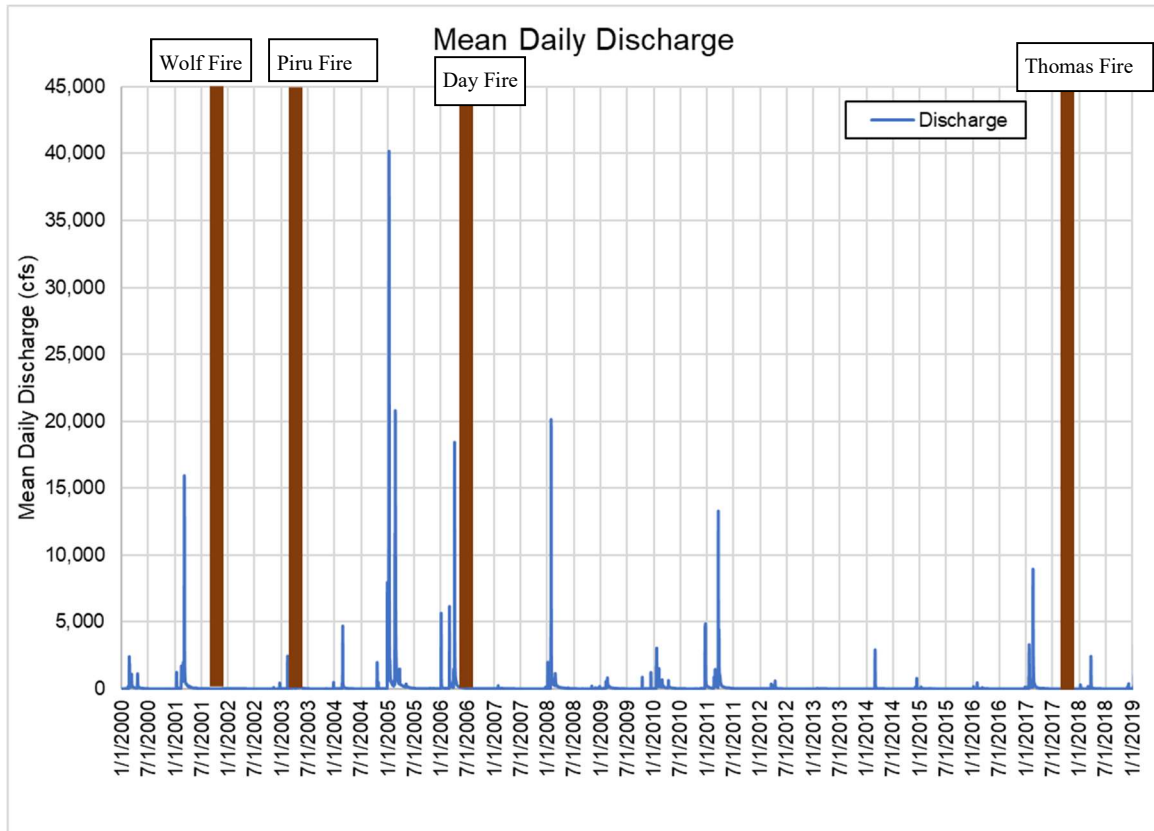
Figure 25. Mean daily discharge in Sespe Creek near Fillmore (USGS Gage 11113000) shown with recent wildfires.

In addition to wildfires, drought may play a large role in aquatic species distribution and abundance. This survey occurred during the end of a six-year drought (2012–2018) in the Sespe Creek watershed which likely influenced fish distribution and abundance during this effort. Drought can lead to fragmented stream habitat (limiting fish migration), while low stream flows during periods of drought can lead to warmer water temperatures (favoring warm-water AIS). Drought can also decrease sediment transport capacity, increasing the duration of influence of wildfires. For example, no large stream flows had occurred between the time of this survey and the recent Thomas Fire (Figure 25).
