White Mountain National Forest

Monitoring and Evaluation Report

FY 2013

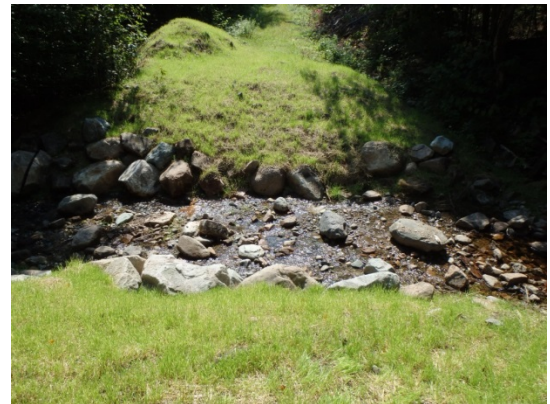
*Higgins Brook site after restoration.
WMNF photo by Jay Milot.*

Fish passage was restored along Higgins Brook. The Higgins Brook Road (FR104) had a double culvert crossing that was prone washouts of the road surface and created a fish barrier to brook trout. In 2013, the culverts were removed and the stream was restored as part of the Higgins Brook Timber Sale, after harvesting was completed. The project was paid for with funds from timber sale receipts. The site is no longer a fish barrier and is suitable for temporary bridge crossings in future vegetation management entries.

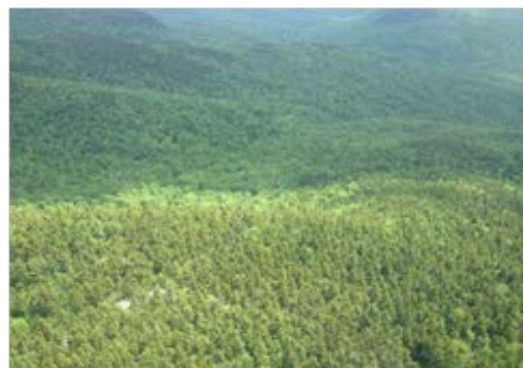
- 3,552 acres of white pine needle damage (discoloration),
- 5,641 acres of hail damage,
- 3,389 acres of frost damage,
- 1,406 acres of leaf scorching (damage on the ground appeared abiotic, most likely also related to frost), and
- 389 acres of forest tent caterpillar (FTC, *Malacosoma disstria* Hubner) defoliation in the sugar maple-beech-yellow birch type.

White pine discoloration. USFS photo.

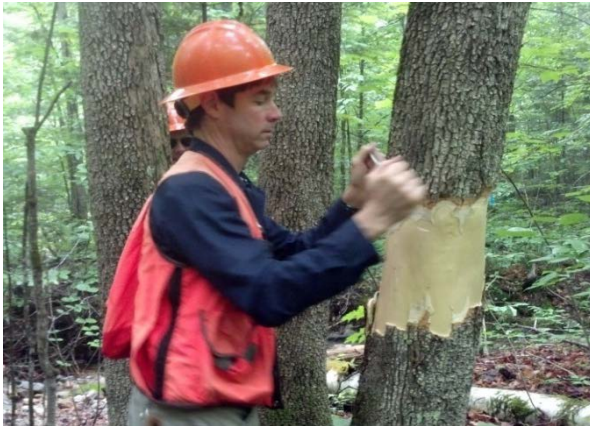
Girdling an ash tree to survey for emerald ash borer. WMNF photo by Roger Boyer.

Trap trees were girdled in June of 2013. Girdling, or removing a band of bark and phloem around the trunk of a tree, interrupts the ability of the tree to transport carbohydrates – the food needed by the tree. Girdled trees become increasingly stressed over the summer. As stress increases, the chemicals emitted from the foliage, bark, and wood of the tree change. The wavelengths of light reflected by the leaves also differ between healthy and girdled trees. Beetles are more attracted to stressed trees than to healthier nearby ash trees. Female beetles tend to lay more eggs on

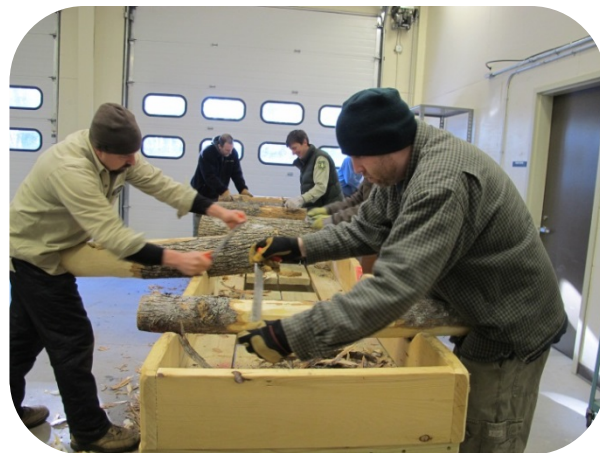
Trap trees were felled, cut into bolts (3' sections), and peeled in late November 2013. EAB eggs hatch in July and early August, after just a couple weeks in the tree, and the larvae start to feed. As they feed and grow, galleries (chambers or passages in wood tissue made by feeding larvae) are formed under the bark. By September these galleries are visible to the naked eye once the bark is peeled.

No EAB larvae were discovered. The WMNF plans to repeat monitoring efforts through use of trap trees again in 2014.

Peeling ash bolts and looking for EAB. WMNF photo by Deb Boyer.

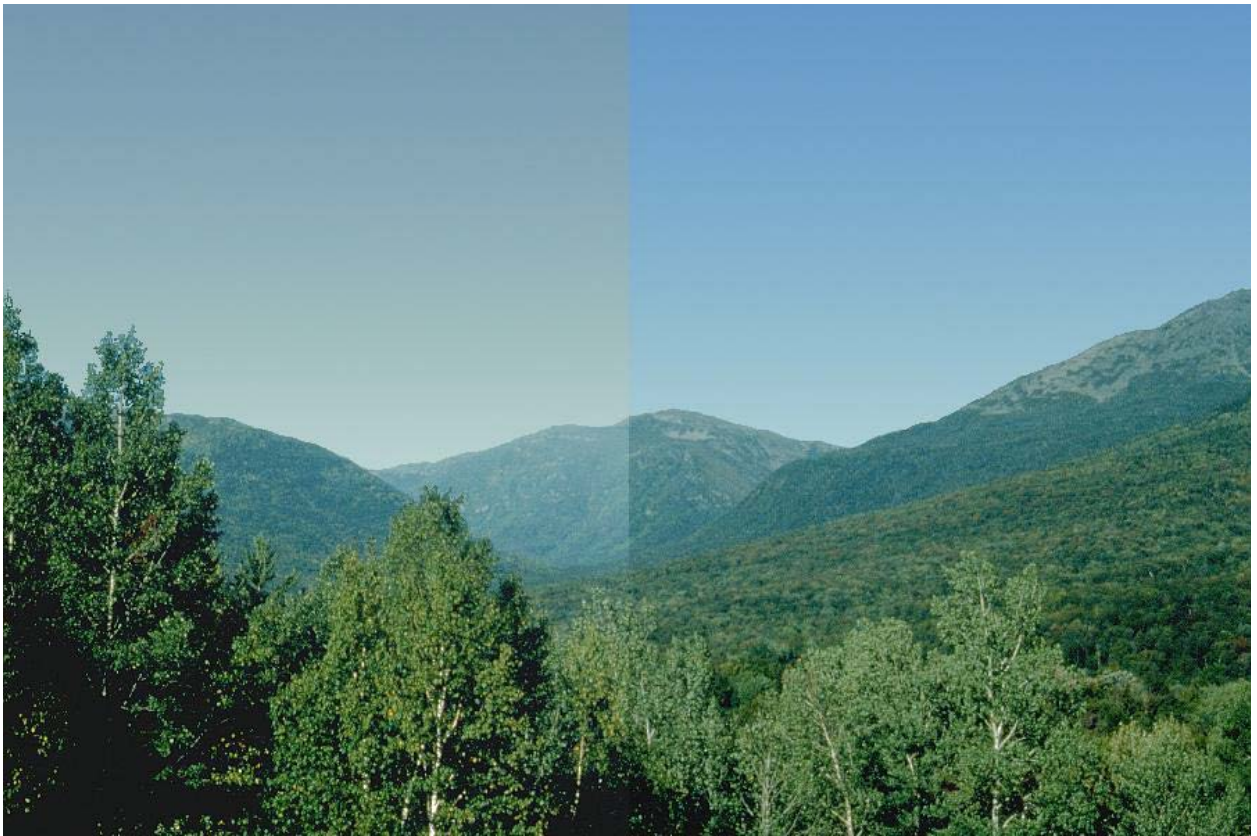
Computer Generated Approximation of the Visibility Improvement at Great Gulf Wilderness Area. (Source: Briefing paper on Visibility Data Summary: Great Gulf and Presidential Range-Dry River Wildernesses, NH, June 2013. USDA Forest Service Air Program.)

Visibility can be quantified using standard visual range (SVR). SVR is the farthest distance one can see a dark object against a light background. SVR on the worst visibility days improved approximately 30% from 2000 to 2009 at Great Gulf and Presidential Range-Dry River Wildernesses. Some of this improvement is due to reduced amounts of sulfate in the atmosphere. The photo above gives an idea of what this improvement looks like.

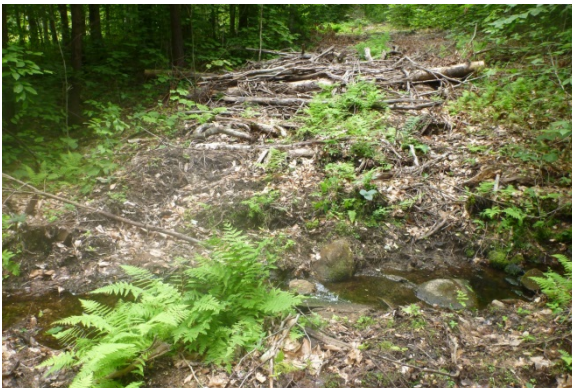
Seven stream crossings were evaluated for compliance with Water Resources standards S-2 and S-3. As disclosed in environmental analysis documents, stream crossings are areas of high risk of sedimentation, and temporary, localized sediment movement may occur. Four skid trail crossings were observed after crossing structures had been

Skid trail crossing approx. one year after close out. Noted minor bank disturbance from placement and removal of bridge panels, which could be minimized by placing slash underneath before installing panels. WMNF photo by Sheila Johnson.

removed. BMPs employed included gradual approaches, water bars on approaches, slash/corduoy on approaches, seeding, and winter operation. Bank disturbance within the width of the skid trail was evident at some sites, but any sediment movement was well within analyzed limits. The three road crossing sites included one permanent bridge and two temporary culvert crossings (previously removed). Similar BMPs were applied on approaches of closed roads, and no ongoing sedimentation was observed. The permanent bridge was constructed as designed and met Forest Plan Water Resources standard S-5, specifying that crossings pass the bankfull

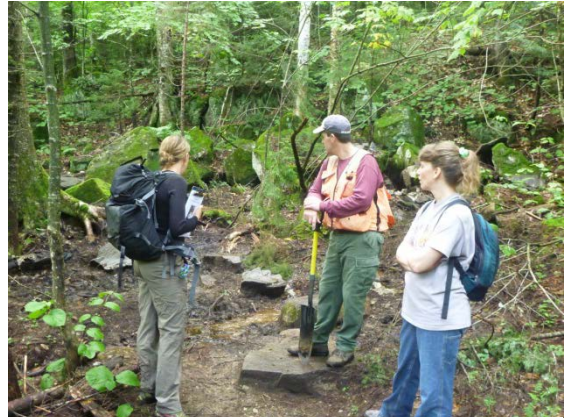
measures to protect soil and water, such as bog bridging and rock steps, were implemented and were effective in preventing erosion and sedimentation over the majority of the trail. One instance of sedimentation was noted, where the trail climbed up slope from a stream crossing. Minor adjustments to trail location and drainage were proposed to mitigate this condition. During the course of construction, groundwater seepage caused some portions of the trail to be wet. Again, minor adjustments to trail location and drainage were devised to keep foot traffic out of seeps. Impacts from trail construction were very small in comparison to potential impacts on the former trail, and were in compliance with Forest Plan standard S-2 for Water Resources. This review highlighted the value of an adaptive management approach on new or relocated trail segments.

A BMP monitoring team observes the use of rock steps on a new section of trail. WMNF photo by Sheela Johnson.

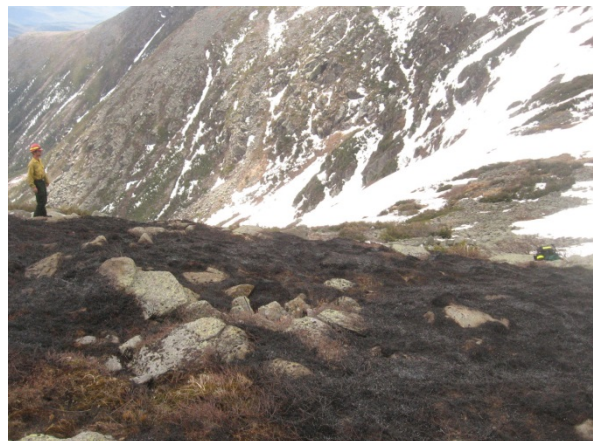
In 2013 the WMNF responded to two wildland fires. Both were human-caused and directly suppressed by WMNF personnel. One was a very small fire in Shelburne, NH. The other was Tuckerman Lip fire, which occurred on May 7 on Mt. Washington and was started by fireworks. The fire burned 0.1 acres of alpine vegetation. Minimum Impact Suppression Tactics were employed by suppression personnel. The location of rare plant species in relation to the fire was also mapped.

Part of the area burned by the Tuckerman Lip fire. WMNF photo by Nate Peters.

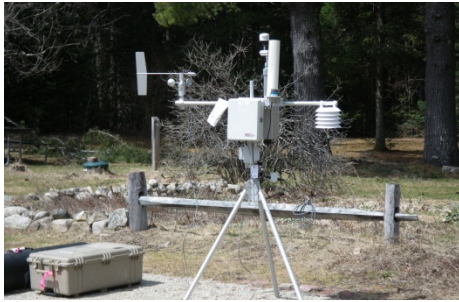
Smoke monitoring equipment at the Russell Colbath House. WMNF photo by Ralph Perron.

particulate matter in the atmosphere near the prescribed fire. The WMNF has access to portable smoke monitoring equipment that includes a nephelometer, which measures light scatter. The 33-acre White's Brook wildlife opening was burned on April 22, 2013. The smoke monitoring equipment was set up at the Russell Colbath House on NH Route 112 to monitor particulate matter resulting from the burn, which was about one mile away.

Throughout the entire prescribed fire event, particulate matter concentrations measured by the smoke monitor remained at background levels, far below levels that generate human health concerns.

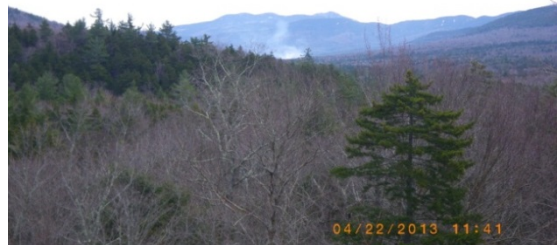
Photographic documentation of impacts to air quality from this prescribed fire was collected at two locations along NH Route 112: the Sugar Hill scenic vista and at the Livermore/Albany town line, a point where drivers heading east are facing directly toward the wildlife opening. Smoke was seen rising in the distance from both locations, but appeared to disperse well throughout the duration of the fire. Anecdotally, the person conducting the monitoring noticed no smoke impacts along NH Route 112 during multiple trips between the smoke monitor at the Russell Colbath House and the Sugar Hill Scenic Vista, locations in opposite directions from the burn site.

Prescribed burn as viewed from Sugar Hill vista. WMNF photo by Ralph Perron.

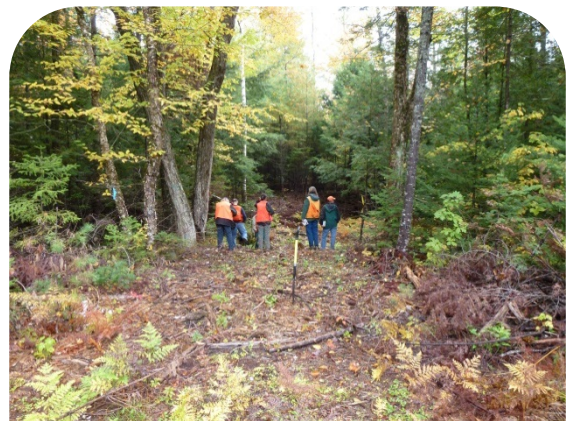
Monitoring showed that other BMP's, such as water bars and slash in the trails to prevent compaction, erosion, and puddling, were being implemented on harvesting operations when appropriate. BMP's are designed for "the control and dispersal of water collecting on truck haul roads, skid trails, and log landings to minimize erosion and reduce sediment and temperature changes in streams." (New Hampshire Best Management Practices A Pocket Field Guide, 2004) On the WMNF, these practices appear to be successful in meeting that objective. None of the monitored sales had any active detrimental erosion occurring where water bars were in place. Where slash was placed in the skid trails, there was no active detrimental rutting that would lead to compaction.

Main skid trail. Orchard Timber Sale. Androscoggin Ranger District. WMNF photo by Andy Colter.

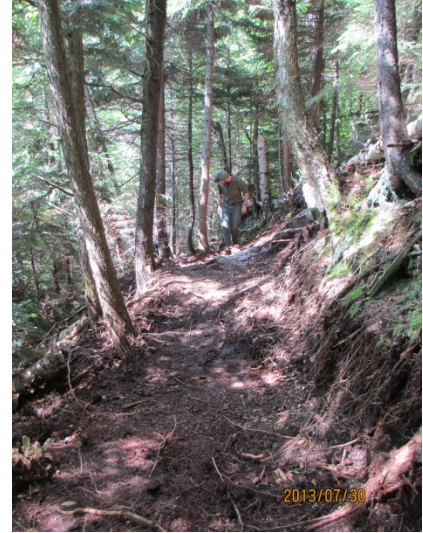
In 2013 a one-half mile long trail relocation was constructed to mitigate a destabilized segment of trail on a very steep slope that was undercut and degraded by Tropical Storm Irene in 2011. The treadway and previously installed trail structures adjacent to Nancy Brook held up to the storm in their original location; however, the collapse of the trail was determined to be imminent and likely during a future heavy rain event. This trail segment slid in the late 1990s and was repaired in 2002 by the Saco Trail Crew by installing substantial rock cribbing to support the trail.

Rather than try to re-establish the trail on a slope that has now slid twice, we looked on both sides of the brook for an alternative. The ground on the far side of Nancy Brook posed several challenges and the relocation would have been well over a mile in length. The ground on the same side of the brook was not ideal due to the extremely steep slope, but was the best option available. A route was identified and constructed to bypass the slope with the greatest slide potential, on which the original trail sits. This required significant ‘bench cutting’ of the trail to cut a wide enough treadway into the steep slope, as well as constructing modified ‘switchbacks’, and rock/log steps and drainage structures. The trail is no longer directly adjacent to the brook, removing the potential for high water to undercut the trail in the future.

New segment of trail. WMNF photo.

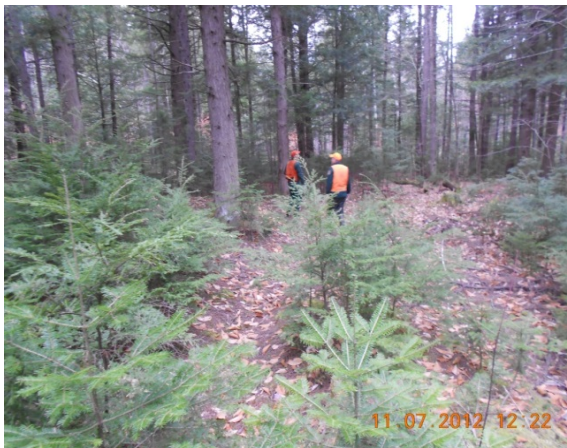
Softwood regeneration in a group selection harvest. WMNF photo by Lesley Rowse

The stands visited were harvested using three different treatment types: group selection, a combination of individual tree selection and group selection, and shelterwood removal to about 40 basal area. Harvest occurred in both fall and winter, depending on the stand. Groups ranged from 0.1 to 0.5 acres in size.

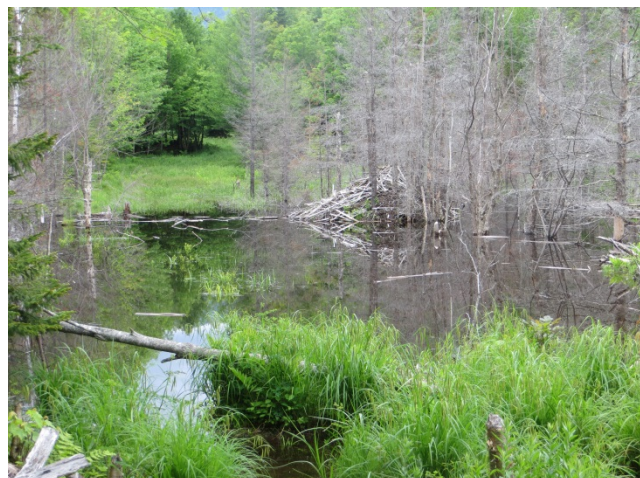
In FY13, the permit administrator visited the old and new trail locations. He found extensive beaver activity along the old trail route, including nearby dams, ponds, and lodges. The relocated section of trail was high and dry with no evident resource damage or trail stability concerns after three years of use. The decision to move the trail clearly resulted in a more sustainable trail network, and happy beavers!

Beaver habitat along old Swan's Way Trail. WMNF photo by Tom Paquette.

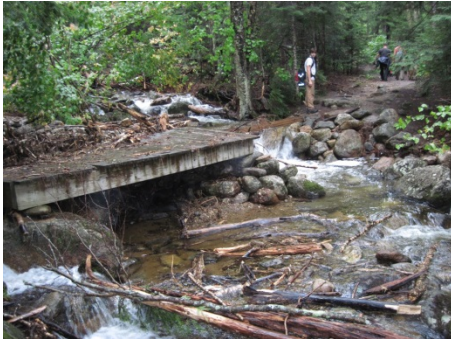
On August 28, 2011, Tropical Storm Irene arrived in New England. The storm brought less than an inch of rain to some areas; to others it brought more than 10 inches within a couple hours. Three nearby USGS rain gauges showed that the discharge of water at these sites was above the 100 year flood estimate. The intensity of the rain and resulting high flows in streams caused extensive damage to roads, trails, bridges, and other infrastructure across the Forest. In 2012 we repaired many sites, developed plans to address damage in other locations, and continued to find more damage as we explored areas throughout the summer.

19-Mile Trail, damaged by Tropical Storm Irene. WMNF photo.

Recovery from Tropical Storm Irene, and from Hurricane Sandy in fall 2012, continued to be a focus across the Forest in 2013. Repair work was completed on the Hales Location and Rocky Branch Roads. Planning and design work continued on several other Forest Roads, including East Branch, Eastside, Livermore, Slippery Brook, and Tunnel Brook roads.
