Layng Creek Watershed Analysis Team
October, 1995

LAYNG CREEK WATERSHED ANALYSIS

Cottage Grove Ranger District

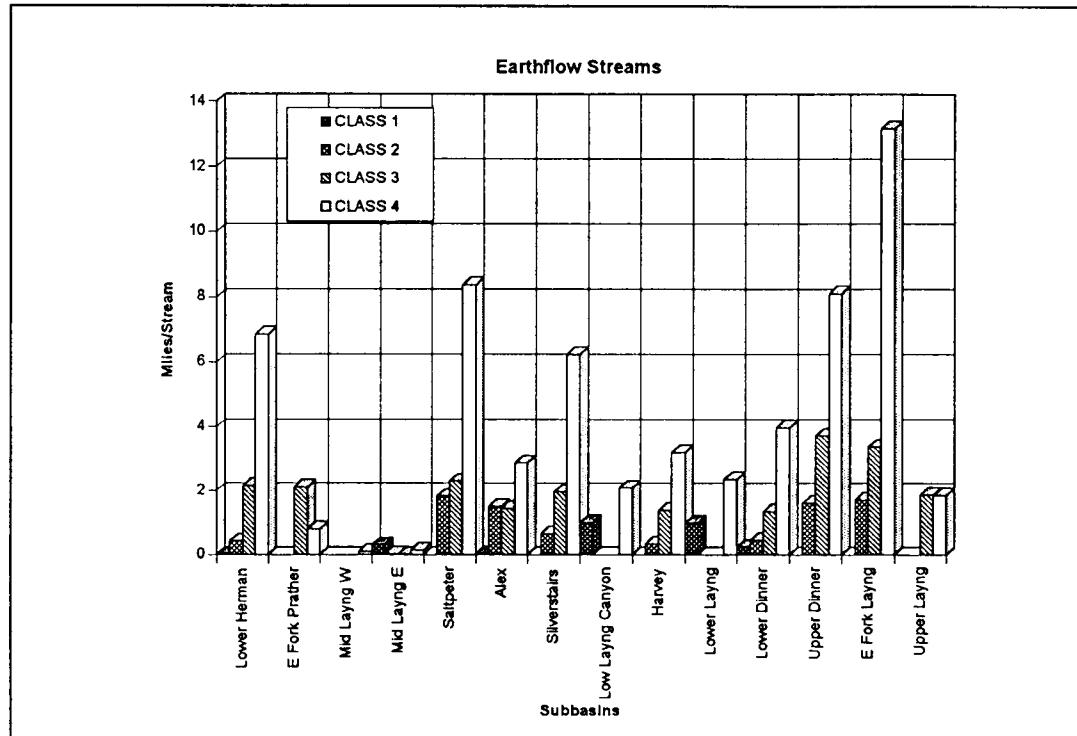
Figure 7. Streams with Earthflows

The relationship between earthflow terrain and channel processes is not well understood, but recent work in Jackson Creek and Little River on similar terrain suggest that these stream channels are extremely sensitive to rapid changes in the flow regime, particularly peak flows. One primary explanation of this is that these deep seated earthflows lack the complex geologic structure typically found in the geology of the Western Cascades. As a result these stream channels are dependent on external structure such as large woody material to provide complexity and stabilize the system. Approximately 21% of the identified streams in the watershed are associated with earthflow terrain. The erosional processes associated with these streams result in a high proportion of fine sediments (clay to sand size) and stream channels that have little armoring of the bed and banks. As a result they show little resistance to downcutting and bank erosion.

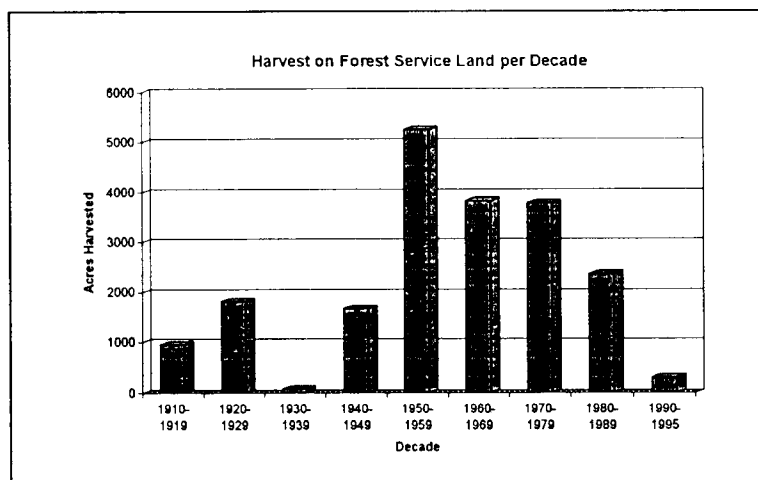
Figure 15. Harvest Acres by Decade.

In the 40 years between 1950 and 1989, 15,000 acres, or 41% of the Layng Creek watershed was harvested on Forest Service lands. The adjacent chart shows the rate of harvest on FS lands.

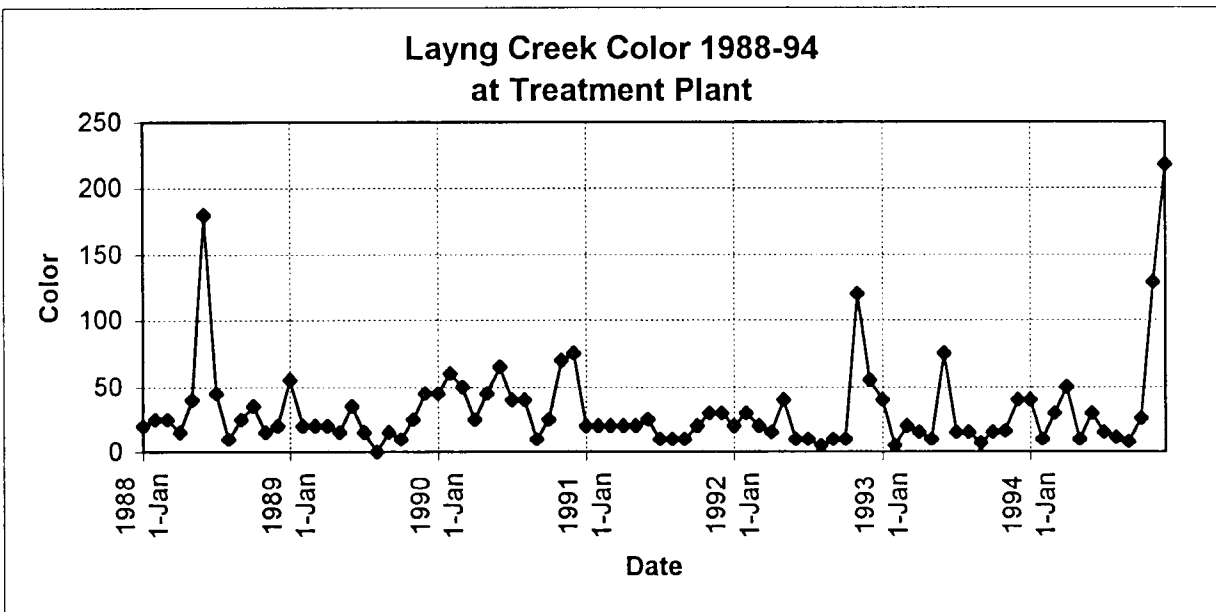
Figure 21. Turbidity of Layng Creek 1988-1994

Besides turbidity, the City monitors several other water quality parameters. Figures 21 and 22 show samples of this data. The Forest Service also routinely monitors stream temperature.
