## CHAPTER 3 - WATERSHED CHARACTERIZATION

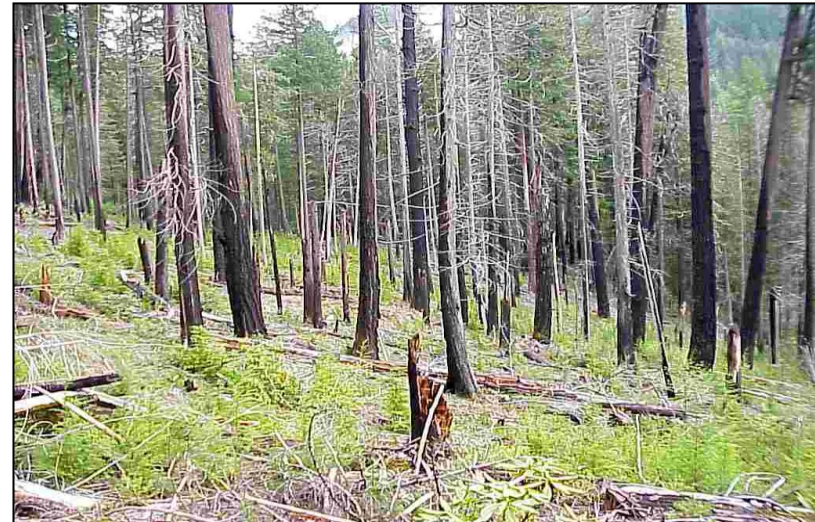
Figure 15. Stand initiation structure resulting from the 1987 Apple Fire.

In this stage, conifer and hardwood seedlings/saplings, grasses, herbs, and/or shrubs dominate the stand (Fig. 15). Normally, components from the previous stand (snags, down wood and remnant larger green trees) would occur. These components are usually absent in old clearcut timber harvest units or where burned areas were salvage logged.

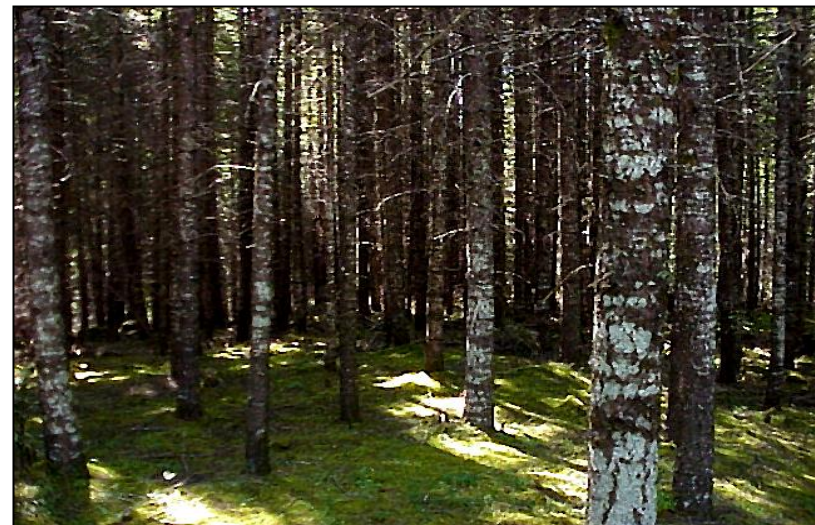
Figure 16. Stem exclusion structure in a Douglas-fir plantation on Panther Ridge.

During the stem exclusion stage, conifers fully occupy the stand forming a single canopy layer (Fig. 16). There is little to no understory development. Forest floor vegetation is sparse and consists of shade-tolerant species such as Oregongrape, swordfern and salal. Understory trees, if any, provide minimal layering and are in “survival” mode. Death of some understory trees may be evident.

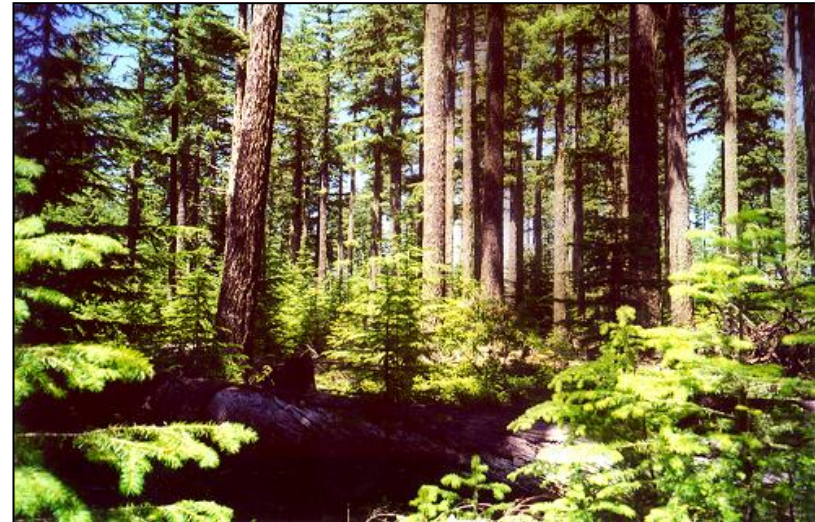
Figure 17. Understory Reinitiation structure in a stand on Panther Ridge.

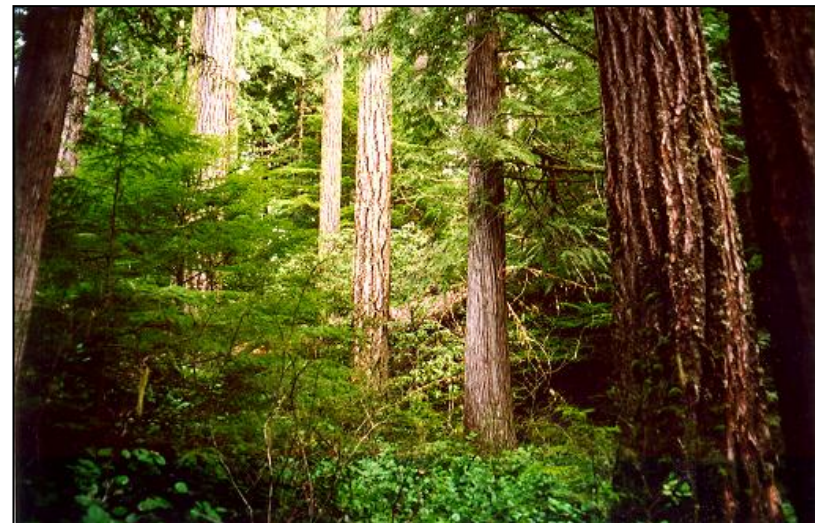
Figure 18. Old forest (old-growth) structure within the watershed.

In old forests, the vertical structure and species composition is more complex than in the understory reinitiation stage (Fig. 18). Shrub and herb layers and multiple tree canopies are present. At the more ecologically complex end of this stand condition are stands that have a mixture of tree cohorts of shade-tolerant and intolerant tree species as well as shrub and herb species.

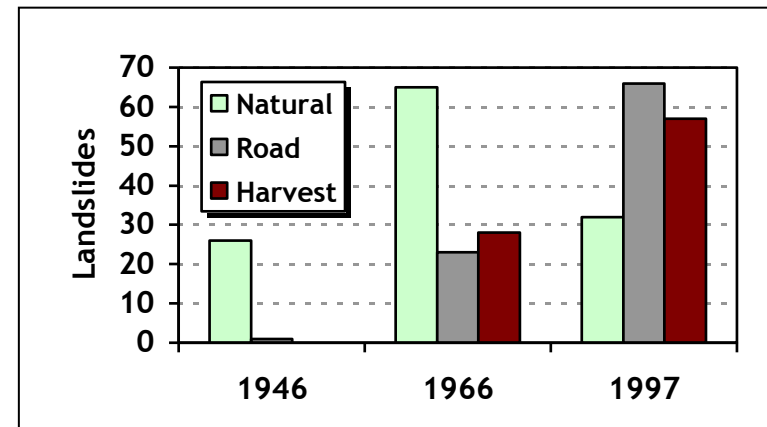
Figure 21. Landslides inventoried within the analysis area for the 1946-1997 time period.

There appears to be a trend of increasing management-related landslides over time (Fig. 21). For the 30-year period from 1967-1997, roughly 122 management-related landslides were detected for a rate of 4.1 landslides per year. The 20-year period encompassing 1947-1966 shows roughly 51 management-related landslides for a rate of 2.6 landslides per year. The majority of the management-related landslides for the period of 1947-1966 are believed to be the result of the 1955 and 1964 flood events. The 1964 flood event was considered to be the storm of record (100+ year recurrence interval) within the lower North Umpqua River basin. Poor road location, design, and construction practices (excessive fills, slash in fills and inadequate drainage structures) during the period prior to the 1980s resulted in a higher incidence of road-related failures. Many of the landslide occurrences detected on the 1997 aerial photographs likely reflect a series of closely spaced storm events that took place between November 18, 1996 and January 31, 1997. The initial November 18, 1996 storm was considered to be a 20-25-year flood event in the lower North Umpqua River basin.
