APPENDIX E

POTENTIAL REPOSITORY SITE IDENTIFICATION AND CHARACTERIZATION INFORMATION

**DRAFT
PRELIMINARY REPOSITORY SITING INVESTIGATION
FOR THE
MIKE HORSE DAM, IMPOUNDED TAILINGS AND FLOODPLAIN WASTES
REMOVAL ACTION ALTERNATIVES**

April 2006

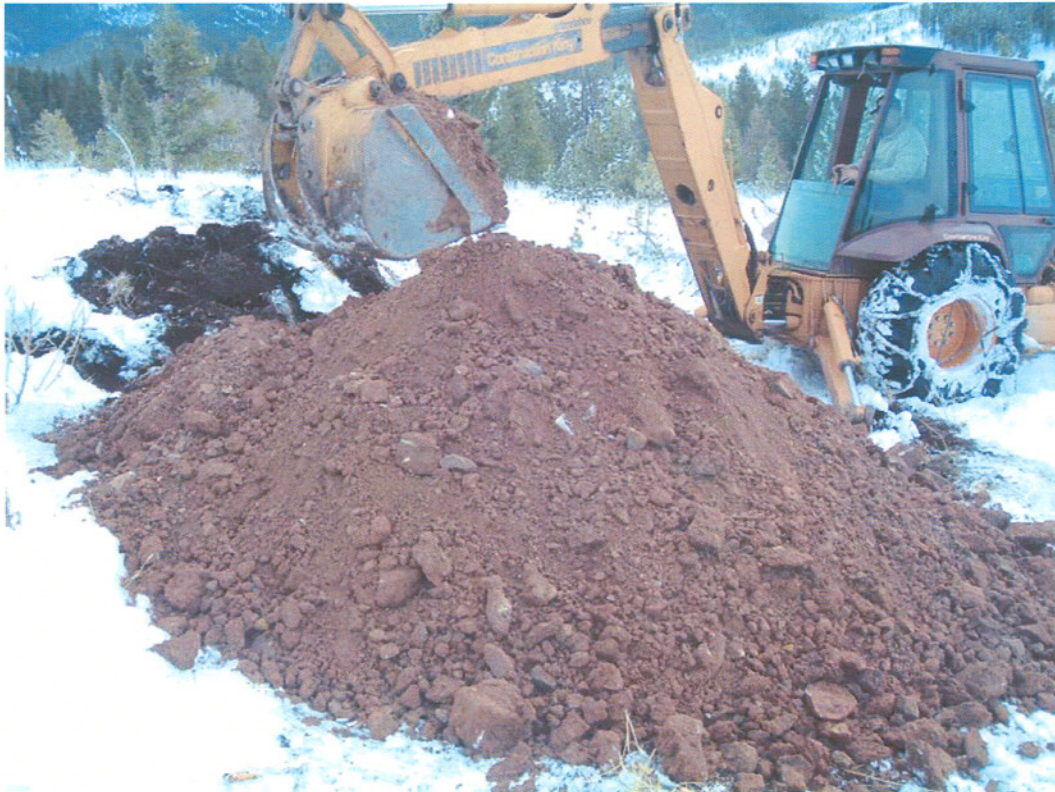
Soil from Test Pit HFC-TP-2

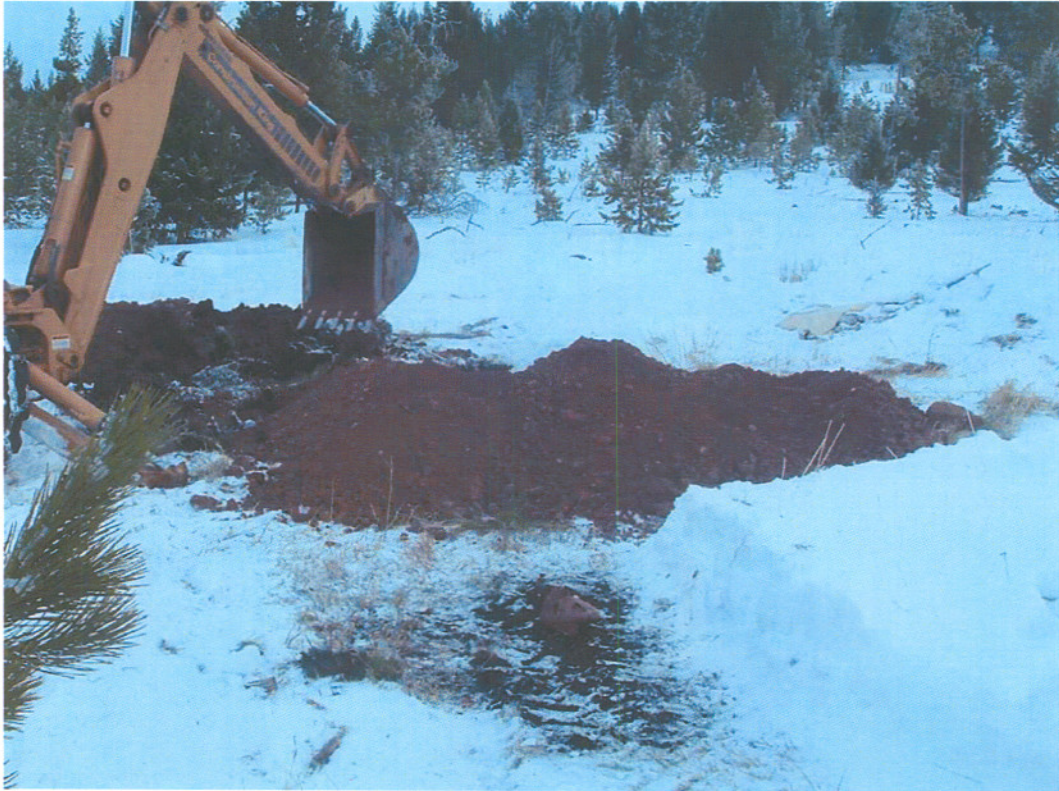
Soil from Test Pit HFC-TP-4
