# White Mountain National Forest

Eastern  
Region

# Monitoring and Evaluation Report 2011

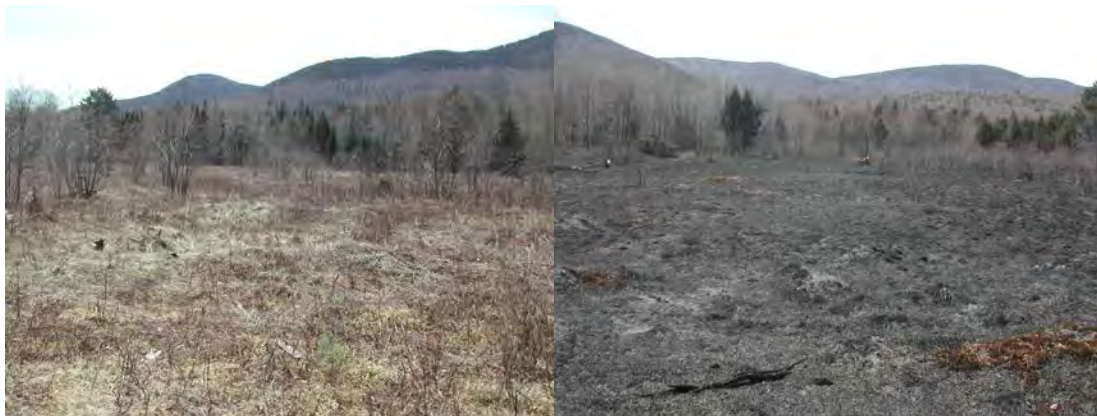
***Pine Bend Site: Photo points show evidence of fuel consumption by documenting the view directly before and directly after burning on May 2, 2011. WMNF photos by John Neely.***

In order to measure success of these burns at meeting the identified objectives, the burn boss and other fire management staff perform periodic observational field trips to inspect burn units. Usually photographs are taken and filed, to be reviewed with pre-burn photographs and observations, and those collected as the site responds over time. This informal monitoring has shown we are meeting the identified broad objectives (e.g. maintenance of openings), but it is not detailed enough to address success at achieving specific objectives (e.g. consumption of 85% of fine fuels).

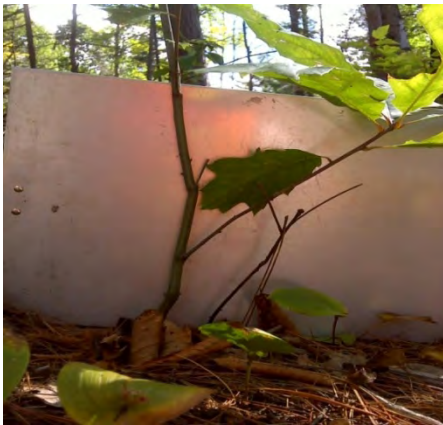
During the summer of 2011, the Right Angle unit (burned May, 2009) was examined for established regeneration red oak with evidence of dieback and re-growth; several red oaks were measured. The pre-burn height and diameter was estimated from burned stems, and new growth was measured for comparison. This monitoring showed a good post-fire response by red oak. New stems and sprouting had occurred in the two years since the treatment, indicating some success in meeting the objective of providing conditions for red oak regeneration. Pine seedlings are scattered in pockets in several areas of the unit.

*Red oak seedlings re-sprouted with vigor. WMNF photo by John Neely*

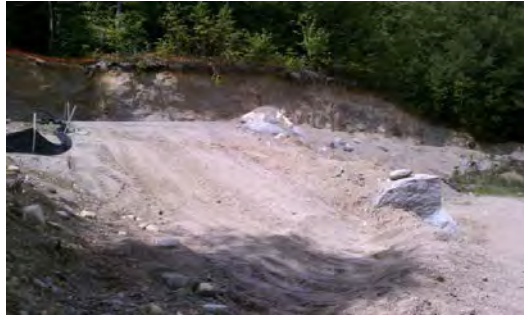
*Bartlett Pit.  
WMNF photo by Roger Simmons.*

All of the sites appeared to be stabilized. Several of the pits appear to have little useable material on hand, but they are being used to stockpile materials that may have been purchased from vendors. Only the York Pond pit has an operating plan.

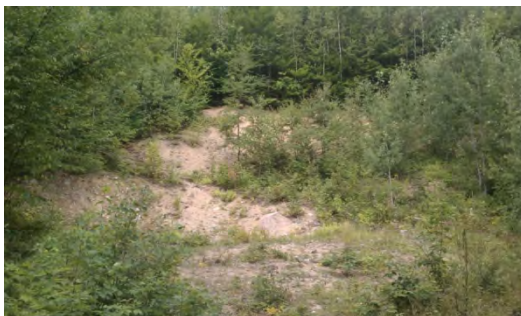
*Lower Sawyer River Road Pit.  
WMNF photo by Roger Simmons.*

The Livermore Road pit was in excellent condition. The other three pits appeared stable but needed additional vegetation to ensure there would not be a risk of erosion in the case of a large storm.

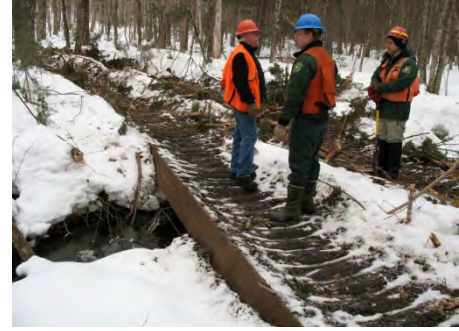
Interdisciplinary team members observed portions of the Upper Ammonoosuc and Rattle River timber sales in March 2011 during operation. The Forest hydrologist observed the Fish Hook Landing sale in July 2011 after close out. For all projects, BMPs prevented runoff from landings from reaching streams. Part of a landing in the Rattle River sale (analyzed prior to the 2005 Forest Plan) was located just within 100 feet of a stream, but the slope of this landing caused all runoff to move away from the stream. All other landings were over 100 feet from water bodies. At bridge, culvert, and pole ford crossings on skid trails, no sediment entered the water from banks or riparian areas. Soil and water conservation practices included appropriate designs and slash or snow covered approaches. A trace amount of sediment was deposited on top of one pole ford, but would not be sufficient to impair water quality if it entered the water during close out. On the Fish Hook Landing sale, approaches to a temporary bridge site were properly closed out with water bars, seeding, and mulch to prevent erosion and runoff into a brook. On all sales, skid trails sufficiently used water bars, slash and seeding, to prevent sedimentation in water bodies.

***Field review of the Upper Ammonoosuc Timber Sale. WMNF photo by Sheela Johnson.***

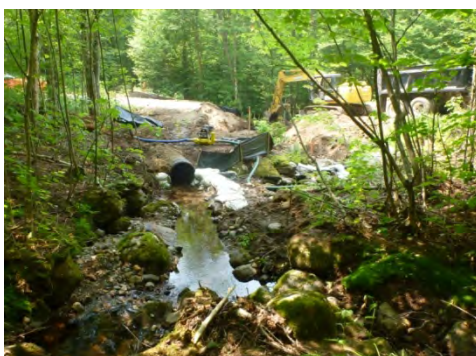
***Best management practices in place on the Bend Brook project. WMNF photo by Sheela Johnson.***

Soil and water conservation practices were also observed during the construction of three bridges in the Gale River watershed, a parking area and trail at Rumney Rocks, and a downhill ski trail at Loon Mountain ski resort. All sites had soil and water conservation practices in place, and no areas of active sedimentation or increased turbidity were observed. The Gale River bridge and Rumney Rocks projects contained well-maintained hay bales, silt fences, or rocked drainages downstream from disturbed areas. See “Project Reviews” section below for more information on the Loon Mountain project.

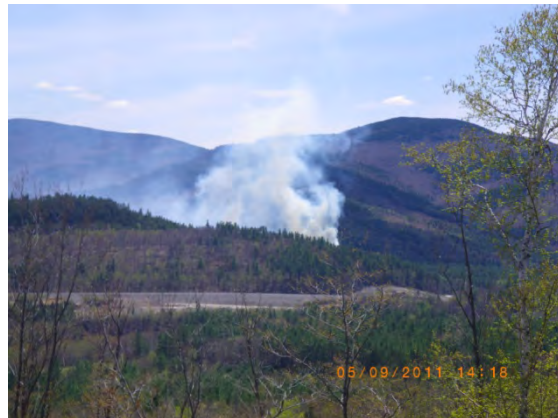
This photo of smoke rising from a WMNF prescribed fire in Gilead, Maine, shows that conditions were appropriate to allow the smoke to rise into the atmosphere, avoiding potential adverse effects to public health, safety, and visibility. The photo looks southerly, with Route 2 in the foreground.

*WMNF photo by Ralph Perron.*

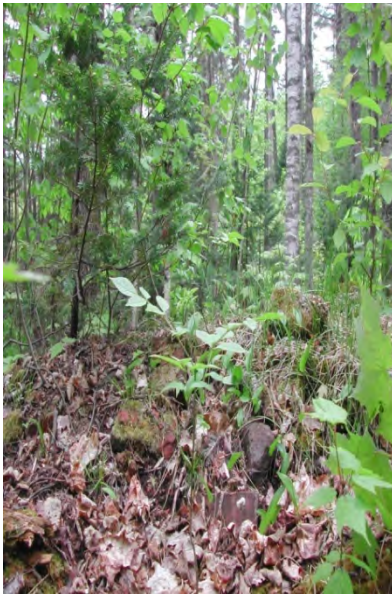
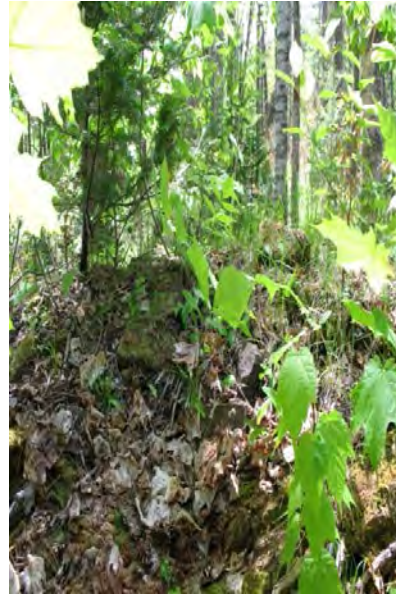
An historic building foundation was identified in a forested area proposed for prescribed burning. Protection of this cultural resource was incorporated into the prescription for the Right Angle Burn. On the day of the burn, firefighters cleared all burnable materials within about 50 feet of the edges of the foundation, creating a fireline to protect the foundation. The area was then treated with water to prevent burning. Burning was done very slowly at the edge of the fireline to strengthen it and create a buffer to further protect the historic site when the rest of the stand was burned.

The foundation was photographed before (left), directly after (right), and two years after the prescribed burn. This monitoring documented the successful protection of this cultural resource while implementing a prescribed burn in the surrounding stand.

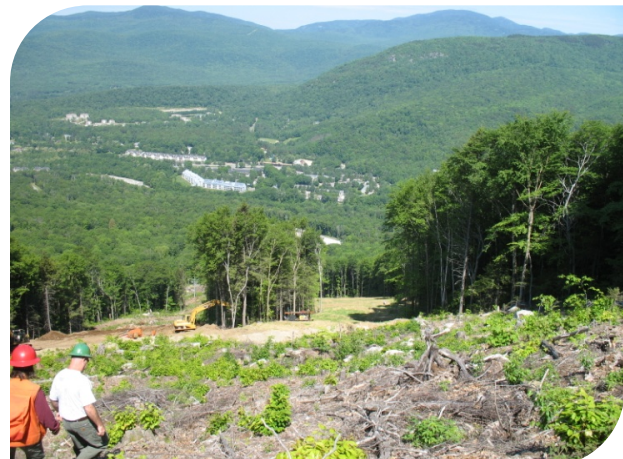
*Straw mulch, grass and water bars to prevent erosion on trails 41&42 South Peak, Loon Mountain. WMNF photo by Andy Colter.*

Construction of new downhill ski trails on South Peak of Loon Mountain Ski Resort was monitored regularly throughout construction to ensure best management practices were being implemented and to gauge the effectiveness of those practices. The Forest has been working with Loon Mountain to ensure the construction of the new trails is done as described in the Loon Mountain Environmental Impact Statement. Each monitoring trip showed that drainage structures were located and constructed to standard, seeding and mulching occurred immediately following construction as required, and straw bales were used as sediment filters where appropriate. Large water bars draining onto well-vegetated ground prevented soil from entering water bodies. All applicable soil and water conservation practices were maintained through project completion, at which point field review showed that all disturbed areas were beginning to revegetate. See the Tropical Storm Irene section below for more detail.

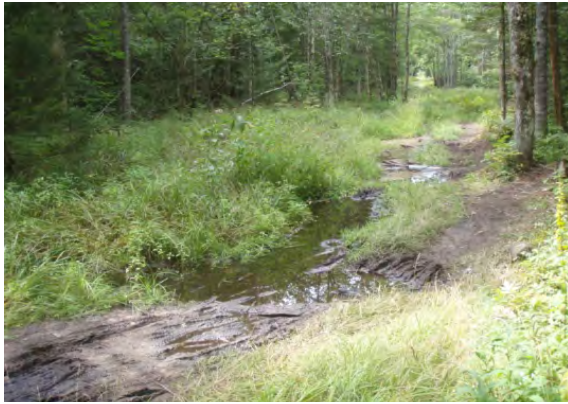
*Snow's Mountain Trail in June 2010.  
WMNF photo by Tom Paquette.*

Many of the nordic skiing trails at the Waterville Valley Ski Resort also are used for mountain biking in the summer. A couple years ago, it was noted that a combination of poor drainage and mountain biking were resulting in resource concerns on the Snow's

Mountain Trail. The trail was closed to mountain biking until the drainage system could be upgraded to handle summer use.

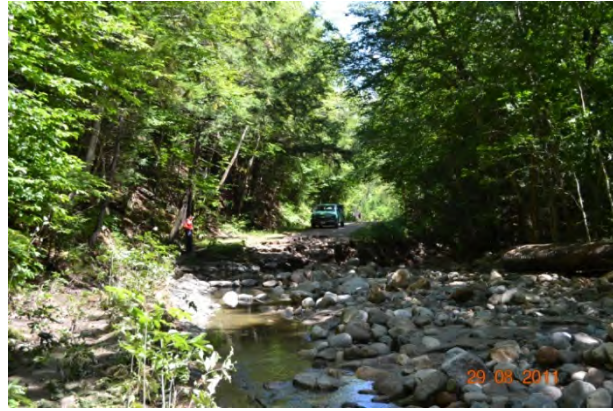
*Tunnel Brook Road after the brook was back in its banks. WMNF photo by Chris Mattrick.*

In some places, just the intensity of the rain caused extensive erosion. Roads and trails were washed away, leaving behind gaping holes in the path. Erosion in rock staircases along trails loosened stones and created instability for hikers. Trail tread and road prisms slumped and sinkholes appeared. Whole sections of roads and trails just gave way to the massive flow of water.

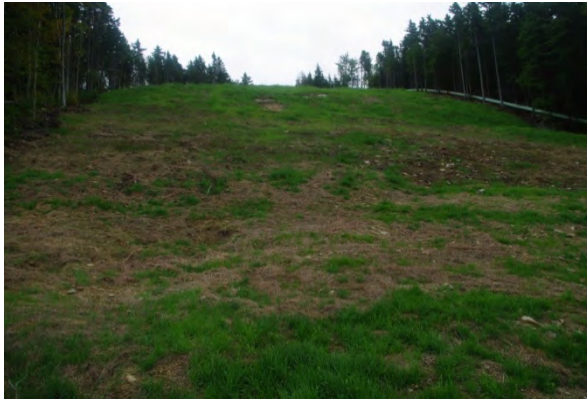
*Newly constructed trail at Loon Mountain, undamaged after T.S. Irene. WMNF photo by Joe Gill.*

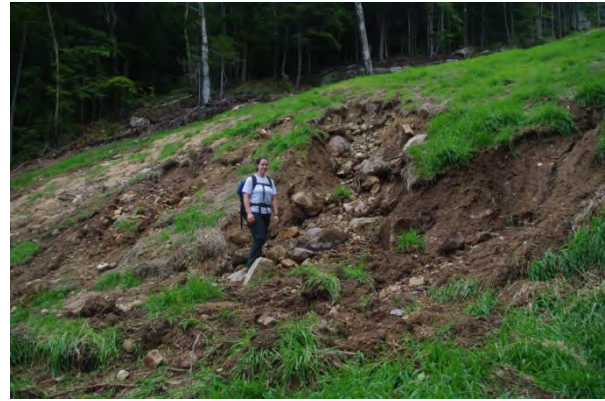
One waterbar blew out as a result of the rain waters. That single failure created a cascading situation that affected four or five waterbars below it and caused some gullying of the new trail surface. There were also a couple of small places where the lower trail

edge slumped slightly. All totaled, roughly one-quarter of an acre of the 16 acre project area was negatively affected by storm waters. Proper application of the design standards, best management practices, and other mitigation measures outlined in the EIS prevented the damage from being considerably worse. Repairs began almost immediately.

*Single failed waterbar on newly constructed trail at Loon Mountain. WMNF photo by Joe Gill.*

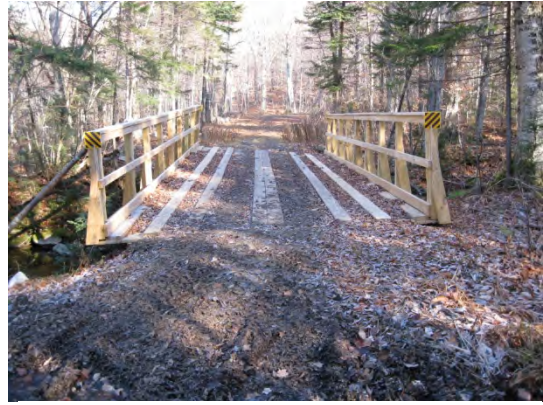
In September 2011, following Tropical Storm Irene, the Kilkenny Snowmobile trail was evaluated for storm related damage. Along the length of the trail from Pond of Safety to South Pond Recreation area only one of the 38 bridges sustained any damage. This bridge was reset using local operators. All drainage features and side ditches established on the trail worked as designed. The tread of the trail was not washed out anywhere.

*New bridge on Kilkenny Snowmobile Trail. WMNF photo by Jen Olmsted*

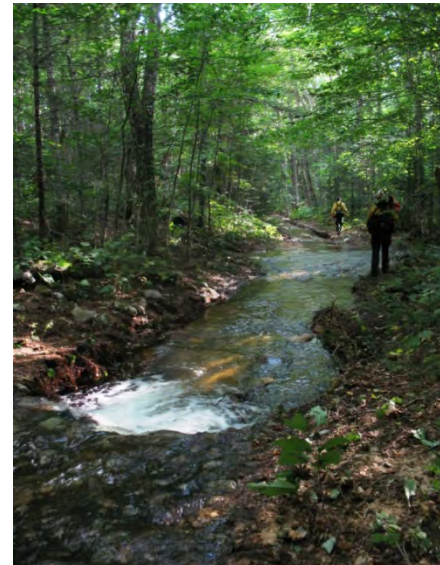
As mentioned previously, older bridges and culverts were often too small to allow flood waters and the debris they carried to flow downstream. Roads and trails that run near or adjacent to streams and rivers are susceptible to other impacts from floods. Rivers eroded and undermined their banks, causing trail and road tread to fall into the river and leaving an unstable slope in its place. Elsewhere streams overflowed or were diverted by debris jams and ended up flowing down roads and trails. In some of these spots, sediment deposits in the river have raised the riverbed so it is now higher in elevation than the adjacent road. High spring run-off or storm flows in coming years could cause the stream to move into the roadbed yet again. Where Tropical Storm Irene caused major damage to roads and trails near streams, the Forest Service is considering whether to repair, relocate, or decommission each route. The lessons of this storm will undoubtedly influence future decisions on where to build roads and trails and whether to relocate some of those that run through a floodplain.

*Mad River flowing down the Greely Ponds Trail. WMNF photo*

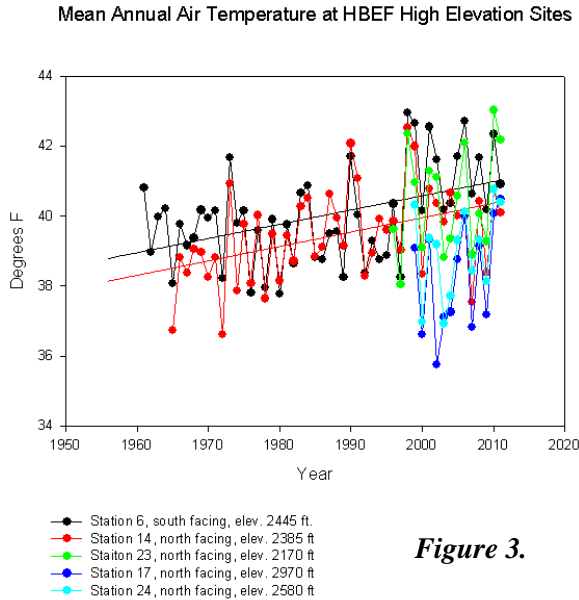
Figure 3.

As shown in Figure 3, there is a trend of increasing air temperature in the 55 year dataset provided for stations 6 and 14, which are at nearly the same elevation but have different aspects. Data from the NH Climate Office indicates a decadal increase state-wide in annual mean temperature of 0.29 degrees F in the same period (1955-2011). This rate of warming produces a total change in average mean air temperature of 1.5 degrees F.

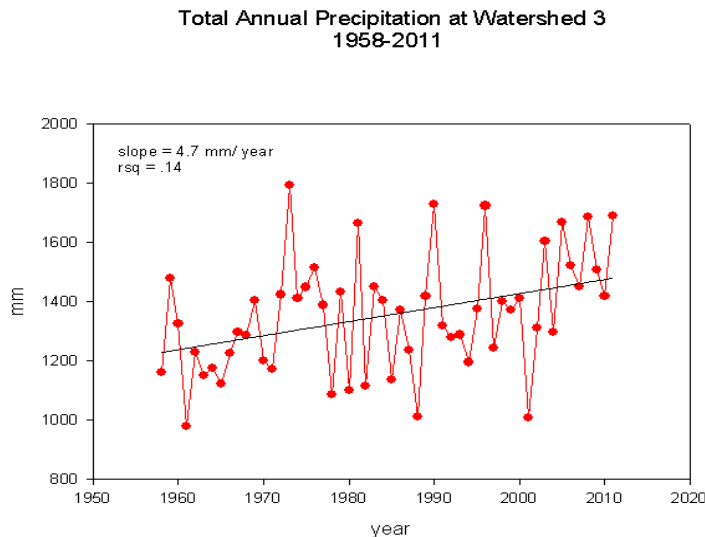
Figure 5.

The precipitation record at HBEF provides a useful on-Forest measurement of this key variable in the climate change picture. All models of climate change predict increased precipitation in this region and the data from HBEF bears this out. As shown in Figure 5,

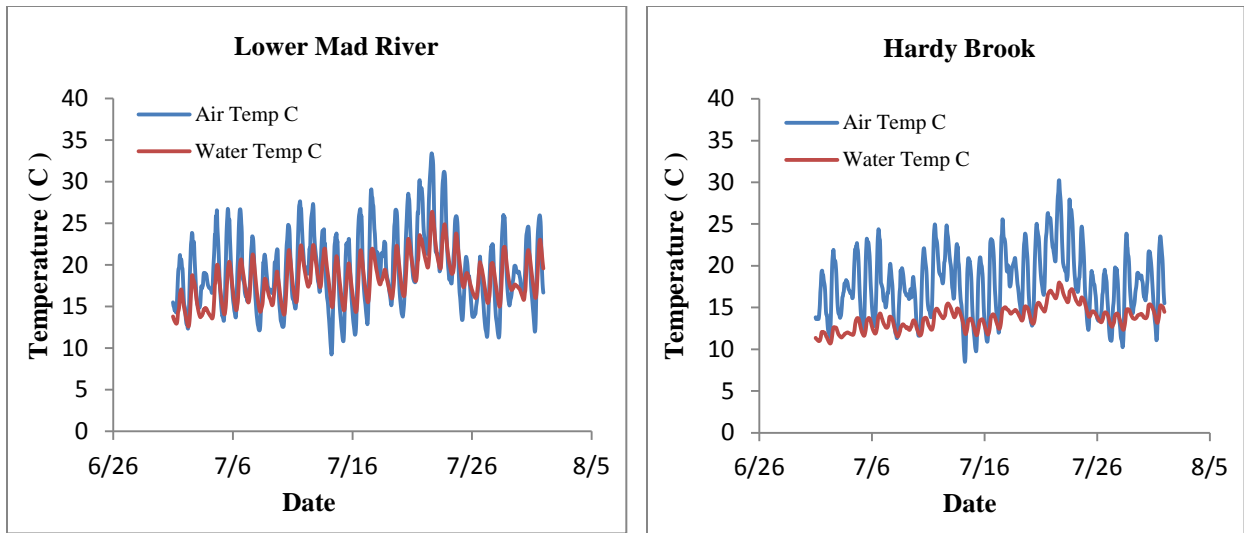
Figures 7 and 8 show plots of hourly air and water temperatures at two sites in the Mad River Watershed. The Lower Mad River site was located on the mainstem Mad River, a third order river that drains 9.8 square kilometers (km<sup>2</sup>) of land; the Hardy Brook site was located near this first order stream’s mouth, where it drains 2.6 square kilometers of land. These two sites are an example of the variation in stream habitats on the WMNF. Hardy Brook is a steeper and narrower channel that is more heavily shaded than the Lower Mad River site. Hardy Brook averages 13.8°C during July and fluctuates very little between day and night, resulting in a very low sensitivity value of 19%. Brook trout dominate these steeper and colder streams within the White Mountains as shown from our fish sampling at the site (Figure 9). The Lower Mad River site averaged 18.2°C in July, suggesting it is classified as a “coolwater” stream. The site photographs indicate there is far less streamside shading of the water surface as compared to Hardy Brook. The site is also much more sensitive to air temperature changes, as indicated by the daily fluctuations and a sensitivity value of 49%. Brook trout are far less common in these larger rivers with higher water velocities and less riparian shading as other species prefer the warmer temperatures.

**Figures 7 and 8. Daily fluctuations in air and stream water temperatures at two sites in the Mad River watershed.**

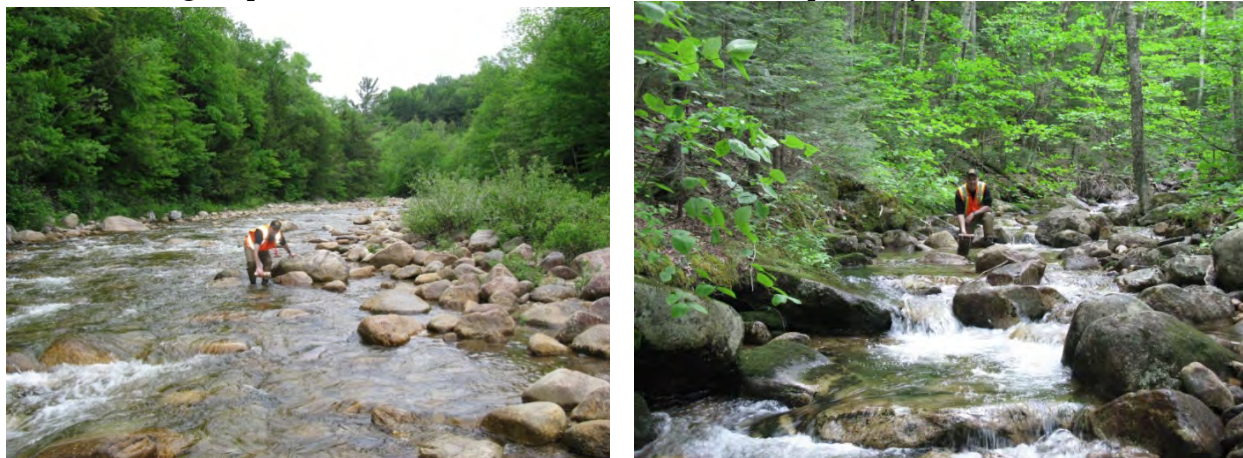
**Figure 9. Results of fish sampling in the same two streams, Hardy Brook and Mad River.**

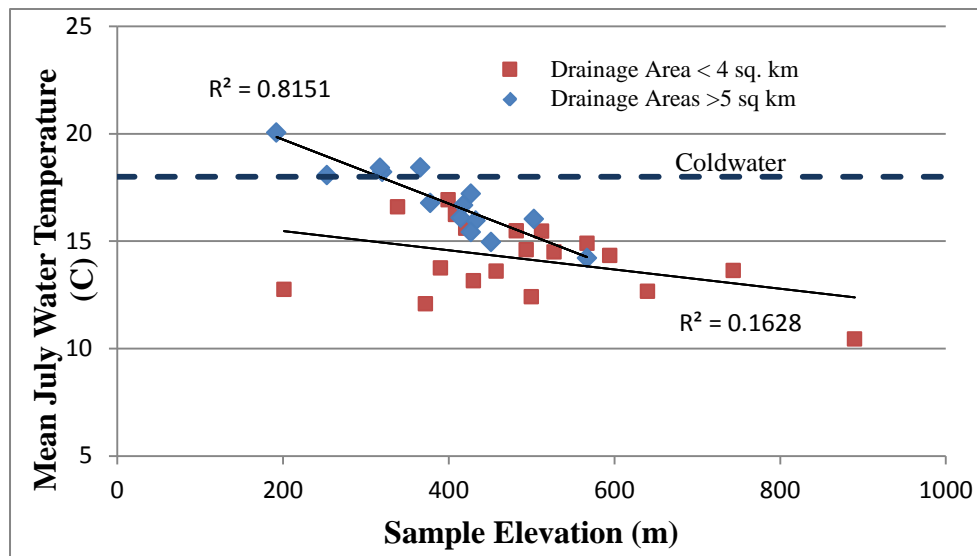
Many local landscape characteristics may interact to influence water temperatures at a particular sample site, such as elevation, slope, aspect, landform shading, riparian cover, and groundwater sources. While the assessment in 2011 did not investigate all of these metrics, the influence of elevation can be assessed quite easily. The influence of sample site elevation on mean July water temperature (MJWT) was examined for two groups of drainage area sizes; sites draining < 4 km<sup>2</sup> and sites draining > 5 km<sup>2</sup> (Figure 10). While there was a slight increasing influence on MJWT from decreasing elevation for sites draining < 4 km<sup>2</sup>, it was not significant and elevation only accounted for 16% of the variation. For larger river sites (>5 km<sup>2</sup>), there was a strong influence on MJWT, with temperature increasing as sample site elevation decreased. The effect was significant and explained 82% of the variation in temperature across all sites.

*Figure 10. Mean July water temperature plotted against sample site elevation for sites at drainages areas <4 km<sup>2</sup> and sites at drainage areas > 5 km<sup>2</sup>.*

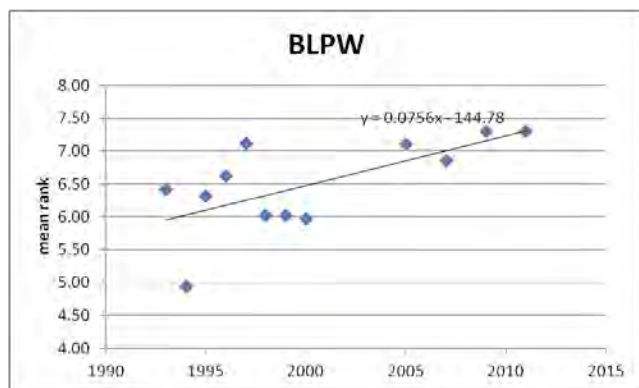
Only one species, the blackpoll warbler, had a statistically significant trend (upward;  $p=0.02$ ; Figure 11). This is by far the most common species of the group, occurring on all 574 points at least once during the 12 years of survey data that were analyzed.

*Figure 11. Blackpoll warbler trend.*

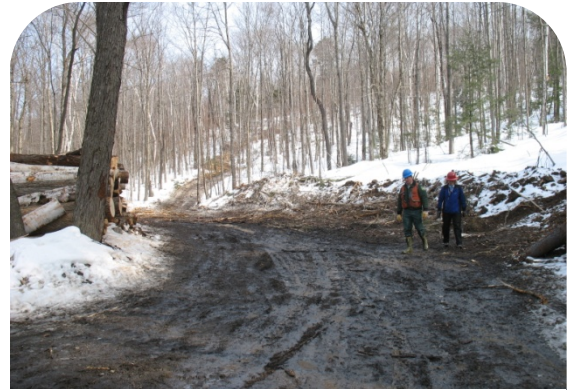
***Landing and main skid trail, Rattle River active winter sale. WMNF photo by Andy Colter.***

Every year monitoring occurs while activities are being implemented on the ground to see whether Forest Plan standard and guidelines to minimize soil movement are being followed and track the effectiveness of best management practices (BMPs). In 2011, monitoring took place on the following active timber sales: South Pond and Rattle River on the Androscoggin Ranger District and Kanc 7 on the Saco Ranger District. Post implementation monitoring occurred on the Right Angle and Hatchery sales on the Pemigewasset Ranger District, Popple South sale on the Saco Ranger District and Mill Brook sale on the Androscoggin Ranger District. Standards and guidelines were generally being followed as proposed.

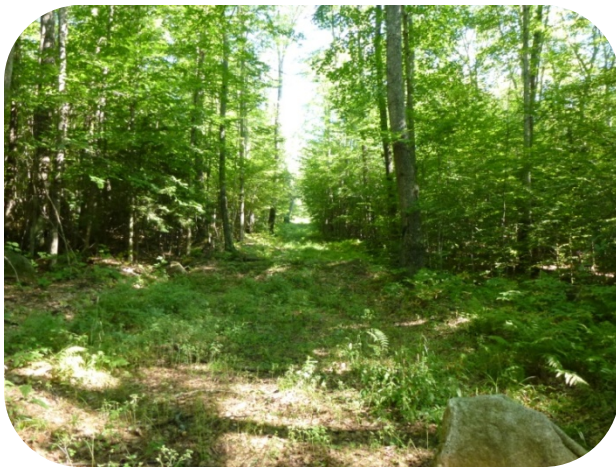
***Main skid trail at Right Angle sale 1.5 years after harvest. WMNF photo by Andy Colter.***

BMP’s are designed for “the control and dispersal of water collecting on truck haul roads, skid trails, and log landings to minimize erosion and reduce sediment and temperature changes in streams.” (NH DRED, 2004) On the WMNF, these practices appear to be

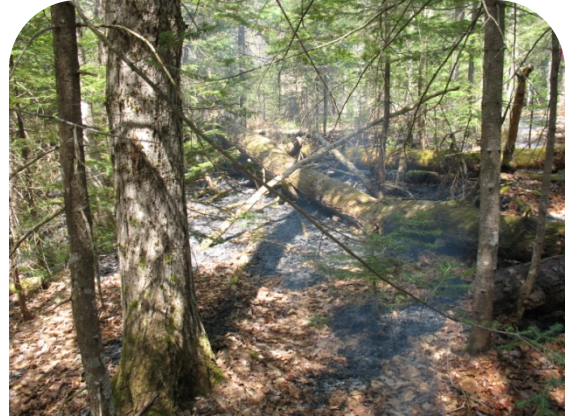
*Camp 7 Prescribed underburn with some of the Oi and Oe consumed. WMNF photo by Andy Colter.*

Prescribed fire is used on the Forest to reduce hazardous fuel loading, prepare sites for restoration of some species, and create, maintain, or improve wildlife habitat. Prescribed burning was used to promote species variation in the Camp 7 underburn part of the Ellsworth Vegetation Management project. Fire was monitored to determine whether soil organic matter in the Oa horizon was consumed by the fire and whether burning resulted in any erosion. While some surface soil organic matter (Oi horizon) may be lost during a prescribed fire, local experience indicates that prescribed burning does not affect rainfall infiltration rates or soil calcium levels. This is because prescribed fires are typically of low severity so most of each site remains covered by organic matter and mineral soil aggregation is not changed. This was the case in the Camp 7 underburn. No organic matter in the Oa horizon was consumed and only some of the Oi and Oe horizons were affected. Some soil nitrogen is probably lost when any organic matter burns, but nitrogen is not considered a limiting factor in tree growth on the WMNF. As a result, there were no detrimental effects.
