Carpenter Ants in Alaska

Alaska Region
R10-TP-156
June 2013

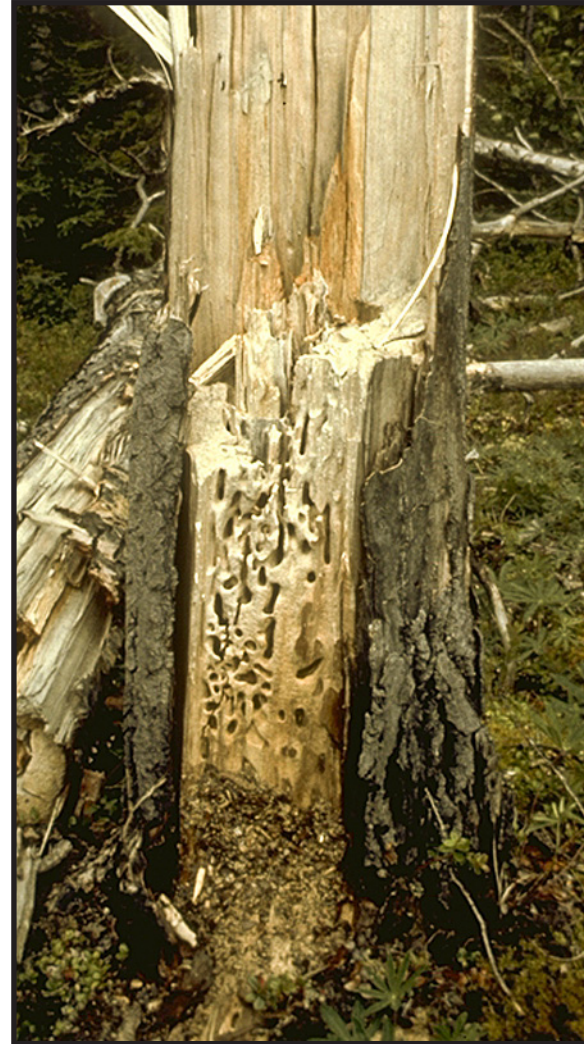
Cover Photo: Carpenter ant gallery in the rotted base of a tree. (Photo: Ed Holsten, USDA Forest Service)

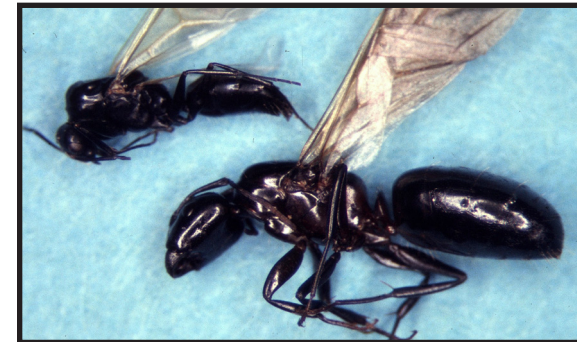
Figure 3: Winged female and a much smaller winged male carpenter ant. (Photo: Whitney Cranshaw, Colorado State University, Bugwood.org)

Queens are generally black while workers will either have some red or brown on their legs or body. Carpenter ants have a smoothly rounded arched shape to the top of the thorax, elbowed antennae, and constricted waists with a single node between the thorax and abdomen. Workers have a large head and small thorax, while swarmers have a smaller head and larger thorax to accommodate flight muscles. Swarmer wings are long, with the forewing longer than the hindwing, clear or brownish with prominent veins (Figure 3).

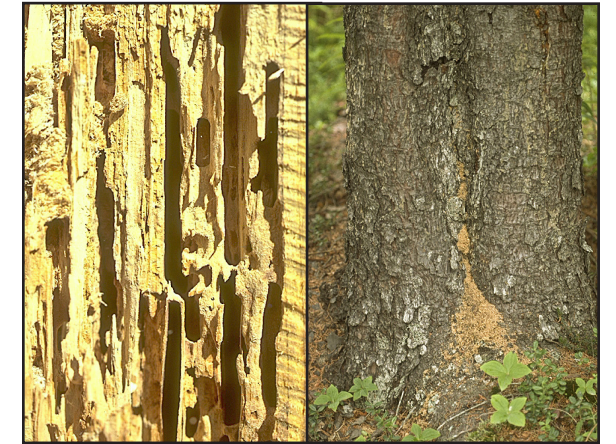
Figure 4. Left: Advanced carpenter ant damage. **Right:** Frass piles are evidence of carpenter ants. (Photos: Ed Holsten and Richard Warner, USDA Forest Service)

Carpenter ants do not eat wood, but excavate galleries to rear their young. They prefer moist (but not wet), deteriorating wood that may be found in existing cavities or void areas in structures. Nests are commonly found in porch pillars, roofs, windowsills, and structural wood in contact with soil. Workers cut galleries in the wood, often extending into adjacent sound wood, expanding the nest size for the enlarging colony. Galleries are irregular, usually excavated with the wood grain (Figure 4a); the walls are smooth and clean with shredded wood fragments (frass) deposited outside of the nest. The clean galleries of carpenter ants are easily distinguished from mud-lined galleries created

The most obvious sign of infestation is the presence of ants inside the house, especially in winter. Carpenter ants may remain active year-round in heated spaces; otherwise they become inactive in the winter. They do most of their foraging at night. Other indications of infestation include piles of the sawdust-like frass expelled from small cracks or openings found in dark closets, under porches, along sills, or at the base of infested timbers (Figure 4b). Carpenter ant frass can be distinguished from regular sawdust by the presence of fragments of ants and other insects mixed with the wood debris.
