Reconstruction of the Nicholson Adit

A Pictorial Summary of the 2010 Effort on the Pulaski Tunnel Trail

Stephan E. Matz
7/12/2010

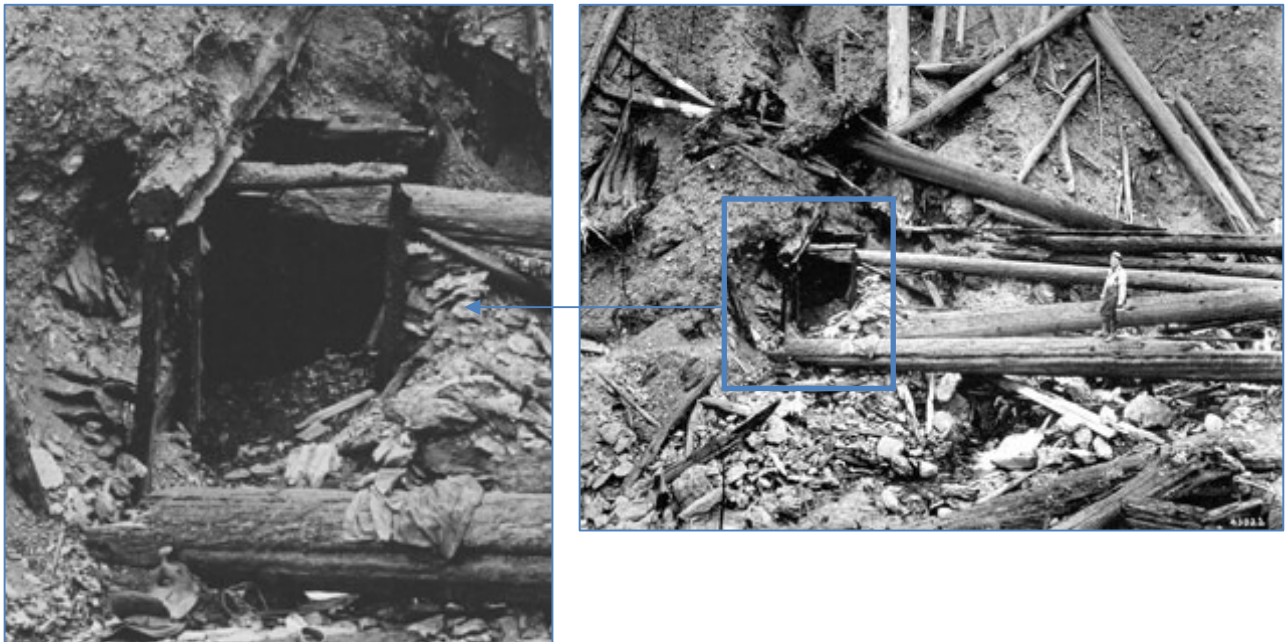
Figure 1. Post fire photograph of W.W. Morris by R.H. McKay of the Nicholson Adit on right and enlarged view of adit portal from same photo on left (photo courtesy of Northern Region Forest Service Archives).

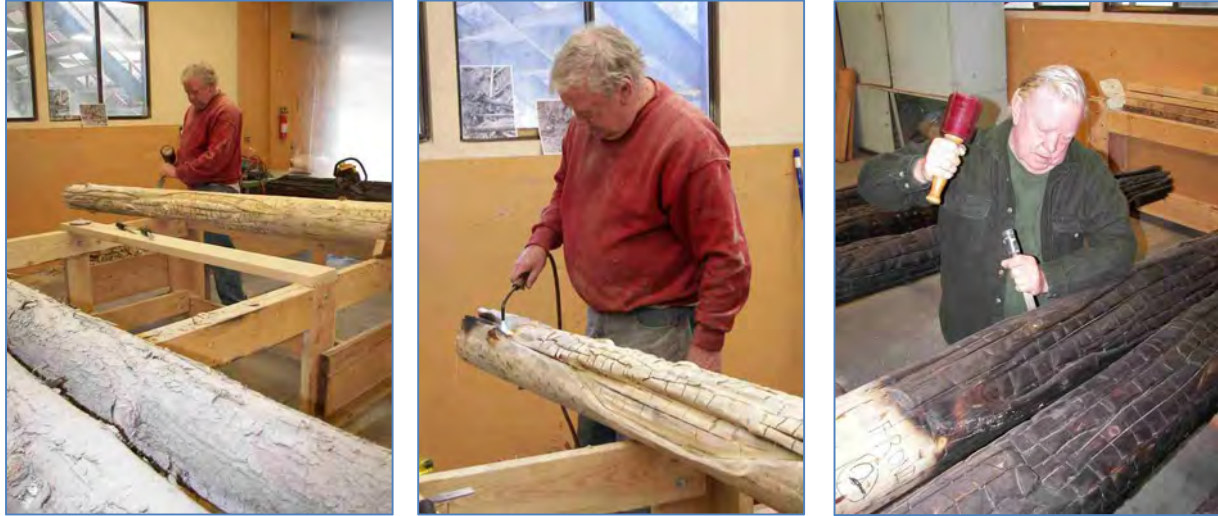
Figure 4. Hal Payne creating posts and caps for Nicholson Adit portal. From left to right: Shaping the log from historic photos, charring the outside of the log to give it the correct color and putting on the finishing touches.

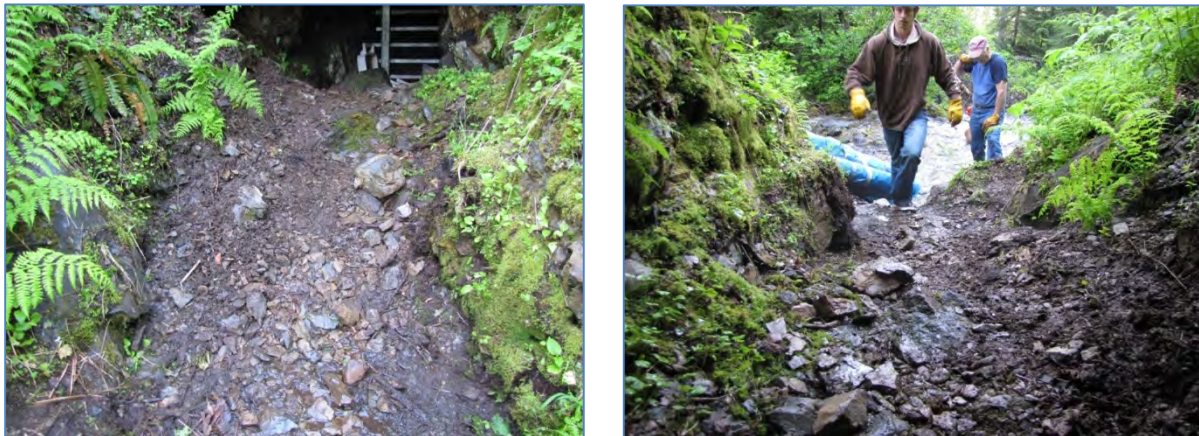
Figure 5. Initial view of the portal area. On the left is the portal from the exterior, while on the right is the portal area from the interior. A large amount of material had caved in since the 1910 Fire, partially closing the tunnel entrance. This material had to be removed in order to place the posts appropriately.

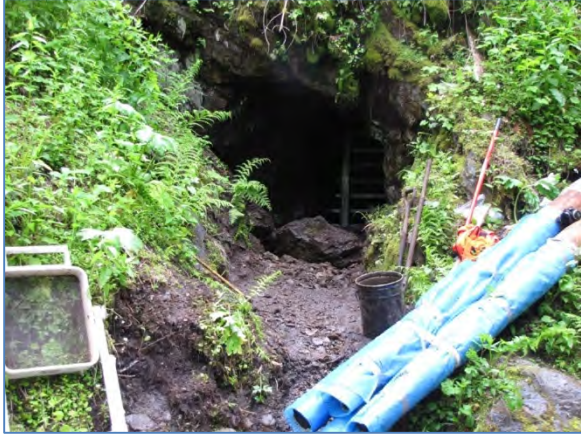
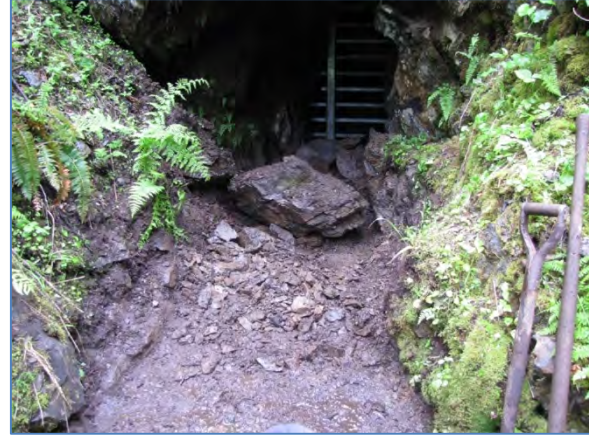
Figure 6. Prior to setting the posts and caps Forest Archaeologist, Steve Matz, systematically removed the material from in front of the portal with a trowel looking for artifacts. Since the material was so wet and rocky it couldn't be screened, but had to be removed very carefully so that any pieces of horse tack or other artifacts associated with the Pulaski crew could be found. All fill material in the area of the posts was removed by trowel down to where clean, undisturbed rock was found. Once troweled the fill was placed back into the mouth of the portal near the metal gate. While only three pieces of heavy sheet metal were found in the fill, contractor Dwight Clift said he had seen decayed pieces of horse tack in the area only several years before.

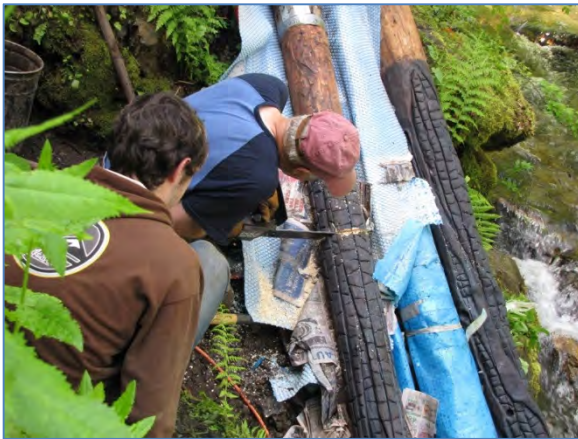
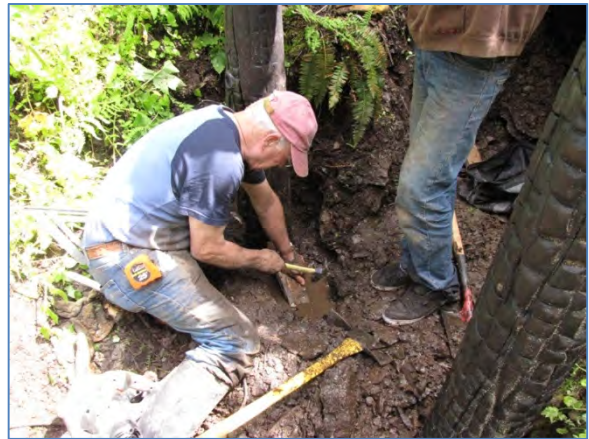
Figure 4. Intial construction of the adit portal sets. Dwight Clift and grandson Steele cut the posts to length with an electric chainsaw (left photo), while Steele steadied the post for Dwight to nail brace into place (right photo).

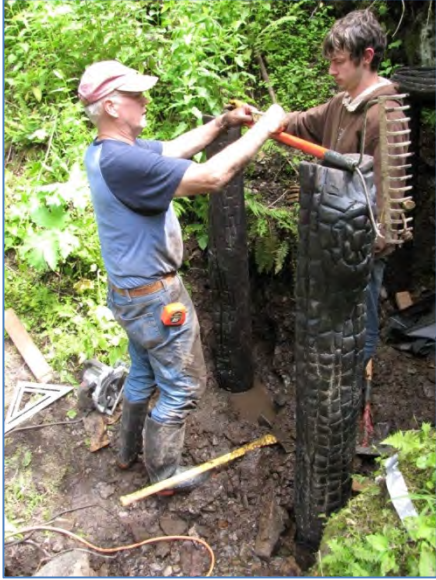
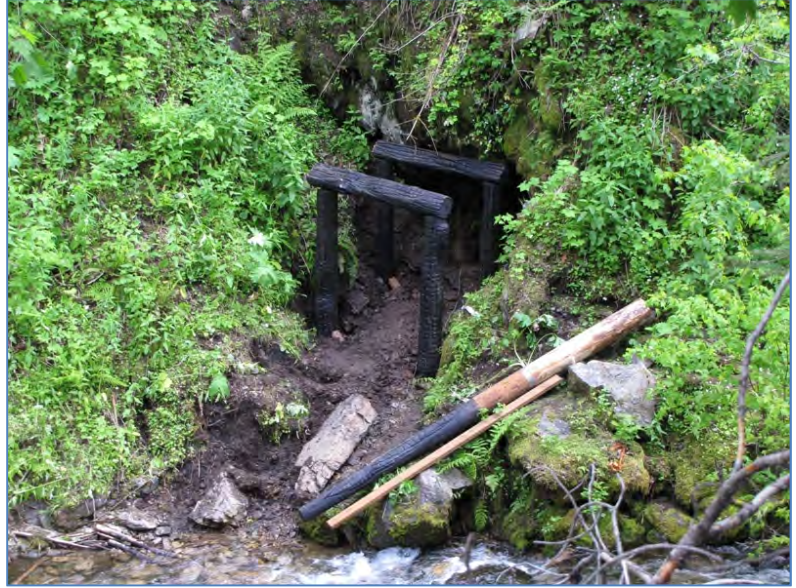
Figure 8. Dwight and Steele level posts in order to set cap log in the left photo, while the right photo shows the two sets nearly finished and the uncut final post lying on the ground.

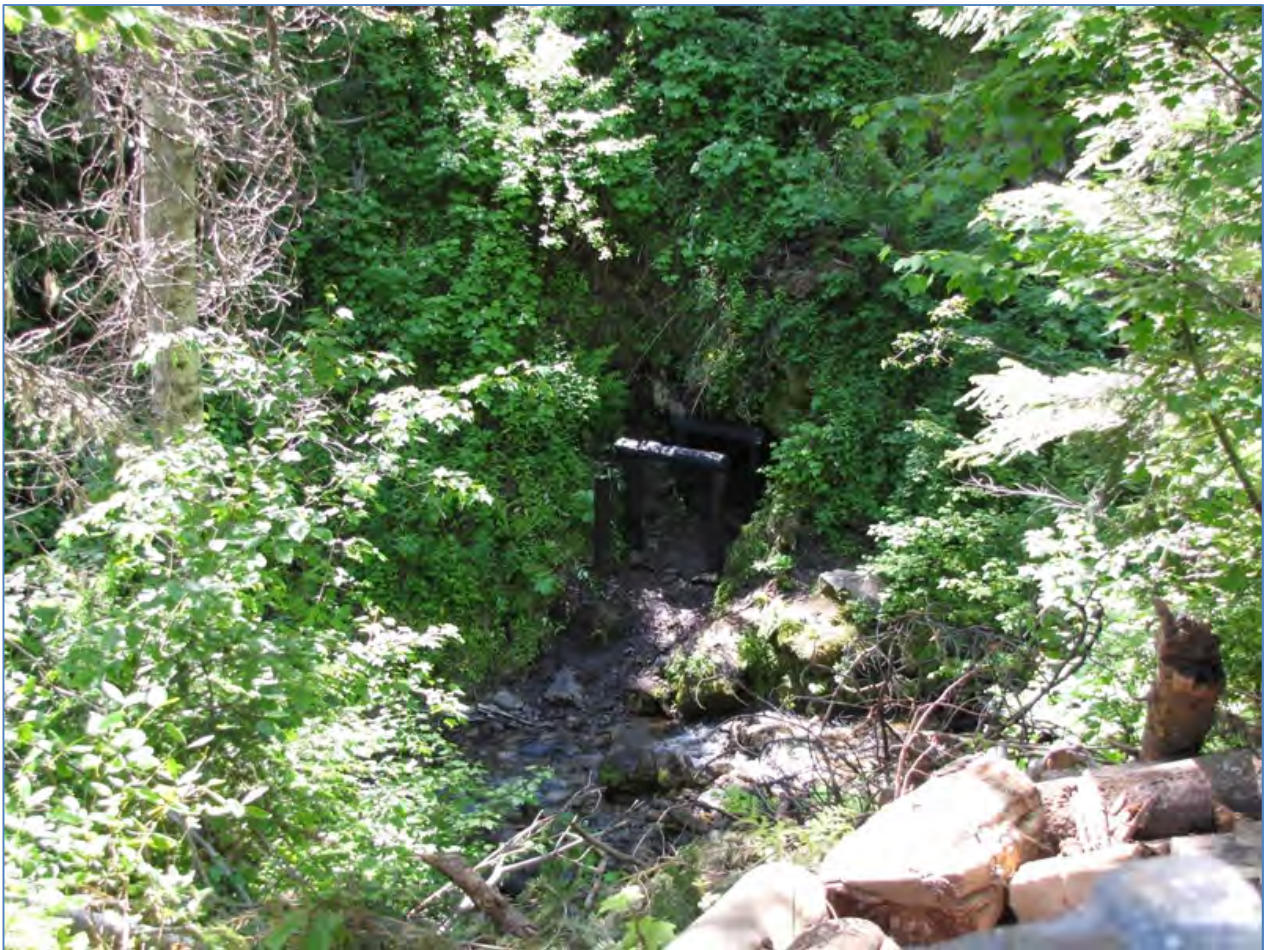
Figure 9. Finished adit reconstruction viewed from Pulaski Tunnel Trail overlook.

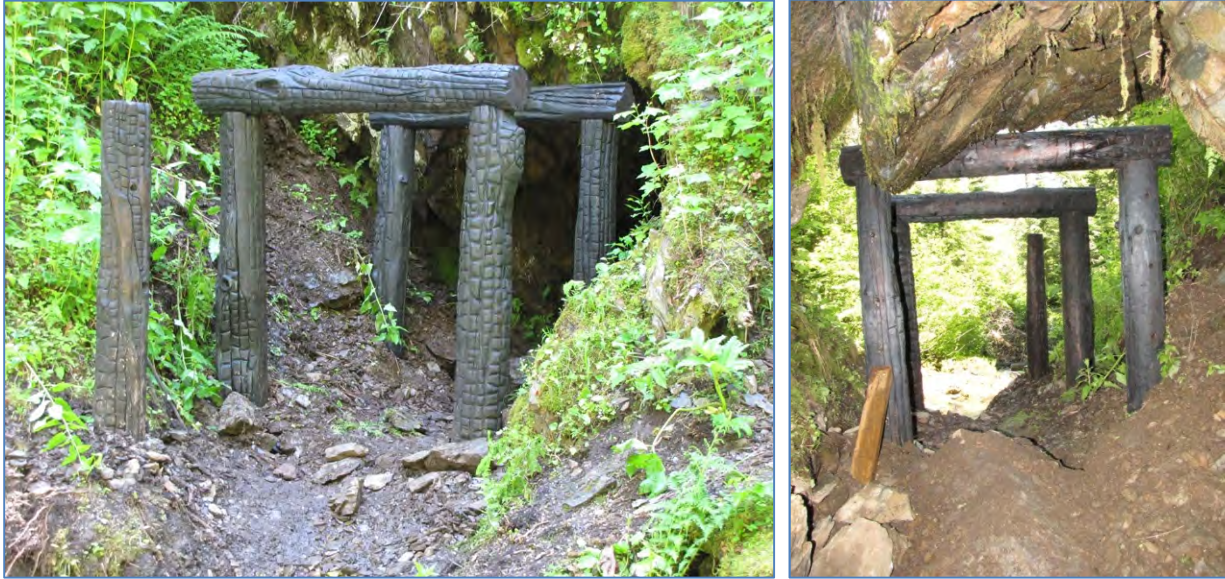
Figure 10. Finished portal reconstruction, viewed from both the exterior (left) and the interior (right) of the adit. Note the brace made of treated 2x4" lumber in the left photo. Each post had a horizontal foot nailed to the bottom that was set in a trench excavated perpendicular to the post. A brace was then nailed to the foot and the post to provide additional support. The braces were covered with soil if they were visible from outside. The braces on the left side as you look out of the portal were set toward the back of the adit, while the braces on the right side were faced toward the adjacent post of the same set (see Figure 7 right). The cap logs were placed in a saddle carved in the top of each post and drilled and fastened with rebar to secure them in place. A marine grade water proofing agent was used on the outside and cut ends of each log to reduce natural deterioration. It is expected that the structure will last about 10 years, which is pretty good considering sets in the Coeur d'Alene mines were generally replaced every three to five years.

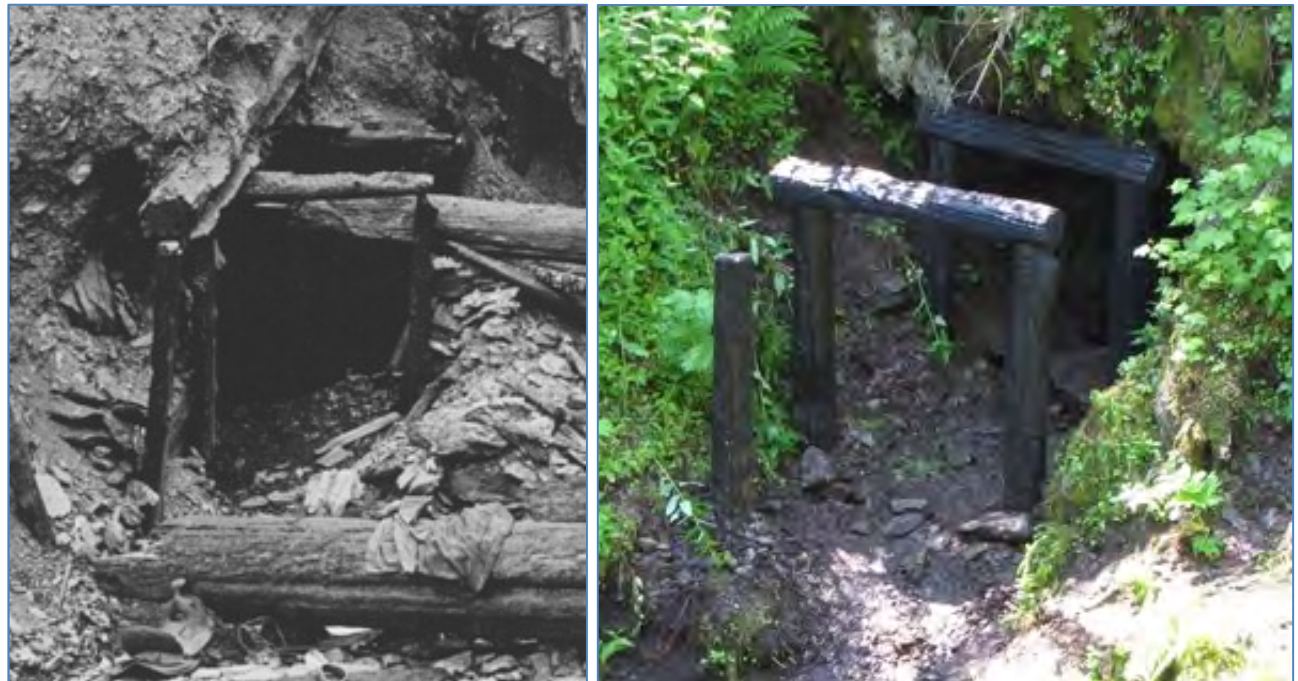
Figure 11. Enlargement of portal section of 1910 McKay photo on left showing original post fire condition and post reconstruction photo taken upon completion of project in 2010 on right.
