United States
Department of
Agriculture

Forest Service

0823 1811—SDTDC
December 2008

Effects of All-Terrain Vehicles on Forested Lands and Grasslands

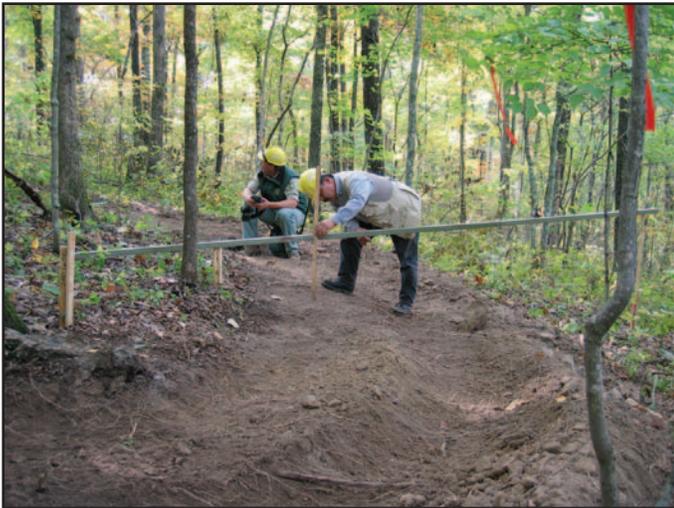
Figure 1—Transect and measurement process.

above. The second assessment was made using cross-section transects. The cross-section transects were designed to measure changes to the trail tread as vehicles made passes over the loops. These measurements were taken each day at the end of the riding period. See figures 1 and 2. Three transects were placed at each of the four transect areas.

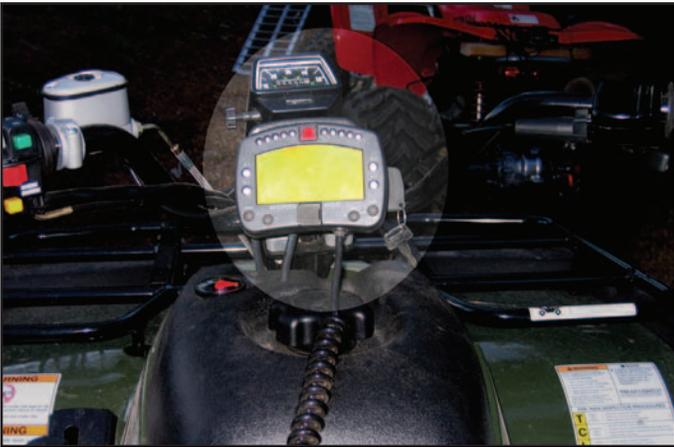
Figure 3—Datalogger.

Utility vehicles were equipped with AIM MyChron 3 Gold dataloggers. This datalogger measured vehicle speed based on the rear wheel. Lap times, engine speed (revolutions per minute [rpm]), and loop distances were also measured. Like the XG Log datalogger, longitudinal acceleration also was calculated. The riders viewed vehicle speed and lap times on a liquid crystal display mounted on the handlebar. See figure 3.

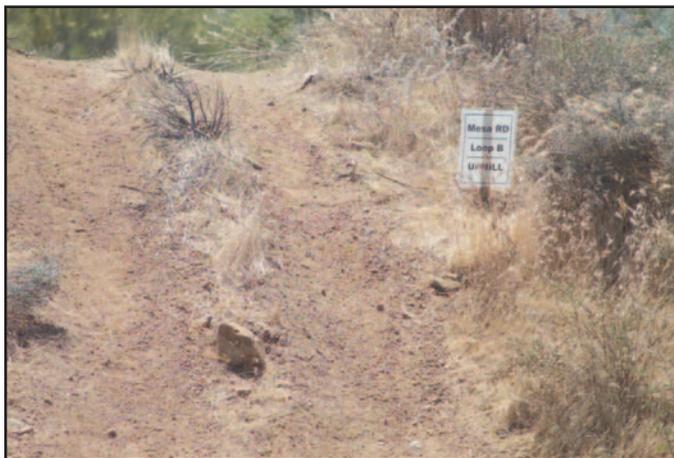
Figure 24—Loop B uphill, rated medium.

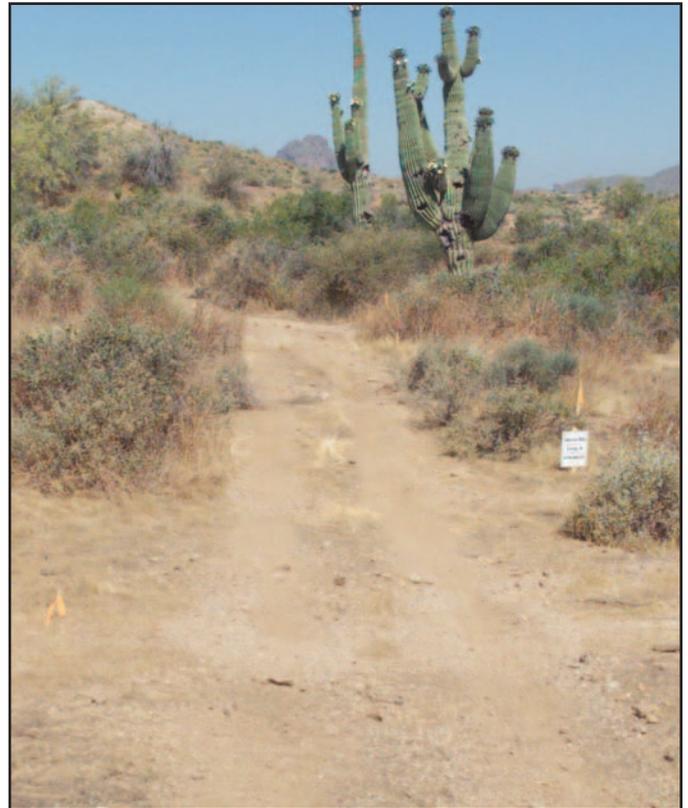
Figure 25—Loop A straight, rated low.

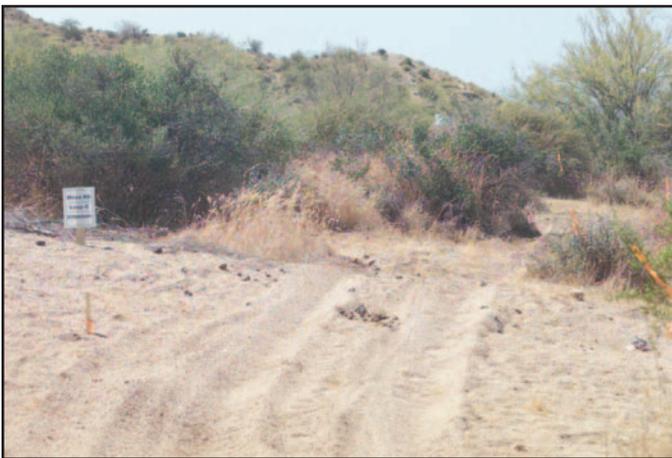
Figure 26—Loop C straight, rated medium.

Loop C reached a high disturbance class in two of the four transect areas and a medium disturbance class in the other two transects. Thirteen of 16 transect areas reached medium or high after only 80 passes. Three had reached bedrock or highly compacted soils after only 40 passes, and condition classes did not change further.

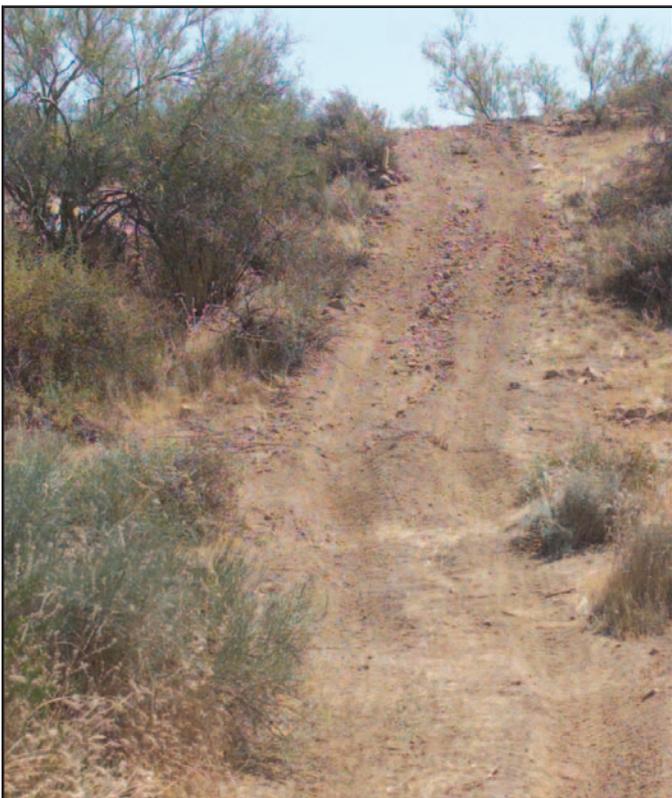
Figure 27—Loop A uphill, rated medium.

Loops A and D showed similar effects moving from low- to medium-disturbance levels between 120 and 160 passes for uphill, downhill, and straight segments of trail.

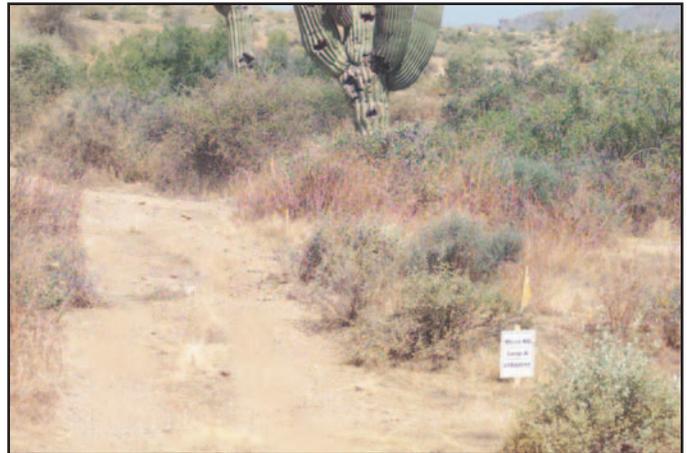
Figure 28—Loop A straight, rated low.

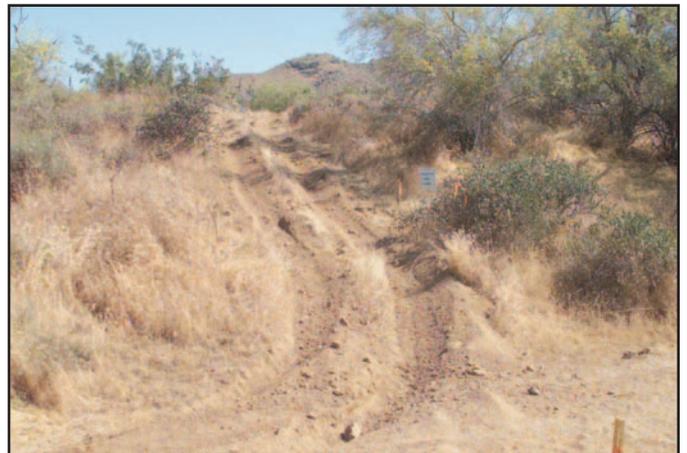
Figure 29—Loop C curve after 60 passes, rated high.

The effects of ATV traffic showed the greatest disturbance in the curves for all loops. Loop C showed the most dramatic change moving from medium to high after 20 additional passes. Riding through the downhill and curve transects was rerouted after 60 passes, and data collection for these transect areas was discontinued. The rerouted section was rated medium after 40 passes.

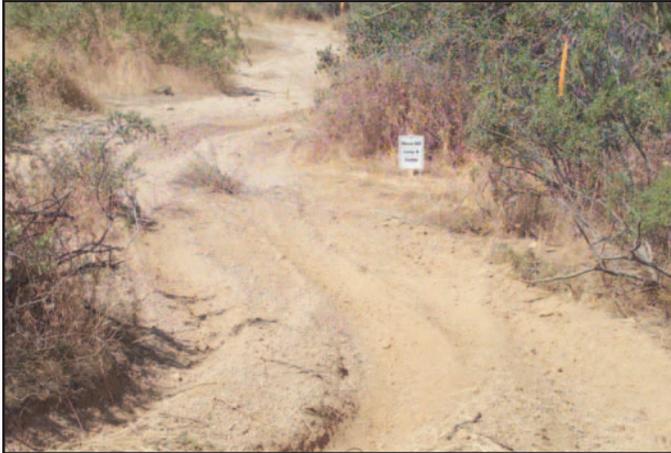
Figure 30—Loop A turn, rated high.

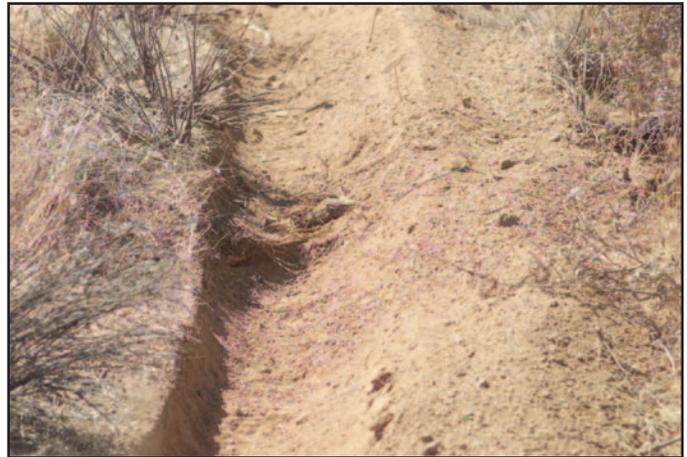
Figure 33—Loop C curve, rated high.

Rut depths up to 16 inches were recorded in the curves and some uphill segments. Shallower (2- to 4-inch) depths were recorded on straight and downhill sections.

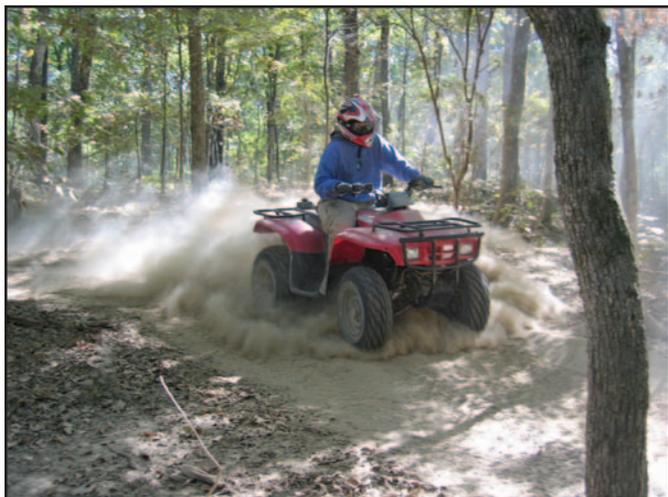
Figure 35—Loop D downhill.

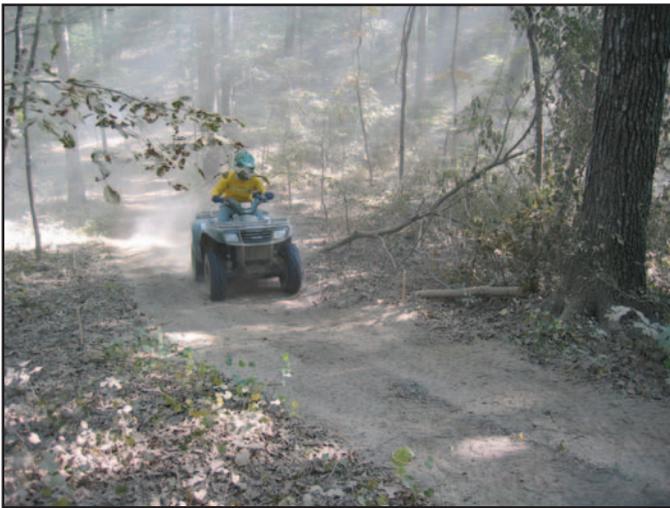
Figure 36—Loop C straight, rated medium.

Between 280 and 800 passes were made on each of the transect areas of uphill, downhill, curves, and straight sections of trail. All trail sections were rated medium or high for all four loops with the exception of loop C's straight section, where a low rating was sustained from 40 to 280 passes (figures 36 through 41).

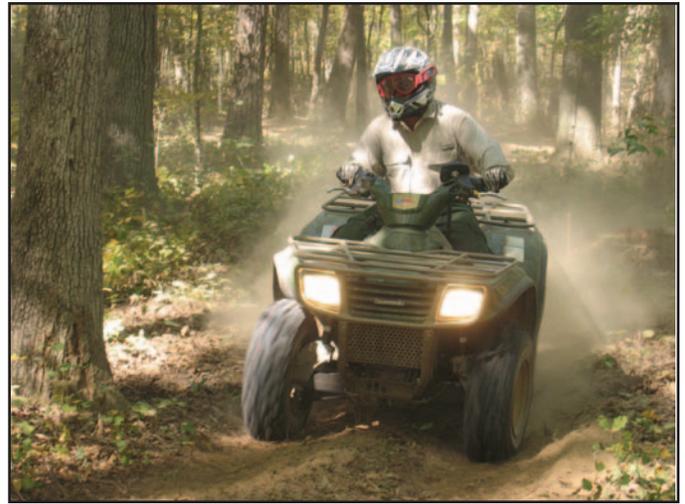
Figure 37—Loop A uphill, rated high.

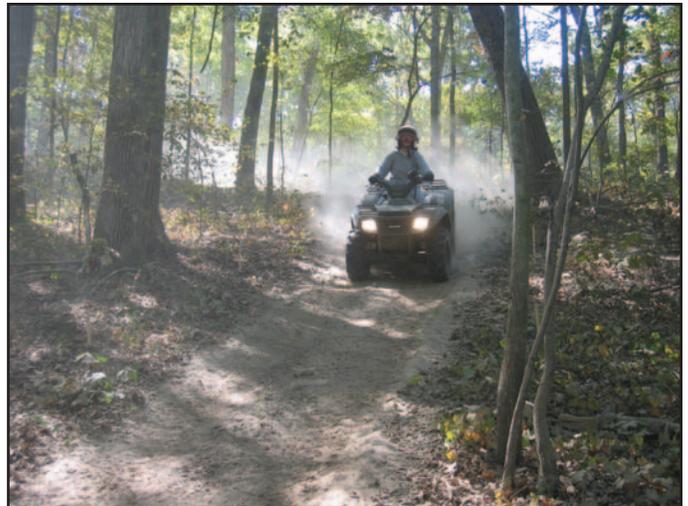
Figure 38—Loop B downhill, rated medium.

For uphill and downhill section on loop B, a high rating was indicated at 320 and 640 passes, respectively, and remained high for the test's 800 passes.

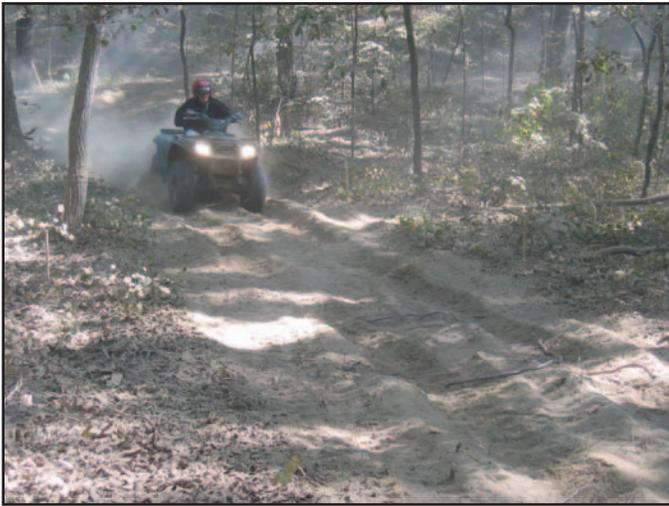
Figure 39—Loop A downhill, rated high.

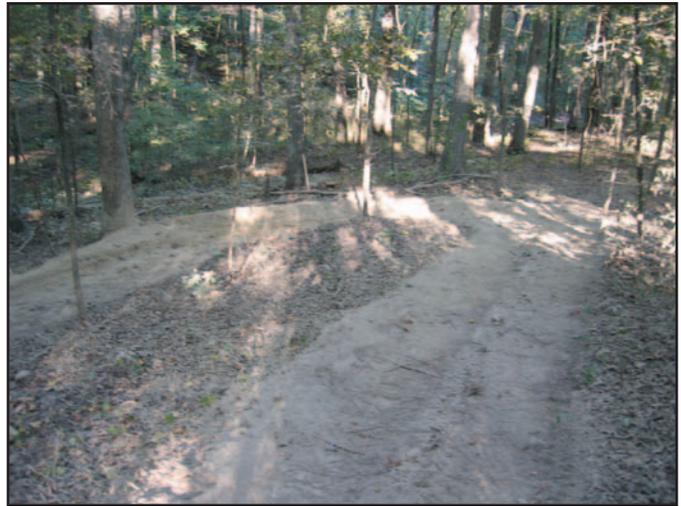
Figure 40—Loop D turn, rated high.

ATV use in curves appeared to show the greatest effects on loops A and C. On loop A, the rating was high after only 40 passes, and on loop C, a high rating was indicated after only 80 passes. Riding through this transect was rerouted after 162 passes, and data collection was discontinued. The curve for loop B indicated a high rating at 320 passes, but fluctuated between medium and high until 680 passes, when a high rating was continued through the test's 800 passes. On loop D, the condition-class rating of medium was indicated from 40 through the test's 280 passes.

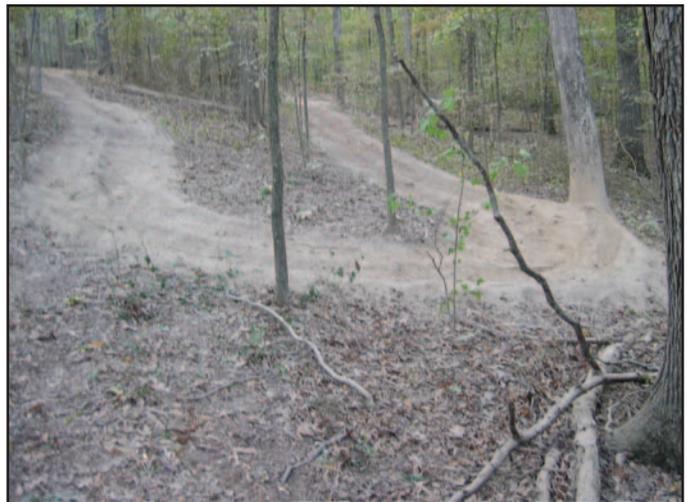
Figure 41—Vegetation/cover completely removed on loop D turn.

Vegetation cover was reduced from 41 to 99 percent on all loops. Conversely, on all loops, bare soil was increased by 43 percent on straight sections and up to 58 percent on curves. In the curves on all loops, bare soil increased from a before-riding level of 5 percent to an after-riding level of 58 percent (figures 42 and 43). Vegetation cover was conversely reduced from 95 percent before riding to 42 percent after riding.

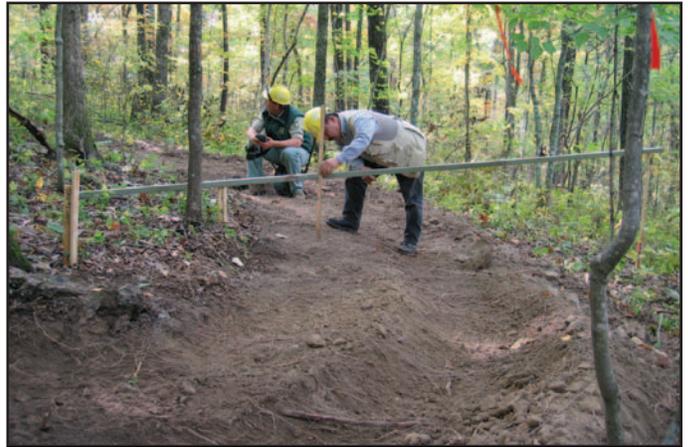
Figure 44—Rut depths of 1 to 4 inches were recorded.

Rut depths to 4 inches were recorded in the turns, with the trail widening up to 6 feet. Rut depths to 3 inches were measured in uphill segments, with the trail widening to 3 feet in these segments. Rut depths of 1 to 4 inches were recorded on straight and downhill sections (figure 44).

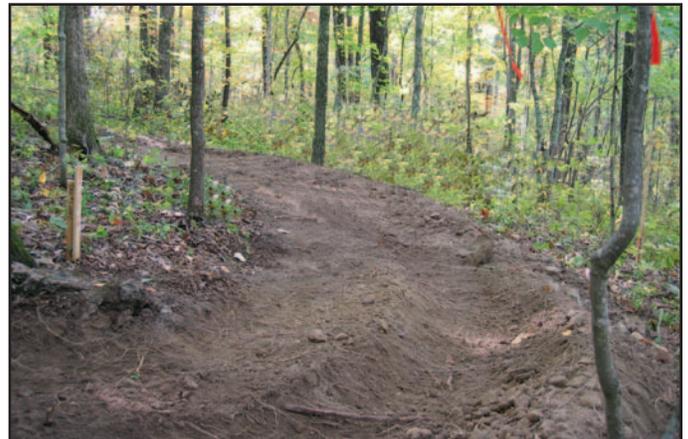
Figure 45—Loop C turn, rated high.

ATVs for loops B and D were fitted with aftermarket tires that appear to have influenced ratings in all sections on loop D. ATVs for loops A and C were fitted with OEM tires and showed much higher condition-class ratings overall (figures 45 and 46).

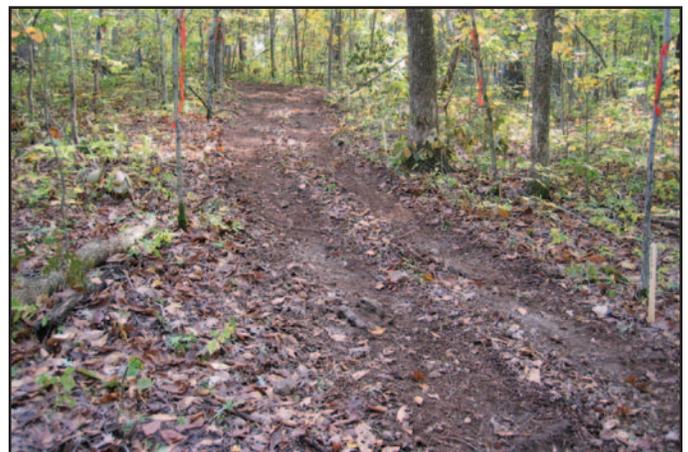
Figure 46—Loop A downhill, rated low.

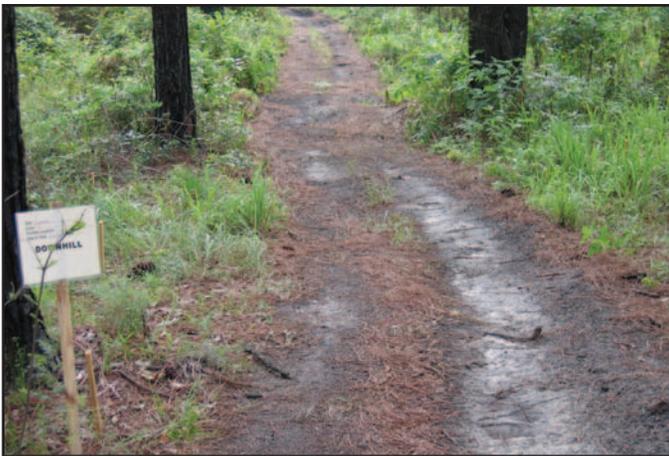
Figure 48—Loop C downhill, rated low.

Between 480 and 740 passes were made over the four transect areas of uphill, downhill, curve, and straight segments. Downhill and straight trail segments were rated low for all four loops, with two exceptions. Loop B indicated a change from low to medium at 640 passes and loop D indicated a change from low to medium at 720 passes.

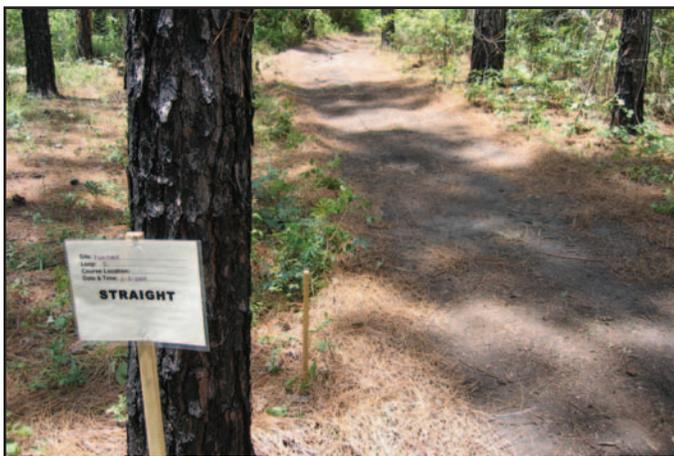
Figure 49—Loop C straight, rated low.

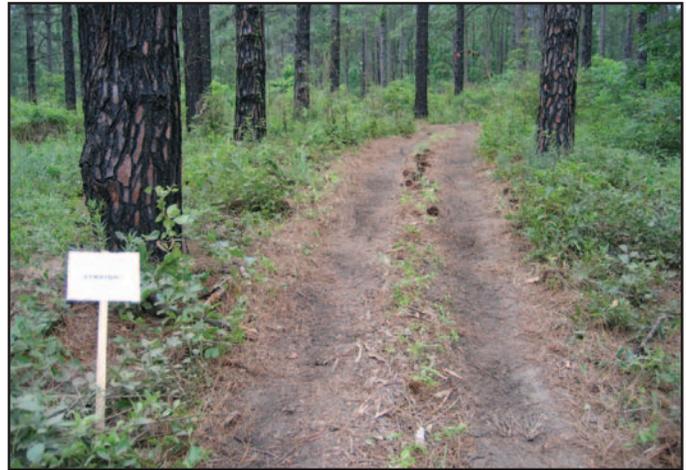
Figure 50—Loop A straight, rated low.

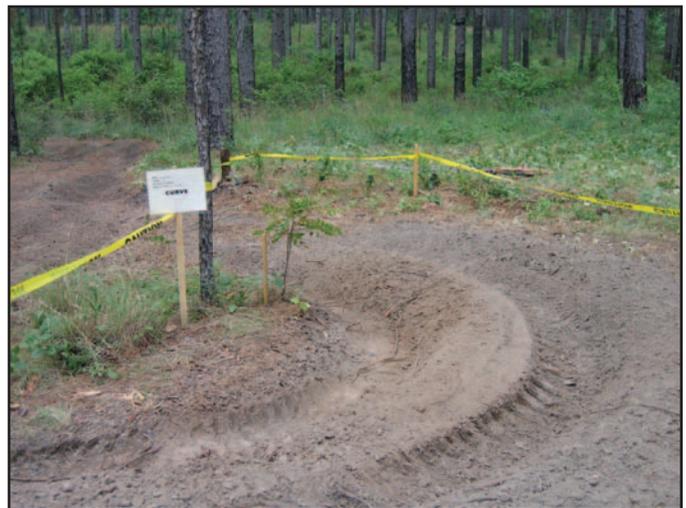
Figure 51—Loop B turn, rated high.

ATVs appeared to have the greatest effects in curves. On loop B, the condition-class rating changed from low to high after only 160 passes. Riding through this transect was rerouted after 162 passes and data collection was discontinued. The curve in loop C demonstrated a similar dynamic. The condition class changed from low to medium at 80 passes and riding was terminated after 200 passes out of concern for rider safety.

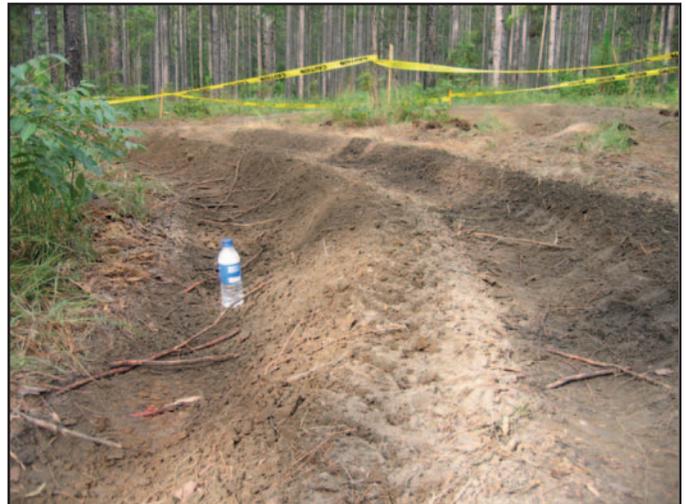
Figure 54—Loop B, 8-inch rut on the turn.

Rut depths up to 8 inches were recorded in the curves with trail-shoulder mounding up to 9 inches in curve segments (figure 54). Rut depths up to 4 inches were measured in uphill segments with the trail-shoulder mounding up to 6 inches in these segments. Shallower depths, 0.5 to 3 inches, were recorded on straight and downhill sections.

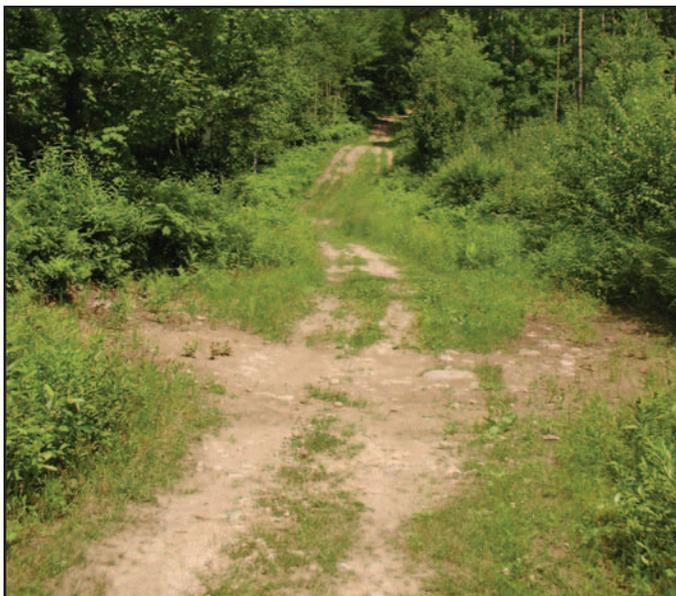
Figure 56—Loop C uphill, rated low.

At each segment, three cross sections were placed to record changes to the natural resources that included changes to vegetative cover and soil profile. The three cross sections were extended to approximately 30 feet to reflect the lessons learned in Louisiana. A pretest soil core sample was taken at each of the four trail sections on loops A and B, and at two sections on loops C and D (figures 56 and 57).

One of the few times we had the opportunity to observe ATV effects on an existing trail was on loop C. Loop C was located on an existing road that was primarily used as a snowmobile route and for logging access. An uphill segment was set up in the shoulder of the road using a bypass on the return trip to prevent double counting. The straight segment was set up in the roadbed itself. A bypass was not setup for the return trip, and double counting was allowed. Data collection for the downhill and turn segments were omitted but observed.

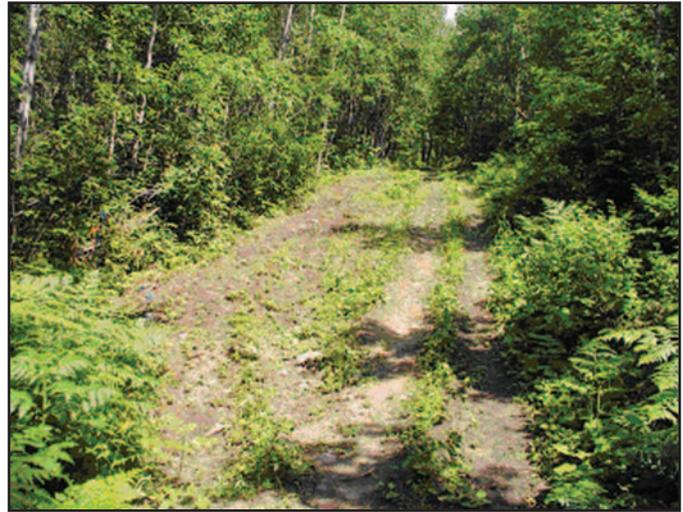
Figure 57—Loop D, rated medium.

Loop D was located on an existing cross-country ski trail and thought to be used previously as a skid trail for logging. An uphill area and a sharp hairpin curve were cleared of vegetation for use as test sections. These test sections were on predominantly uncompacted soils. Data collection for the downhill and turn segments were omitted but observed.

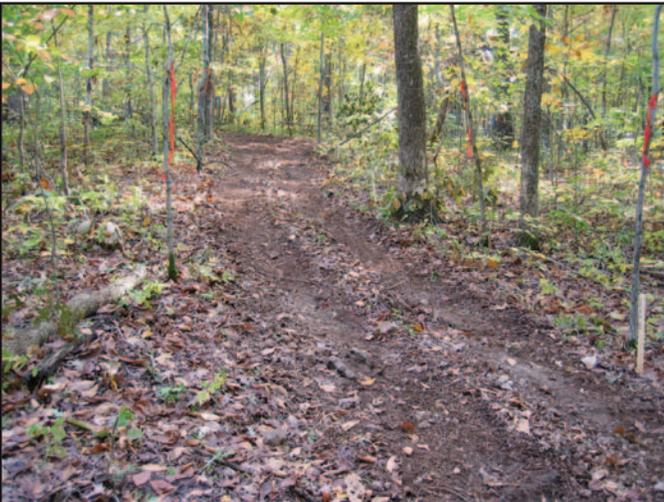
Figure 64—Loop A downhill, rated low.

Loop A changed from low to medium at 160 passes in the downhill section of the trail, and loop B changed from low to medium at 280 passes in the downhill section as well.

Between 480 and 560 passes were made over the transect areas on each of the uphill, downhill, curves, and straight sections of trail (figures 63-69). The downhill section of trail was rated low for loop D and low for loop C until after 500 passes, when the rating changed to medium.

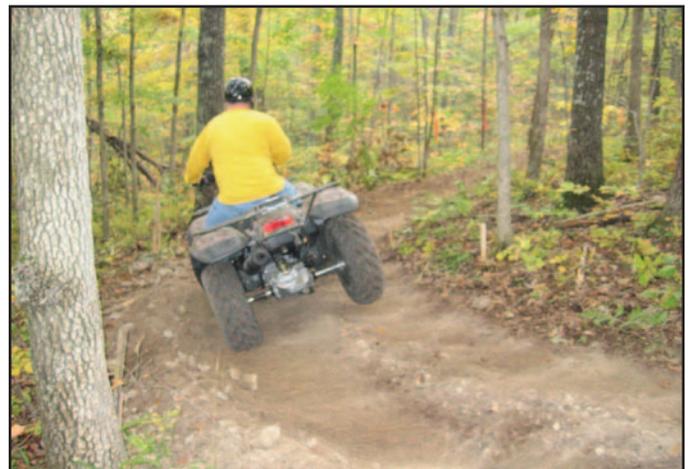
Figure 66—Loop B, rated high.

ATV use in curves on loops A and B indicated the greatest effects early in the number of passes. On loop A, the condition-class rating changed from medium to high after only 80 passes. The curve for loop B demonstrated a similar dynamic. Its condition-class rating changed from medium to high at 80 passes, fluctuated back to medium at 120 passes, and then back to high for the remainder of the test's 520 passes.

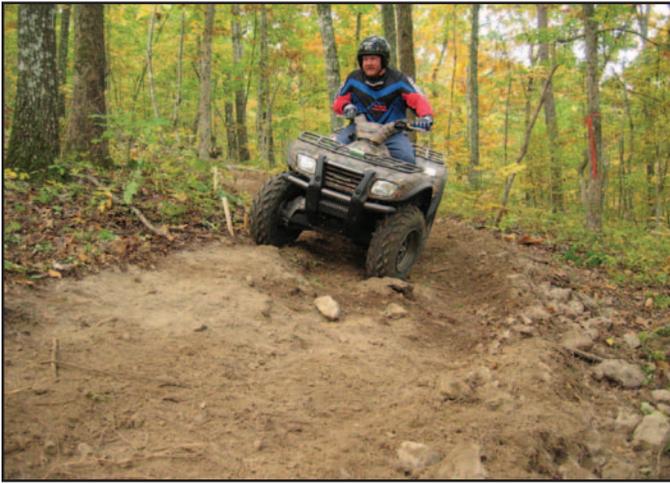
Figure 67—Loop A turn, rated high.

ATV use in turns appeared to show the greatest effects on loops B and D. On loop B, the rating was high after only 80 passes and, on loop D, a high rating was achieved after only 40 passes. Riding through this section was discontinued after 80 passes, as a high-condition class was reached and sustained. The turn for loop A indicated a high rating at 240 passes, after a medium rating was sustained from 40 through 200 passes.

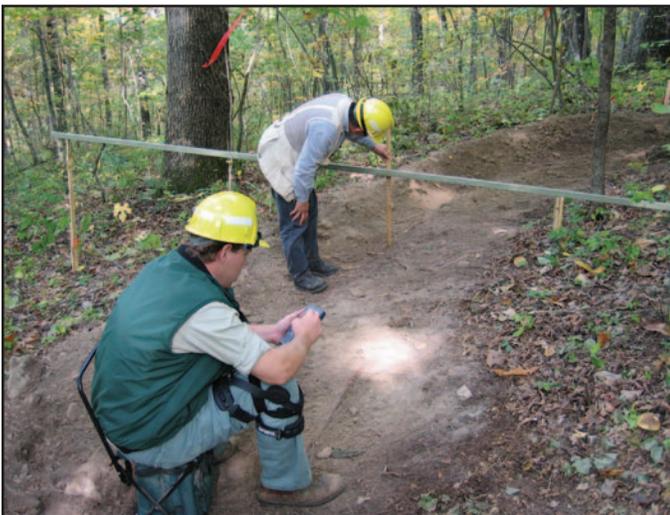
Figure 68—Loop C turn, rated high.

The effect rating for the curve section on loop C changed at 120 passes from low to medium and changed at 480 passes from medium to high and remained at high for the remaining passes. Loop D changed from low to medium at 280 passes.

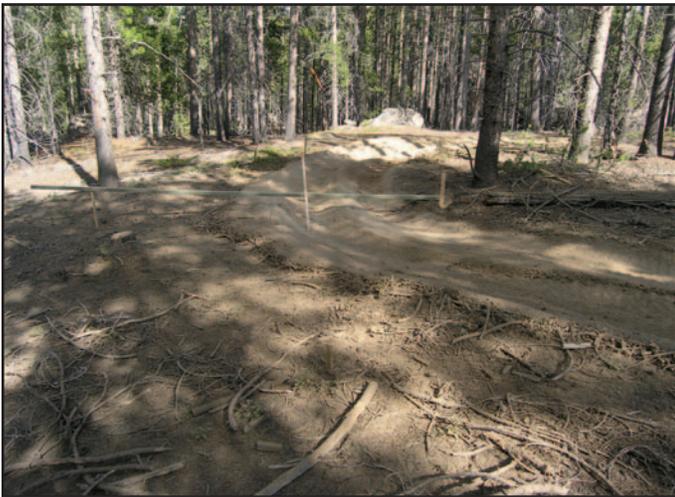
Figure 73—Loop C turn, rated high.

Between 840 and 960 passes were made over the transect areas on the trail's uphill, downhill, curves, and straight sections. Downhill and straight sections of all four trail loops were rated high, with one exception. Loop C changed from low to high at 120 passes on the downhill section of the trail and remained at a high condition class to the end of the test, 960 passes. Loop D changed from low to medium at 640 passes on the downhill section of the trail and remained the same to the end of test, 960 passes (figures 73 through 76).

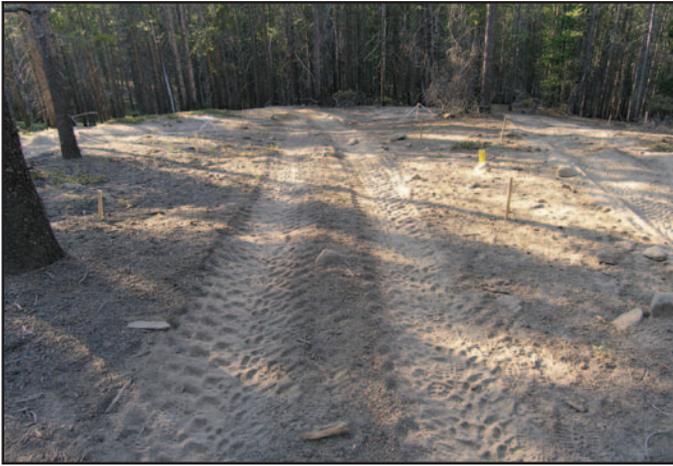
Figure 74—Loop B downhill, 640 passes rated medium.

On the downhill section of loop A, a medium condition class was indicated at 340 passes and remained medium through the rest of the test, 960 passes. On the downhill section of loop D, the condition class was low until 640 passes and then medium for the remaining test, 960 passes. On loop B, the downhill section indicated a low from the start of the test through 280 passes, at which time a medium was indicated generally through to the end of the test, 840 passes. At 400 passes—and from 640 to 720 passes—a low was indicated briefly.

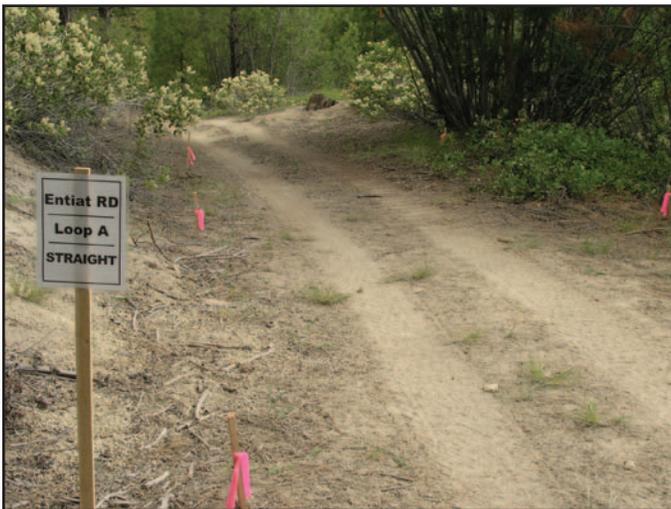
Figure 80—Loop A straight.

The straight section of loop A also remained at a low condition class throughout the 240 passes.

Between 240 and 960 passes were made on each of the transect areas of uphill, downhill, curves, and straight sections of trail. All curve sections of trail were rated medium or high, with the exception of loop C. This exception was due to the fact that the curve was abandoned on this loop (figures 80 through 86).

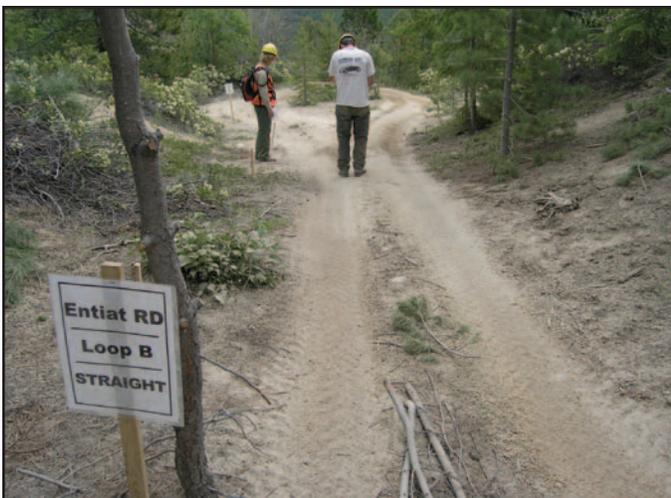
Figure 81—Loop B straight after 960 passes.

On loop B, the straight section indicated a low rating until 480 passes, when the condition class rose to medium. The rating remained medium to the end of the test, 960 passes.

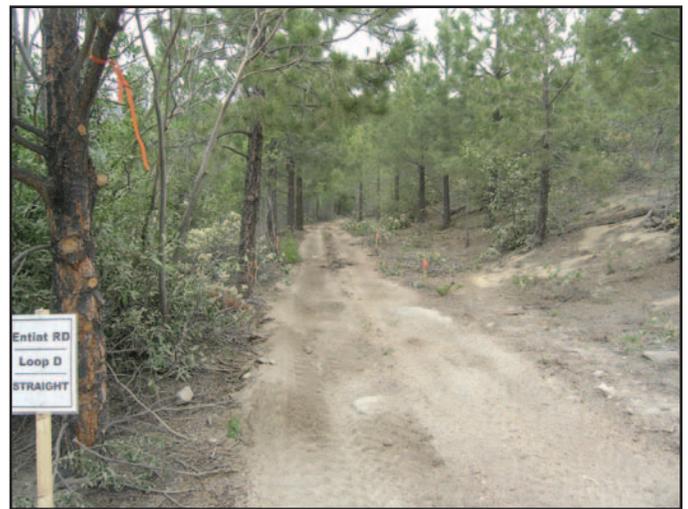
Figure 82—Loop D after 440 passes.

On loop D, the condition class was low from 40 through 120 passes. At 160 passes, it switched to medium and remained the same to the end of the test, 440 passes.

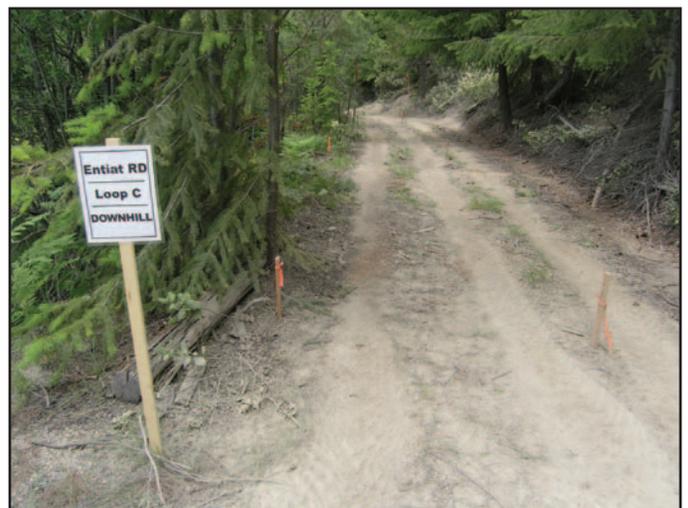
Figure 83—Loop C downhill, rated low.

The downhill section of loop C remained low until 200 passes, when it increased to medium. The condition class reverted to low again on the downhill section at 240 passes.

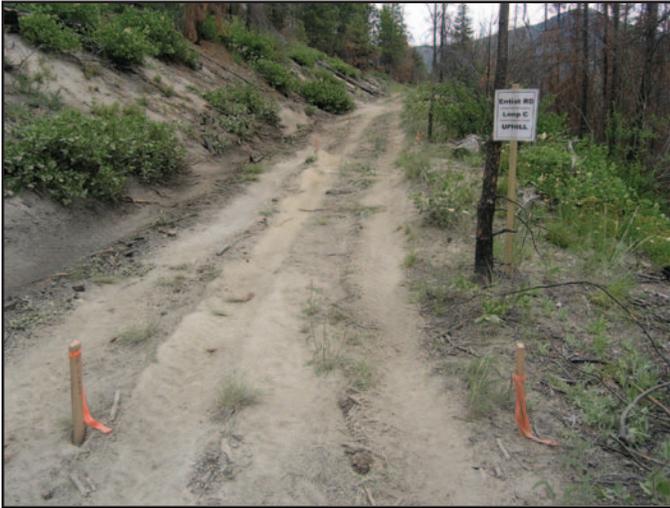
Figure 84—Loop C uphill, rated low.

On the straight and uphill sections of loop C, the condition-class rating remained low from 40 passes through the end of the test, 240 passes.

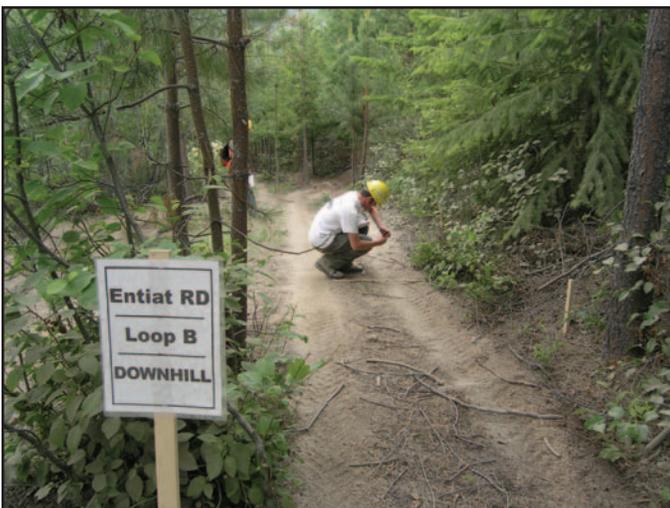
Figure 85—Loop B downhill, rated medium.

On loop B, on uphill and downhill sections, a medium rating was indicated at 240 passes and 480 passes, respectively, and remained medium to the end of the test, 480 passes. On loop D, a medium rating was achieved on the uphill section at 240 passes and through the end of the test, 440 passes. Again on loop D, a medium rating was achieved on the downhill section at 80 passes. On this section, a medium rating was sustained to the end of the test, 440 passes.

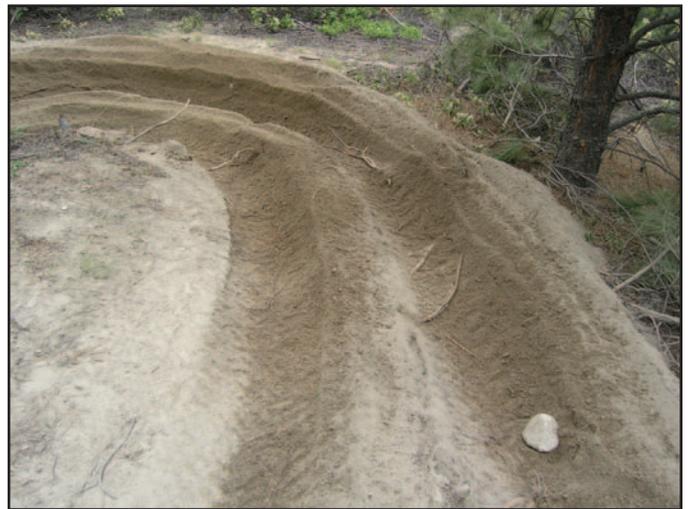
Figure 90—Loop D turn, rut depth 10 inches.

Rut depths up to 10 inches were recorded in the turns, with the trail widening to 6 feet. Rut depths up to 3 inches were measured in uphill segments, with the trail widening to 4 feet in these segments. Rut depths of 1 to 4 inches were recorded on straight and downhill sections (figures 89 and 90).

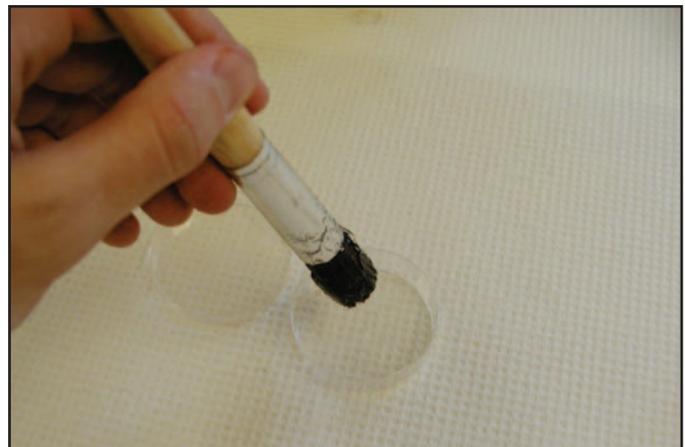
Figure 2—Preparation of “sticky-trap” dust collector.
