U. S. FOREST SERVICE RESEARCH NOTE PSW-29 1963

"FIRST AID" FOR BURNED WATERSHEDS

ABSTRACT: Most of the vegetative cover on the San Dimas Experimental Forest was destroyed by a wild-fire in 1960. Following the fire an emergency research program was initiated to test several "first-aid" treatments aimed at reducing flood and erosion damage from burned watersheds. This paper summarizes first- and second-year results of the research program.

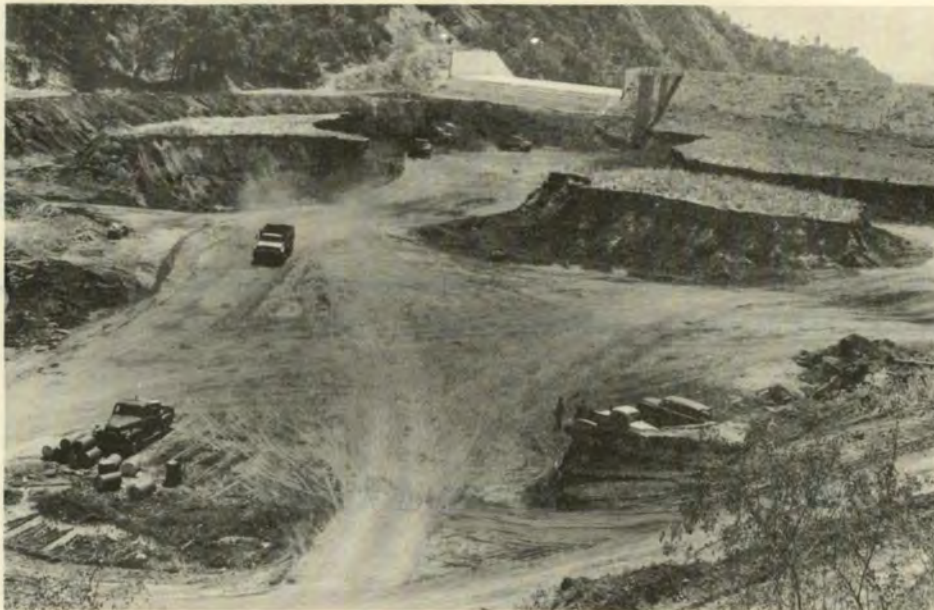
↑ Figure 1.--Material deposited in a debris basin during the rainy season of 1961-62 is removed to maintain storage capacity.

Wildfires destroyed more than 70,000 acres of brush-covered watersheds in the San Gabriel Mountains in July 1960, and about 15,000 acres of the San Dimas Experimental Forest were burned in one fire. Burned southern California watersheds have long had a reputation for extreme erosion rates (fig. 1) and high flood discharge records. Consequently, after that disastrous month, an emergency research program was started on the experimental forest to test several "first-aid" treatments. These treatments are aimed at reducing the flood and erosion damage that usually follows fires in these steep mountains. This note presents quantitative data on peak discharges and debris production to augment the qualitative results previously published, and presents second-year results of the research program.

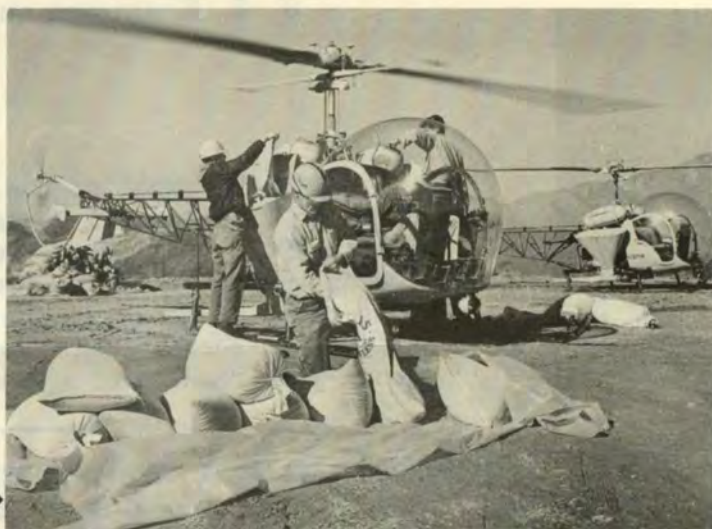
Figure 2.--Crew loads seed hoppers for broadcast sowing of grass on experimental watersheds. →

The methods under study include broadcast seeding of annual and perennial grasses (fig. 2), large contour trenches, small channel stabilization dams, and contour row plantings of barley (fig. 3). Twenty small (2- to 8-acre) gaged watersheds make up the study areas.

A mixture of annual grass seed, the most widely used "first-aid" treatment in southern California, was broadcast on the watersheds at two rates: 20 pounds per acre and 2.25 pounds per acre. Ryegrass (*Wimmera 62* ryegrass, *Lolium rigidum*) and Blando brome (*Bromus mollis*) were the annual grasses sown.
